<b>Coal Tip Name</b>	<b>Godre'r-Graig Higher / Pentwyn No. 3 Levels</b>		<b>Tip Ref Number</b>	<b>L044C</b>		
			<b>Ownership Status</b>	<b>Private</b>		
<b>Located In</b>	<b>Godre'r Graig, Neath Port Talbot</b>		<b>Tip Category</b>	<b>D</b>		
<b>Inspection Led By</b>		<b>Date of Inspection</b>	<b>09/09/2024</b>	<b>Date of last Inspection</b>	<b>08/11/2023</b>	
<b>Weather</b>	<b>Sun</b>		<b>Dry</b>		<b>Calm</b>	
<b>General Remarks</b> (e.g. access, limitations)	<p>Access to the site gained via access track to Pentwyn Farm, leading from Graig Road, Godre'r Graig.</p> <p>It should be noted that this inspection was conducted without the benefit of a detailed site plan; whilst in certain areas vegetation limited accessibility and visual inspection. Therefore, instability within these areas could exist but was not detectable at the time of the inspection.</p>					
<b>Features Causing Concern</b>			<b>Description</b>

<b>Coal Tip Name</b>	Godre'r-Graig Higher / Pentwyn No. 3 Levels	Tip Ref Number	L044C
		Tip Category	D
Date of Inspection	09/09/24	Inspection led by

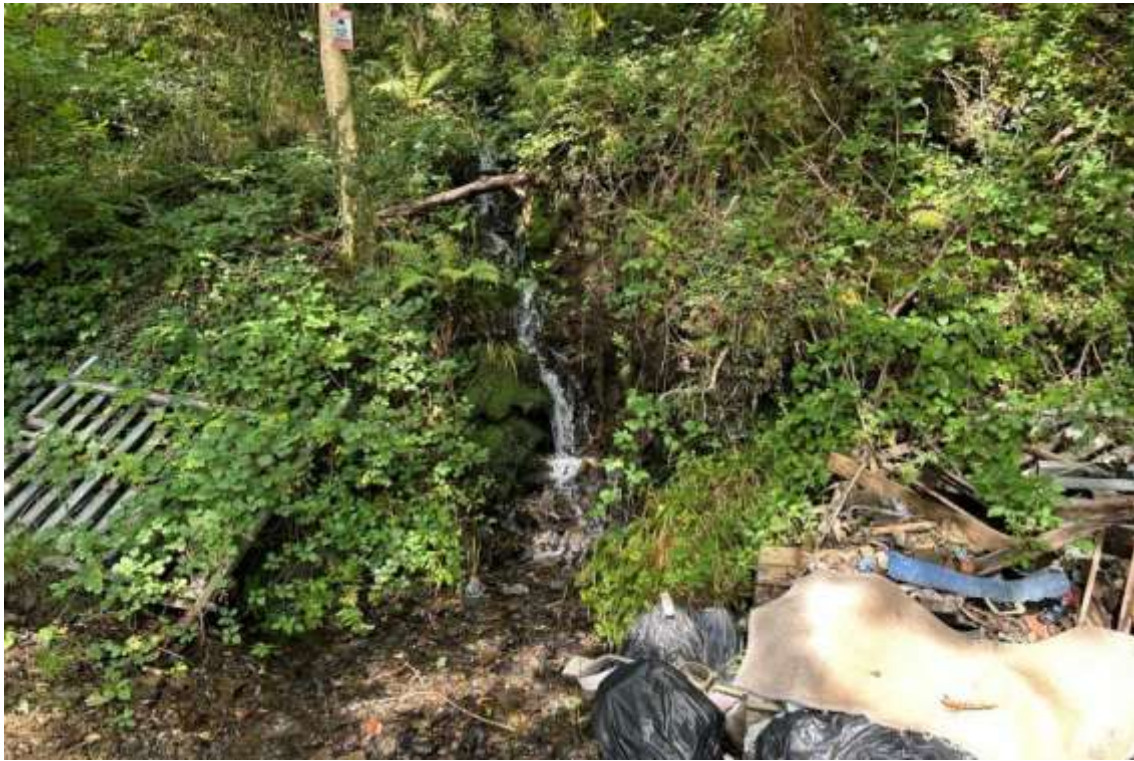
i.	Uncontrolled flows; associated scouring and undercutting (Photo 1,2 & 11).		
			ii.	Flows observed seeping from the embankment adjacent to the gated driveway of the residential property of Glanderri, situated off the toe of the tip (Photo 3).		
			iii.	Poor condition of the retaining wall structure associated with the residential property of Glanderri, situated along the access track off the toe of the tip (Photo 4-5).		
<b>Item</b>		<b>Change to Condition</b> (New, Worse, No Change or N/A)	<b>Description</b>			
<b>Ground Movement</b>						
1	Within body of the tip	No Change	Minor, shallow surface slip situated along the toe of the tip, adjacent to the access track. Natural ground material has been exposed across the slip surface, with a thin veneer of overlying spoil material evident (Photo 7). No evidence of recent ground movement observed at the time of inspection.			
2	Above the tip	No Change	Cilmaengwyn landslide (ID - 3549). No evidence of recent ground movement observed at the time of inspection.

No Change	toe. Resultant minor scour and undercutting of the tip body observed (Photo 1 & 11). Longstanding scour of the access track situated off the toe of the tip, induced by issues which discharge off the toe (Photo 2).
<b>Pollution &amp; Contamination</b>			
16	Invasive species	N/A	None observed.
17	Fly tipping	No Change	Disused plant vehicle and associated equipment discarded on the north-eastern section of the tip plateau. Presumably stored by land owner rather than fly tipped (Photo 9).
<b>Land Use</b>			
18	Has the land use change	No Change	No evidence of a recent change in land use observed at the time of inspection.
19	Has there been any excavation	No Change	No evidence of excavation observed at the time of inspection.
20	Has there been any material deposited	No Change	No evidence of deposited material observed at the time of inspection.
21	Is there sign of burning	No Change	No evidence of burning observed at the time of inspection.

<b>Photo No.</b>	1	<b>Comment</b>	Issues which convey through the body of the tip discharging off the toe. Resultant scour and minor undercutting observed. Flows discharge onto the access track situated adjacent to the property of Glanderi.
------------------	---	----------------	--

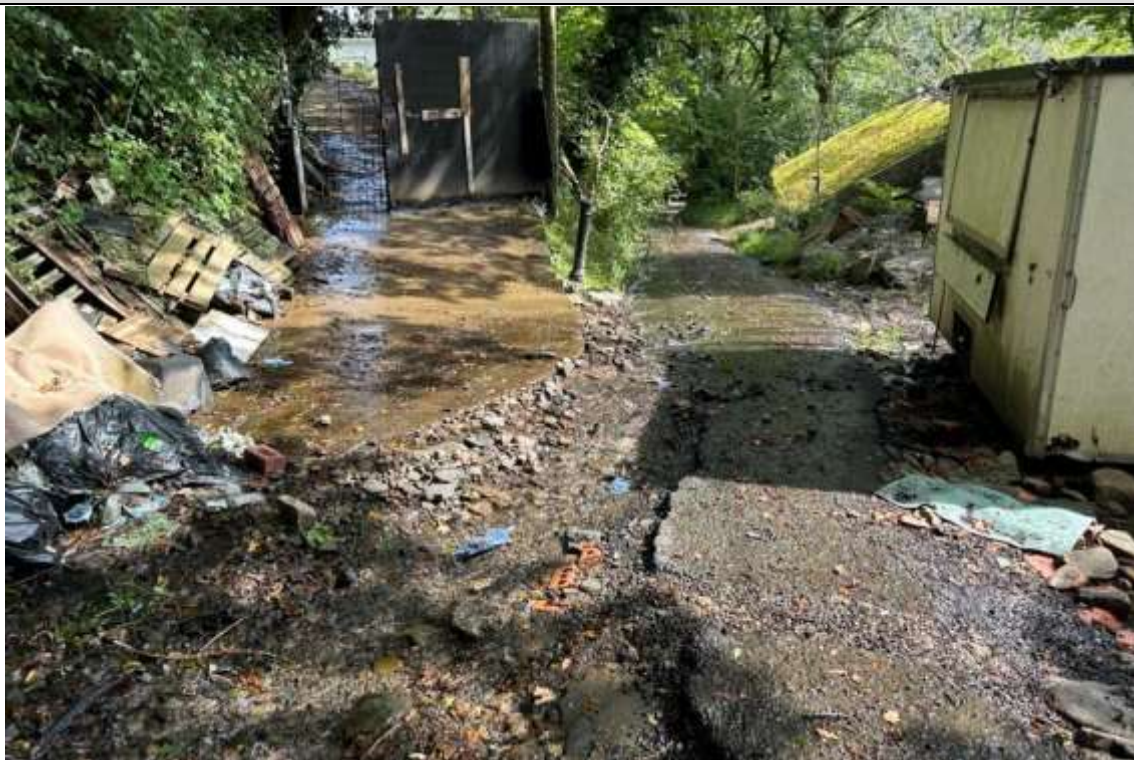
off conveys along the access track, resulting in instances of scour (Photo 2).
5	Sub-surface drainage (e.g. French drains, inclined drains)	N/A	None present.
6	Adits, tunnels & culverts	No Change	Issues emanating from historic mine entries discharge moderate flows across the north-eastern section of the tip plateau, which then convey through the body of the tip and discharge off the toe. Saturated ground conditions observed (Photo 10).
7	Ponds & overflows	N/A	None present.
8	Standing water (e.g. saturated ground)	No Change	Saturated ground conditions spatially associated with issues emanating from historic mine entries situated within the north-eastern section of the tip plateau (Photo 10).
<b>Structures</b>			
9	Within body of the tip	N/A	None present.
10	Other	New	Retaining wall structure relating to the residential property of Glanderri, situated along the access track off the toe of the tip is in poor condition. Flows observed seeping from cracks within the structure (E-274925, N-206774) (Photo 4-5)

<b>Photo No.</b>	2	<b>Comment</b>	Flows associated with the issues which convey through the body of the tip discharging along the access track situated off the toe. Resultant scour of the access track is evident.
------------------	---	----------------	--

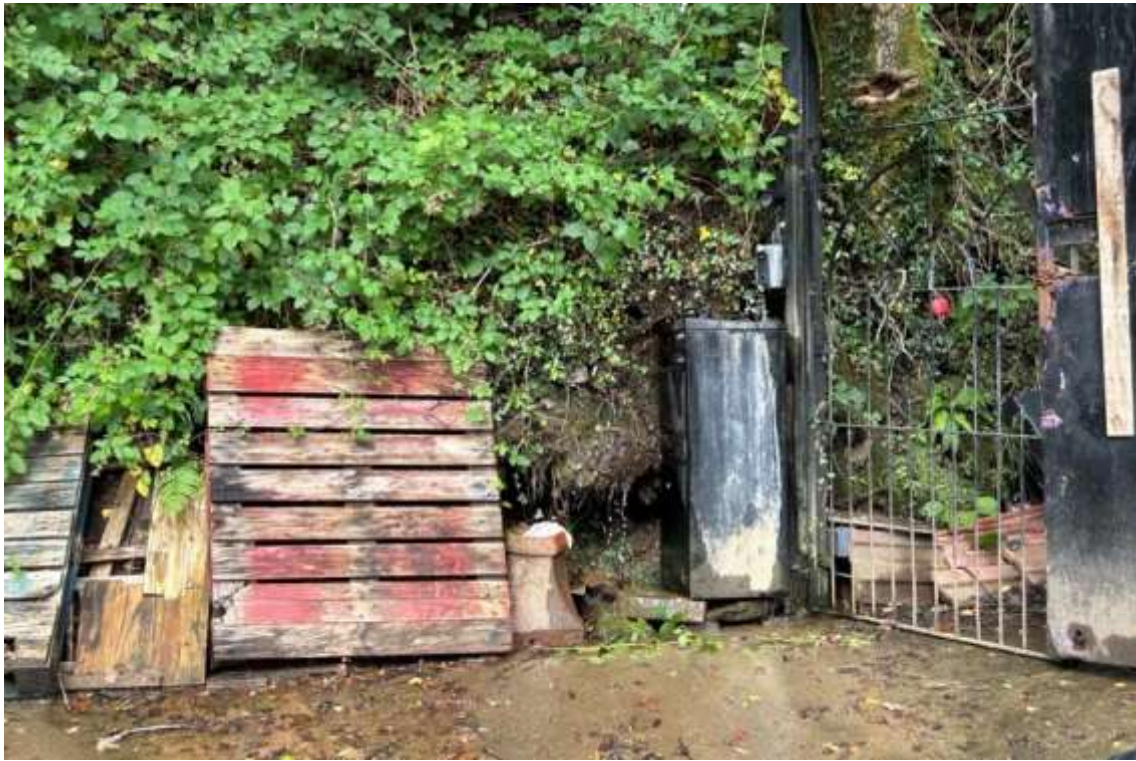
<b>Seepage</b>			
11	Within body of the tip	No Change	Minor seepage emanating from the embankment off the toe of the tip, adjacent to the access track at E-274861, N-206777 (Photo 6)
12	Above the tip	No Change	See item 6.
13	Below the tip	New	Flows observed seeping from the embankment adjacent to the gated driveway of the residential property of Glanderri, situated off the toe of the tip (Photo 3).
<b>Erosion</b>			
14	Surface erosion	No Change	Minor erosion attributed to issues which convey across a section of the tip body. Tip flank and plateau are well-vegetated with bramble, ferns and multiple mature trees (Photo 11-12).
15	Physical erosion (e.g. scour, undercutting)	No Change	Flows relating to issues emanating from historic mine entries within the north-eastern section of tip plateau convey through a section of the tip body, before discharging onto the access track adjacent to the residential property of Glanderri, situated off the

<b>Photo No.</b>	3	<b>Comment</b>	Flows observed seeping from the embankment adjacent to the gated driveway of the residential property of Glanderri, situated off the toe of the tip.
------------------	---	----------------	--

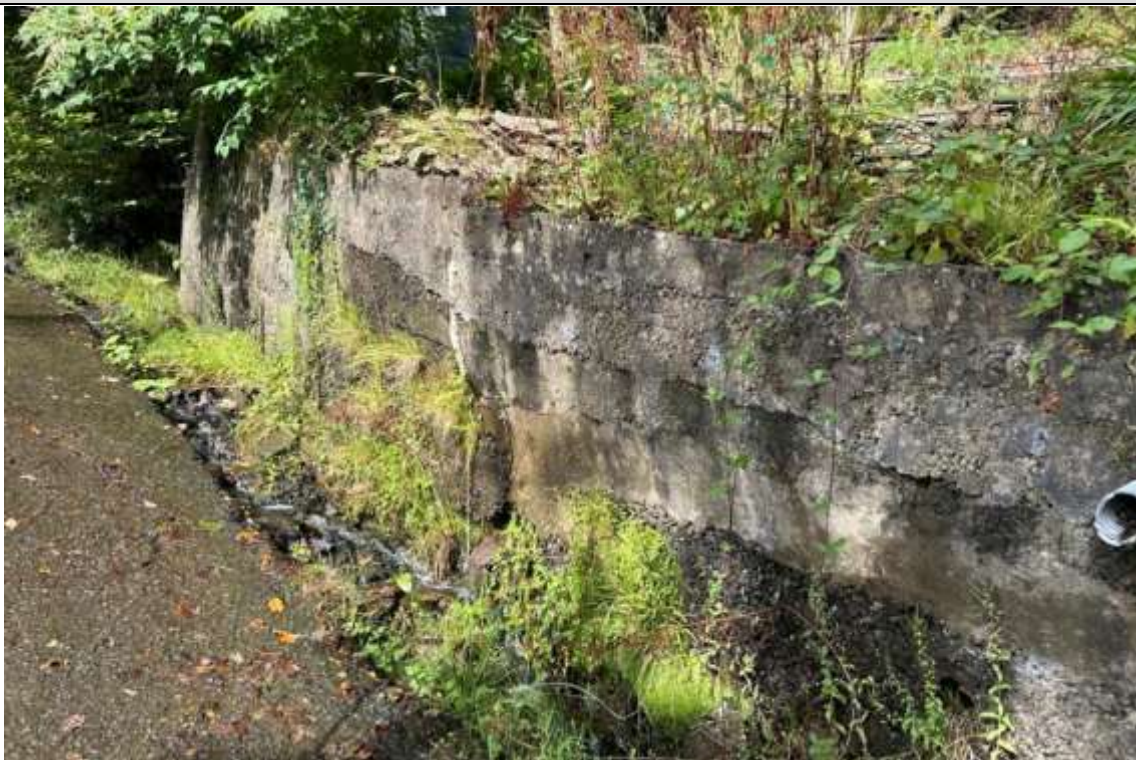
<b>Photo No.</b>	4	<b>Comment</b>	Retaining wall structure relating to the residential property of Glanderri, situated along the access track off the toe of the tip is in poor condition. Flows observed seeping from cracks within the structure.
------------------	---	----------------	---

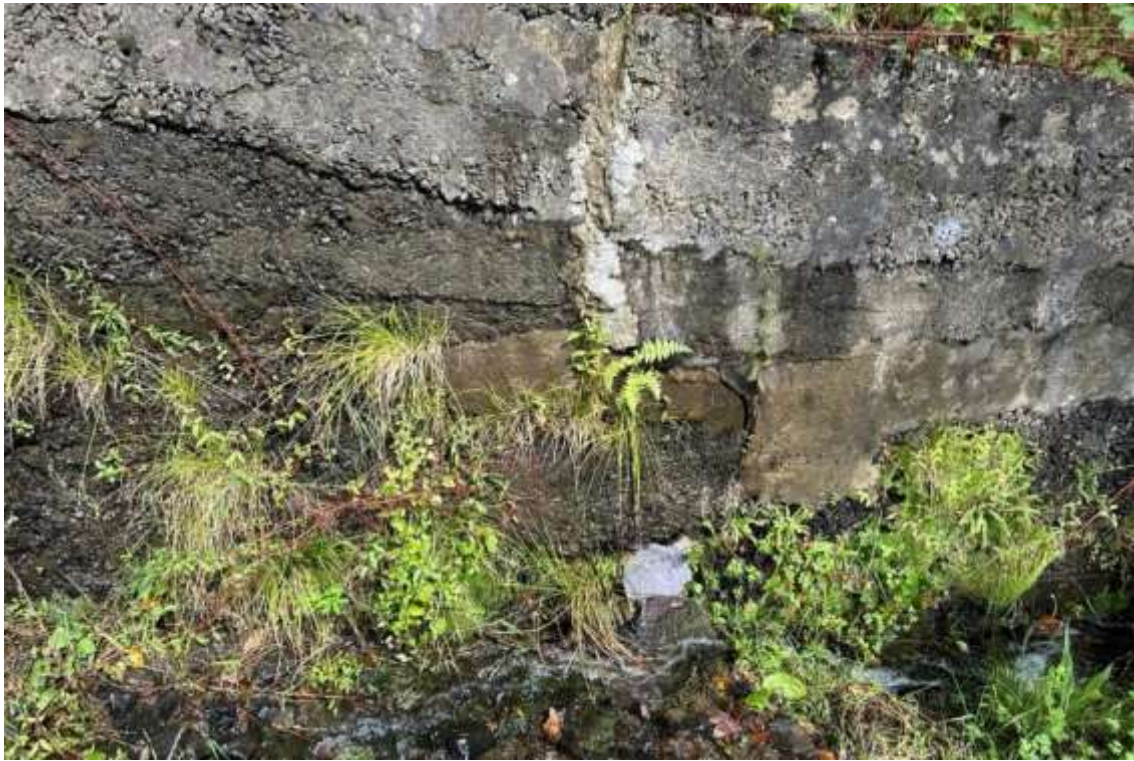
<b>Photo No.</b>	5	<b>Comment</b>	Flows seeping through small cracks and voids within the retaining wall structure situated along the access track off the toe of the tip.

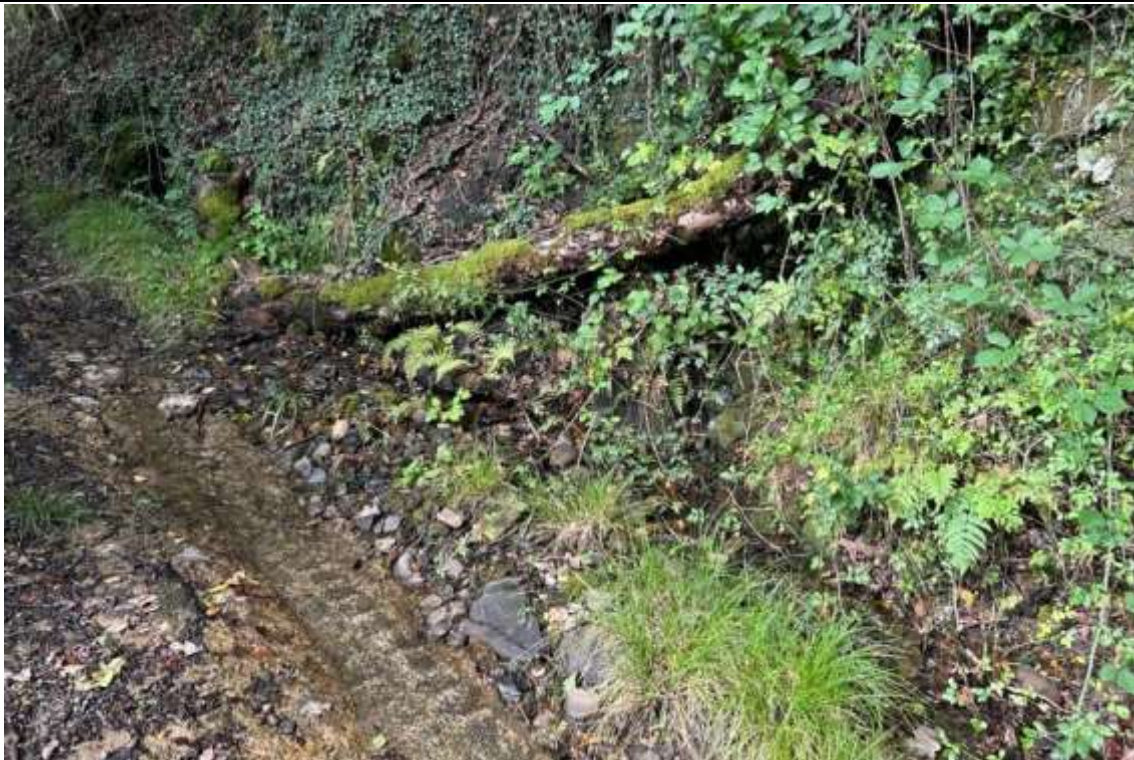
<b>Photo No.</b>	6	<b>Comment</b>	Minor seepage emanating from the embankment off the toe of the tip, adjacent to the access track at E-274861, N-206777.

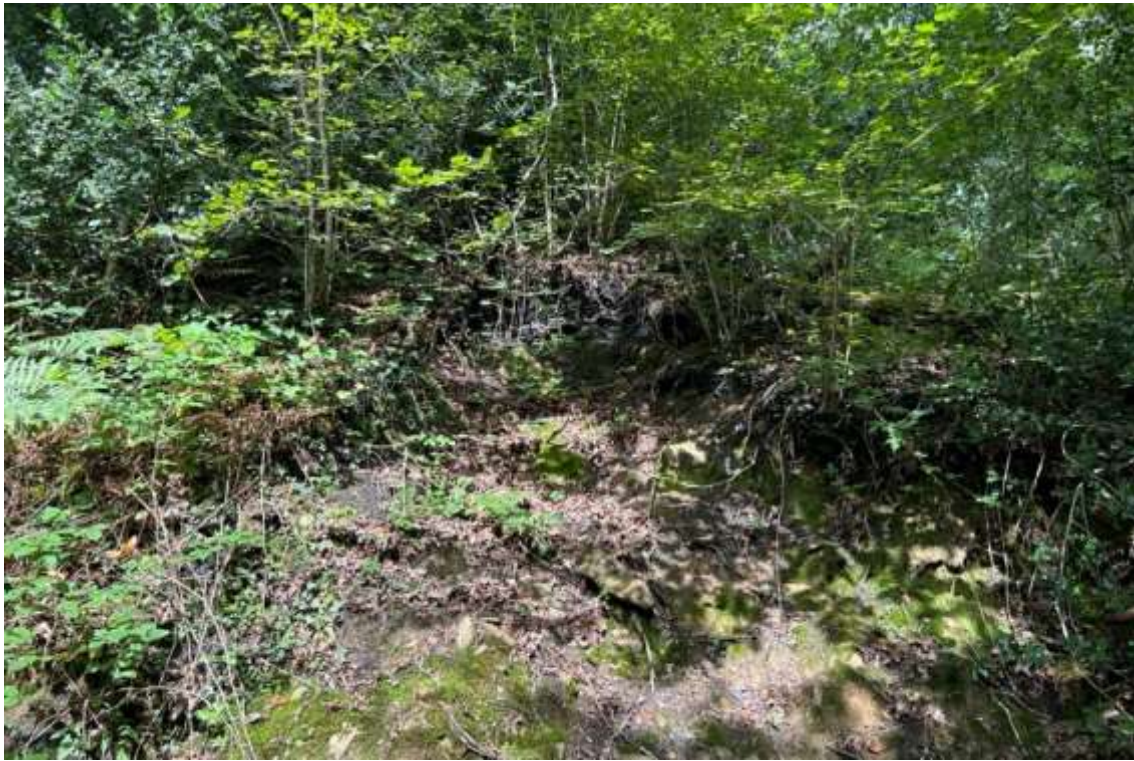
<b>Photo No.</b>	7	<b>Comment</b>	View looked towards the backscarp of the minor, shallow surface slip situated along the toe of the tip, adjacent to the access track. Natural ground material has been exposed across the slip surface, with a thin veneer of overlying spoil material evident.

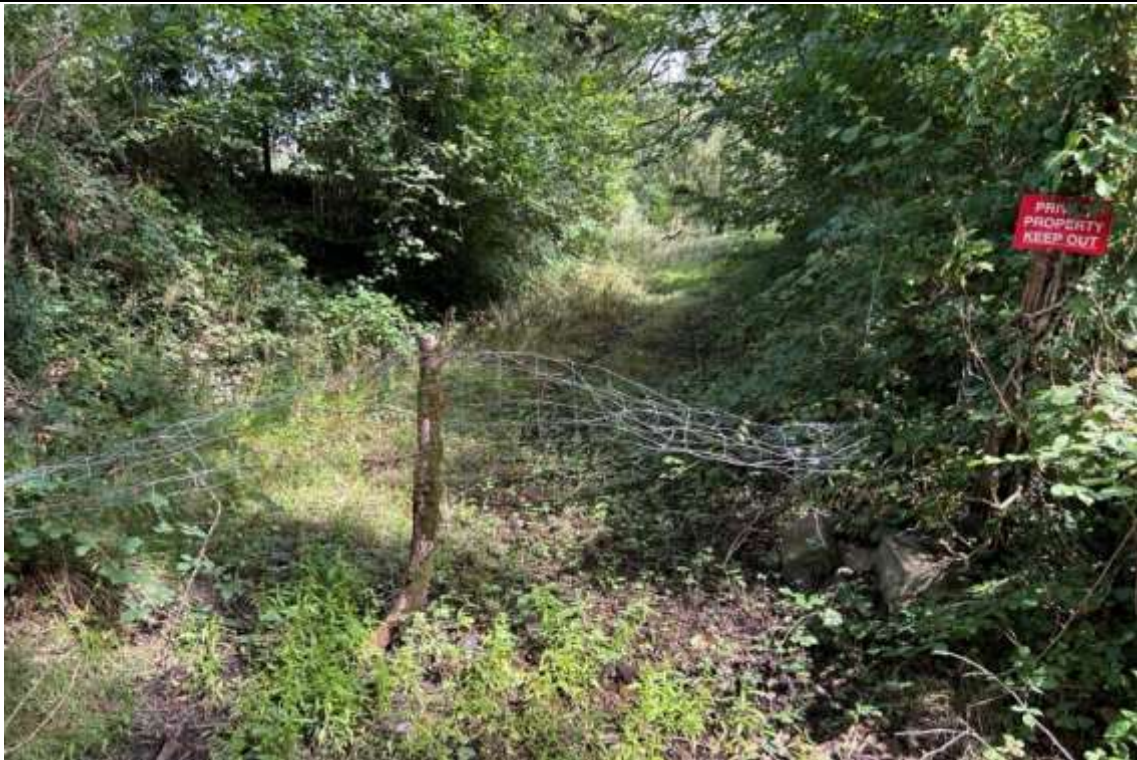
22	Security (e.g. fencing, access gates, signage)	New	Recently installed temporary fencing along the disused access track which climbs the site off the Western perimeter. Presumably installed by land owner (Photo 8).
<b>Name</b>			
<b>Date</b>			
<b>Signature</b>			
<b>Approver</b>			
		17/9/2024

<b>Photo No.</b>	8	<b>Comment</b>	Recently installed temporary fencing along the disused access track which climbs the site off the Western perimeter.

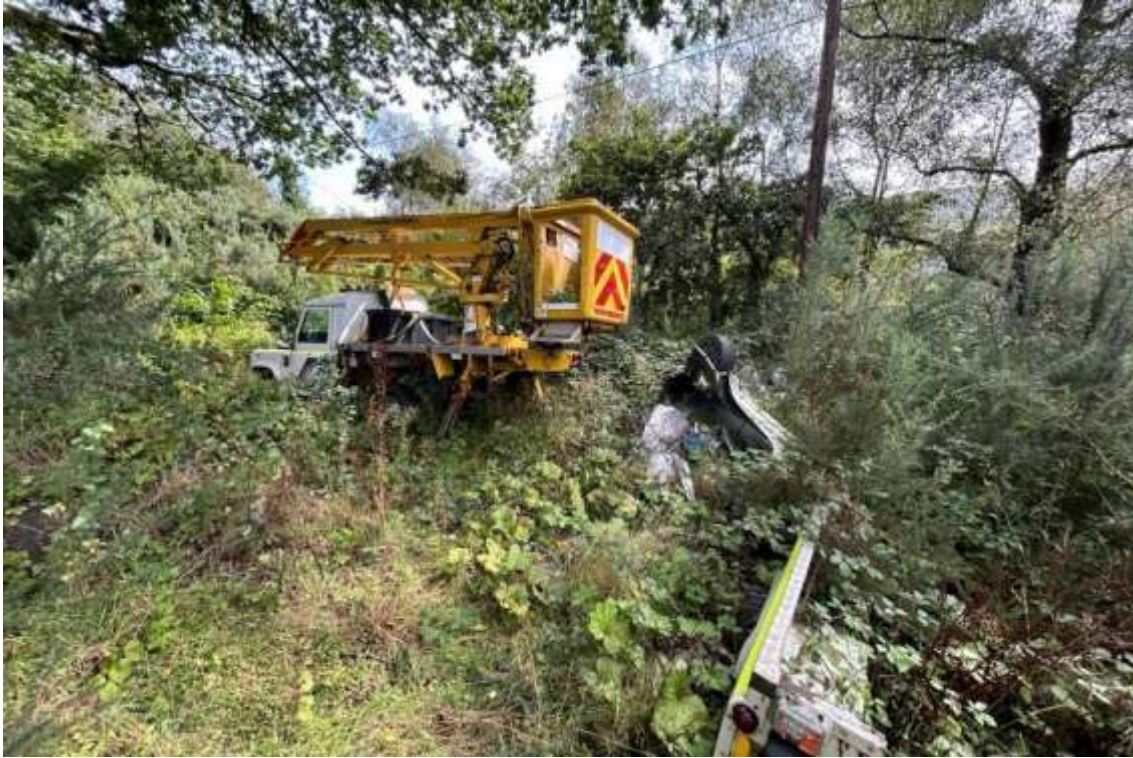
<b>Photo No.</b>	9	<b>Comment</b>	Disused plant vehicle and associated equipment discarded on the north-eastern section of the tip plateau.

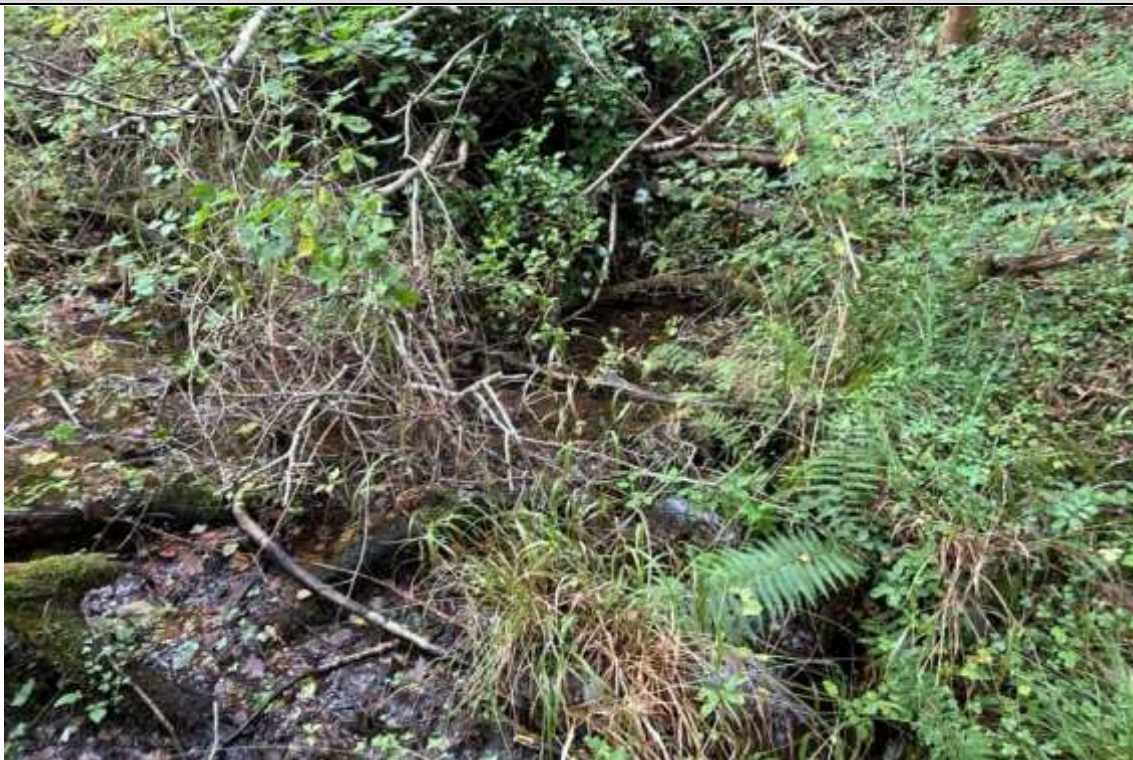
<b>Photo No.</b>	10	<b>Comment</b>	Issues emanating from historic mine entries discharge moderate flows across the north-eastern section of the tip plateau, which then convey through the body of the tip and discharge off the toe. Saturated ground conditions observed.

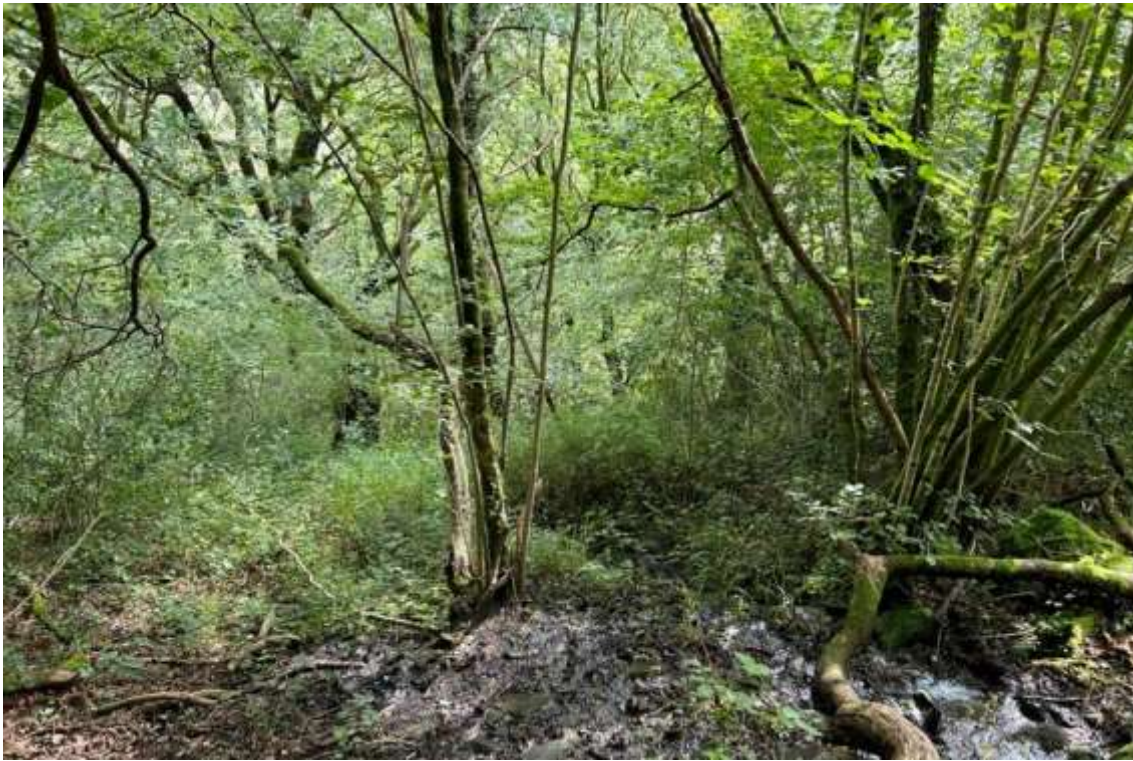
<b>Photo No.</b>	11	<b>Comment</b>	Flows associated with issues conveying through a section of the tip body along the Eastern perimeter of the site. Minor instances erosional scour observed. Flows discharge off the toe, adjacent to the residential property of Glanderri as outlined in Photo 1.

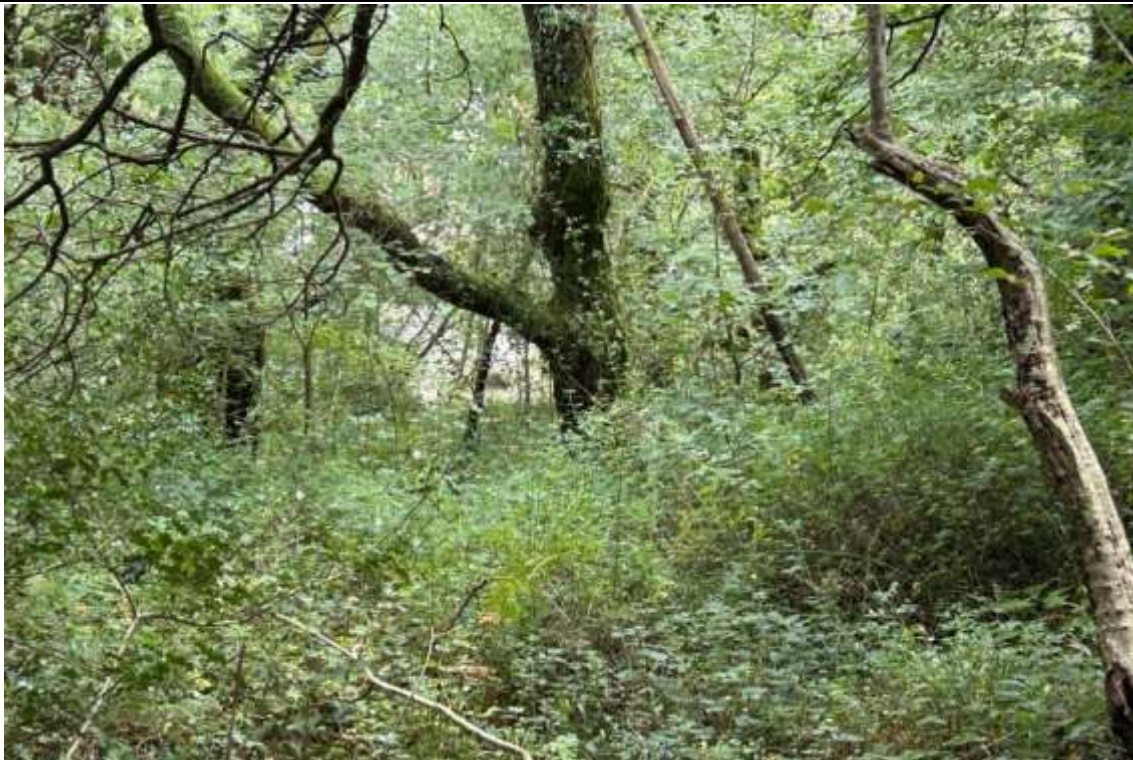
<b>Photo No.</b>	12	<b>Comment</b>	Dense vegetation cover along the south-eastern perimeter of the site preventing access and visual inspection of the entire flow path of issues which skirt a section of the tip body.
