## Godre'r Graig Primary School, Godre'r Graig Preliminary Investigation and Additional Assessment

Report Reference: ESP.7234e.02.3302

## Godre'r Graig Primary School Preliminary Investigation and Additional Assessment

**Prepared for:**  
**Neath Port Talbot County Borough Council**  
 The Quays, Baglan Energy Park,  
 Brunel Way, Briton Ferry,  
 SA11 2GG

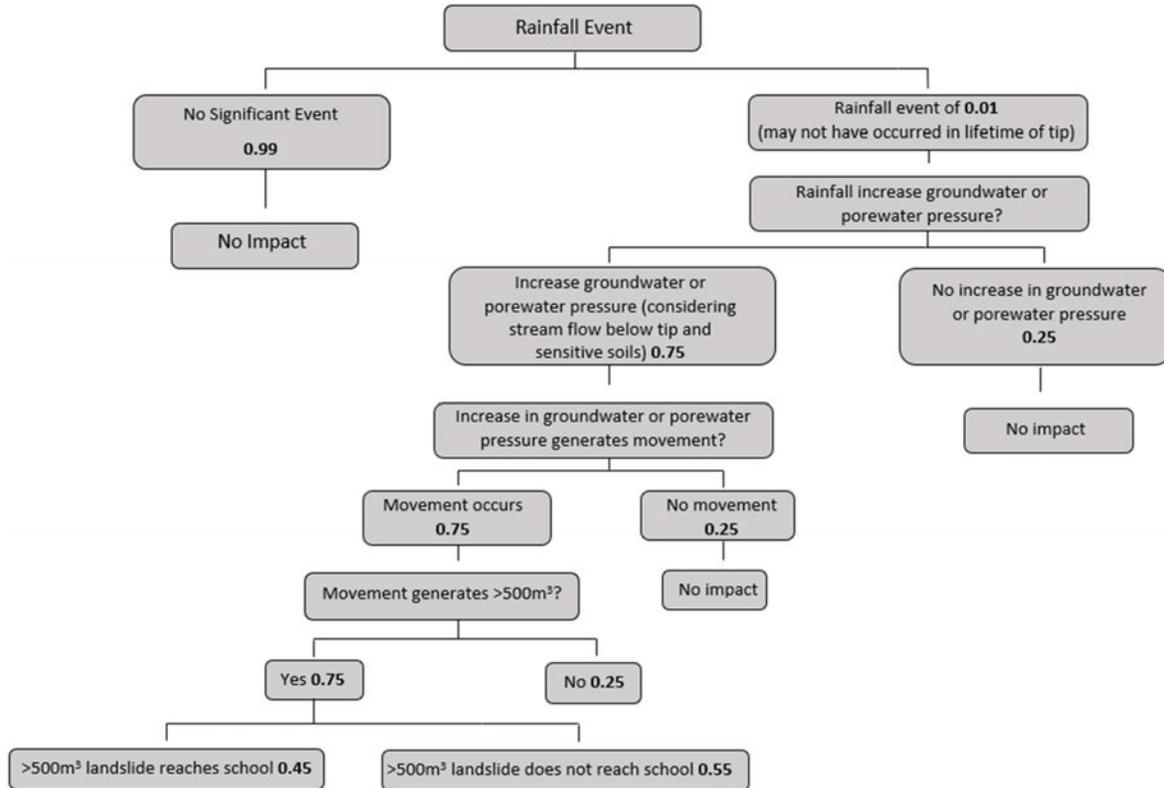
In order to assess the risk from Hazard 2, "impact from debris avalanche initiating from quarry spoil", an event tree was produced to provide a qualitative, indicative value of approximate annual probability for such an event occurring. Based on the event tree and the qualitative risk analysis matrix detailed in the previous report (ESP, 2019 -Section 7), a medium risk was identified.

Using the probabilities assigned in the event tree, for a 1 in 100 year rainfall event (which is equivalent to 0.01), it suggests that the estimated annual probability of a landslide hitting the school is 0.0019, or  $1.9 \times 10^{-3}$ .

This annual probability correlates to a 'possible' likelihood i.e. the event could occur under adverse conditions over the design life. Using a consequence of 'moderate', for a >500m<sup>3</sup> landslide hitting the school, the qualitative risk assessment is of medium risk.

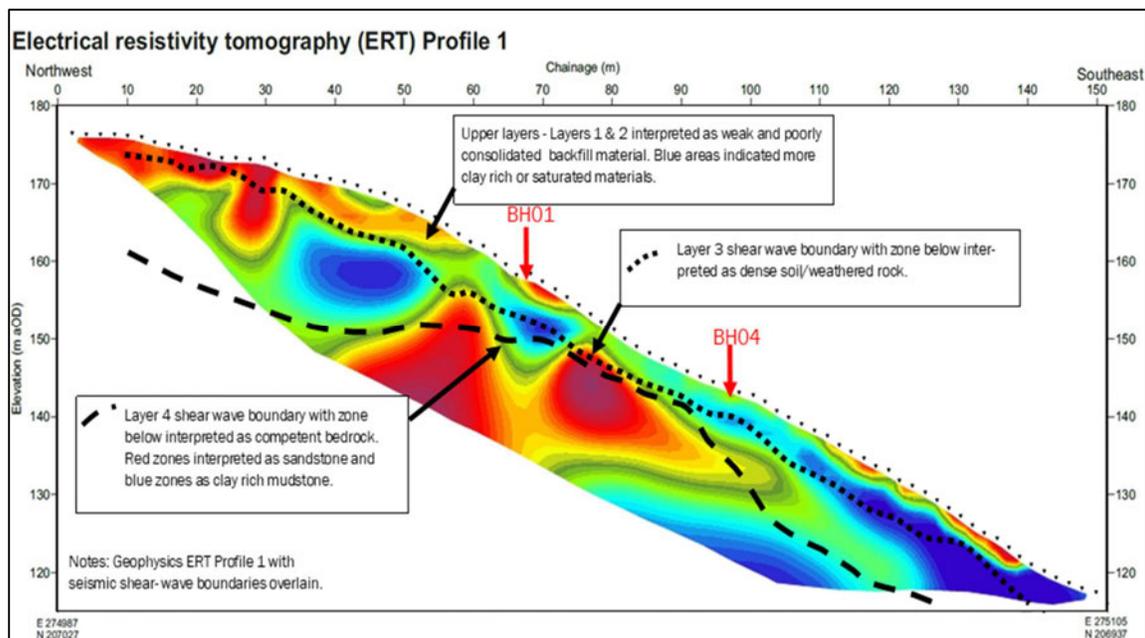
**Insert 9:** Summary of geophysical data (ERT and Seismic data) interpolated from Terradat report (2019). Full report displayed in Appendix K.

In the lower portions of the slope, the more conductive material is present at shallower depths and becomes indistinguishable from the unit interpreted as mudstone bedrock. Trial pitting in the area indicates this portion of the layer may represent clay rich Glacial Diamicton.

Laterally across the area, the resistivity survey indicates a deeper portion of dry backfill material to the west with a pinching out of the conductive backfill layer. This coincides with a marked drop in the S-wave refraction boundary and is indicative of deeper rockhead. The more conductive backfill is consistently present to the east which may be representative of the excavation related to the Upper Pinchin coal seam. On the lower portions of the slope, the Profile 2 indicates a possible shallowing out of the backfill material to the east and may represent the western extent at this level. Profile 2 corresponds with the location of former adits identified by the Coal Authority and in the historical mapping.

The seismic survey generally shows good correlation between the P and S-wave boundaries of layer 3 (dense soil/weak rock) and termination of the cable percussive boreholes on presumed weathered Upper Coal Measures. Comparison of BH05 shows good correlation between the P and S-wave Layer 4 (competent rock).

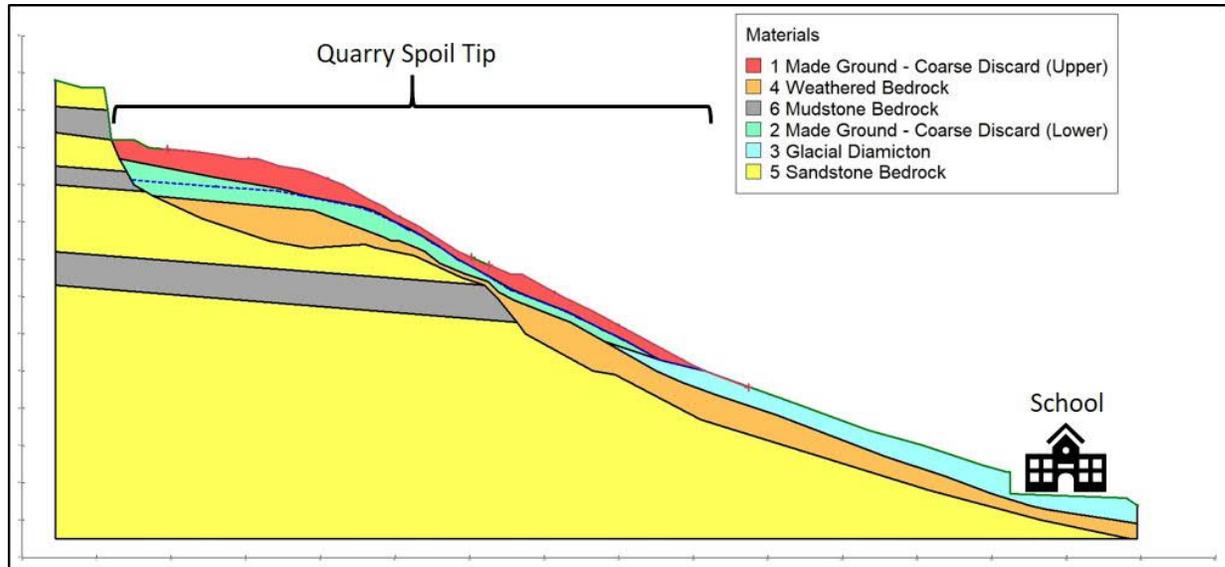
Insert 10: SlopeW digital Ground Model

Initial groundwater monitoring data, along with visual observations has been used to draw an anticipated piezometric line (Water Table) in the Ground Model.

The slope stability ground model can be seen in Insert 10 below.

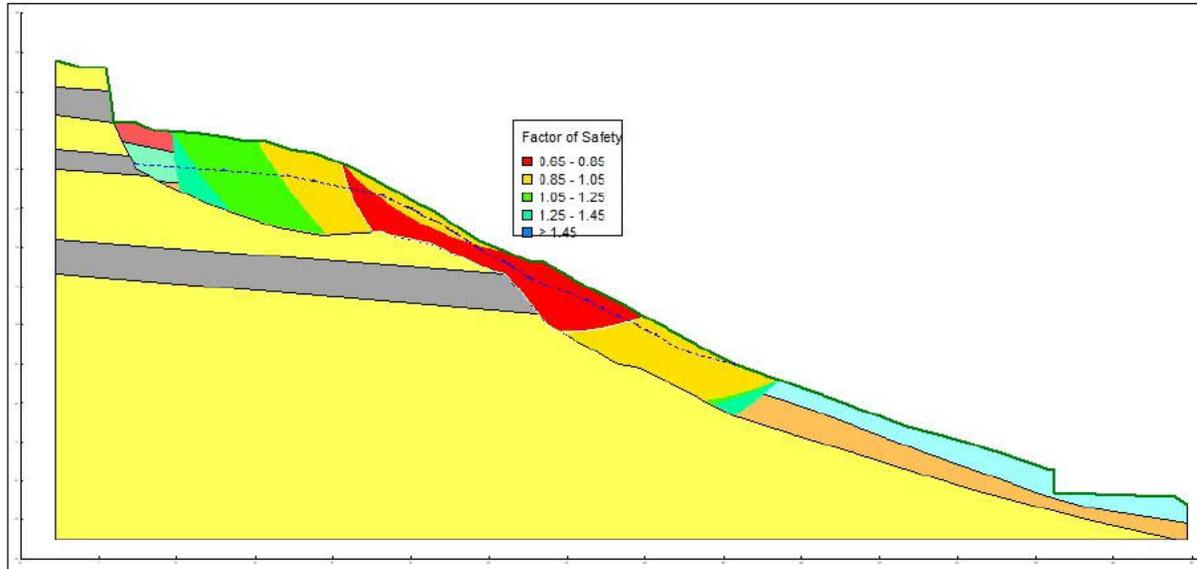
Insert 11: Contoured failure planes in Quarry Spoil Tip using Reasonable Case Parameters.

Analyses of the section has shown that for the strength parameters outlined in Table 9 and on the assumed piezometric surfaces shown, a minimum factor of safety of around 0.6 can be assumed when considering the current slope geometries. The model shows numerous potential failures below a Factor of Safety of 1, suggesting that the Quarry Spoil Tip is unstable.

The site walkover, historical mapping and aerial photographic review show no sign of instability predicted by the modelling. It is therefore likely that the Reasonable Case Material Parameters adopted are too low as signs of movement would likely be visible at the Quarry Spoil Tip.

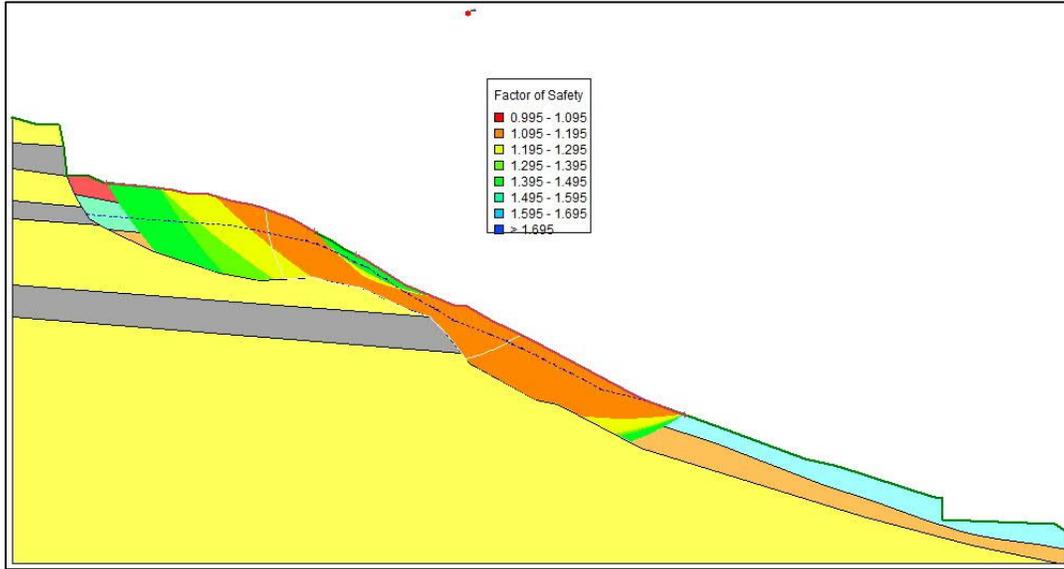
Insert 12: Contoured failure planes in Quarry Spoil Tip using Upper Range Parameters.

Analyses of the section has shown that for the Upper Range Parameters outlined in Table 10 and on the assumed piezometric surfaces shown, a minimum factor of safety of around 0.95 can be assumed when considering the current slope geometries. Much of the possible failure planes are however above unity, i.e. have a factor of safety of 1 or above, as can be seen on Insert 12 below.

The modelling shows that the Quarry Spoil Tip could be considered marginally stable, which is likely to represent the current condition, as the material would have been ‘end tipped’ and reached a state of stability on the hillside. Based upon the above, it is likely that the Upper Range Parameters are reasonable for modelling of the slope.

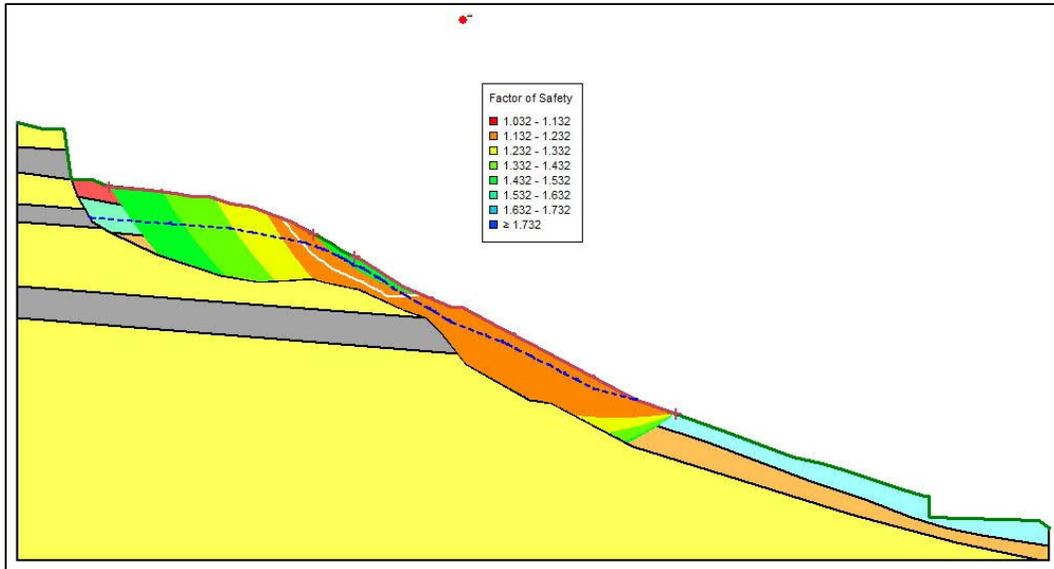
**Insert 13:** Contoured failure planes in Quarry Spoil Tip using Upper Range Parameters – DA1 C1.

The above inserts show that the worst-case design situation would be DA1, C2, with significantly lower FoS, or AFs being realised.

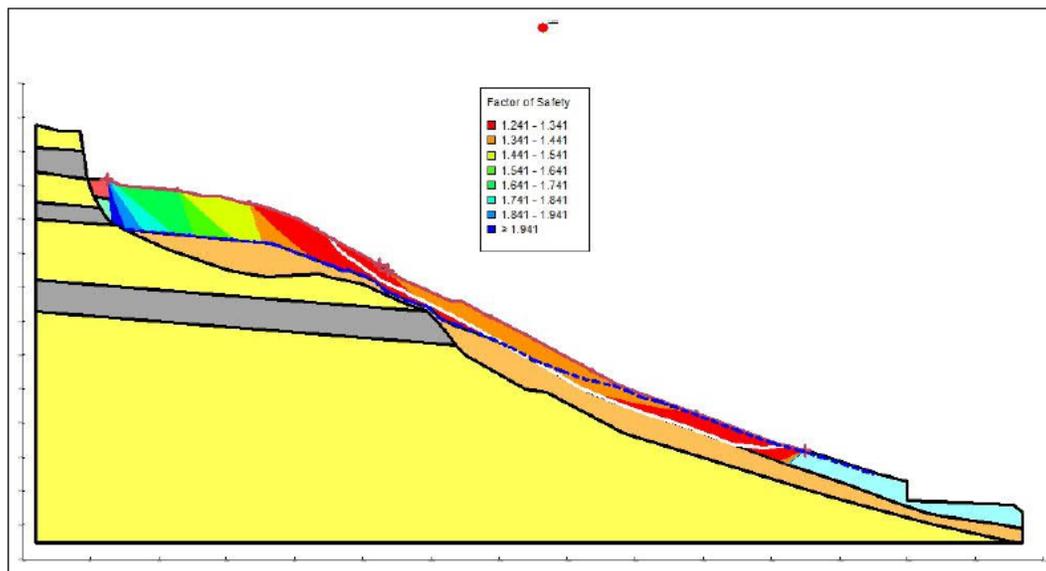
Insert 15: Contoured failure planes in Quarry Spoil Tip using Upper Range Parameters and groundwater at the tip base – global stability.

The above shows that an increase in groundwater height decreased the quarry Spoil Tip stability and reducing the groundwater level to 2m below the expected base of the tip increased stability.
