# Investigation Report into Flooding Incident of 3rd September 2016 Gough Road, Ystalyfera

**Neath Port Talbot**  
**Castell-nedd Port Talbot**  
County Borough Council Cyngor Bwrdeistref Sirol

Highways and Drainage Services  
Environment Directorate  
Neath Port Talbot County Borough Council  
The Quays  
Brunel Way  
Briton Ferry  
Neath  
SA11 2GG

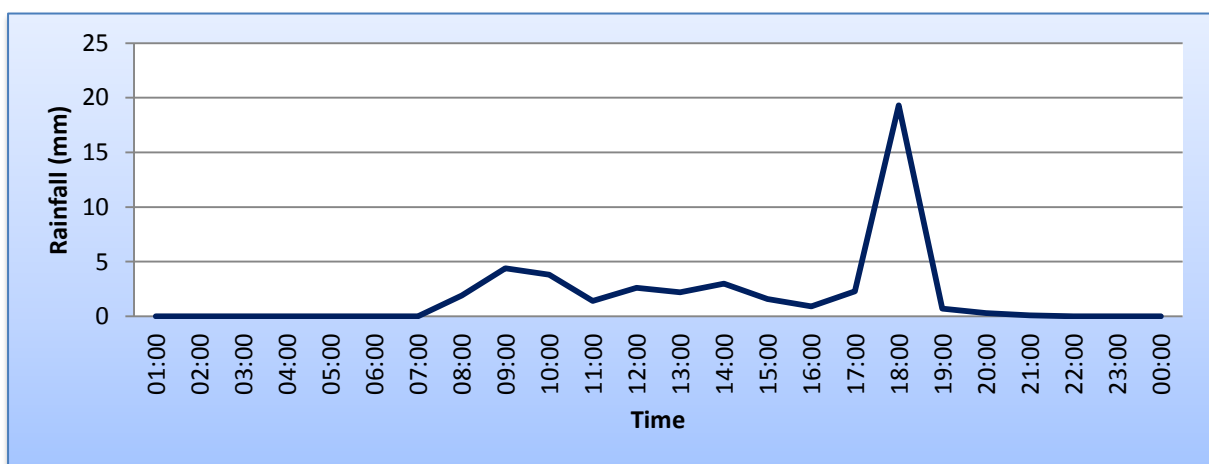
Figure 1, Rainfall in Ystalyfera on 3rd September 2016 (Rainfall data provided by MetDesk Limited)

The graph identifies that between 18:00hrs and 19:00hrs the average rate of rainfall in Ystalyfera was approximately 19.3mm/hr. However when studying the five minute rainfall radar over the same period, it was found that the peak rainfall intensity during that hour reached between 50-100mm/hr. A screenshot of the rainfall radar produced by NPTCBC's weather forecasters MetDesk

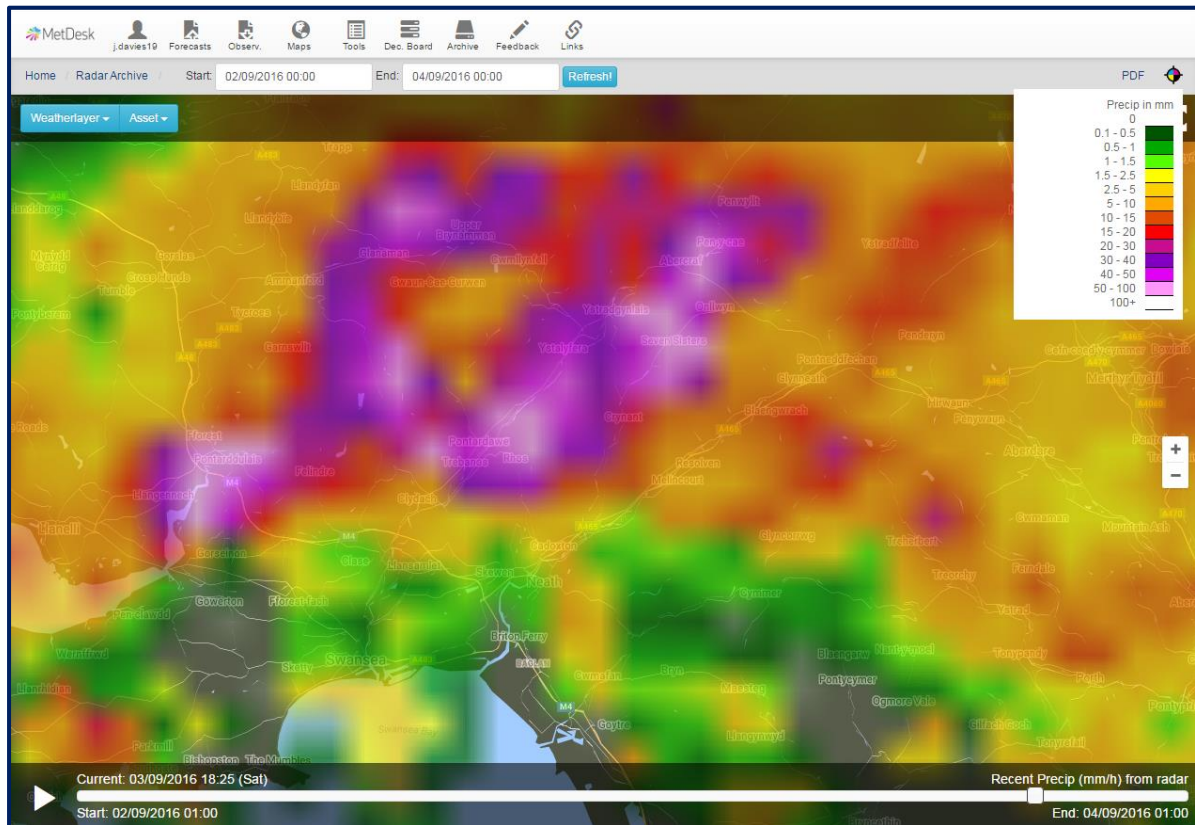
Figure 2, Screenshot of radar imagery showing precipitation levels at 18:25 on 3rd September 2016 (Provided by MetDesk Limited)

Limited can be seen in Figure 2. The period where the rainfall intensity peaked above 50mm/hr was the time that numerous communities throughout the North West of the County Borough began to suffer from surface water, ordinary watercourse and river flooding. After 19:00hrs the rainfall intensity significantly reduced until it stopped completely by 21:00hrs.

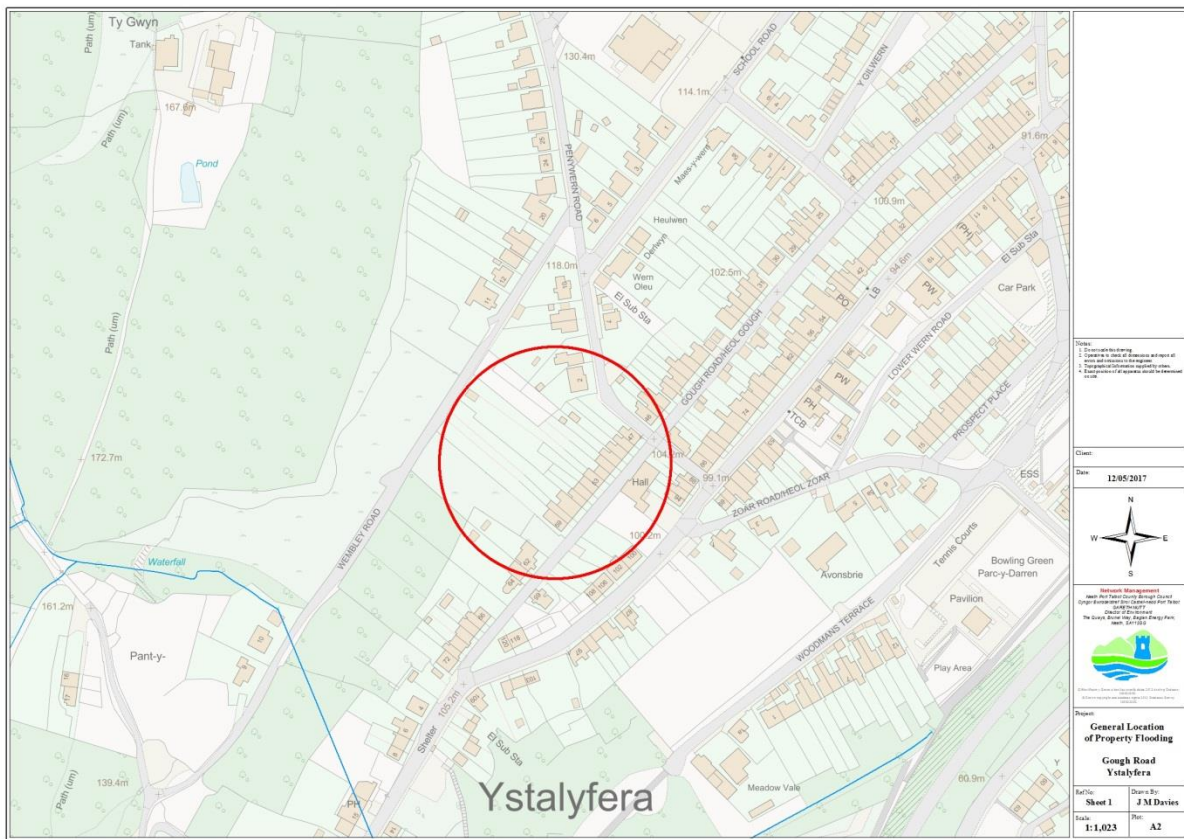
Figure 3, General location of properties affected by the flood event on 3<sup>rd</sup> September 2016

A number of properties located at the South end of Gough Road suffered internal flooding on 3<sup>rd</sup> September. Figure 3 illustrates the general location of the properties that were affected by flooding.

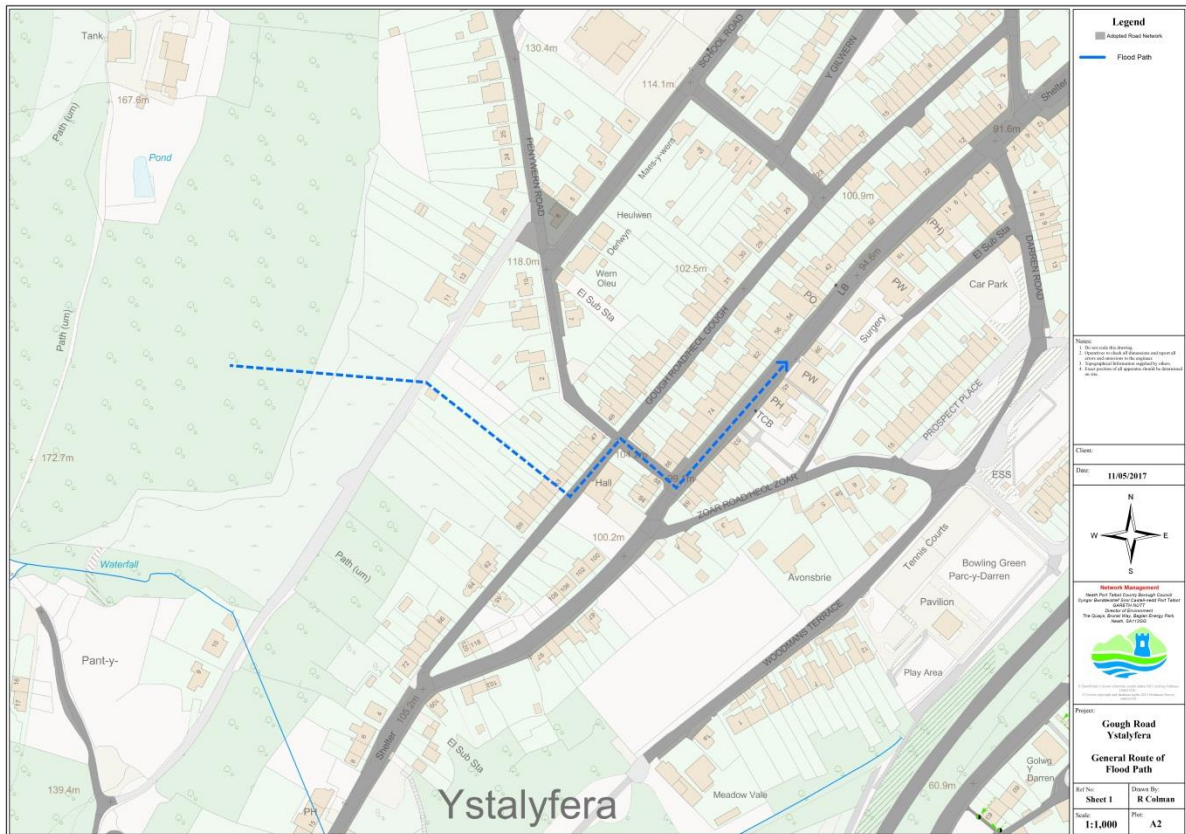
Figure 4, Map showing the flow route of surface water affecting Gough Road

The water that caused the flooding to the properties on Gough Road emanated from the steep mountainside located above Wembley Road. It is believed that the water passed over Wembley Road itself and then ran down the steep rear gardens of the properties situated on Gough Road before flooding the properties internally. Once the water had entered the properties it continued to flow through the ground floor and out of the front doors before continuing down Gough Road, Pen-y-Wern Road and Wern Road. The flow path of the flood water has been illustrated in Figure 4 below.

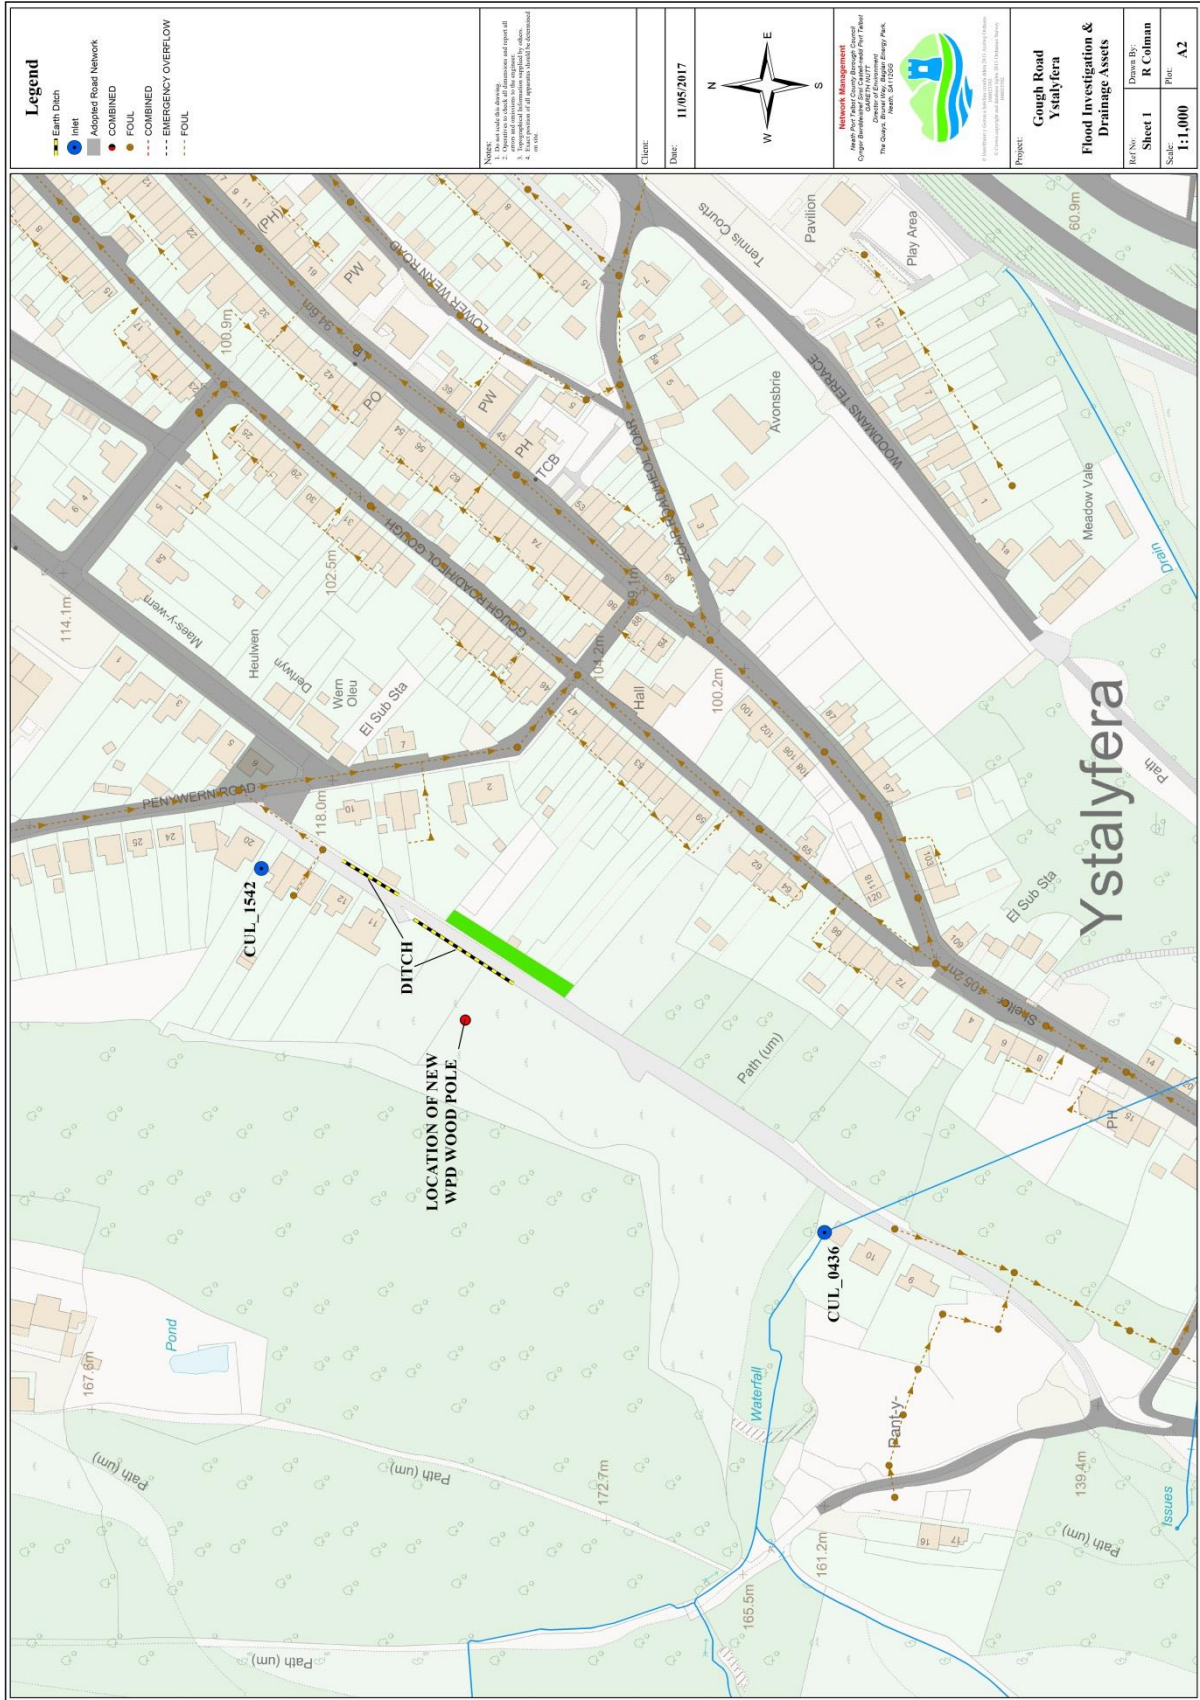
Figure 5, Key assets/issues at the rear of Gough Road

Figure 5 identifies the location of Webley Road, whilst also indicating the flood risk management assets that are located within the vicinity of the flood incident. The plan also identifies two locations where construction/clearance work has been undertaken in recent years.

The Culvert (ID: CUL\_0436), indicated by a blue point on the left hand side of Figure 5, collects a number of small watercourses from the mountainside before conveying them underneath Wembley Road to the Swansea Canal. Investigations identified that minor works had previously been undertaken by the Authority to improve the intake structure including a new grid and dwarf wall. The works were undertaken using the Council's permissive powers under the Land Drainage Act whilst the landowner was informed at the time that maintenance liability for the system rested with them as the riparian owner. It is believed that Culvert ID: CUL\_0436 did not contribute to the flood water that affected the properties on Gough Road.

The Culvert (ID: CUL\_1542), indicated by a blue point in Figure 5, is a land drainage culvert that collects surface water from behind the properties situated at the North East end of Wembley Road before conveying it via a 225mm diameter piped watercourse down Penywern Road. As Wembley Road falls to the North East, it is believed that this culvert did not contribute to the flood water that affected the properties on Gough Road.

A ditch runs adjacent to Wembley Road for approximately 40-50m in length and collects surface/ground water that emanates from the mountainside above Wembley Road and conveys it to an intake structure/gully opposite number 12 Penywern Road. The ditch is indicated by a dashed black and yellow line on Figure 5. It is located on the private land adjacent to the un-adopted highway. The intensity and volume of rainfall that fell on 3<sup>rd</sup> September 2016 far exceeded the capacity of the ditch and intake structure, allowing surface water to flow over Wembley Road and into the rear gardens of the properties on Gough Road.

Western Power Distribution recently undertook work to install a new wooden post on the private land located on the hillside above Wembley Road, indicated by a red point on Figure 5. Vegetation was removed on the hillside to gain access to the location at which the work was undertaken. It is the belief of some residents that were affected by the flooding that the work undertaken by Western Power Distribution disturbed a culvert/spring, hence contributing to the problem. Drainage officers have been unable to confirm this assertion as there is no clear evidence of a watercourse or spring at the location. The track that was created to gain access to the works location would however have conveyed surface water that fell on the hillside.

As previously identified, there is currently no upstand at the boundary of Wembley Road and the rear gardens of the affected properties on Gough Road. This location is indicated by a green polygon on Figure 5. Figure 6 is a photograph taken two days after the flood incident showing the boundary of Wembley Road and the rear gardens of the properties situated on Gough Road.

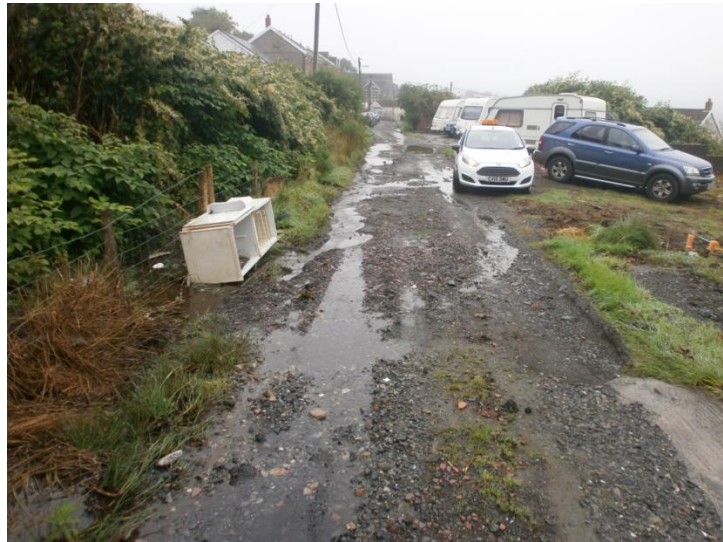
Figure 6, Photograph of Wembley Road taken on 5th September 2016

It is believed the vegetation has been cleared over the years to allow access to the rear of the properties on Gough Road, which the land currently is being used to park vehicles and caravans as shown in Figure 6. The removal of the vegetation on the boundary to allow for vehicle parking and access means that there is nothing to deter surface water from flowing over Wembley Road and down the rear gardens of Gough Road.

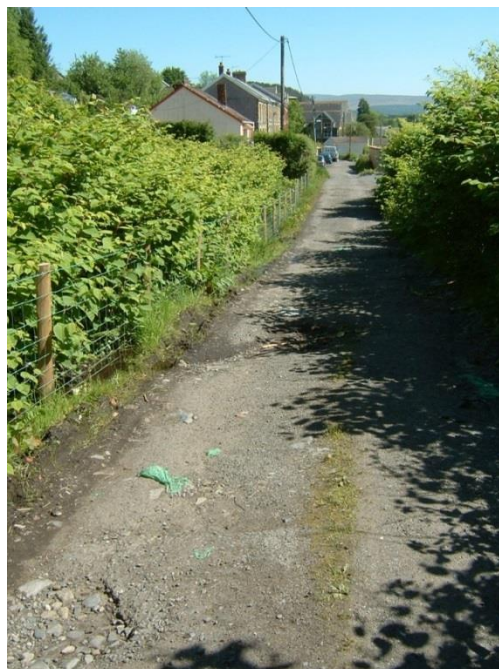
Figure 7, Photograph of Wembley Road taken on 2<sup>nd</sup> June 2006

Figure 7 is a photograph that was taken in June 2006, showing significant vegetation growth on the boundary of Wembley Road and the rear gardens of Gough Road.
