Client  
APPENDIX E  
SITE WALKOVER SURVEY MAP  
JACOBS UK Ltd  
REPORT No. B15974EX / 12858 / R5095

Project  
PANTTEG/ GODRE-GRAIG  
LANDSLIP AREA  
SLOPE STABILITY REVIEW 2013

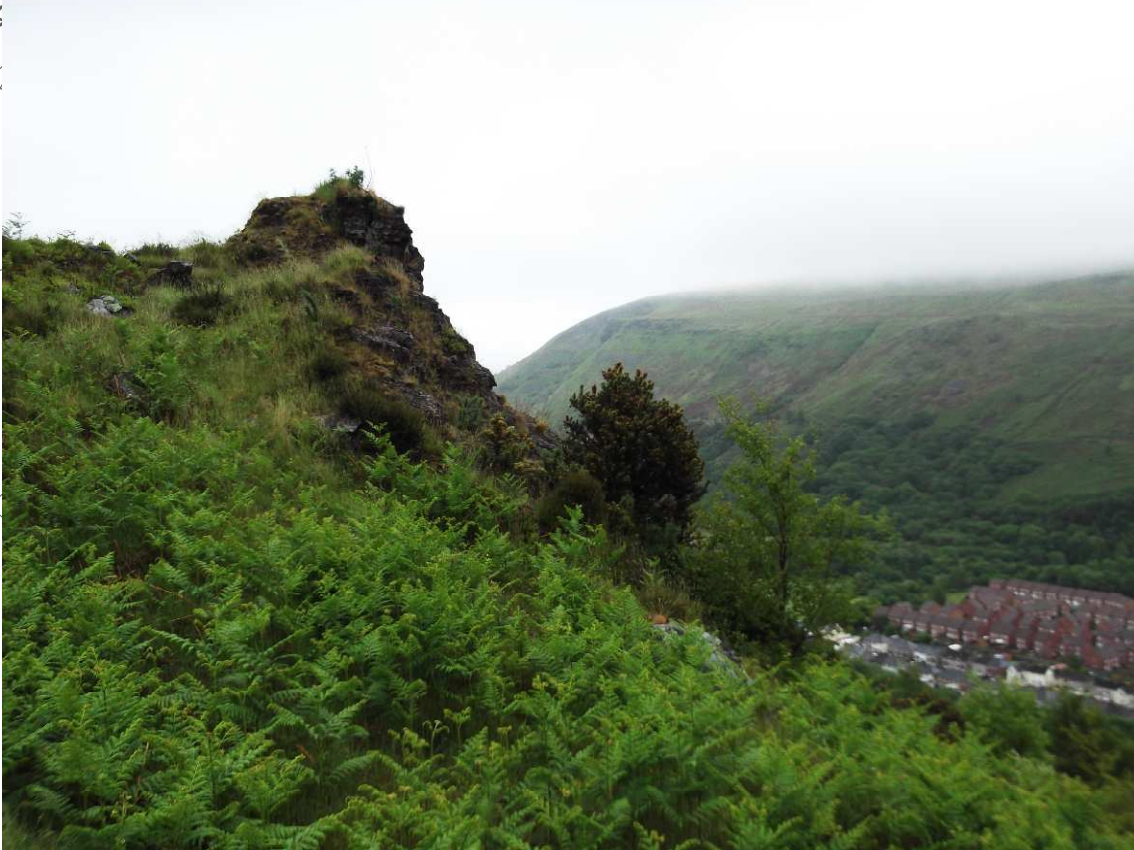
UNSTABLE SANDSTONE OUTLIER

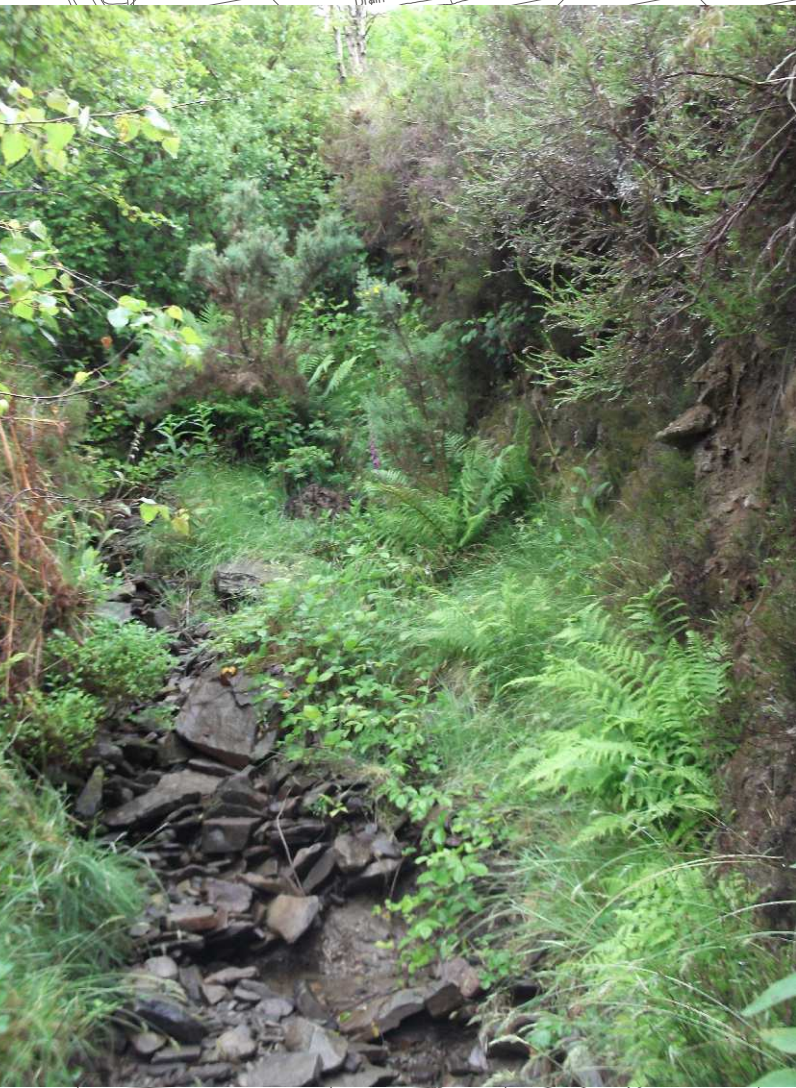
DEEPLY ERODED CILBRWYN STREAM AT FOOTPATH

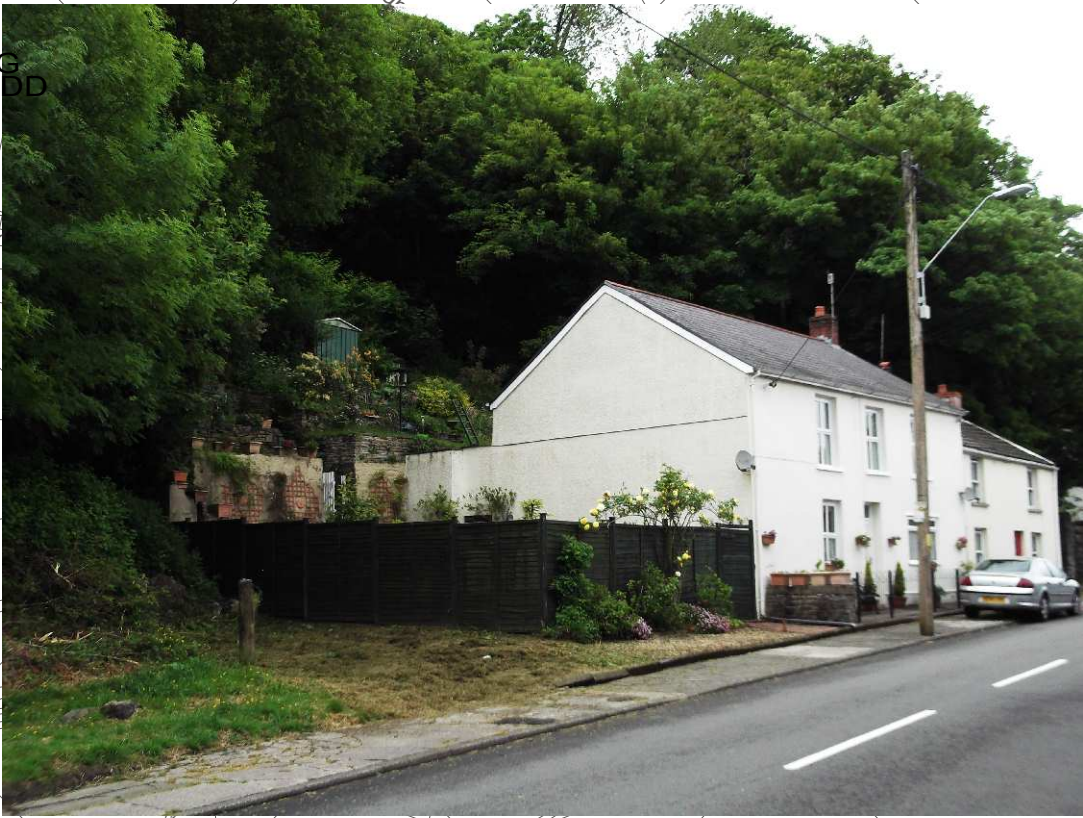
21-27 PANTTEG, SHOWING PROXIMITY OF SLOPE TO REAR OF PROPERTIES
