| Coal Tip Name | Godre'r-graig Quarry / Cilmaengwyn | | UID | T37552 | |
| Located in | Godre'r Graig, Neath-Port Talbot | | Tip Category | D | |
| Inspection Led by | | Date of Inspection | 12/02/2025 | Date of last Inspection | 09/09/2024 |

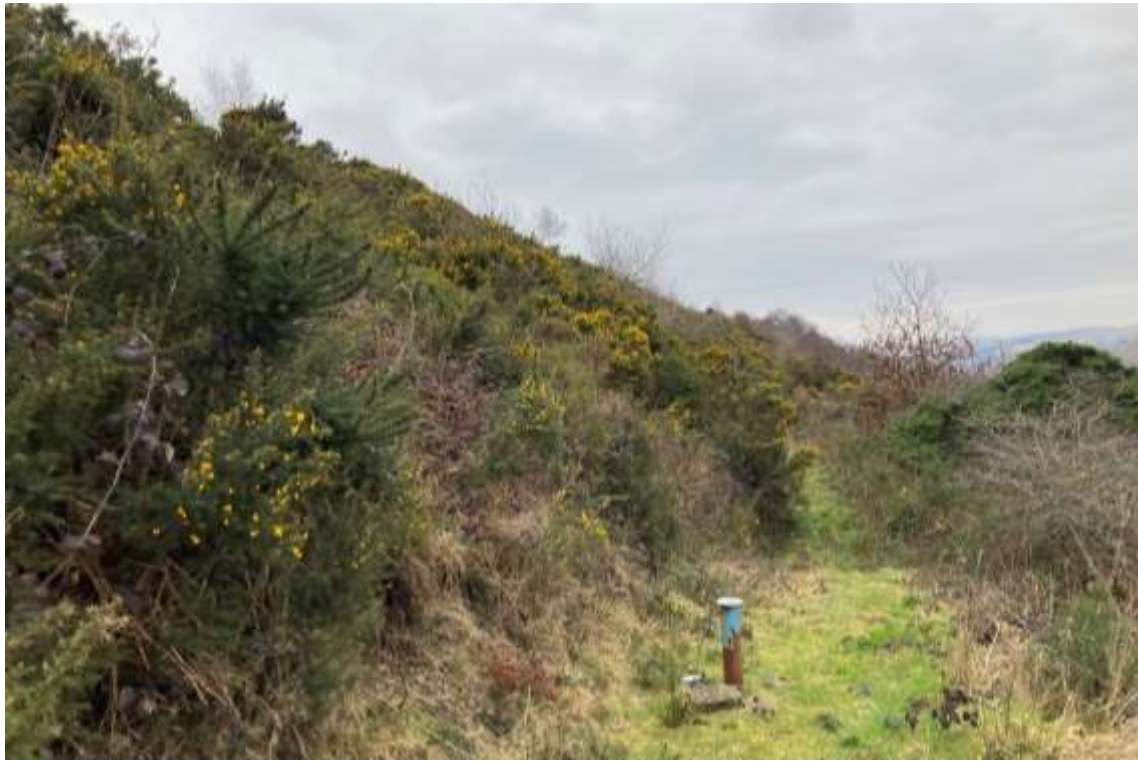
| Feature ID | 25/IM/01 | | |

| OBSERVATIONS | | | | |
|---|---|---|---|--|
| 25/IM/01 | Piezometers & Inclinometers | E – 275048 N - 206996 | Series of piezometer boreholes and monitoring wells, situated on the site access track (outside the provided site boundary). Plastic casing associated with a piezometer appears to have been discarded next to a path which ascends towards the tip. Inclinometers are recorded as being installed within some of the boreholes. | None |

| Photo No. | 1 | Comment | Piezometer borehole located on the site access track, downslope (outside the provided site boundary). |

| OBSERVATIONS | | | | |
|---|---|---|---|--|
| Recommendations | | | - Continue to utilise the monitoring equipment across the site. | |

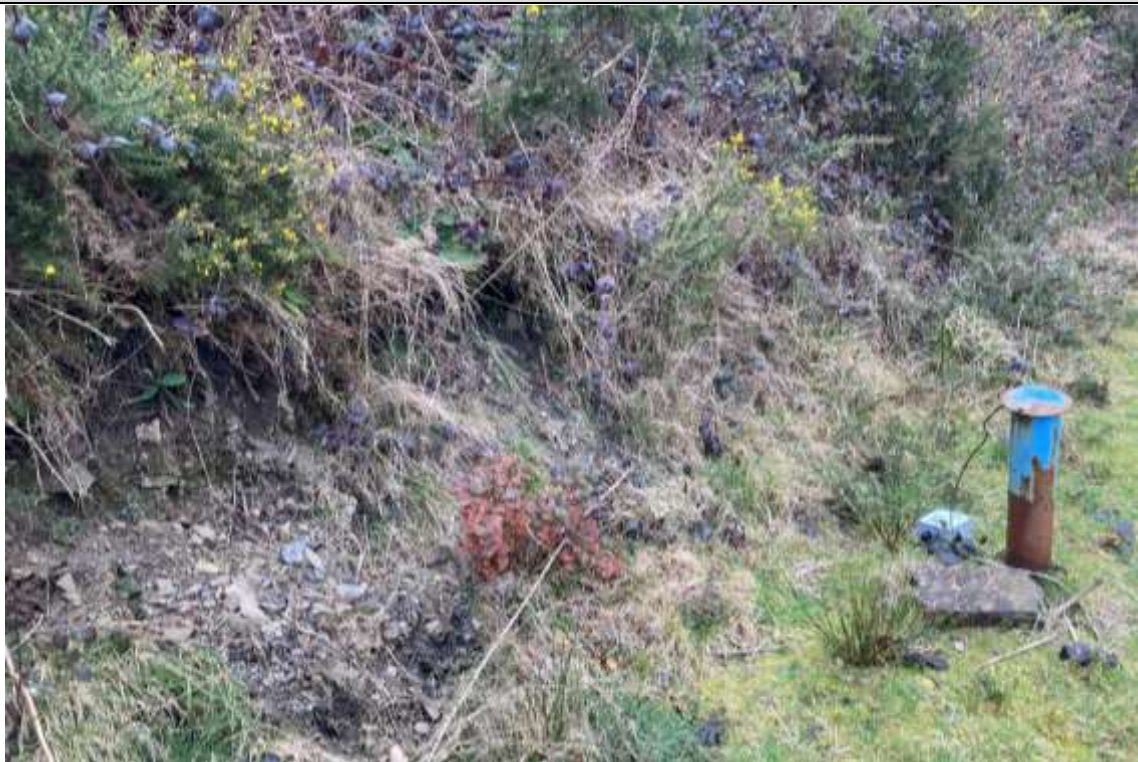
| Feature ID | N/A | | |

| Photo No. | 2 | Comment | A small exposure of overburden and sandstone spoil material, adjacent to the site access track. |

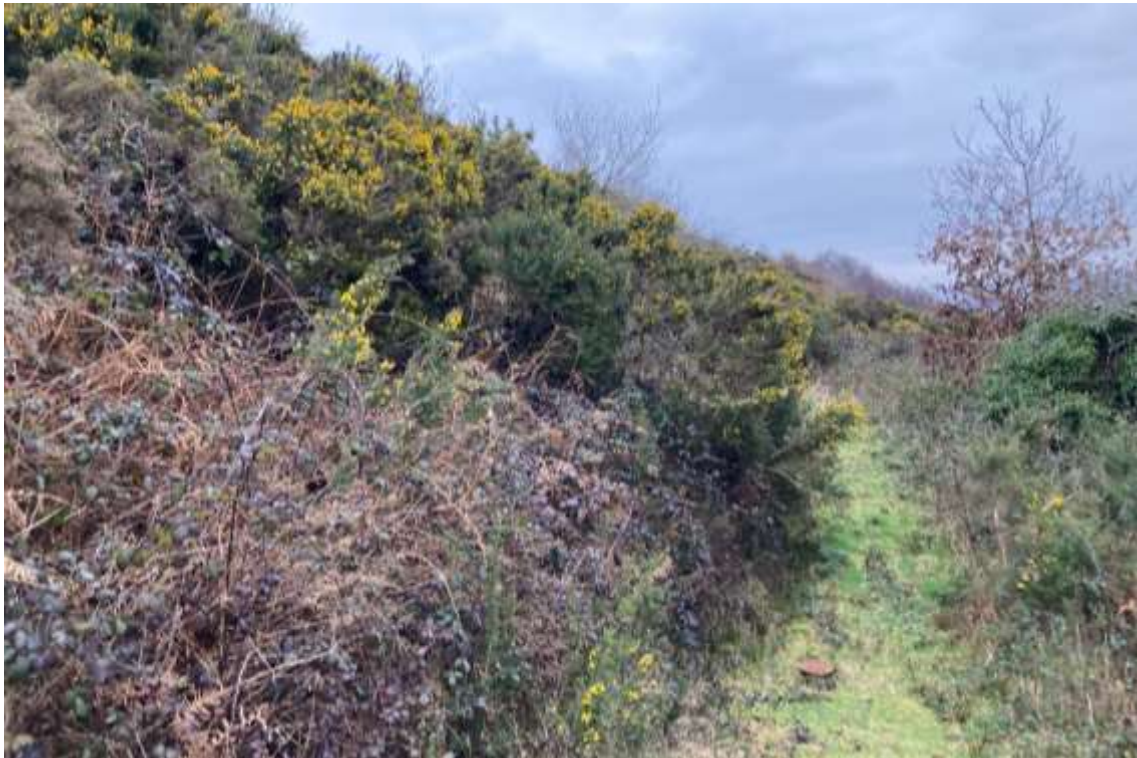
| Feature ID | 25/IM/01 | | |

| Photo No. | 3 | Comment | Monitoring well located on the site access track, downslope (outside the provided site boundary). |

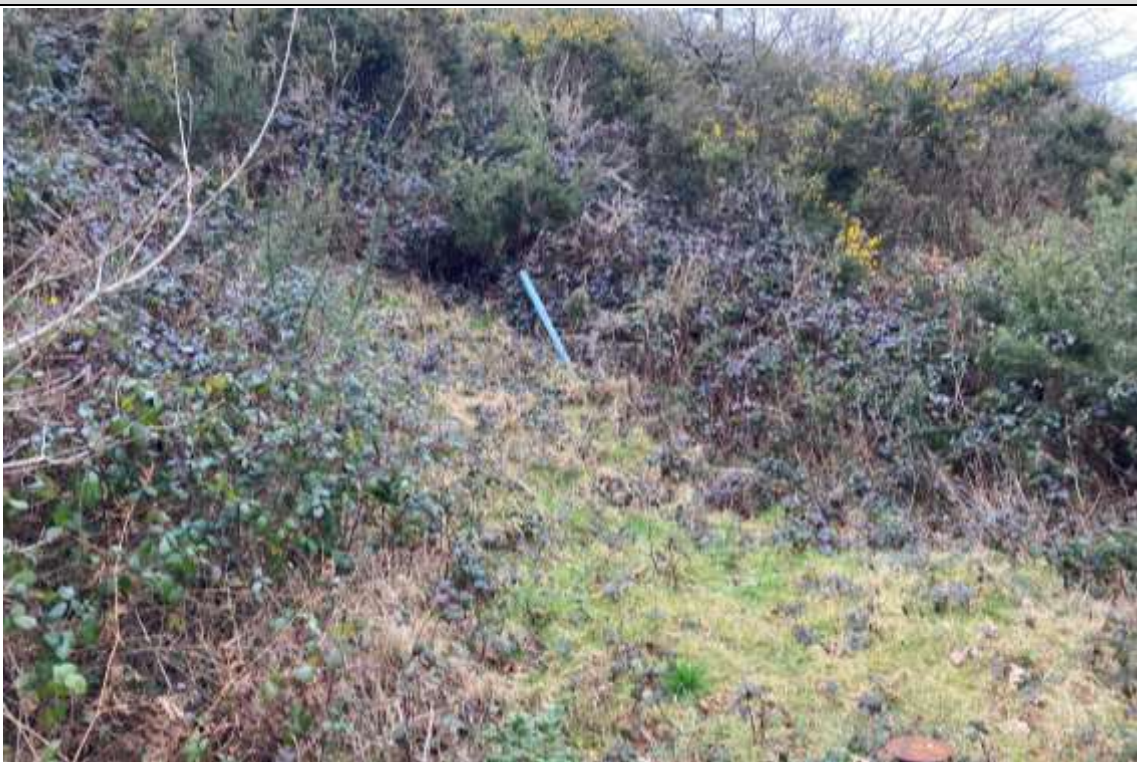
| Feature ID | 25/IM/01 | | |

| Photo No. | 4 | Comment | View looking towards the narrow, overgrown access path; of which extends up-slope off the main site access path, towards the site. Plastic casing associated with a piezometer appears to have been discarded next to the path. |
