<b>Coal Tip Name</b>	Cwar Pentwyn Quarry / Cilmaengwyn	<b>UID</b>	T11695
<b>Located in</b>	Godre'r Graig, Neath-Port Talbot	<b>Tip Category</b>	
<b>Inspection Led by</b>		<b>Date of Inspection</b>	12/02/2025
		<b>Date of last Inspection</b>	09/09/2024
<b>Weather</b>	Overcast	Damp	Breeze
<b>Comments on access and any limitations</b>	<p>Access to the site was gained via an access track situated just off Graig Road, which leads to Pentwyn Farm.</p> <p>It should be noted that this inspection was conducted without the benefit of a detailed site plan. Dense vegetation significantly limited accessibility and visual inspection. Therefore, instability within these areas could exist, but was not detectable at the time of the inspection. The location of the tip on privately owned land also limited the coverage of this inspection.</p>		
	<b>Description</b>	<b>Status</b>	
<b>RAG Status: Capital &amp; Maintenance Works</b>	Investigate ownership of the site and establish what measures, if any, have been taken with regard to placing recent materials over historic spoil.	2

<b>Coal Tip Name</b>	Cwar Pentwyn Quarry / Cilmaengwyn	UID	T11695
		Tip Category	D
Date of Inspection	12/02/2025	Inspection le

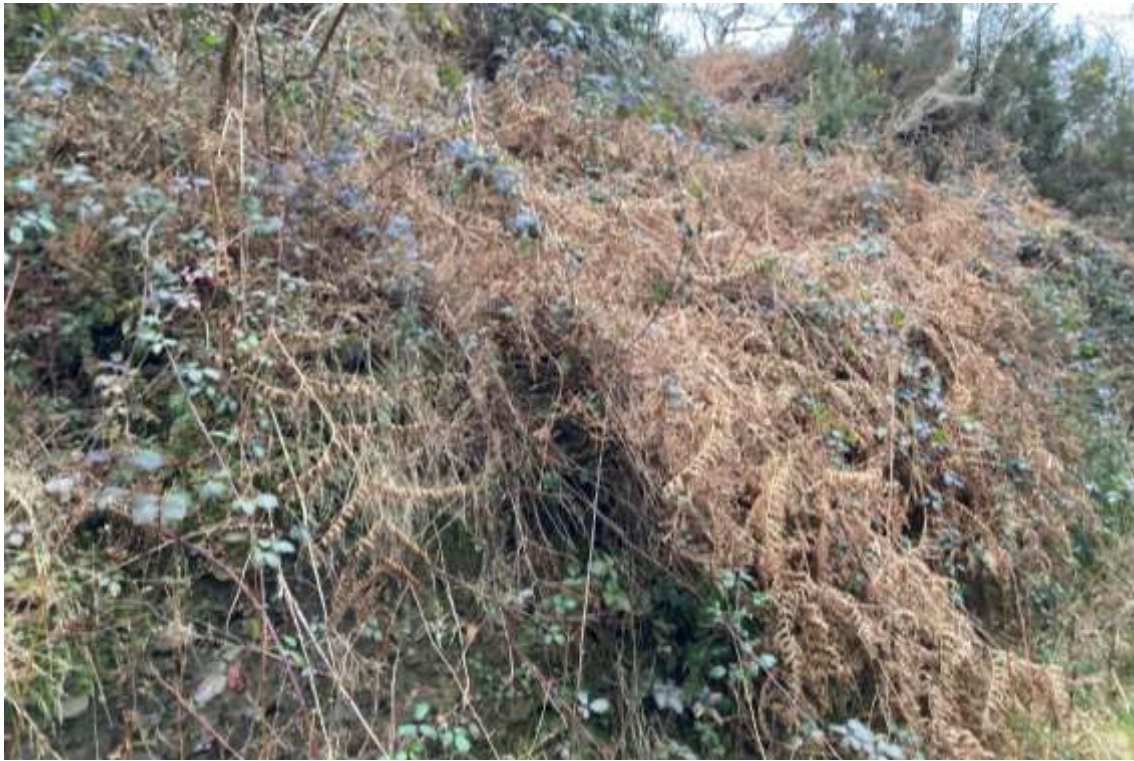
<b>Photo No.</b>	1	<b>Comment</b>	View looking towards a small exposure of sandstones, shales and clays; situated within the densely vegetated western extent of the site.
<b>Feature ID</b>	N/A

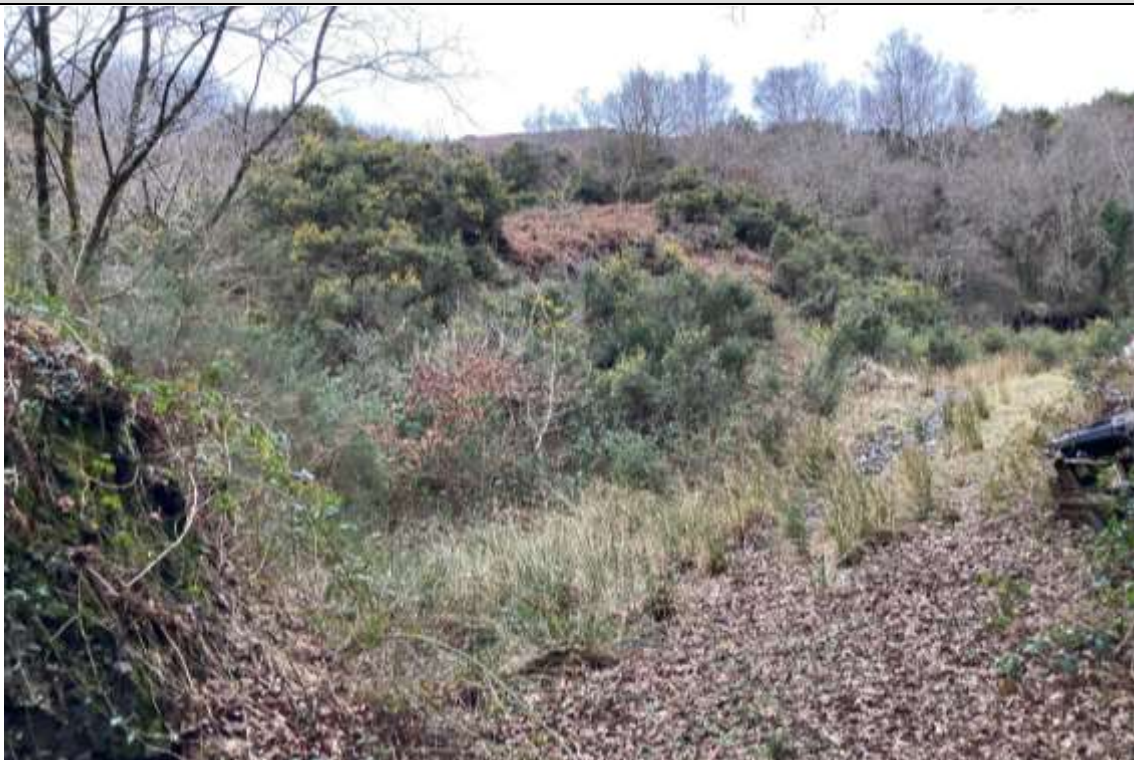
<b>OBSERVATIONS</b>				
<b>GEOTECHNICAL</b>				
<b>ID</b>	<b>Feature</b>	<b>Location</b>	<b>Comment</b>	<b>Change to Condition (New, Worse, None or N/A)</b>
25/G/01	Ponding	E – 274845 N - 206869	Issues (E - 274889, N – 206911) convey over an excavated face to the North of the site boundary. Flows convey towards the flat-lying ground/quarry floor, adjacent to the northern perimeter of the western section of the site. Resultant minor ponding and associated saturated ground conditions present.	None
<b>Recommendations</b>				
<b>DRAINAGE</b>				
<b>ID</b>	<b>Feature</b>	<b>Location</b>	<b>Comment</b>	<b>Change to Condition (New, Worse, None or N/A)</b>
N/A				
<b>Recommendations</b>				
<b>ENGINEERING INFRASTRUCTURE</b>				
<b>ID</b>	<b>Feature</b>	<b>Location</b>	<b>Comment</b>	<b>Change to Condition (New, Worse, None or N/A)</b>
N/A				
<b>Recommendations</b>				
<b>INSTRUMENTATION &amp; MONITORING</b>

<b>Photo No.</b>	2	<b>Comment</b>	Flows convey towards the flat-lying ground/quarry floor, adjacent to the northern perimeter of the western section of the site.
<b>Feature ID</b>	25/G/01

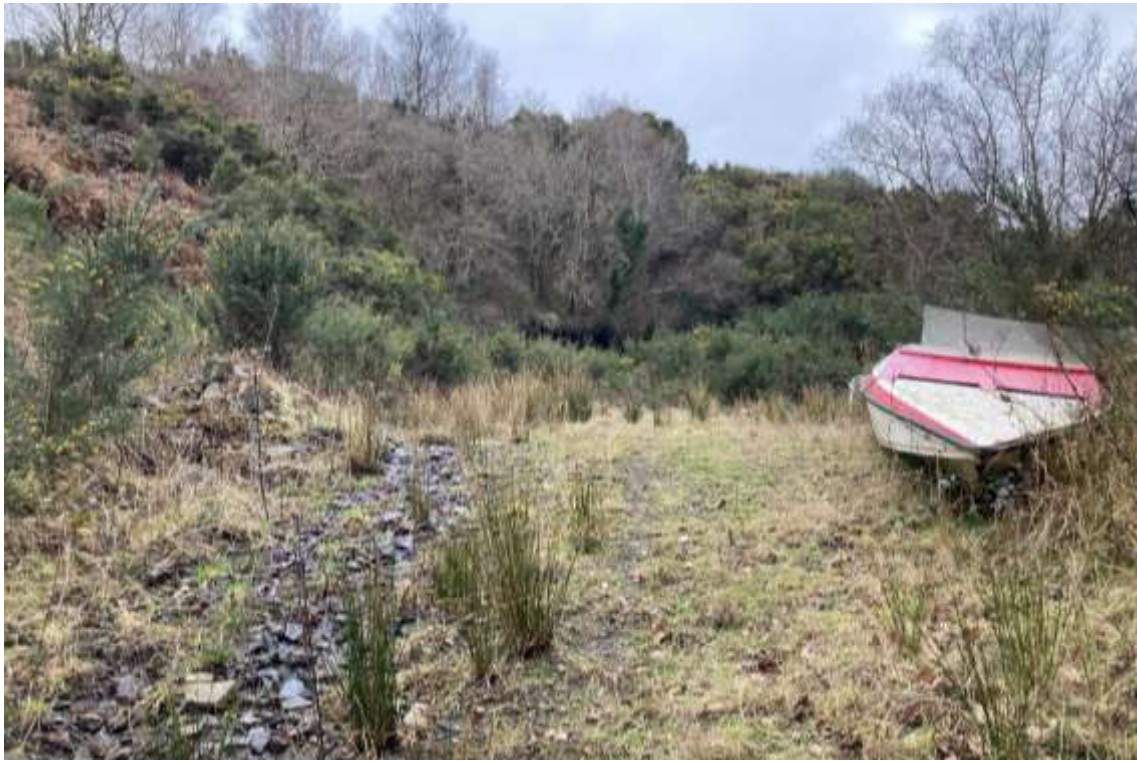
<b>Photo No.</b>	3	<b>Comment</b>	Flows convey towards the flat-lying ground/quarry floor, adjacent to the northern perimeter of the western section of the site. Evidence of human activity within the Quarry floor; abandoned boat.
<b>Feature ID</b>	25/G/01

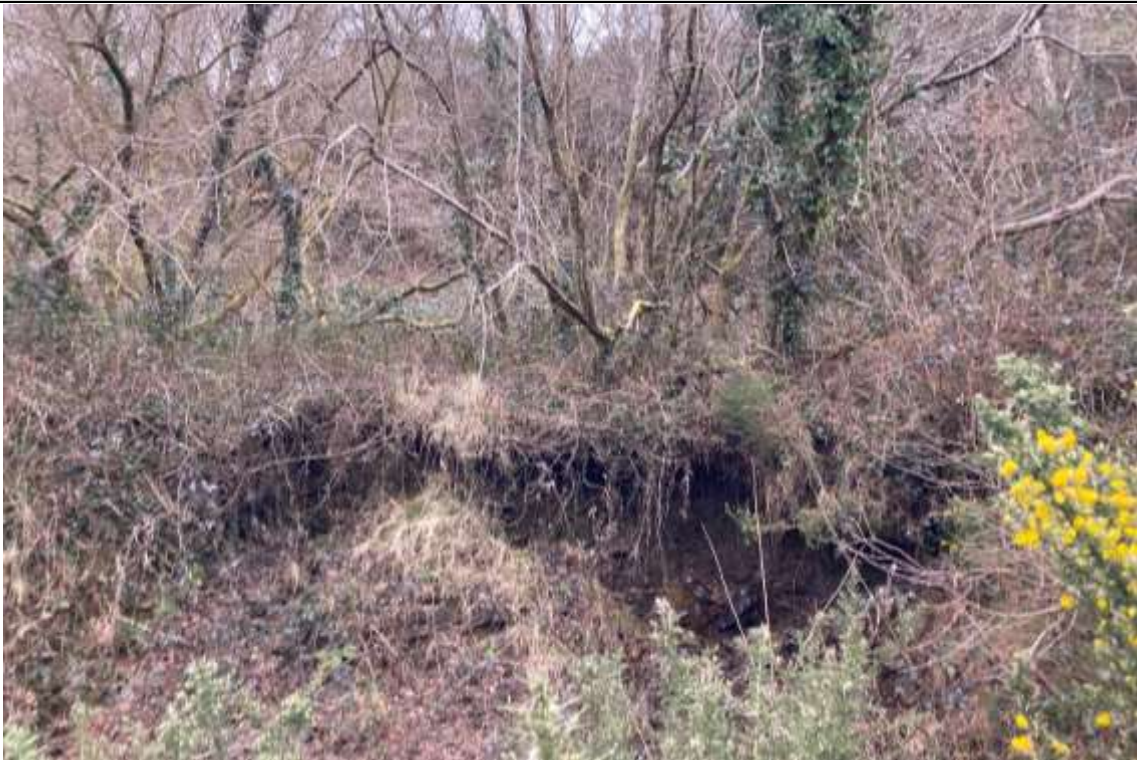
<b>Photo No.</b>	4	<b>Comment</b>	Issues convey over an excavated face to the North of the site boundary.
<b>Feature ID</b>	25/G/01
