Coal Tip Name	Godre'r-graig Quarry / Cilmaengwyn	Tip Ref Number	L044A
		Ownership Status	Private
Located in	Godre'r-graig, Neath-Port Talbot	Tip Category	D
Led by		Undertaken on behalf of	Welsh Government
Date	08/11/2023	Date of last Detailed Inspection	24/07/2023
Weather	Overcast	Damp	Calm
Comments on access and any limitations	<p>Access to the site was gained via an access path situated just off the Pentwyn Farm access track. The access path extends up the hillside in a north-easterly direction, passing through Cwar Pentwyn Quarry before reaching a narrow, overgrown path which extends up-slope towards the site.</p> <p>It should be noted that this inspection was conducted without the benefit of a detailed site plan; whilst dense vegetation significantly limited accessibility and visual inspection. Therefore, instability within these areas could exist, but was not detectable at the time of the inspection. The densely overgrown nature of the site prevented inspection of the spoil material; it is presumed that the site is comprised of sandstone quarry waste material, however some exposures of colliery spoil material were present downslope (outside the provided site boundary), adjacen

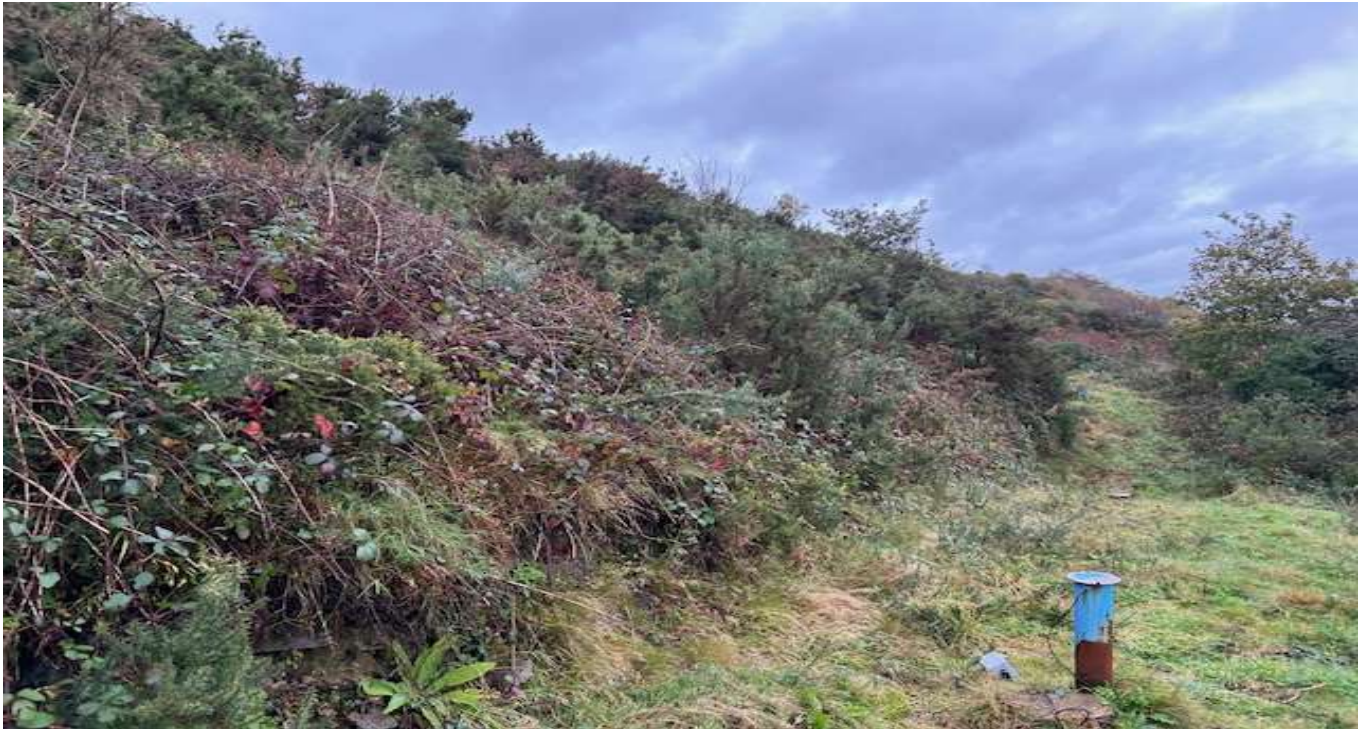
Photo No.	1	Comment	Piezometer borehole located on the site access track, downslope (outside the provided site boundary).
Feature ID	23/IM/01

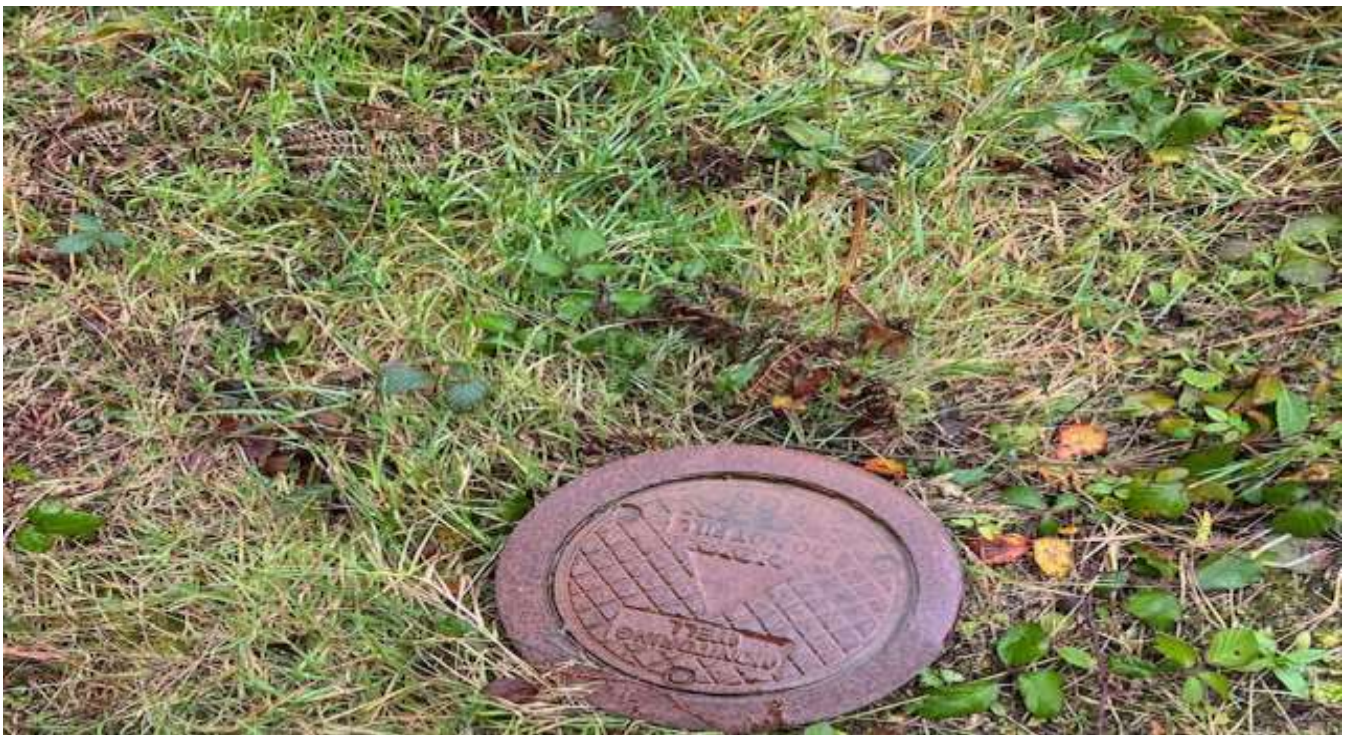
Photo No.	2	Comment	Monitoring well located on the site access track, downslope (outside the provided site boundary).
Feature ID	23/IM/01

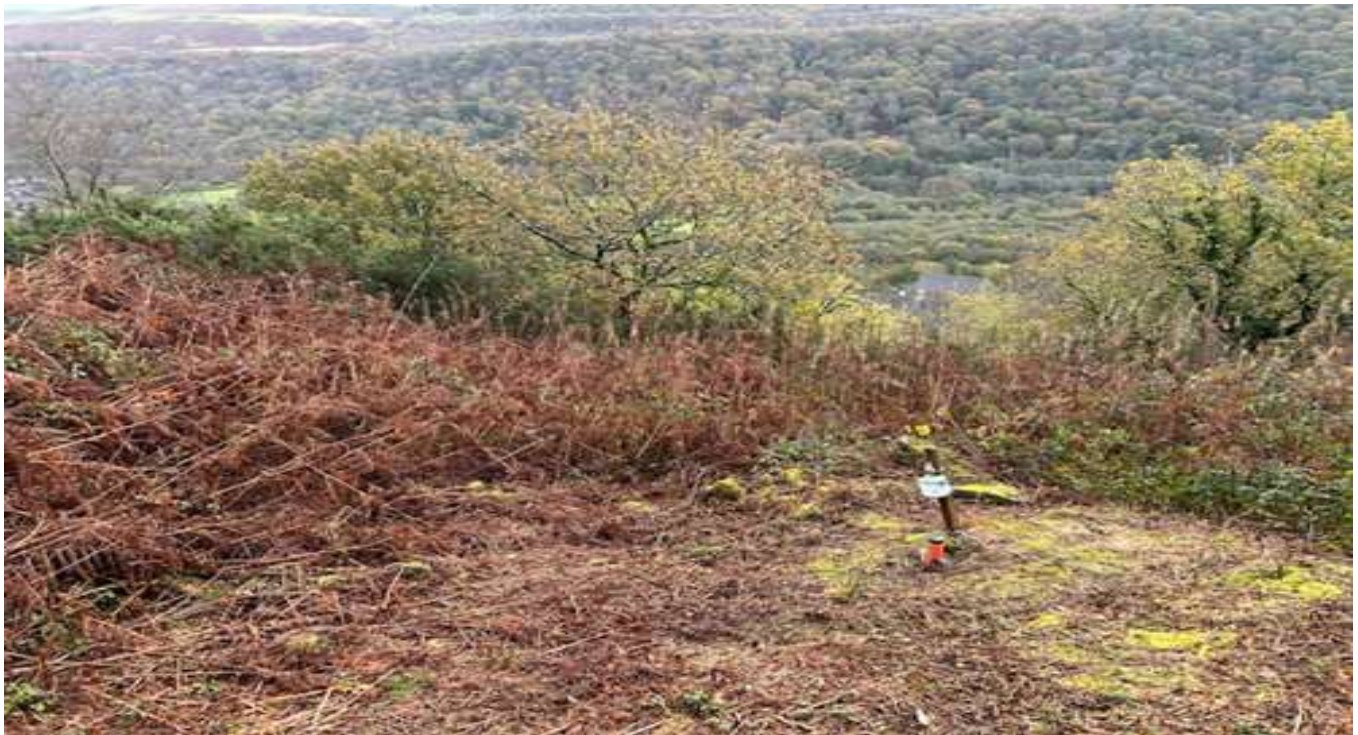
Photo No.	3	Comment	Piezometer located downslope (outside the provided site boundary). Recent vegetation clearance has been undertaken to provide access.
Feature ID	23/IM/01

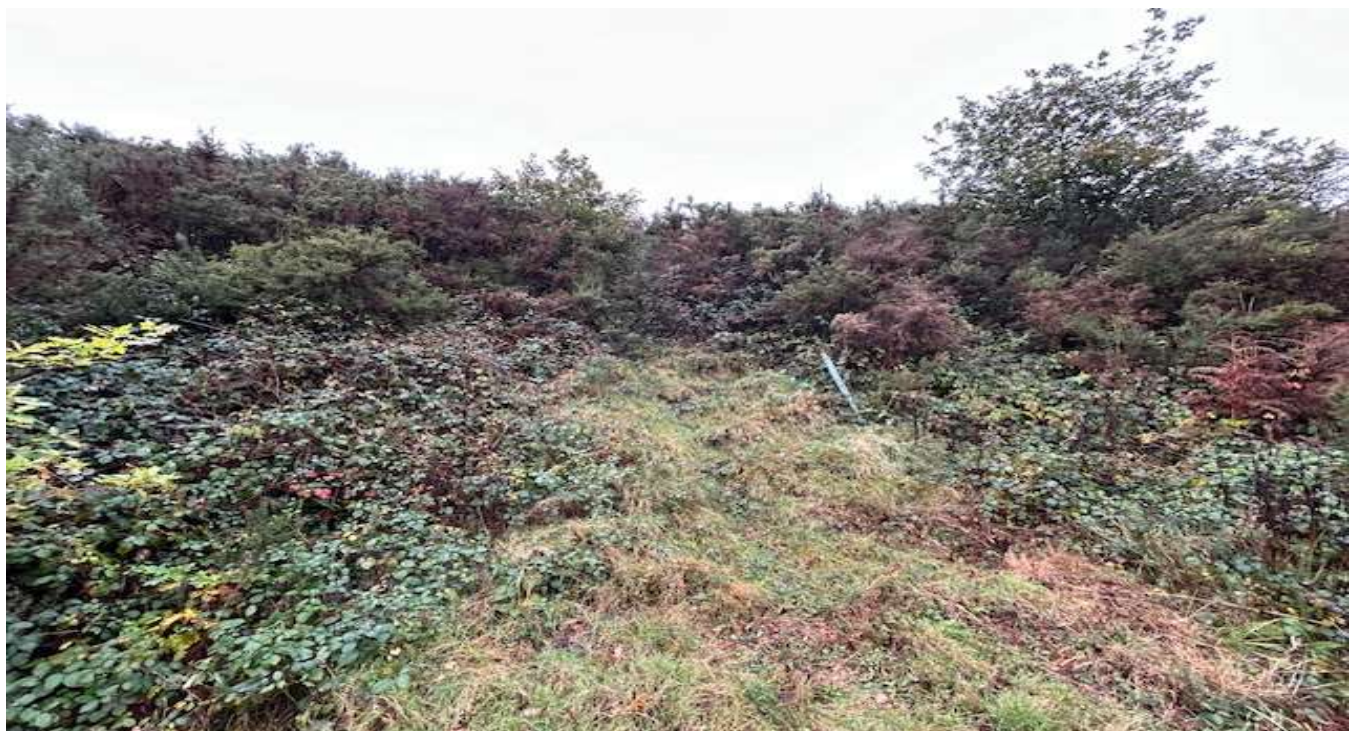
Photo No.	4	Comment	Minor surface erosion exposing bare spoil material along a narrow, overgrown access path; of which extends up-slope off the main site access path, towards the site. Plastic casing associated with a piezometer appears to have been discarded next to the path.
Feature ID	23/IM/01

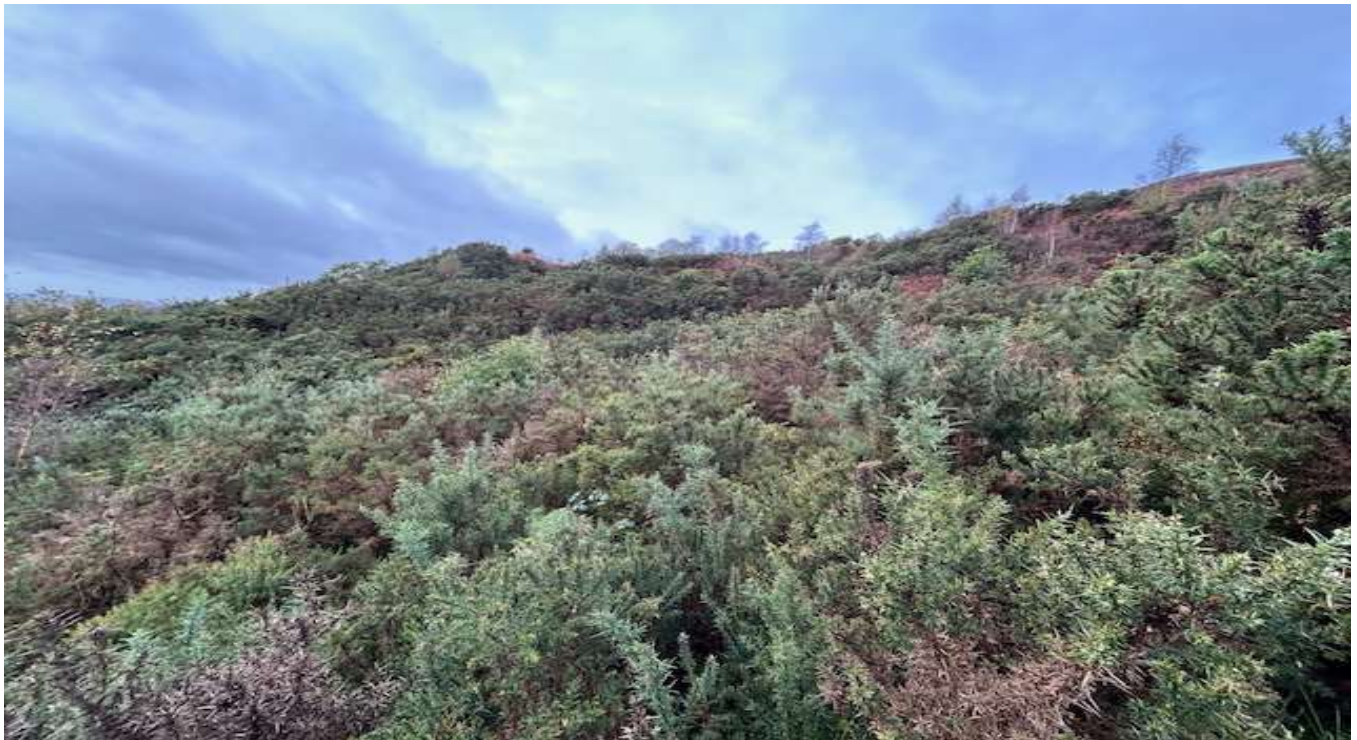
Photo No.	5	Comment	View looking south-west across the very densely vegetated lobes of tip material. Image conveys associated accessibility issues.
Feature ID	23/L/01

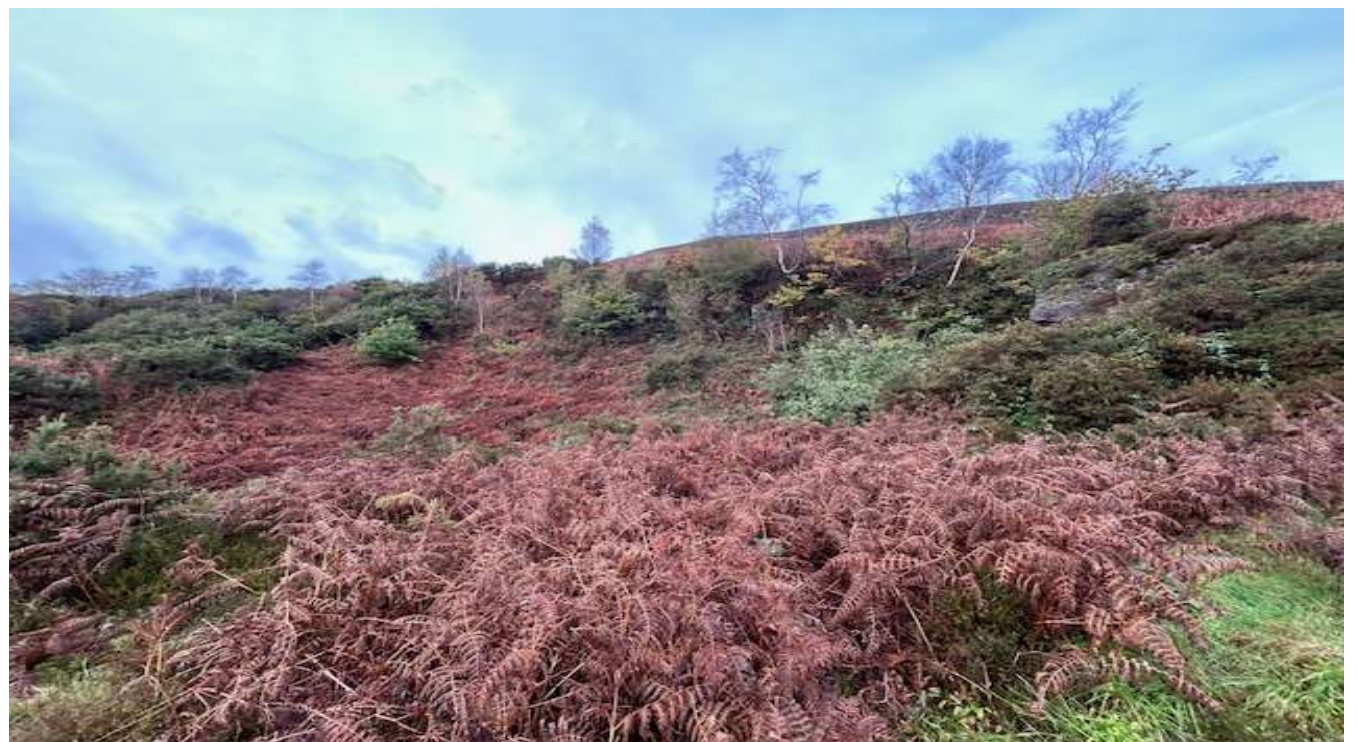
Photo No.	6	Comment	View looking towards an outcrop of bedrock at the rear of the tip; likely the quarry high wall.
Feature ID	23/L/01
