Coal Tip Name	Godre'r-Graig Higher / Pentwyn No. 3 Levels		UID	T42668	
Located in	Godre'r Graig, Neath Port Talbot		Tip Category	D	
Inspection Led by		Date of Inspection	12/02/2025	Date of last Inspection	09/09/2024
Weather	Overcast		Dry	Calm	
Comments on access and any limitations	<p>Access to the site gained via an access track situated just off Graig Road, which leads to Pentwyn Farm.</p> <p>It should be noted that this inspection was conducted without the benefit of a detailed site plan; whilst in certain areas vegetation limited accessibility and visual inspection. Therefore, instability within these areas could exist but was not detectable at the time of the inspection.</p>				
	Description				Status
RAG Status: Capital & Maintenance Works	Consider implementing appropriate drainage infrastructure to effectively capture the uncontrolled flows associated with the outfall of issues. Consider formalising/lining the flow pathway of the issues, to prevent further scouring (25/G/01/06).				2

Coal Tip Name	Godre'r-Graig Higher / Pentwyn No. 3 Levels	UID	T42668
		Tip Category	D
Date of Inspection	12/02/25	Inspection led by

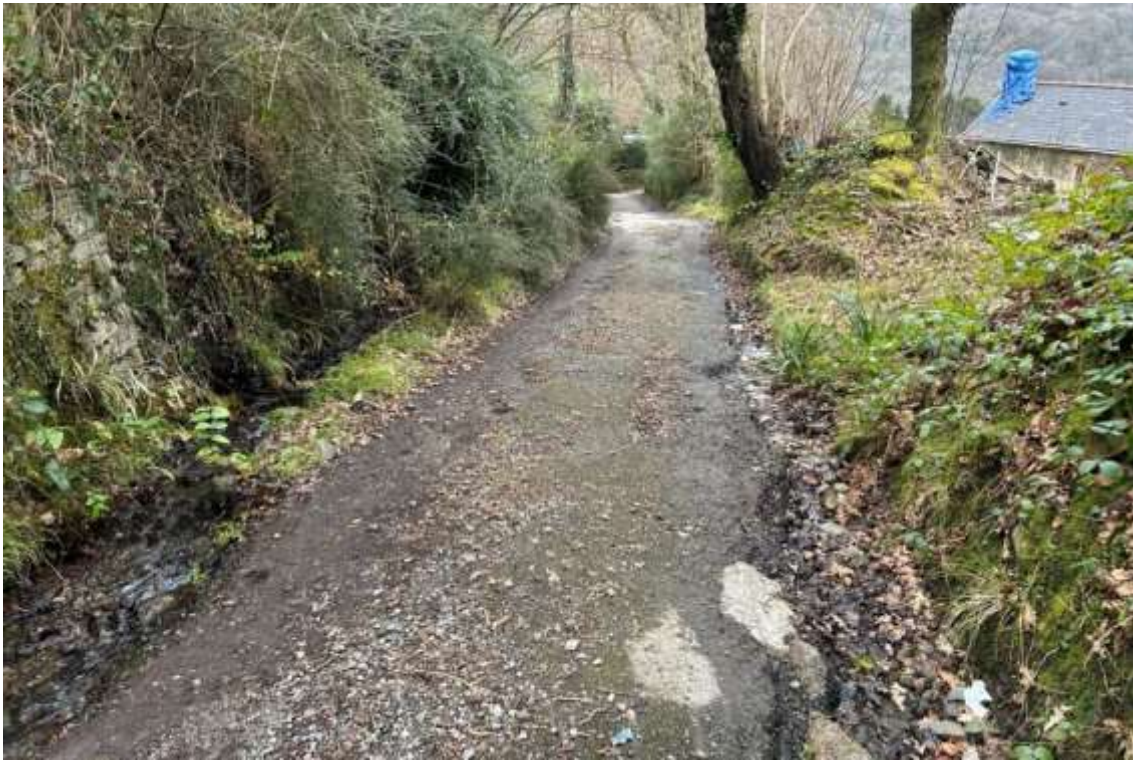
DRAINAGE				
ID	Feature	Location	Comment	Change to Condition (New, Worse, None or N/A)
25/D/01	Channel	E-274919, N-206774	An unlined trackside channel spans the upper section of the access track leading to Pentwyn Farm. This access track is significantly scoured in places, indicating that flows escape the trackside channel during heavy rainfall (Photo 1).	None

Photo No.	01	Comment	Scoured access track leading to Pentwyn Farm. Flows visible on LHS of image, conveying along an unlined, trackside channel.
Feature ID	25/D/01

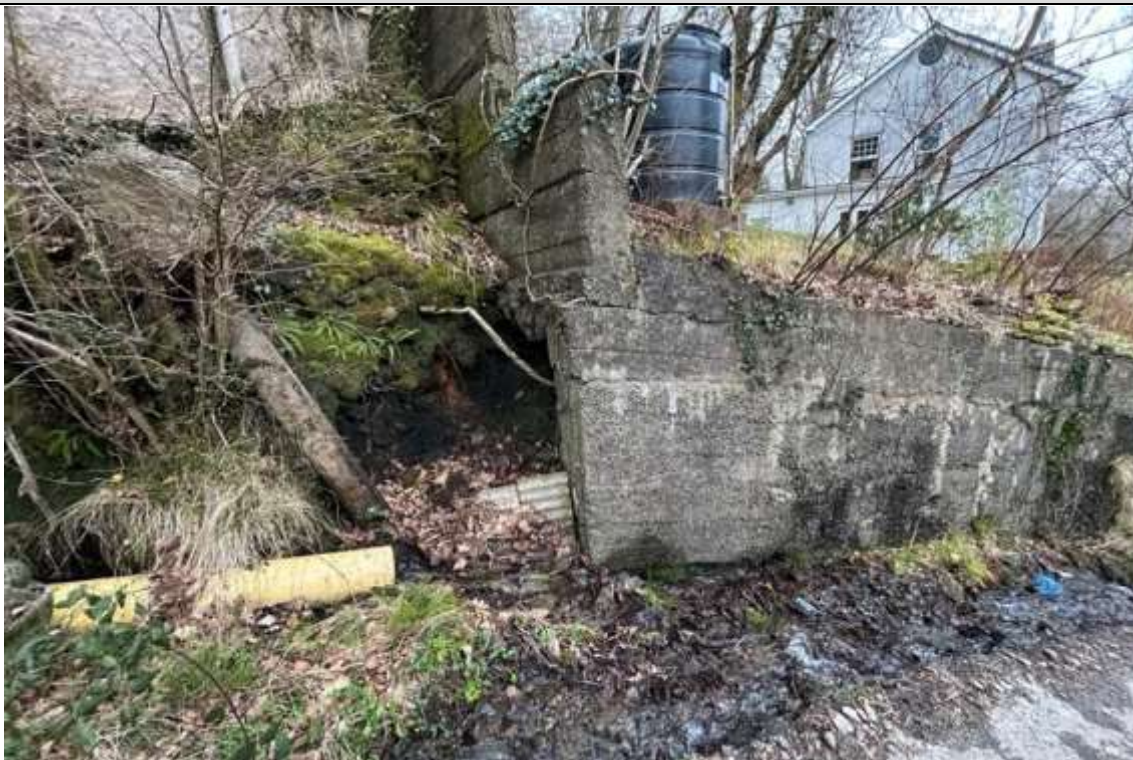
Photo No.	02	Comment	Minor seepages and saturated ground conditions observed adjacent to the retaining wall situated along the residential property of Glanderi, located just East of the site.
Feature ID	25/E/01

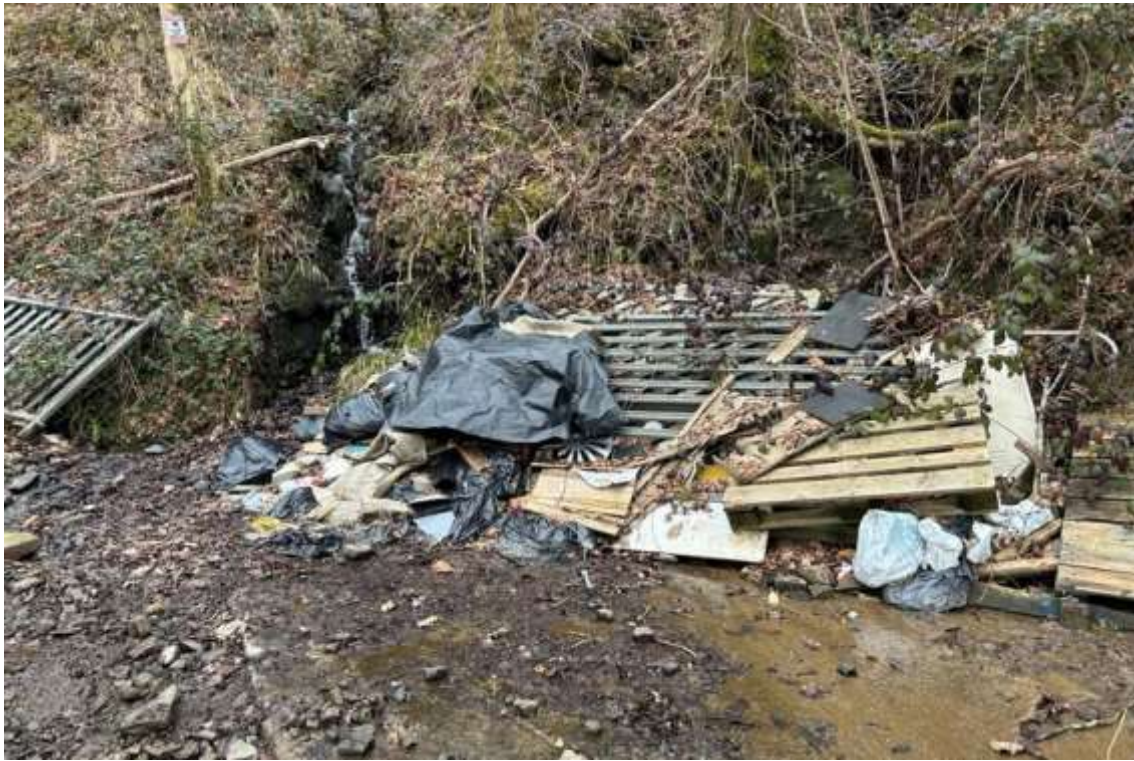
Photo No.	03	Comment	Pallets and other miscellaneous materials discarded below the outfall of flow path of issues which skirts the Eastern perimeter of the tip body. Material deposited on the driveway of the residential property Glanderri.
Feature ID	25/L/01

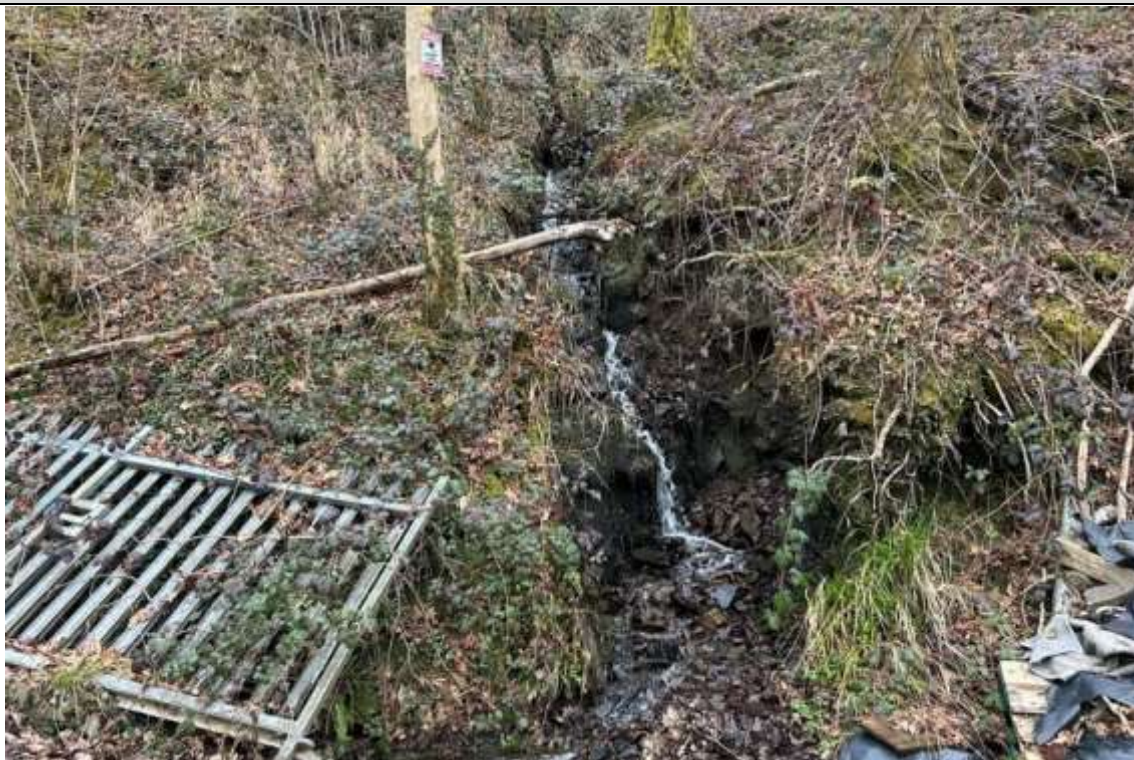
OBSERVATIONS				
GEOTECHNICAL				
ID	Feature	Location	Comment	Change to Condition (New, Worse, None or N/A)
25/G/01	Erosion	E-274886, N-206778	Minor erosion of natural ground noted at the outfall of the flow pathway of issues which skirt the Eastern perimeter of the tip body (Photo 4).	Worse
25/G/02	Slumping	E-274847, N-206774	A very small section of the toe of the tip has been subject to minor slumping, relating to a fallen, uprooted tree displacing a small amount of spoil material (Photo 5).	None
25/G/03	Minor Seepage	Toe of the tip	Previously reported multiple, minor seepages emanating from the toe of the tip and conveying along the adjacent access track. At the time of inspection, no seepages were identified but it is assumed that they wax and wane depending on weather conditions (Photo 6).	None
25/G/04	Backscarp	E-274813, N-206763	Minor, arcuate backscarp approximately 5m in width located along the Western section of the toe of the tip, indicating the presence of a historical, superficial surface slip (Photo 7).	None

Photo No.	04	Comment	View looking towards the outfall of the flow path of issues which skirt the Eastern perimeter of the tip body located further upslope. A small amount of natural ground material has been eroded adjacent to the outfall
Feature ID	25/G/01

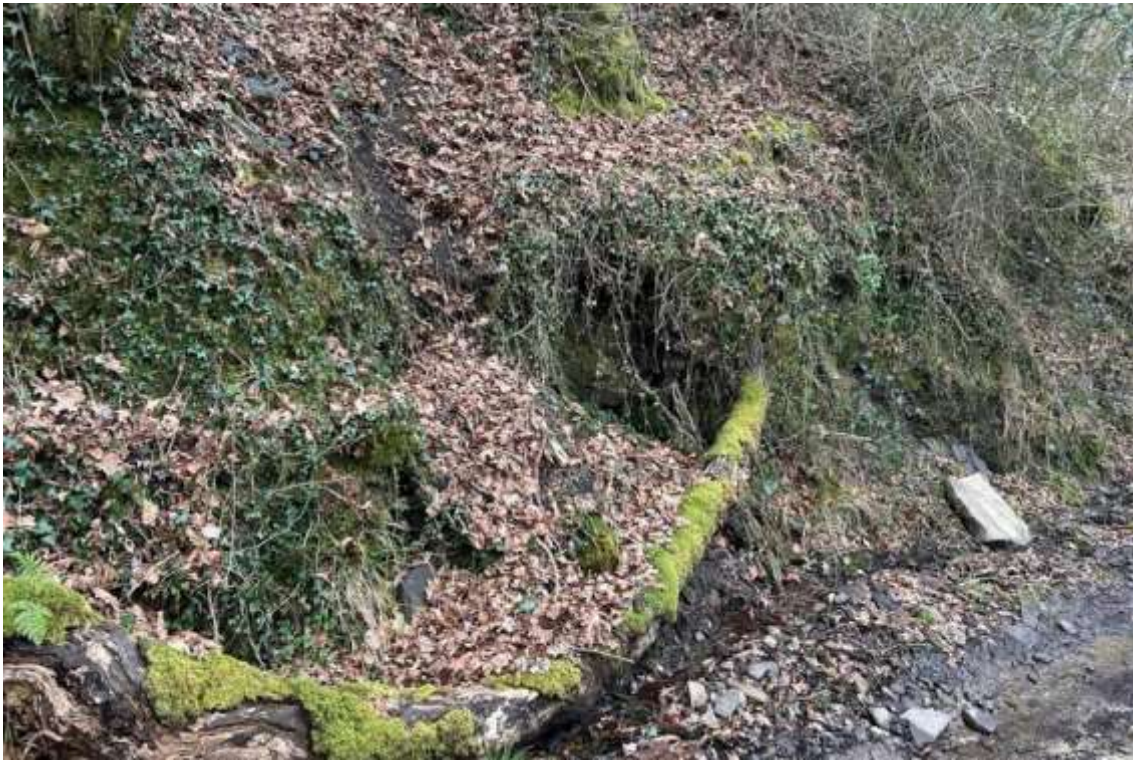
Photo No.	05	Comment	View from the access track which spans the toe, looking towards the small section of slumped material, likely associated with the uprooted tree.
Feature ID	25/G/02

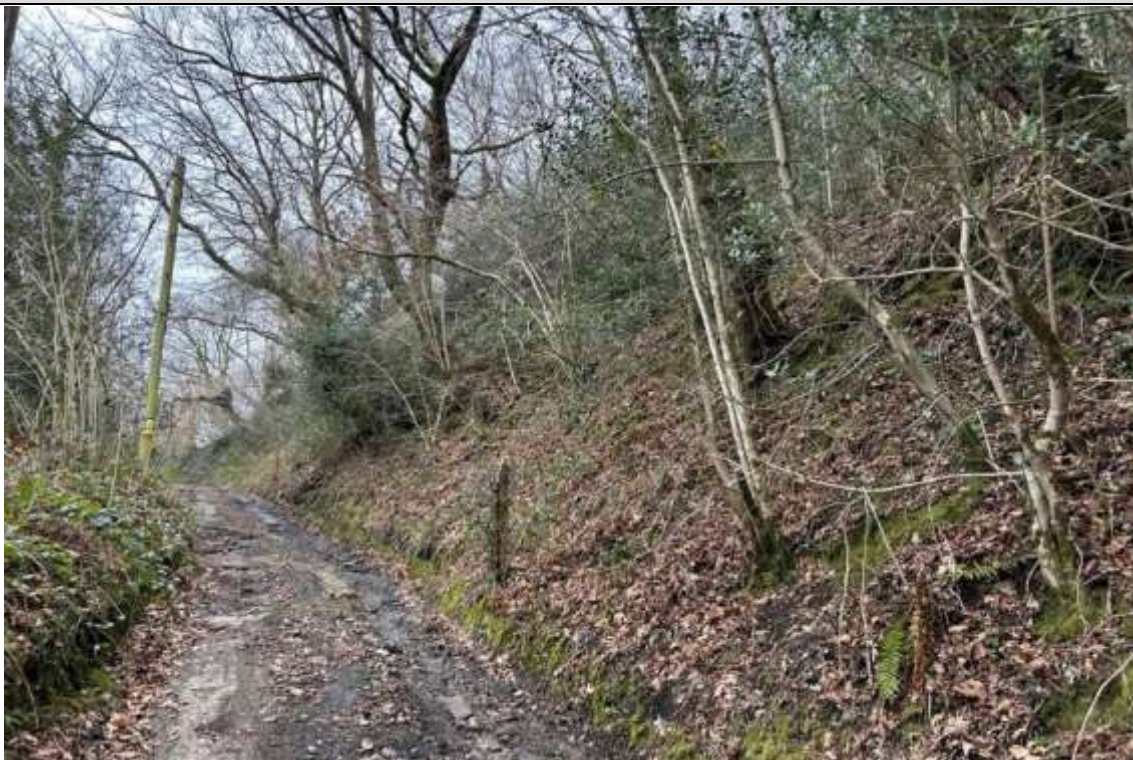
Photo No.	06	Comment	View from the access track, looking across the steep lower section and toe of the tip flank. Previously, multiple minor seepages have been identified along the toe. At the time of inspection, no seepages were identified but it is likely that they wax and wane.
Feature ID	25/G/03

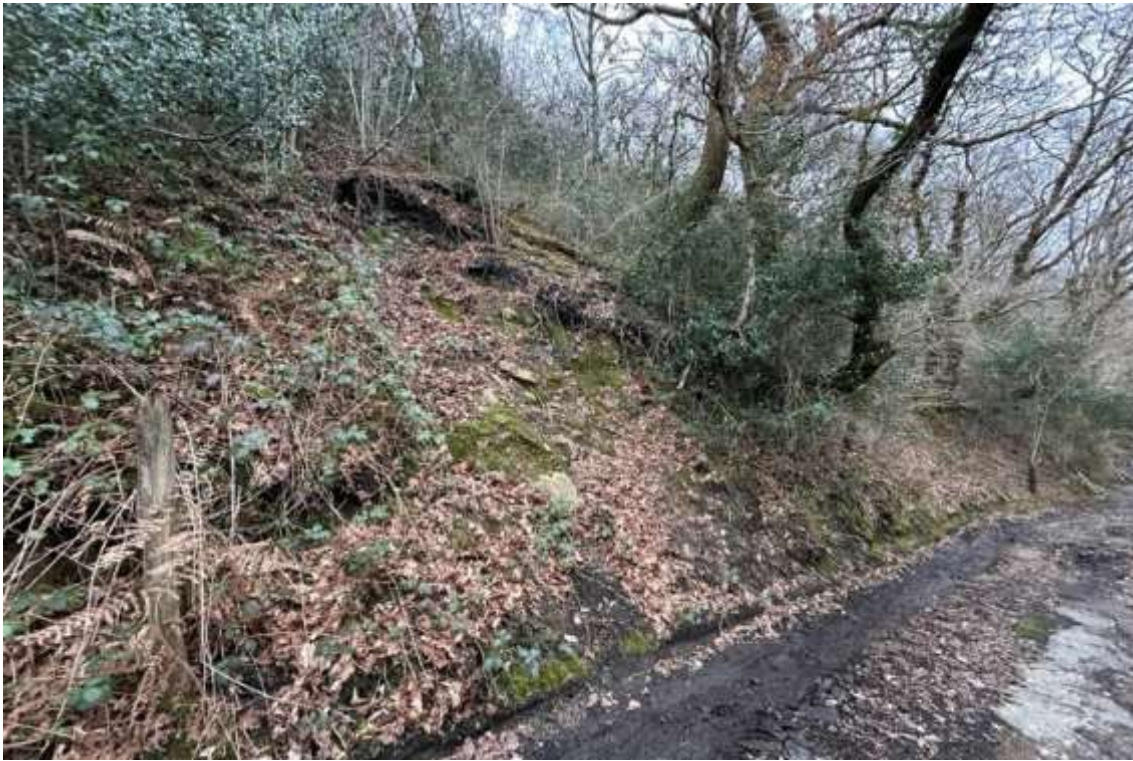
Photo No.	07	Comment	View from the toe, looking towards the minor, arcuate backscarp approximately 5m in width indicating the presence of a historical, superficial surface slip.
Feature ID	25/G/04

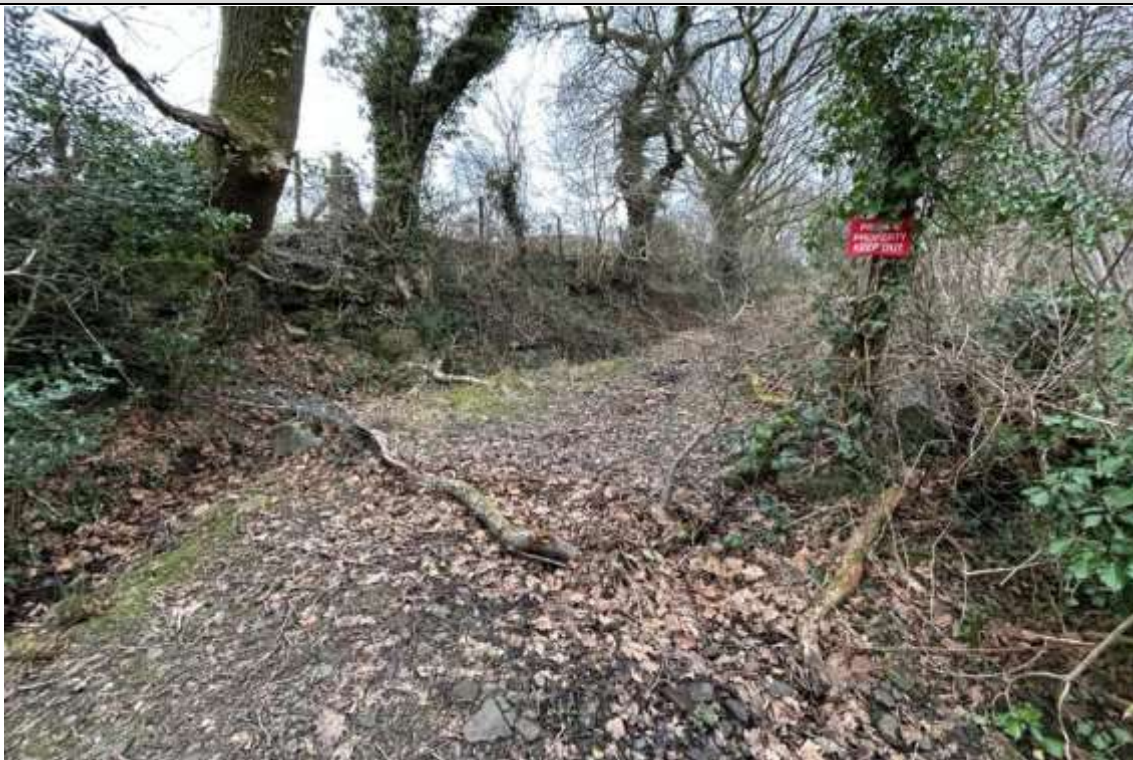
Photo No.	08	Comment	The temporary fencing erected at the entrance to the access track which climbs the Western site perimeter has since fallen.
Feature ID	25/L/02

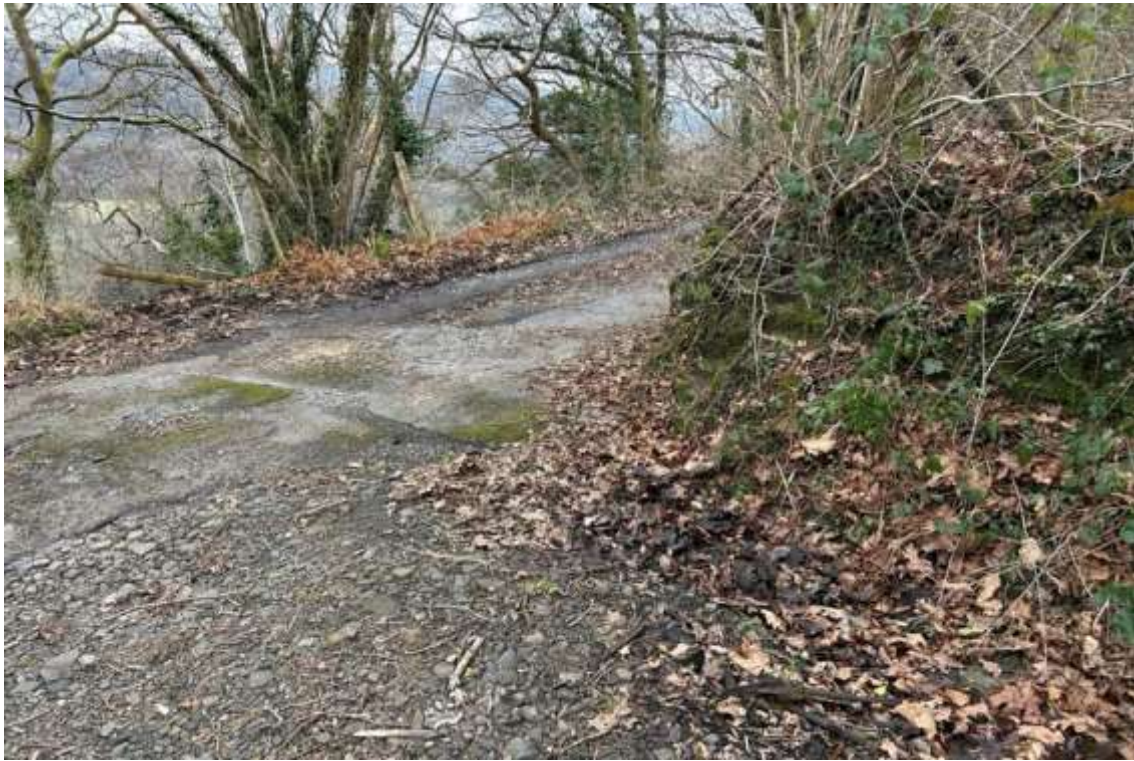
25/D/02	Culvert	E-274776, N-206736	Leaf litter obstructing flows from entering the trackside drain, located adjacent to the access track which spans just off the Western site perimeter (Photo 9).	Worse
Recommendations			Consider removing the leaf litter obstructing flows from entering the trackside culvert structure at the Western site perimeter (25/D/02).	
ENGINEERING INFRASTRUCTURE				
ID	Feature	Location	Comment	Change to Condition (New, Worse, None or N/A)
25/E/01	Retaining Wall	E-274907, N-206777	The retaining wall located along the property of Glanderri (located just east of the site) is in poor condition, with multiple minor seepages emanating from cracks/voids within the structure. Flows conveying along the base of this structure and enter an unlined, trackside channel. This has resulted in minor saturation along the base of the retaining wall (Photo 2).	None
Recommendations			Continue to monitor the condition of the retaining wall structure associated with the residential property of Glanderri for a deterioration (25/E/01).

Photo No.	09	Comment	Leaf litter obstructing flows from entering the trackside drain, located adjacent to the access track which spans just off the Western site perimeter.
Feature ID	25/D/02

Consider removing the leaf litter obstructing flows from entering the trackside culvert structure at the Western site perimeter (25/D/02).				2
	Consider the feasibility of implementing a retaining structure along the base of flank/toe of the tip, as it directly abuts an access track (25/G/02-03).				3
	Continue to monitor the condition of the retaining wall structure associated with the residential property of Glanderri for deterioration (25/E/01).				
General Remarks	<p>An elongated lobe of colliery spoil material orientated north-east to south-west, formed by traditional loose-end tipping practice. The tip has been constructed with a plateau and a well-vegetated, steeply-sloping, south-east facing flank. An access track abuts the toe of this flank. Most notably, issues emanating from the natural hillside to the rear of the site (which potentially contains historical mine entries) convey along the natural ground hillside just East of the site and skirt a partial length of the Eastern site perimeter, resulting in minor erosion via scour. These flows outfall at the access track at the toe of the tip resulting in instances of erosional scour along the access track, as the unlined trackside channel is ineffective in conveying flows. Just East of the toe of the tip, the residential property of Glanderri is located. The outfall of issues is located just off the driveway of the property, which has resulted in localised saturated ground conditions. The retaining wall associated with this property is also in poor condition, although not retaining tip material. Some evidence of minor, historical instability was noted along the toe of the tip, with minor seepages being reported previously. These seepages likely wax and wane depending on weather conditions. No evidence of recent ground movement observed at the time of inspection.</p>

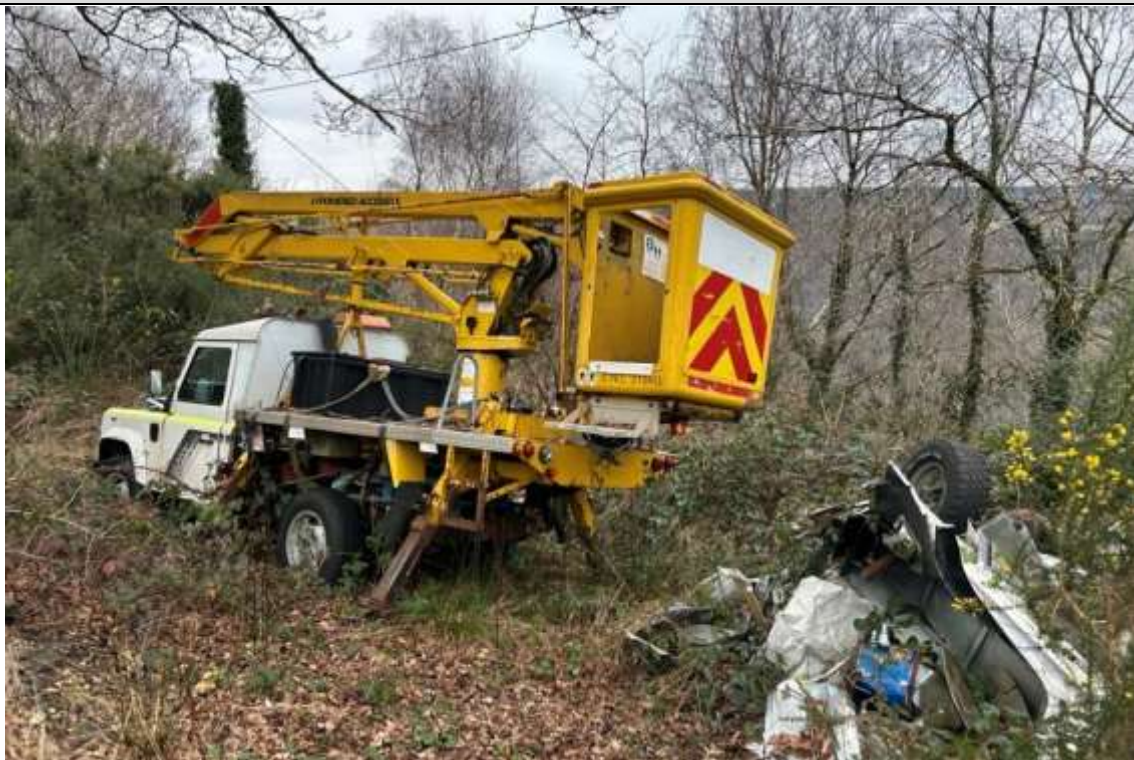
Photo No.	10	Comment	Disused plant vehicle and associated equipment discarded on the north-western section of the tip plateau.
Feature ID	25/L/03

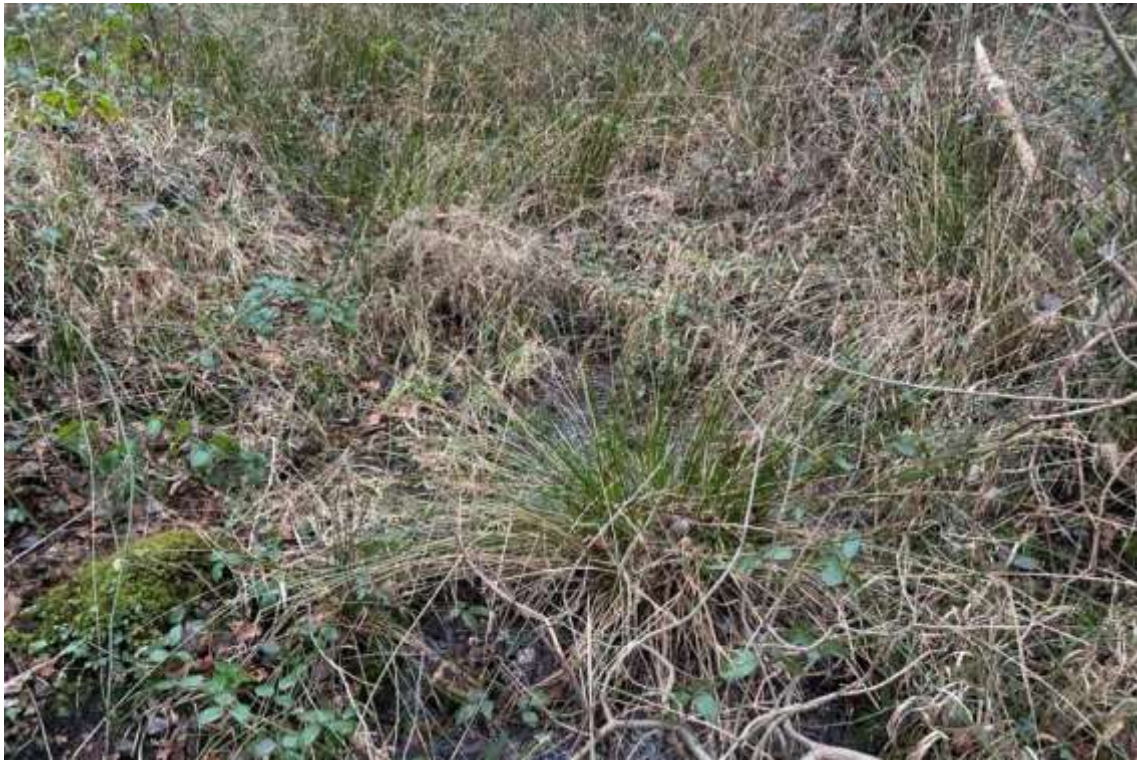
25/G/05	Saturated Ground	E-274845, N-206825	Saturated ground conditions marked by reed growth and minor ponding observed along the upper, north-eastern section of the tip body. This is a longstanding feature of the site (Photo 11).	None
25/G/06	Erosion	E-274853, N-206816	Minor erosion of the tip body by the flow pathway of issues which skirt a small section of the Eastern site perimeter. Flows emanate from the natural ground hillside to the rear, which presumably contains historic mine entries. Flows outfall from this pathway adjacent to the residential property of Glanderri, as displayed in image 4 (Photo 12-13).	None
Recommendations			Consider implementing appropriate drainage infrastructure to effectively capture the uncontrolled flows associated with the outfall of issues. Consider formalising/lining the flow pathway of the issues, to prevent further scouring (25/G/01/06).	
			Consider the feasibility of implementing a retaining structure along the base of flank/toe of the tip, as it directly abuts an access track (25/G/02-03).

Photo No.	11	Comment	Saturated ground conditions marked by reed growth and minor ponding observed along the upper, north-eastern section of the tip body.
Feature ID	25/G/05

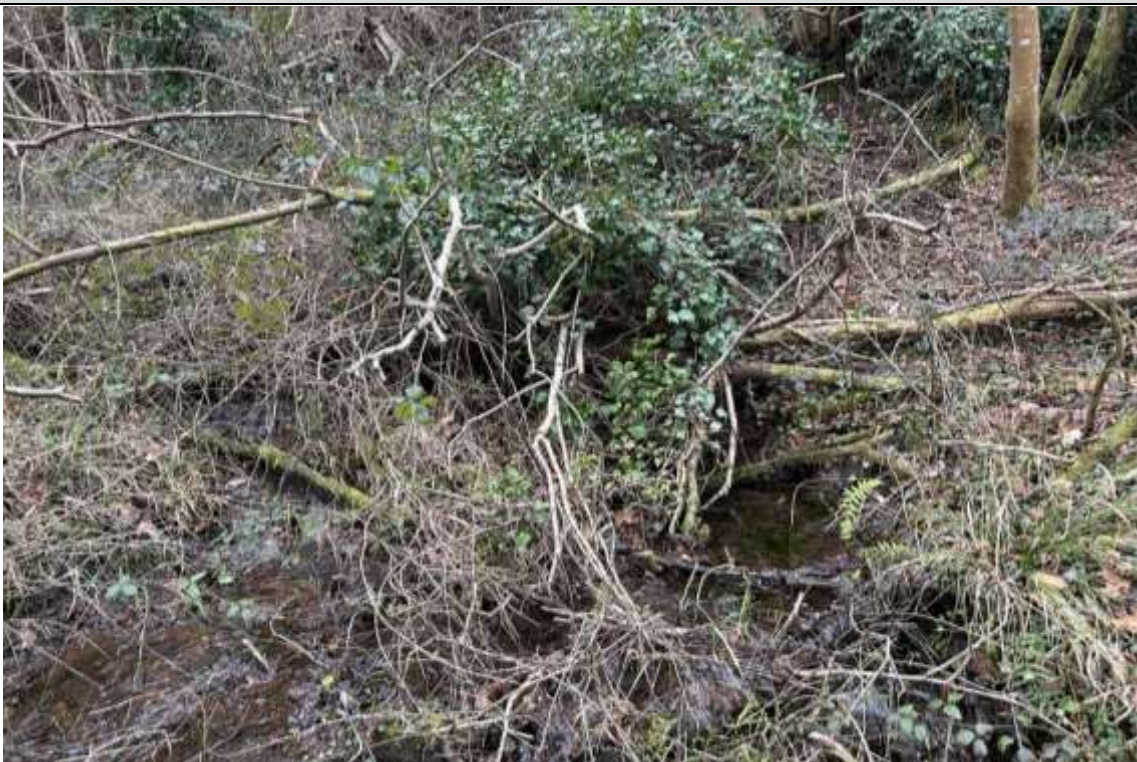
Photo No.	12	Comment	A moderate levels flows emanating from the hillside to the rear of the upper, north-eastern section of the site and potential, historic mine entries convey along a partial length of the Eastern site perimeter, before conveying further downslope.
Feature ID	25/G/06

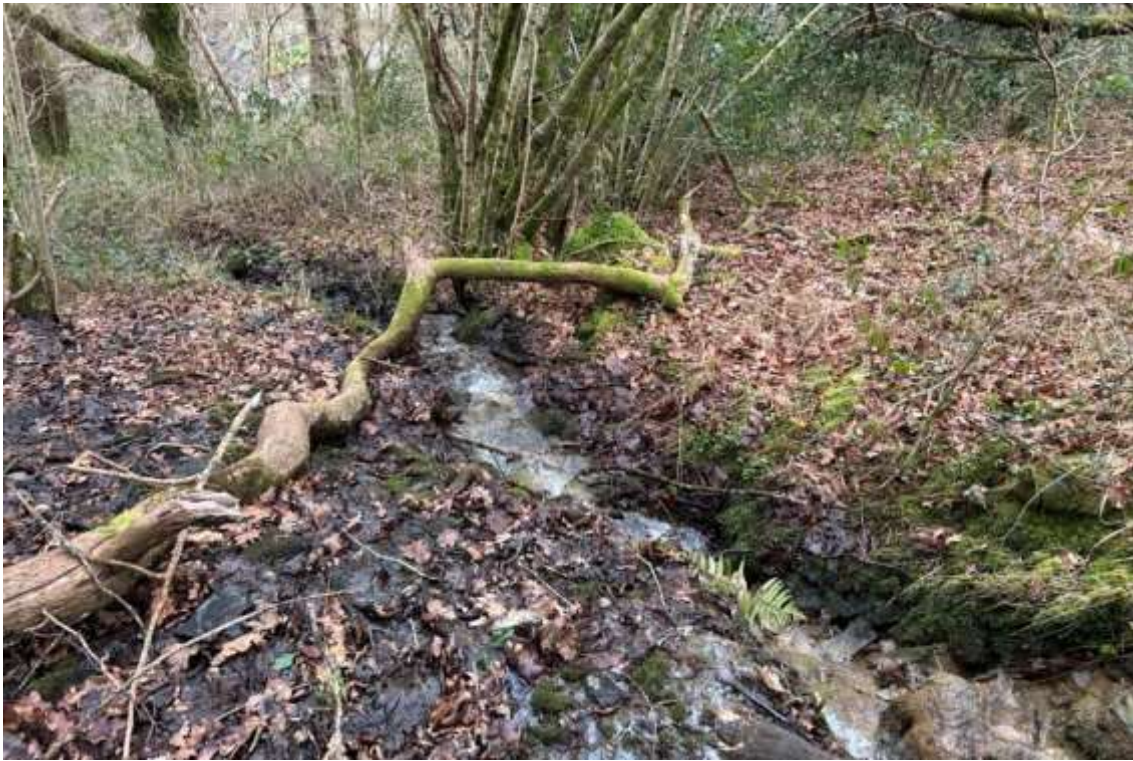
Photo No.	13	Comment	Flow pathway of issues which skirt a small section of the Eastern site perimeter, resulting in minor erosional scour.
Feature ID	25/G/06

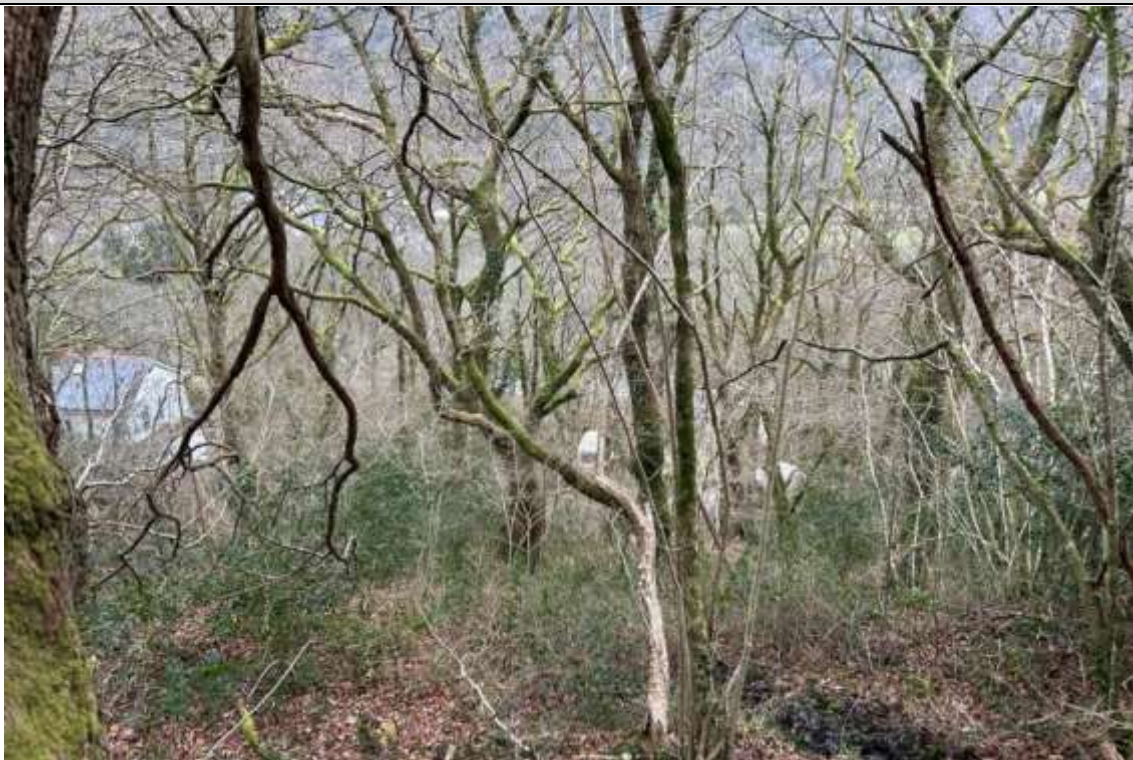
Photo No.	14	Comment	View from the upper slope, looking across the well-wooded tip body.
Feature ID	25/L/04
