**The Coal  
Authority**

## **Site Inspection Report**

### **Pen y Graig Quarry, Ystalyfera**

**Date: August 2017**

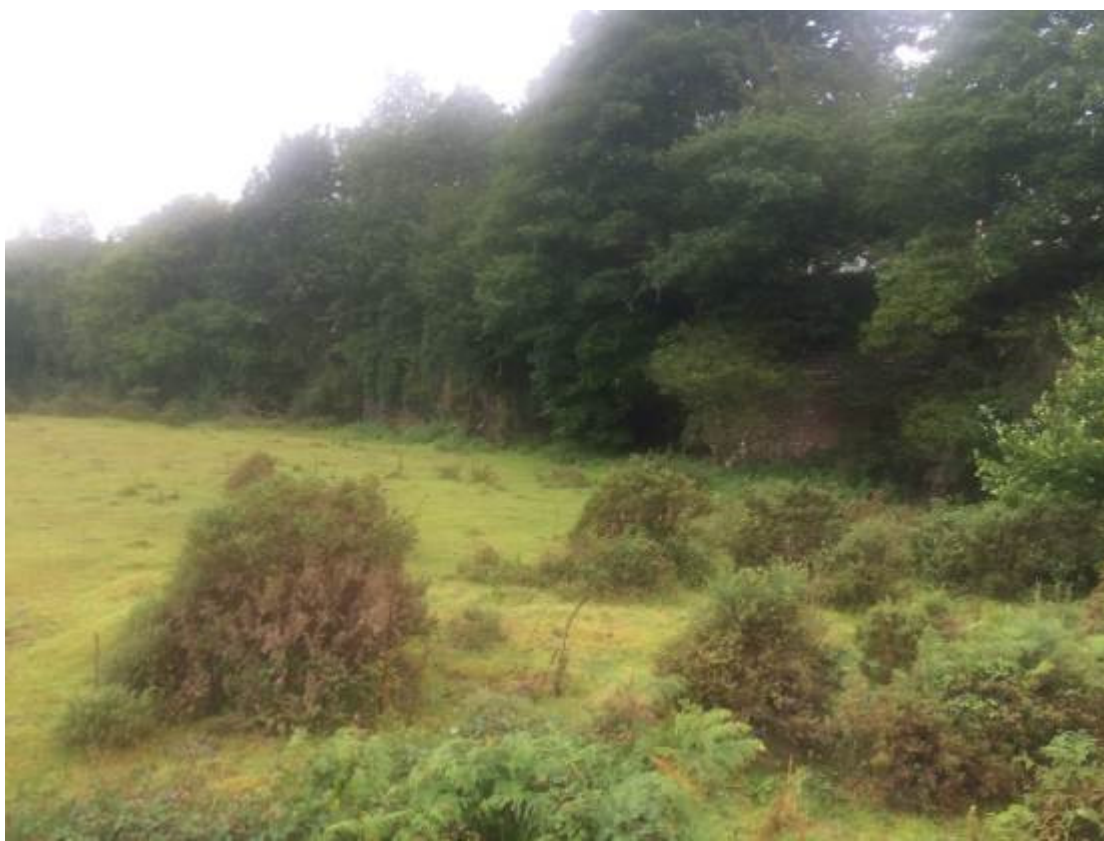
The quarry high wall is generally vertical, with the exposed strata comprising moderately weathered thin to thickly bedded sandstone units, with occasional subordinate siltstones.

**Photograph 1 – Quarry high wall location**

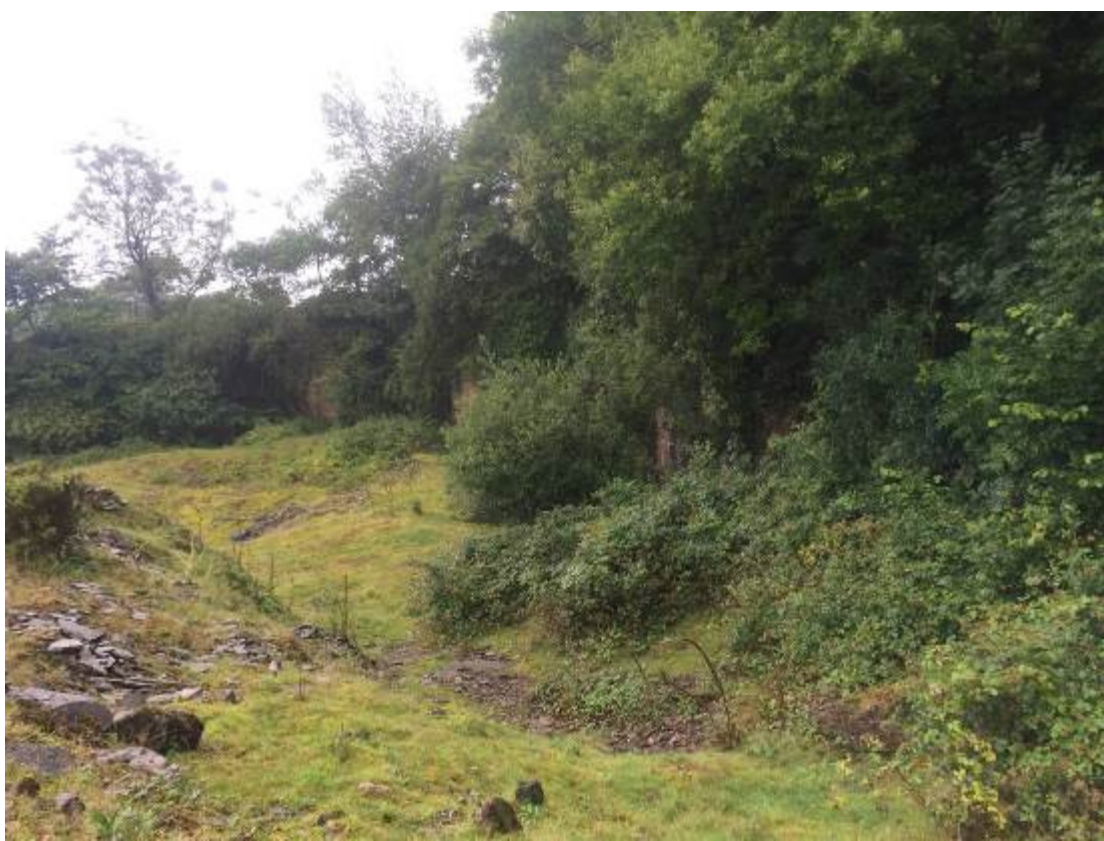
**Photograph 2 – Quarry high wall location**

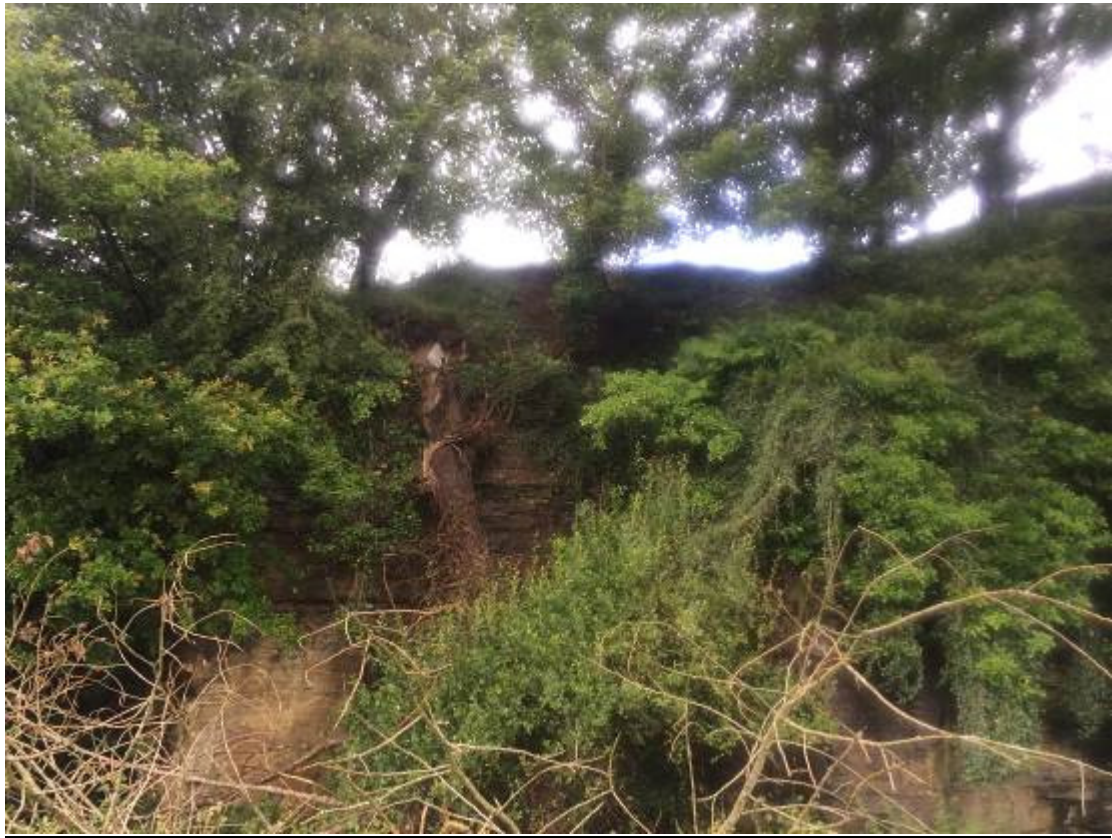
There was no evidence of significant loose or overhanging blocks, and only occasional minor seepages were noted from the face, generally at the interface of sandstone / siltstone units. An area of uprooted and fallen trees was observed at the mid-point just below the crest, appearing to have been a relatively recent occurrence.

**Photograph 3 – Quarry high wall showing fallen trees**

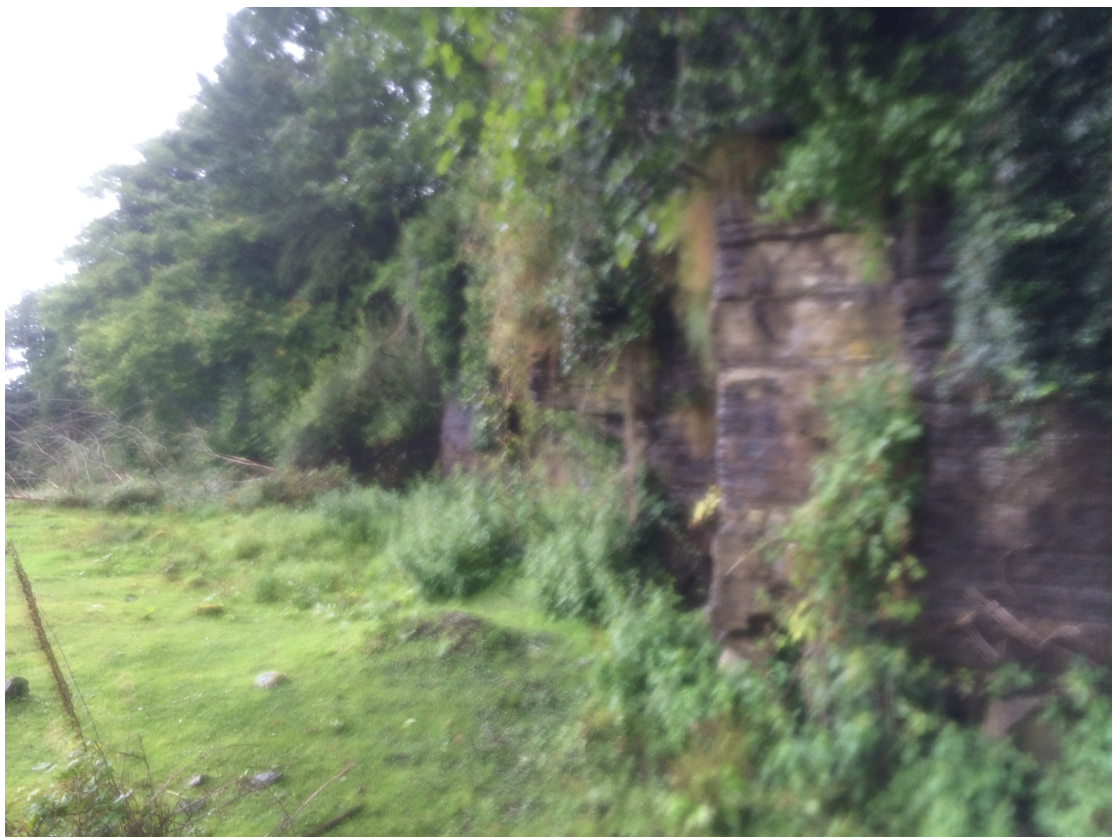
**Photograph 4 – Quarry high wall showing vertical face**

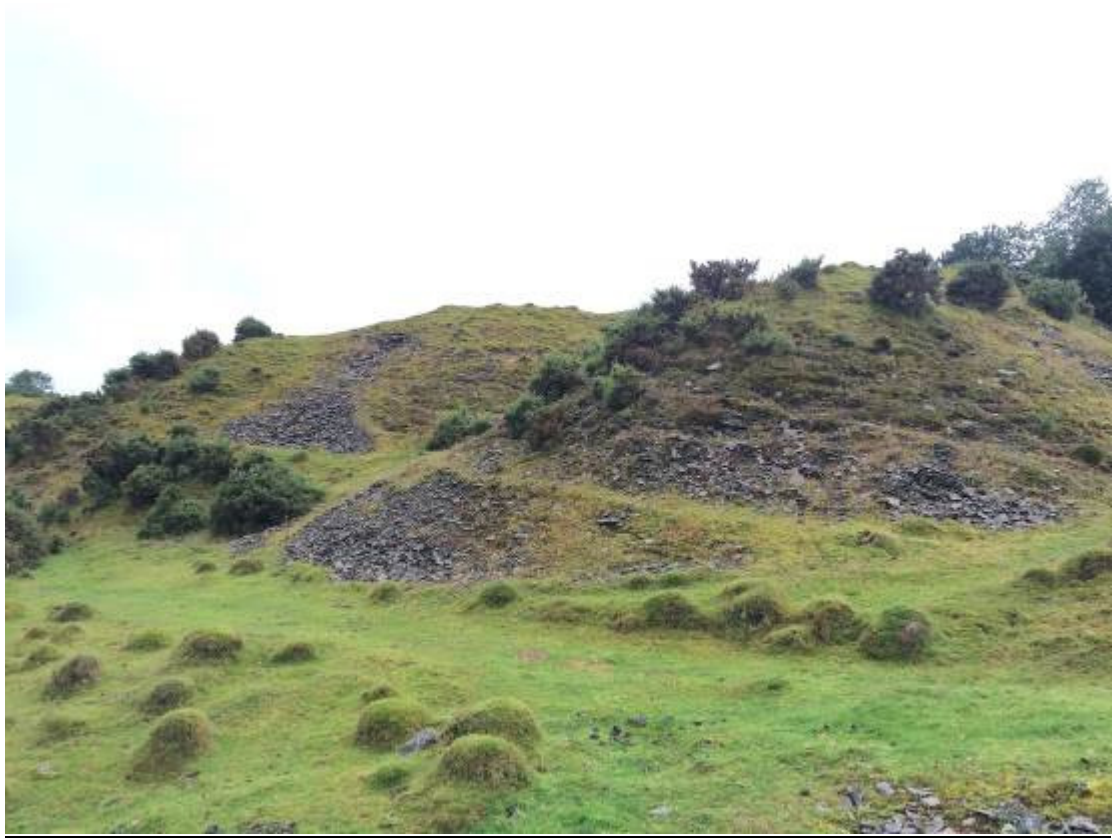
The mounds are generally set at the maximum angle of repose, having been end tipped with little or no compaction. Where the spoil is un-vegetated, the materials appeared relatively loose.

**Photograph 5 – General view of part vegetated spoil mounds**

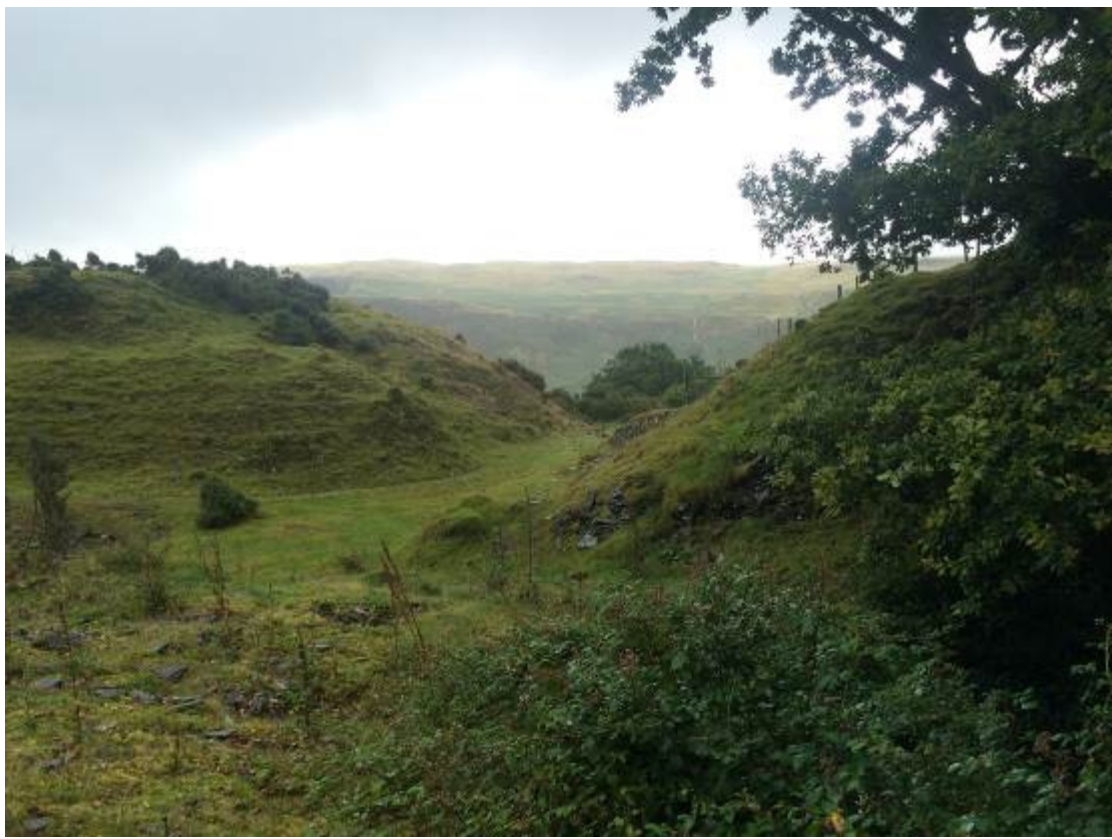
**Photograph 6 – General view of vegetated spoil mounds**

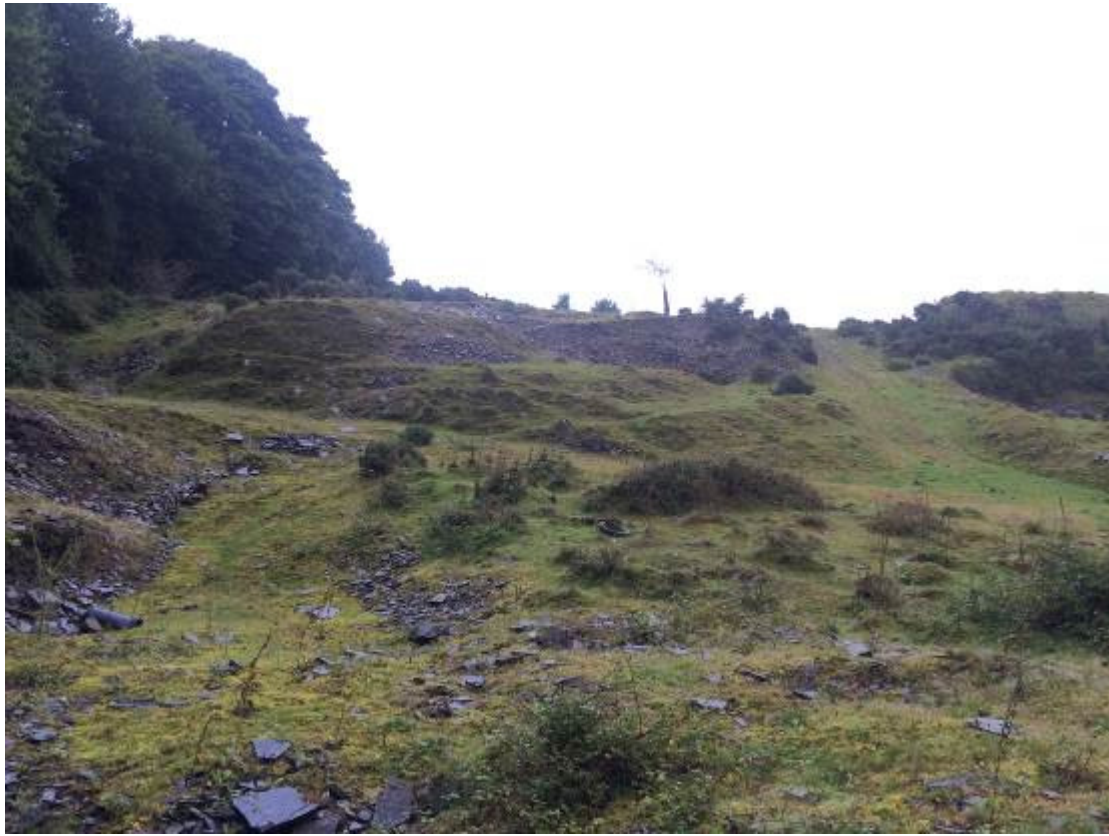
**Photograph 7 – General view of part vegetated spoil mounds**

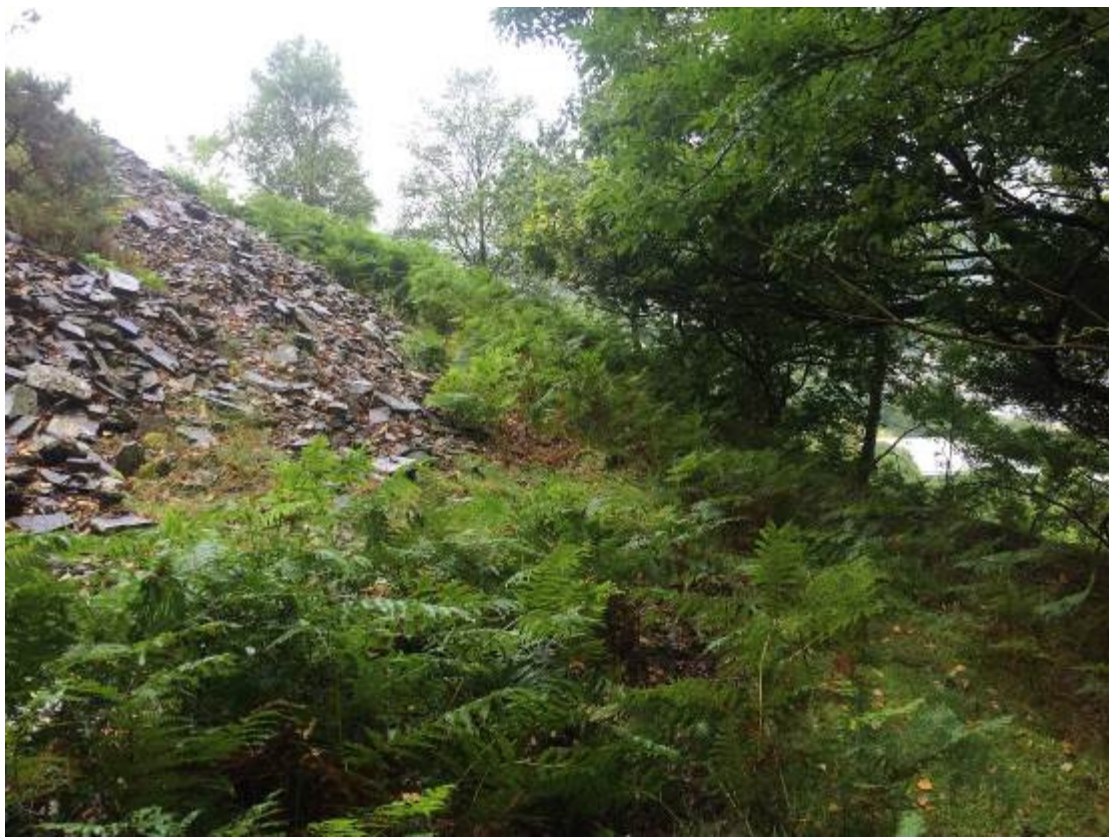
The inspection proceeded to the southern eastern perimeter, where a vertical cliff forms the site boundary. The spoil mounds in this area are in close proximity (<2m in places) to the cliff edge.

Localised spalling and surface erosion of the bare spoil mound sections adjacent the cliff edge may result in small amounts of spoil escaping over the cliff edge during extreme weather events. There was no visual evidence of significant spalling and erosion reaching the cliff edge, but the potential for this to occur presents a low to moderate risk.

**Photograph 8 – Toe of bare spoil mound adjacent cliff edge**

It is recommended that a further inspection is undertaken during the winter months, when vegetation conditions will permit an inspection of the eastern boundary cliff face, in order to assess any instability which could affect the quarry site.

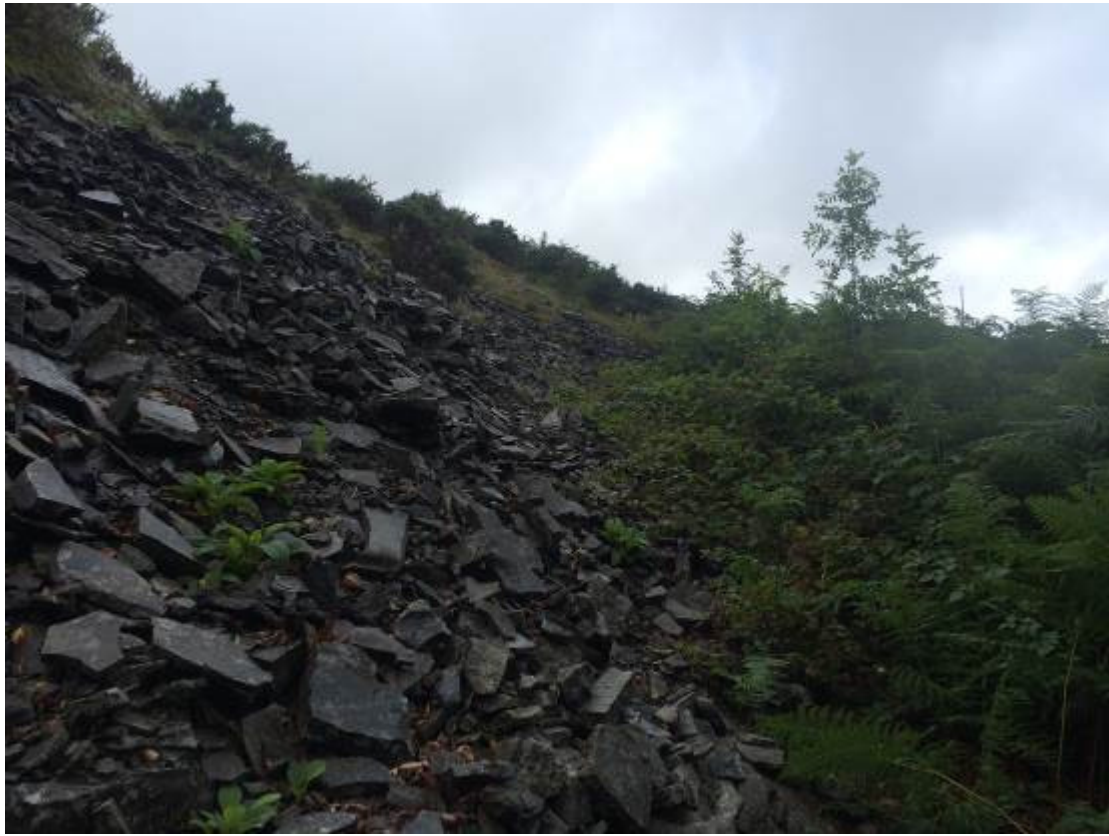
**Photograph 9 – Toe of bare spoil mound in vicinity cliff edge**

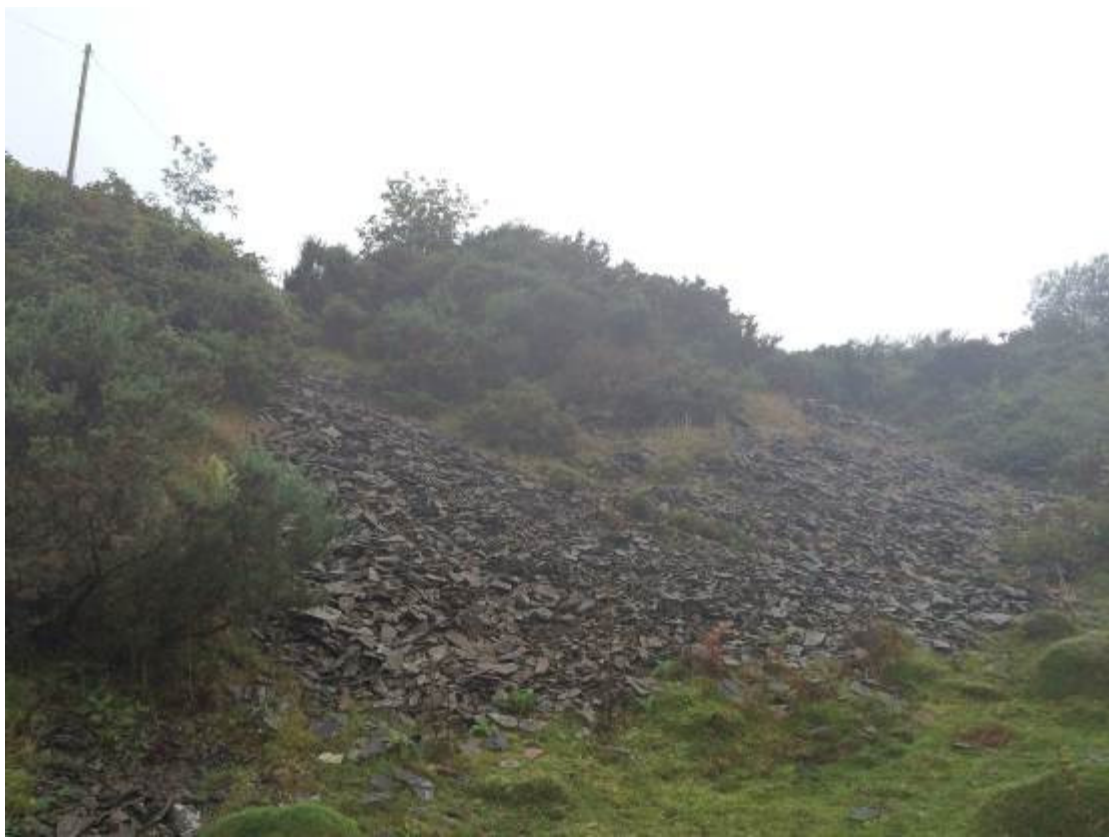
**Photograph 10 – Bare spoil mounds at northern edge perimeter of site**

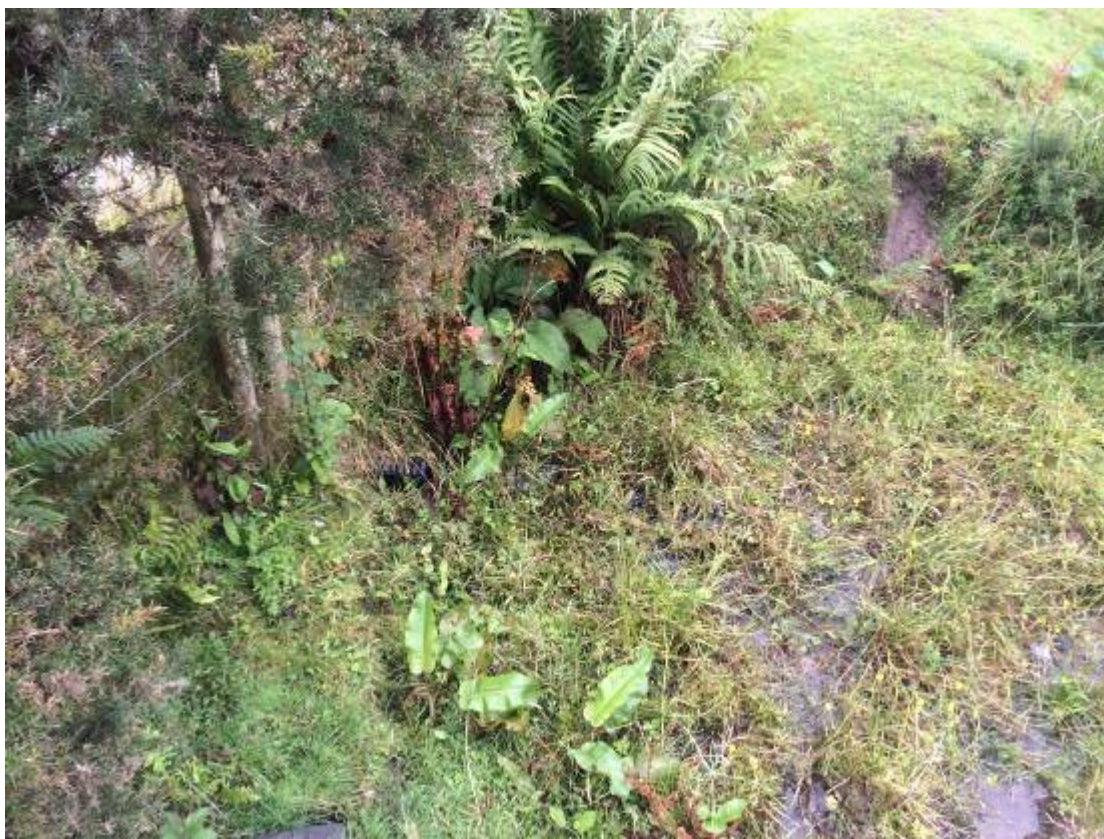
A small stream was observed in this area, with ground conditions to the north being markedly wetter underfoot, possibly indicating more impermeable natural ground compared to the re-graded quarry area.

**Photograph 11 – Small stream in field to north of quarry site**

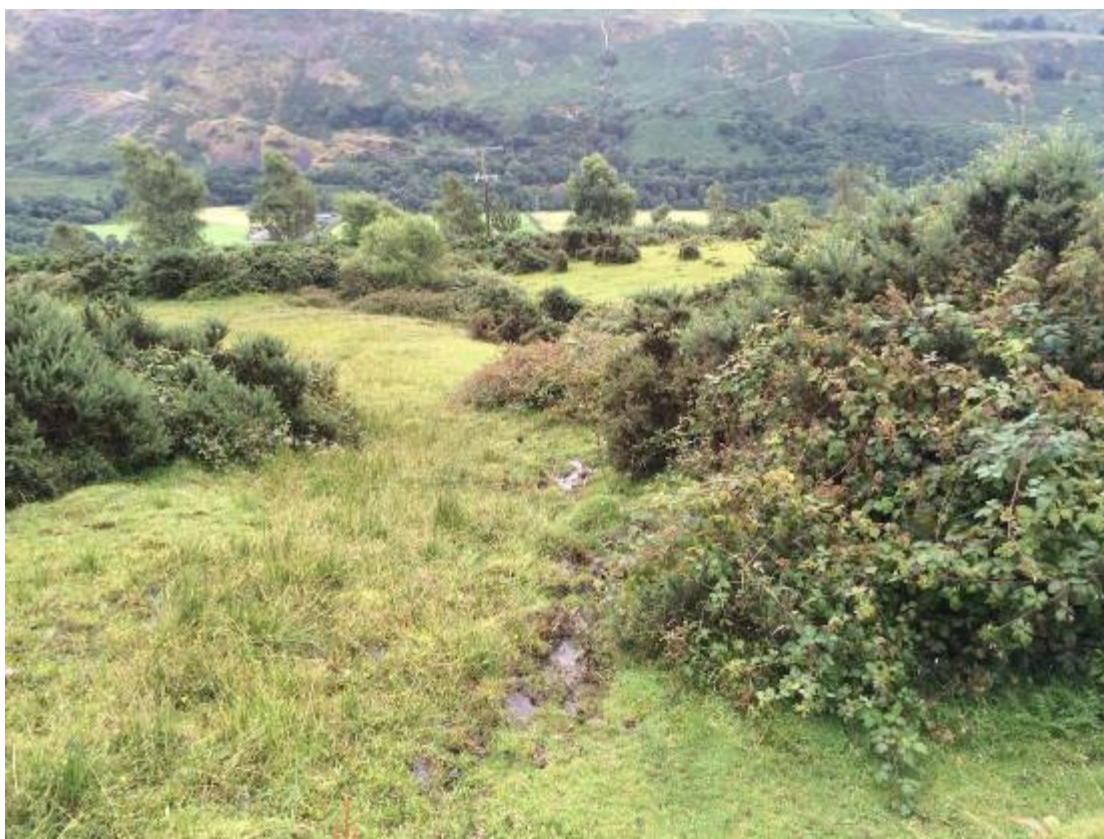
**Photograph 12 – Small stream in field to north of quarry site**
