Coal Tip Name	Godre'r-Graig Higher / Pentwyn No. 3 Levels		Tip Ref Number	L044C		
			Ownership Status	Unknown		
Located In	Godre'r-Graig Higher, Neath-Port Talbot		Tip Category	D		
Inspection Led By		Date of Inspection	05/07/2023	Date of last Inspection	16/02/2023	
Weather	Overcast, intervals of rain		Wet		Calm	
General Remarks (e.g. access, limitations)	Access to the site was gained via an access track situated just off Graig Road, which leads to Pentwyn Farm. It should be noted that this inspection was conducted without the benefit of a detailed site plan. In certain areas, dense vegetation significantly limited accessibility and visual inspection. Therefore, instability within these areas could exist, but was not detectable at the time of the inspection. The location of the tip on privately owned land also limited the coverage of this inspection.					
Features Causing Concern			Description

Coal Tip Name	Godre'r-Graig Higher / Pentwyn No. 3 Levels	Tip Ref Number	L044C
		Tip Category	D
Date of Inspection	05/07/2023	Inspection led by

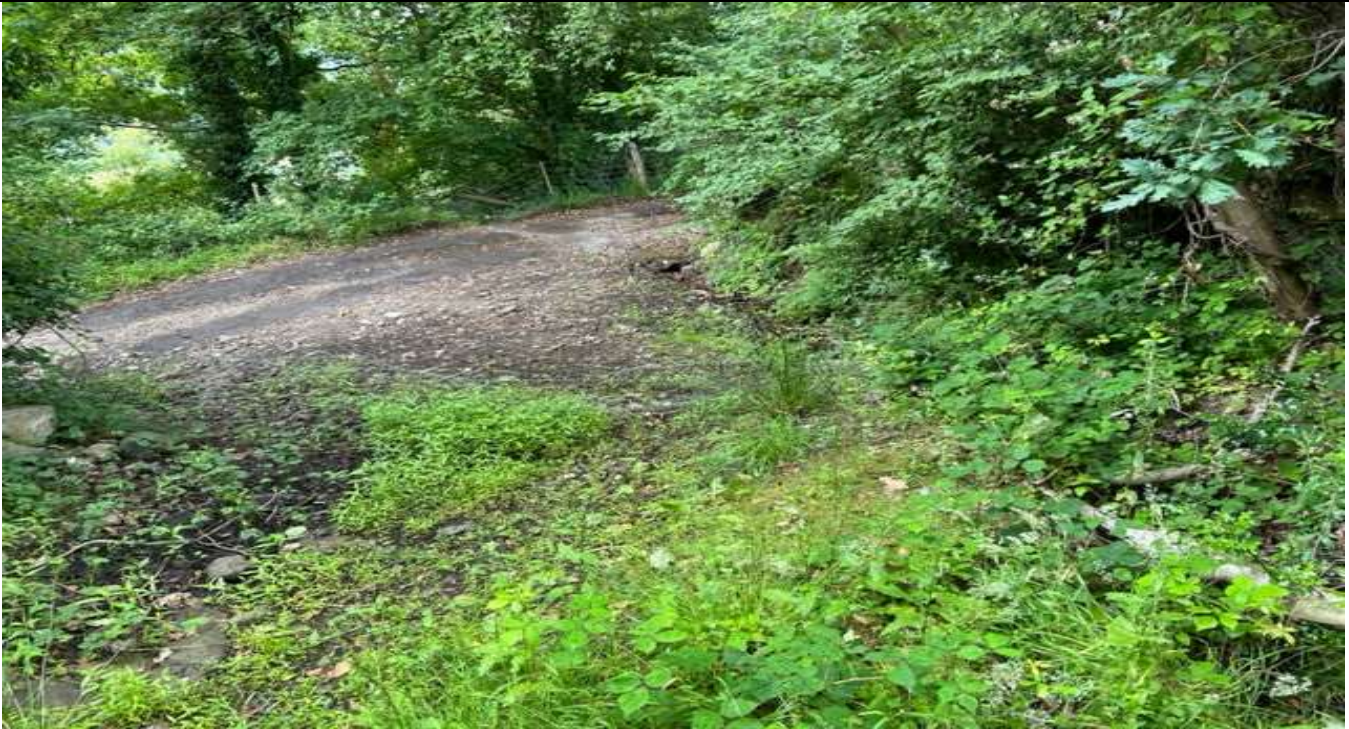
Photo No.	1	Comment	Vegetation and silt debris partially obstructing the shallow, unlined cut-off channel which runs parallel to the access track, located to the rear of the tip. Channel ineffectively capturing some flows, surface runoff migrating downslope, resulting in scouring of the access track. Some flows being conveyed towards the associated narrow diameter, cast iron culvert inlet as intended.

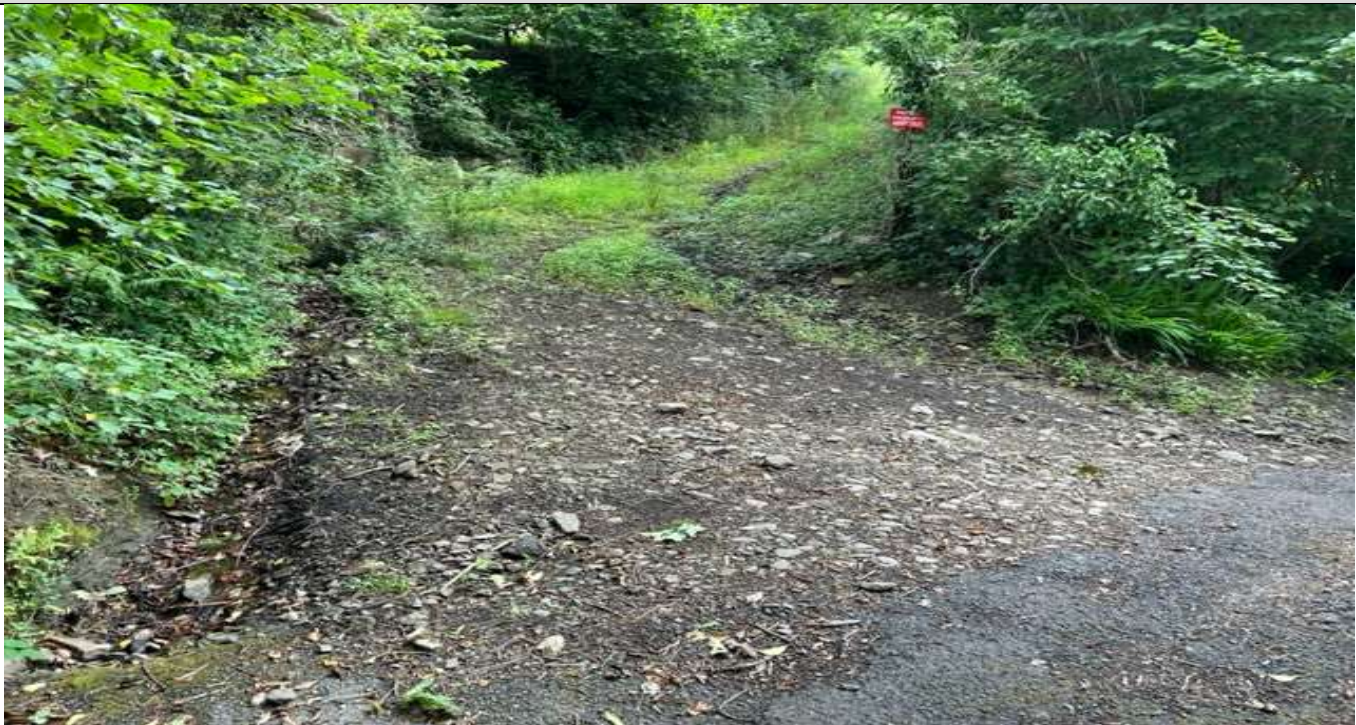
Photo No.	2	Comment	Vegetation and silt debris partially obstructing the shallow, unlined cut-off channel. Channel ineffectively capturing some flows, surface runoff migrating downslope, resulting in scouring of the access track. Private property signage present.

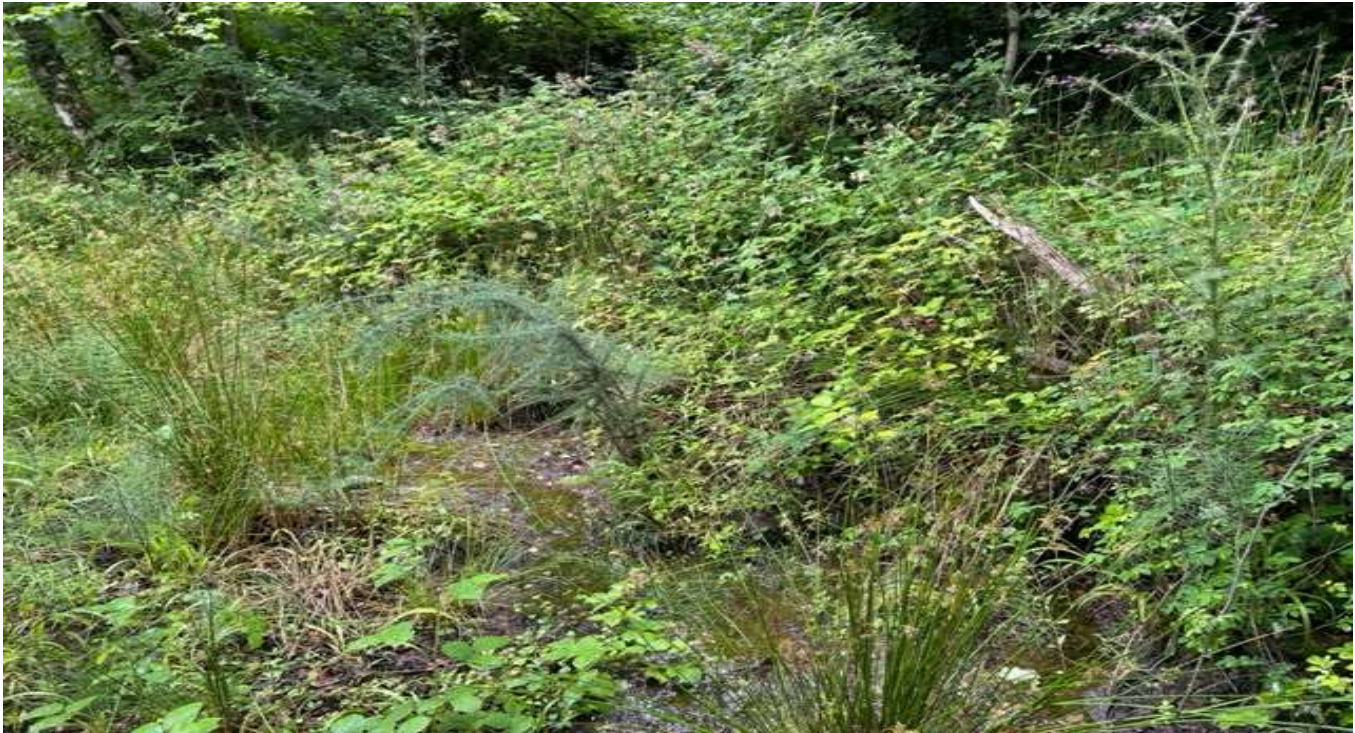
Photo No.	3	Comment	Multiple seepages situated on the north-eastern section of the tip plateau, associated saturated ground conditions.
------------------	---	----------------	---

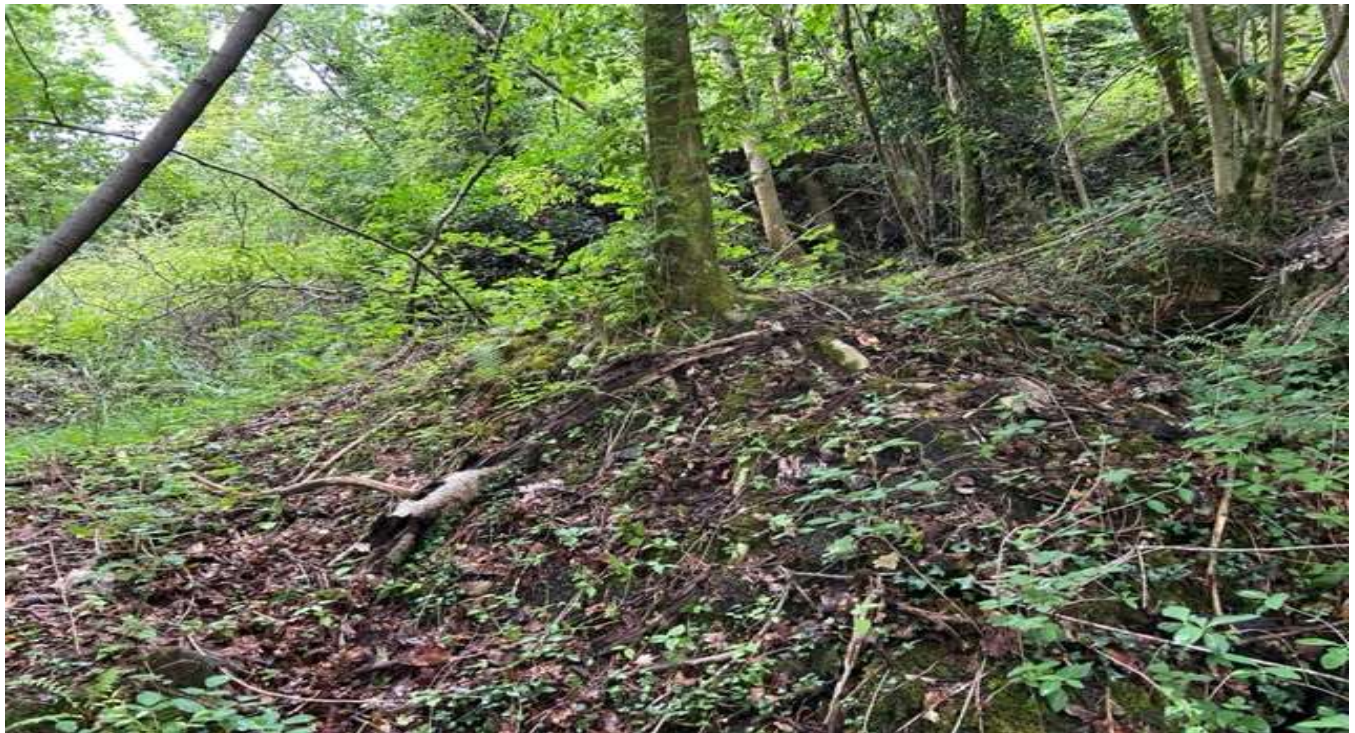
Photo No.	4	Comment	Seepage/flows emanating from an unknown brick structure, located directly adjacent to the incised watercourse which skirts the eastern perimeter.
------------------	---	----------------	---

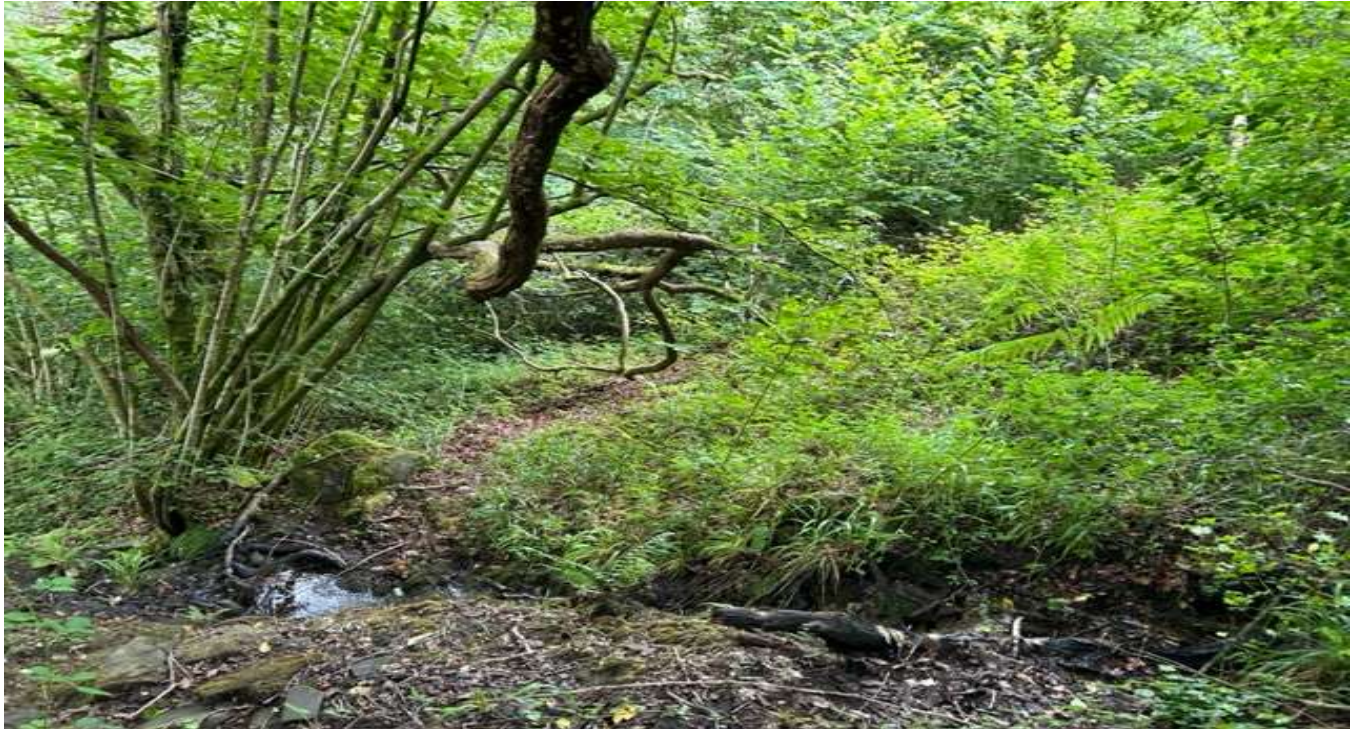
Photo No.	5	Comment	Incised scouring along the eastern boundary, induced by strong flows associated with the unnamed issue/watercourse.
------------------	---	----------------	---

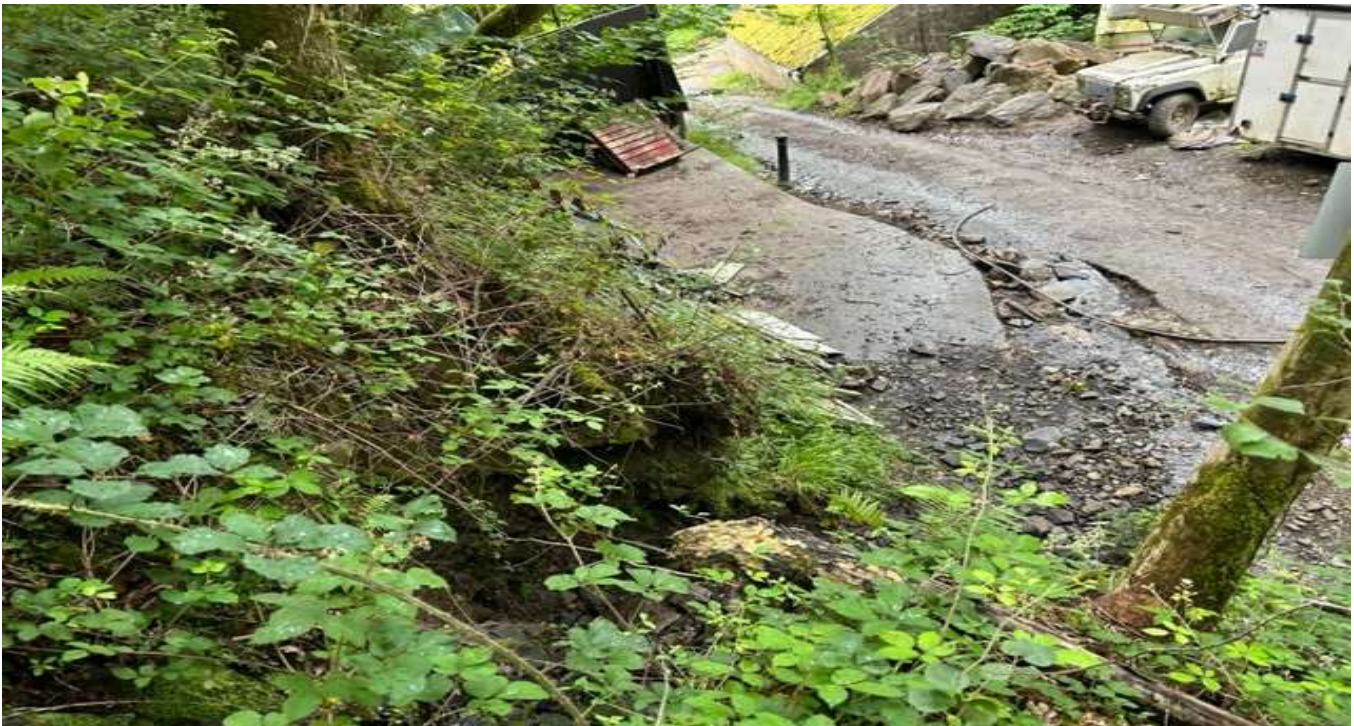
Photo No.	6	Comment	Incised scouring along the eastern boundary, where the flows associated with the unnamed issue/watercourse cascade onto the access track.
------------------	---	----------------	---

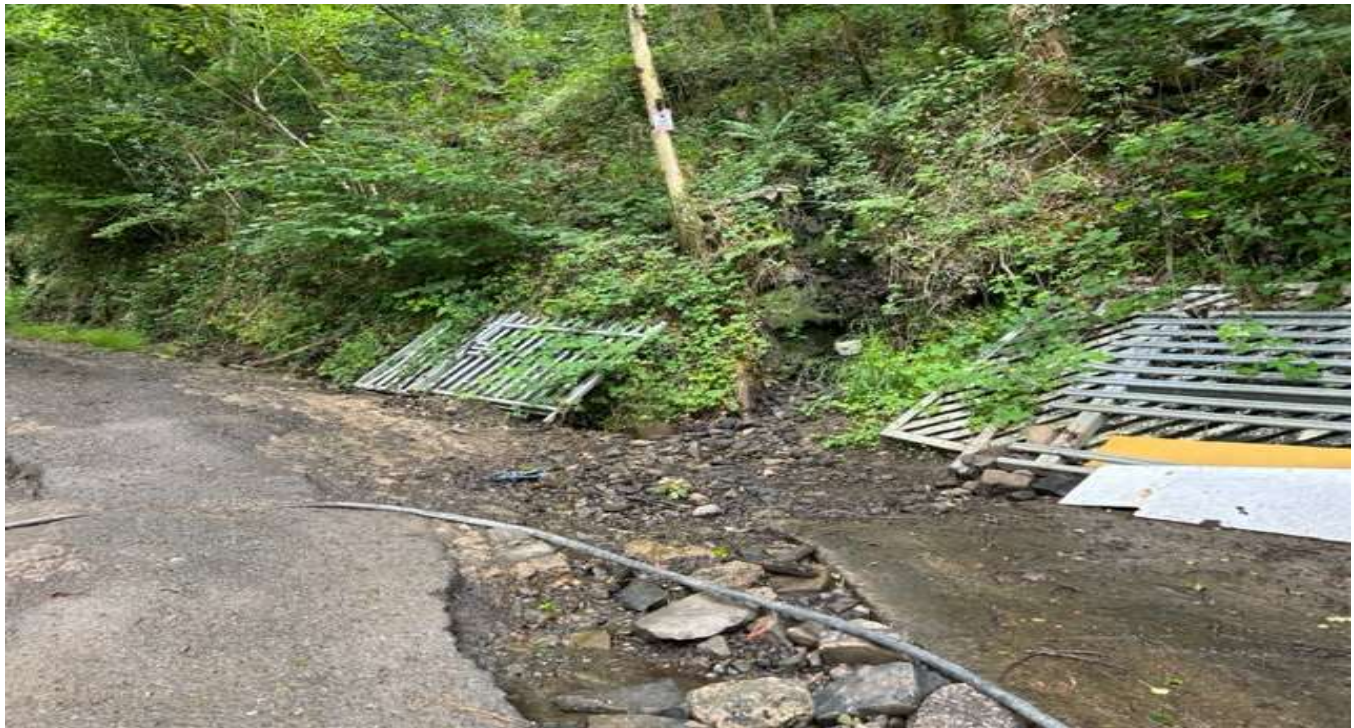
Photo No.	7	Comment	View looking north-west across the densely vegetated tip flank. Scoured, undercut section of the toe, where the unnamed issue/watercourse cascades onto the access track. Associated scouring of the adjacent access track, induced by the downslope migration of uncontrolled flows.

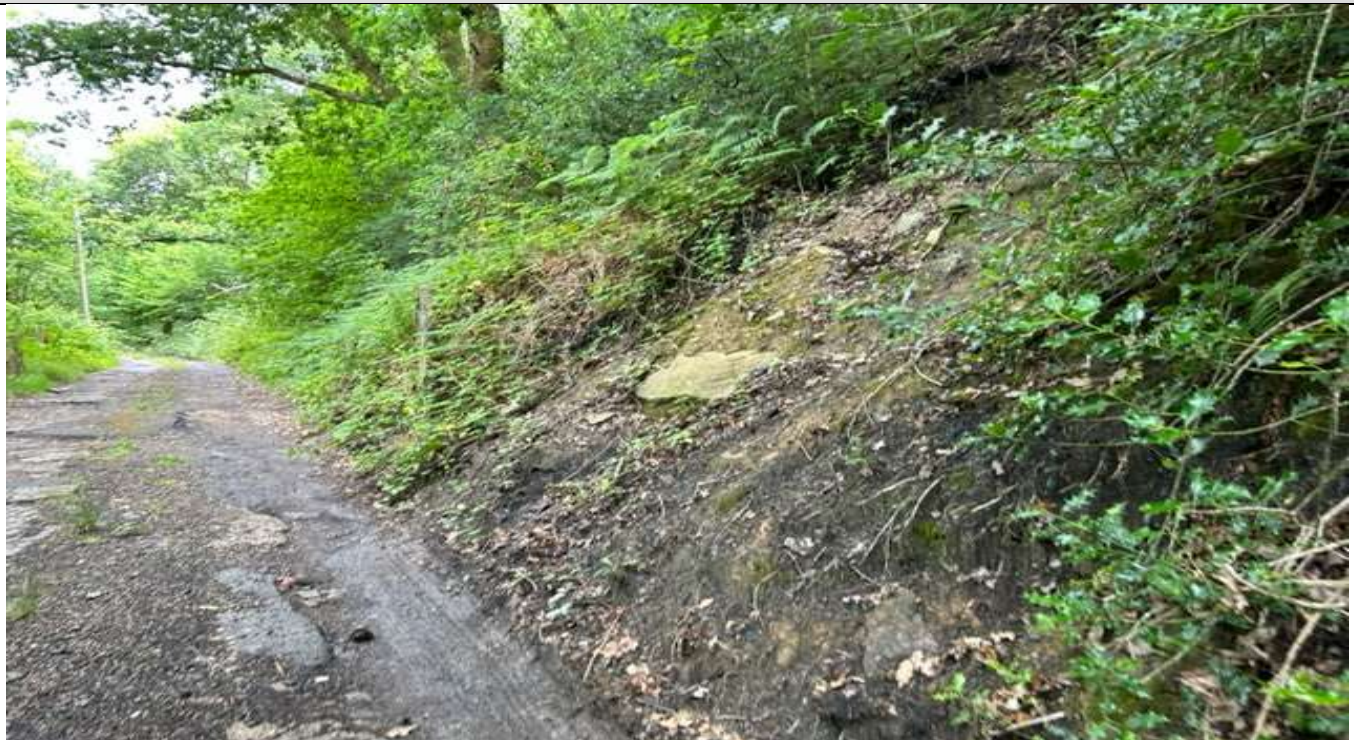
Photo No.	8	Comment	View looking across a minor, shallow surface slip situated along the toe, adjacent to the access track. Natural ground material has been exposed along the slip surface, with a thin veneer of overlying spoil material evident.
