Coal Tip Name	Godre'r-Graig Higher / Pentwyn No. 3 Levels	Tip Ref Number	L044C
		Ownership Status	Private
Located in	Godre'r-Graig, Neath-Port Talbot	Tip Category	D
Led by		Undertaken on behalf of	Welsh Government
Date	08/11/2023	Date of last Detailed Inspection	05/07/2023
Weather	Overcast	Damp	Calm
Comments on access and any limitations	<p>Access to the site was gained via an access track situated just off Graig Road, which leads to Pentwyn Farm.</p> <p>It should be noted that this inspection was conducted without the benefit of a detailed site plan. Dense vegetation and the steep, slippery nature of the flank limited accessibility and visual inspection. Therefore, instability within these areas could exist, but was not detectable at the time of the inspection.</p>		
	Description	Status	
RAG Status: Capital & Maintenance Works	Consider clearing the vegetation and silt debris partially obstructing the shallow, unlined cut-off channel which runs parallel to the access track, located to the rear of the tip.	2

Coal Tip Name	Godre'r-Graig Higher / Pentwyn No. 3 Levels	Tip Ref Number	L044C
		Tip Category	D
Date of Inspection	08/11/2023	Inspection led by

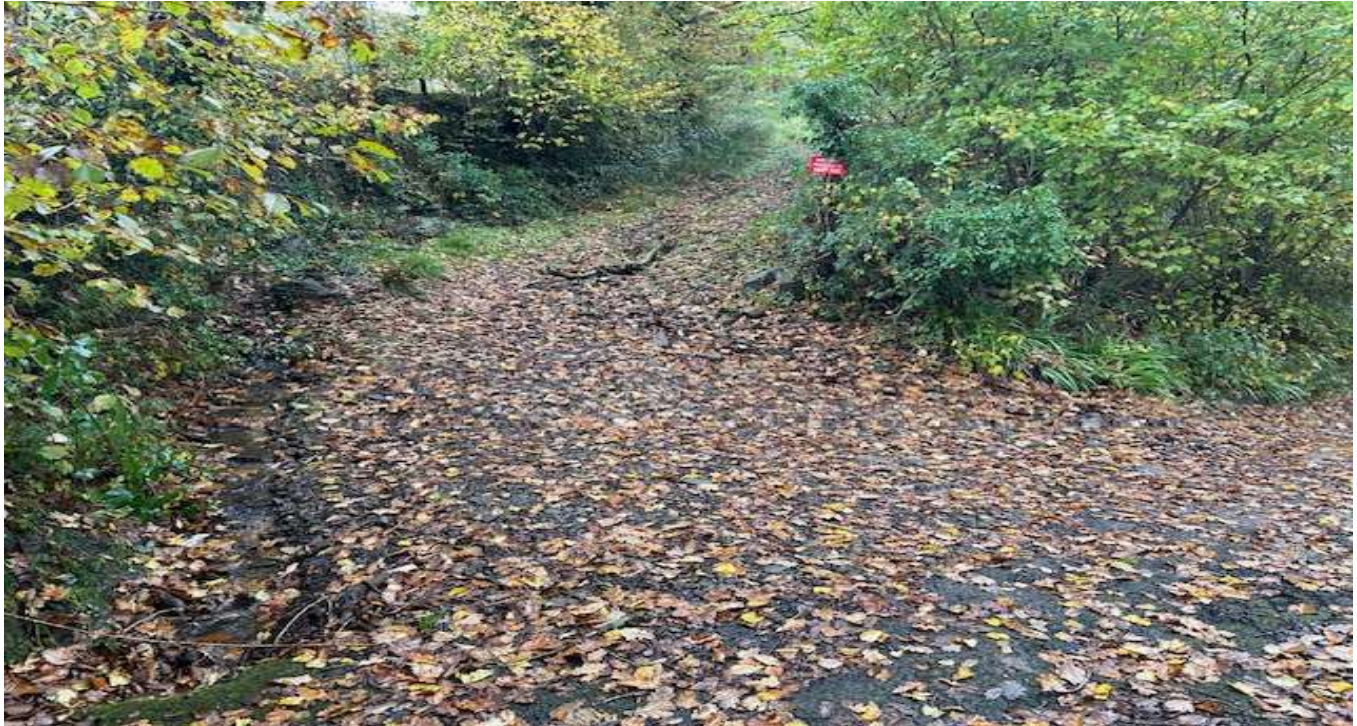
DRAINAGE			
ID	Feature	Location	Comment
23/D/01	Channel	E – 274794 N - 206765	Vegetation and silt debris partially obstructing the shallow, unlined cut-off channel which runs parallel to the access track, located to the rear of the tip. Areas of choking flows along sections of the channel are evident. The channel is ineffectively capturing some flows, with surface runoff migrating downslope along the access track. Flows conveying off-site, adjacent to the front drives/access tracks of residential houses, situated off the main access track.
Recommendations			Consider clearing the vegetation and silt debris partially obstructing the shallow, unlined cut-off channel which runs parallel to the access track, located to the rear of the tip.
ENGINEERING INFRASTRUCTURE			
ID	Feature	Location	Comment
N/A			
Recommendations

Photo No.	1	Comment	Vegetation and silt debris partially obstructing the shallow, unlined cut-off channel which runs parallel to the access track, located to the rear of the tip. Channel ineffectively capturing some flows, surface runoff migrating downslope, resulting in scouring of the access track.
Feature ID	23/D/01

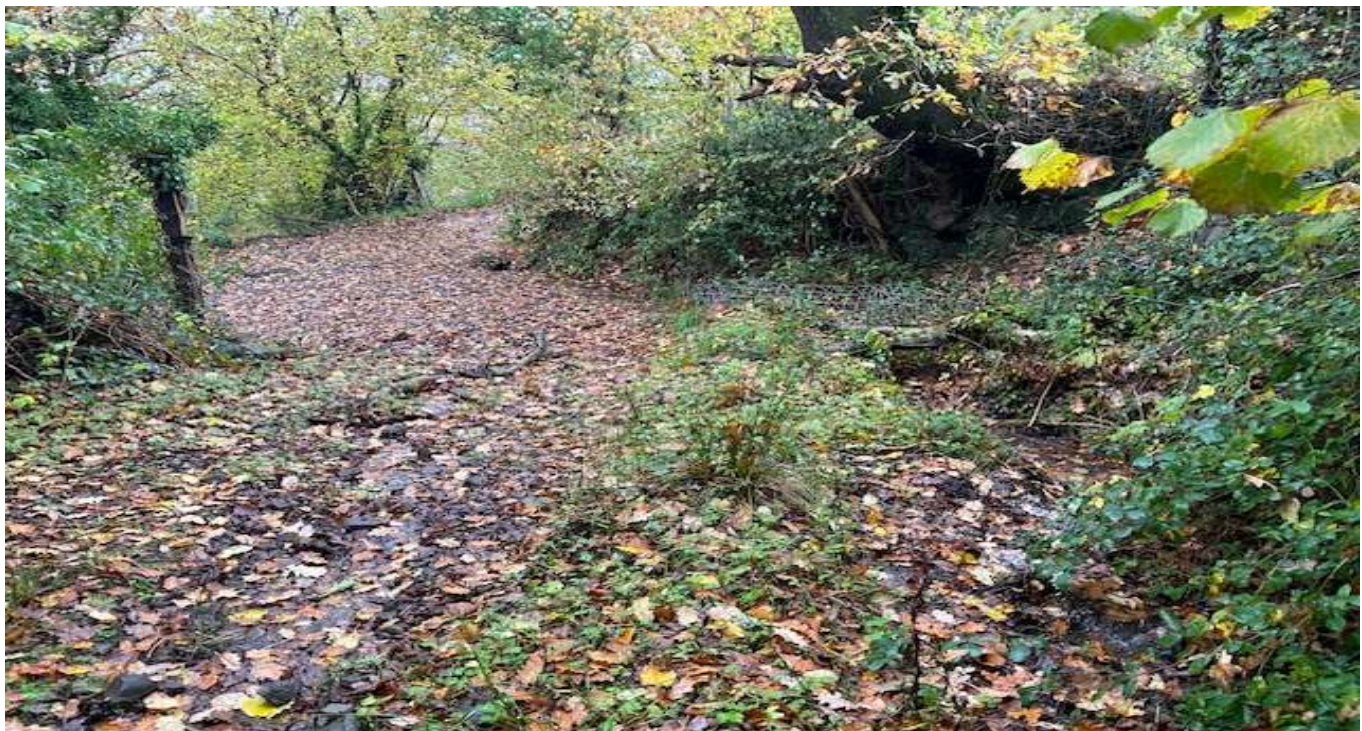
Photo No.	2	Comment	Vegetation and silt debris partially obstructing the shallow, unlined cut-off channel which runs parallel to the access track, located to the rear of the tip. Channel ineffectively capturing some flows, surface runoff migrating downslope, resulting in scouring of the access track.
Feature ID	23/D/01

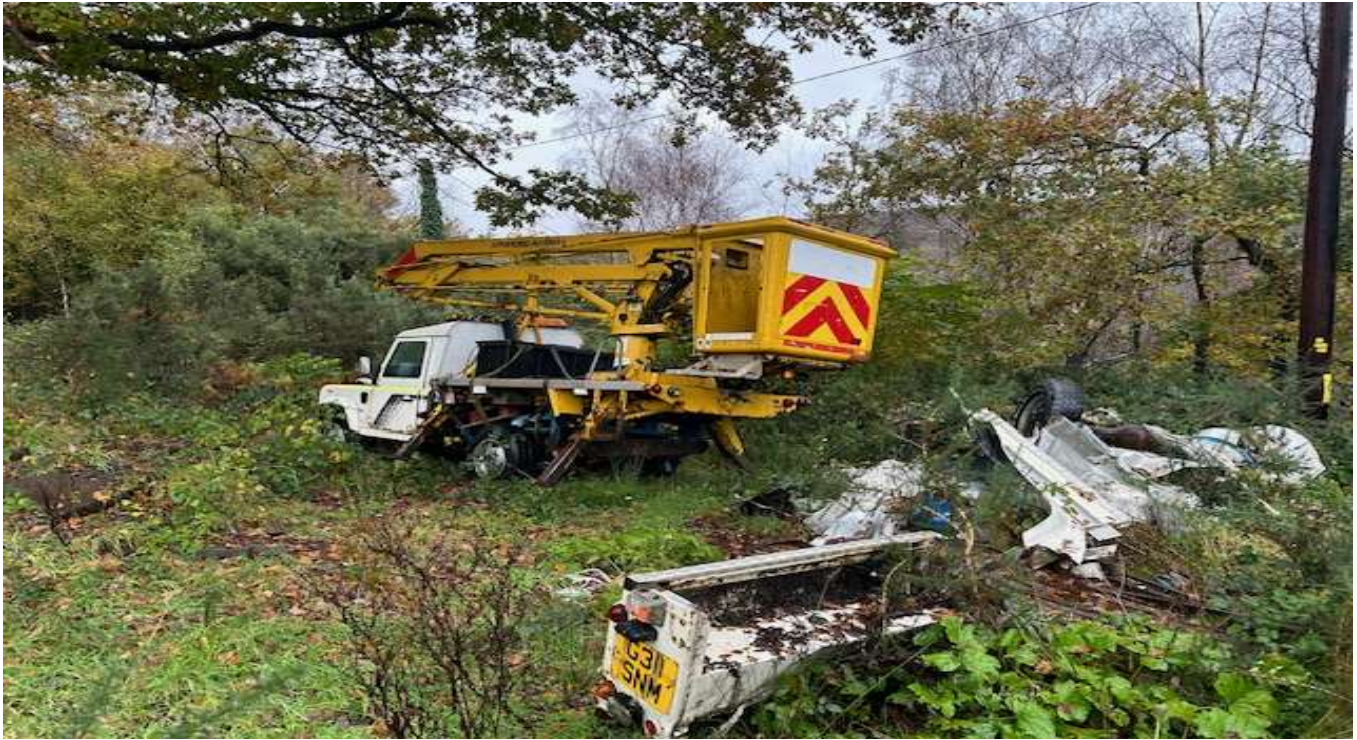
Photo No.	3	Comment	Vehicle and machinery situated on the north-eastern section of the tip plateau.
Feature ID	23/L/02

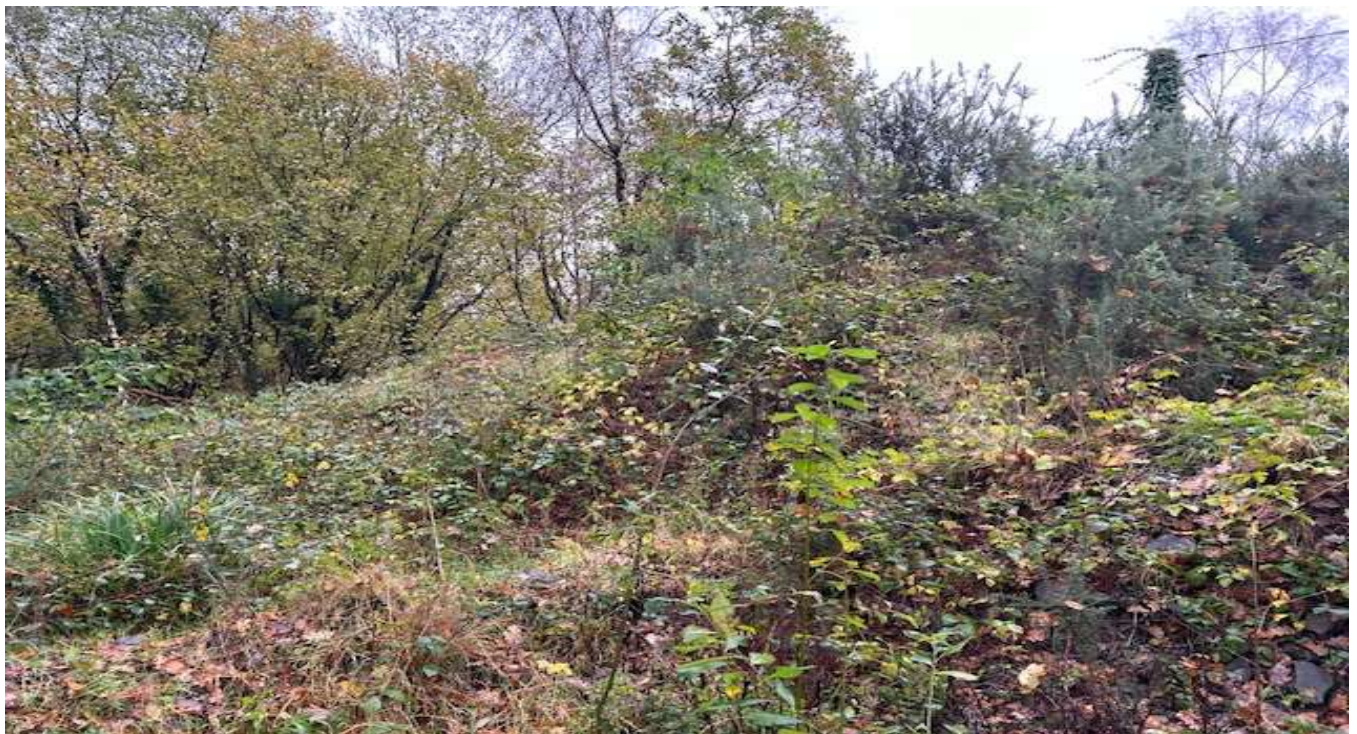
Photo No.	4	Comment	Sandstone quarry waste material, likely sourced from the nearby Cwar Pentwyn quarry deposited on the north-eastern section of the tip plateau.
Feature ID	23/L/02

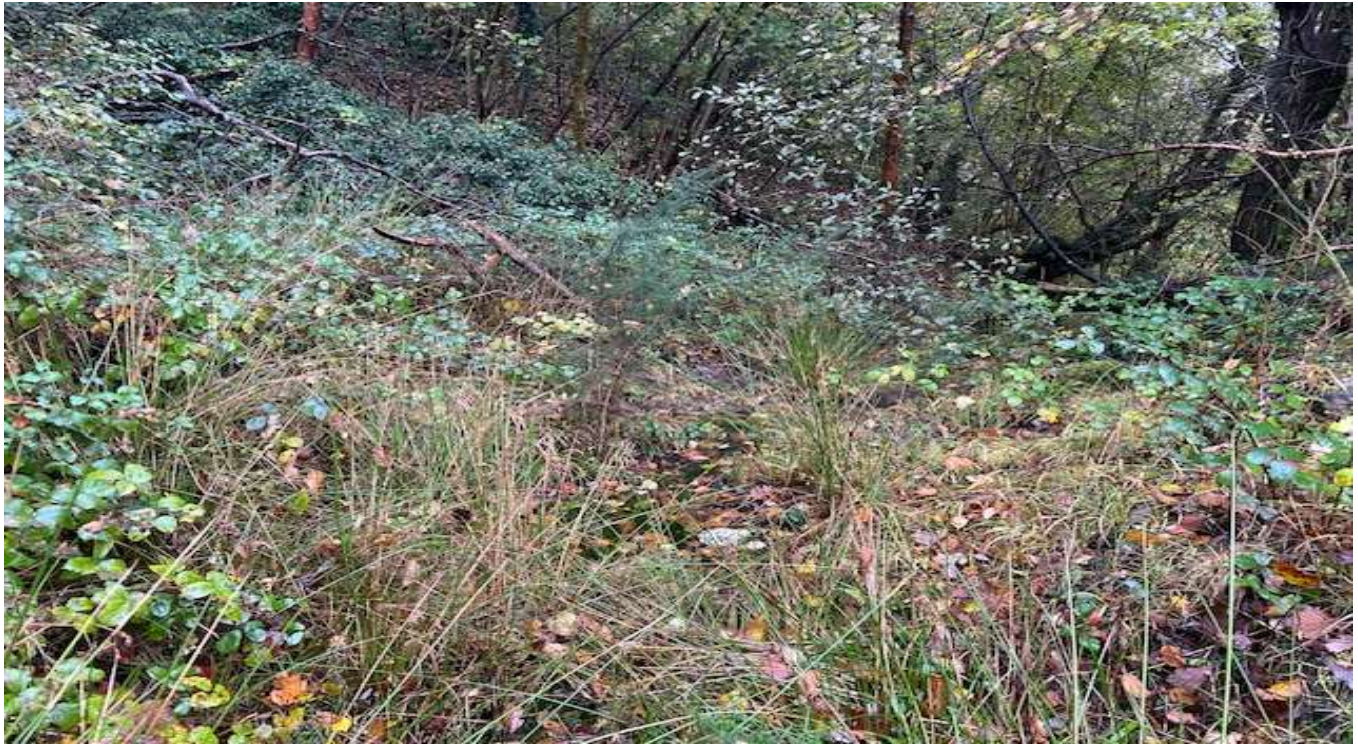
Photo No.	5	Comment	Multiple seepages situated on the north-eastern section of the tip plateau. Associated saturated ground conditions.
Feature ID	23/G/03 23/G/05

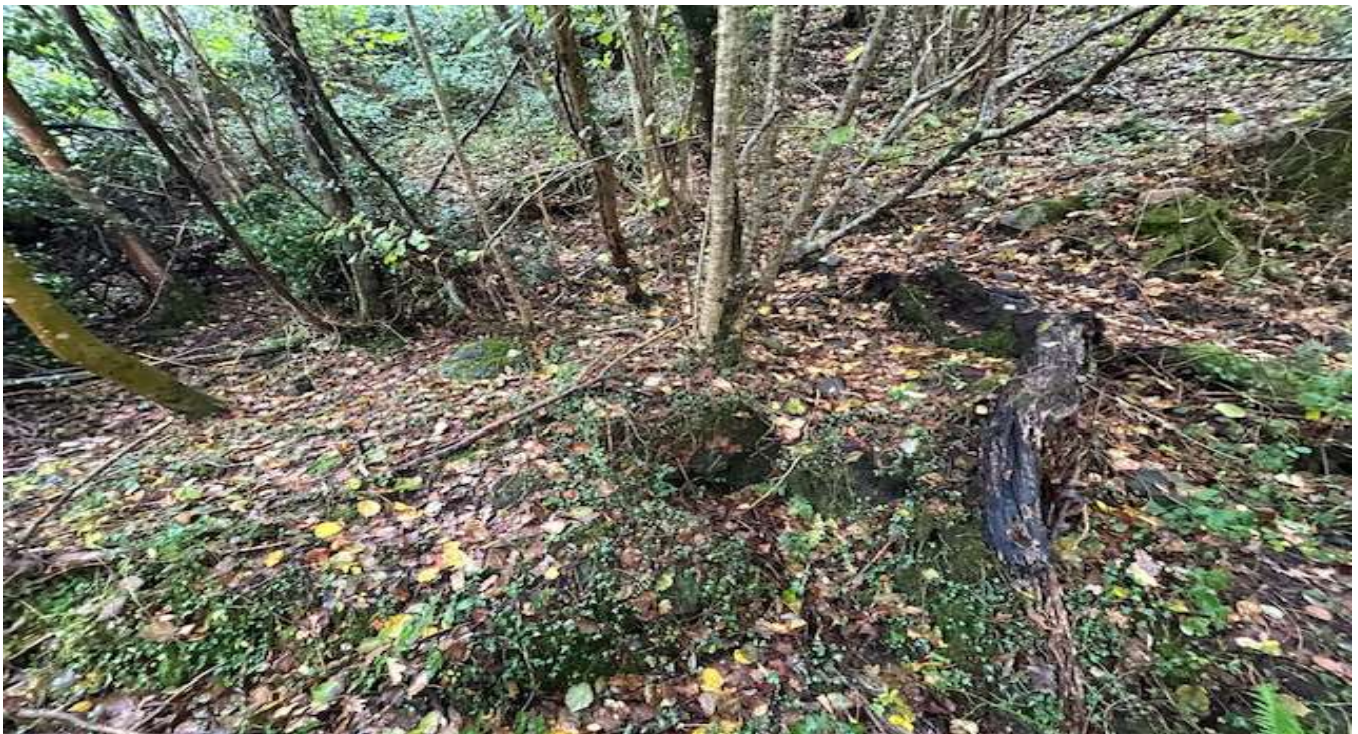
Photo No.	6	Comment	Flows emanating from an unknown brick structure, located directly adjacent to the incised watercourse which skirts the eastern perimeter.
Feature ID	23/G/03

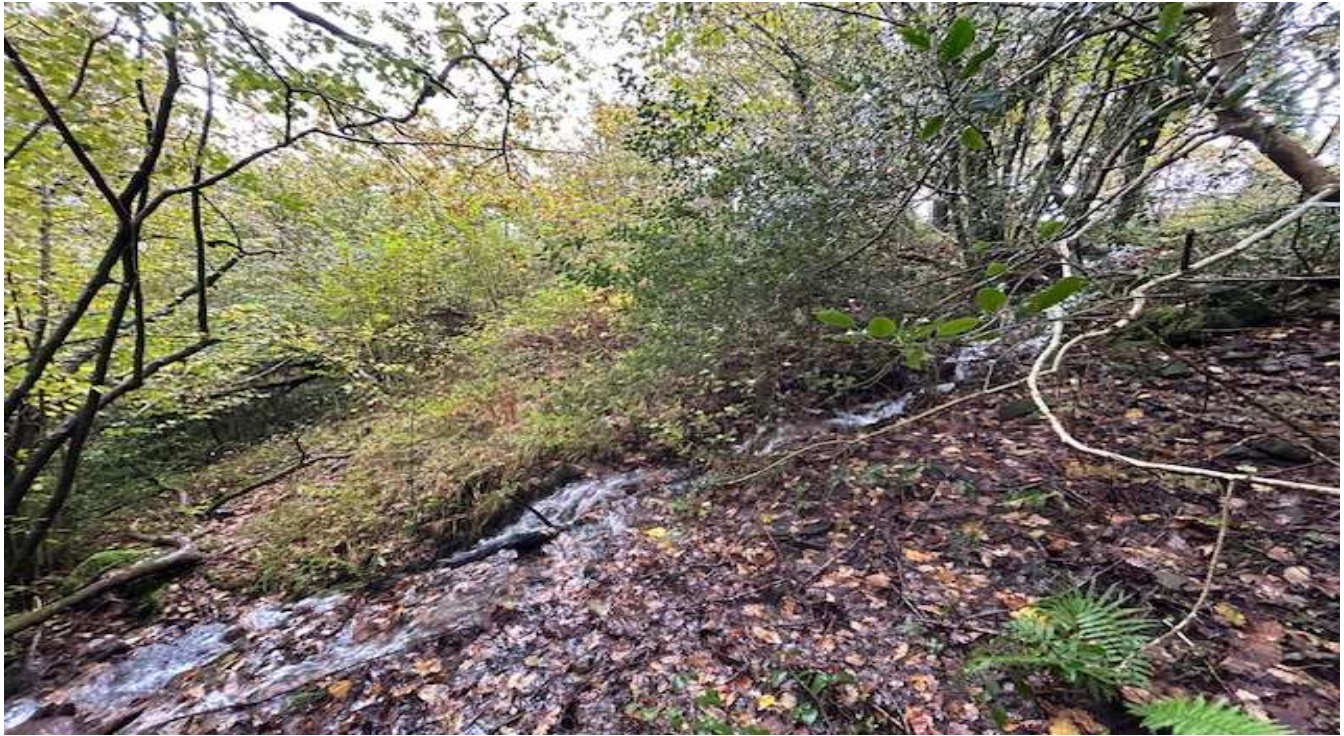
Photo No.	7	Comment	Incised scouring along the eastern boundary, induced by strong flows associated with the unnamed issue/watercourse.
Feature ID	23/G/07

Consider implementing appropriate drainage infrastructure to effectively capture the series of seepages, as well as the uncontrolled flows associated with the outfall of the watercourse. Consider formalising/lining the flow path of the watercourse, to prevent further scouring.	2	
	Investigate if planning permission was given for the quarry waste material to be deposited on the tip plateau. Consider undertaking a geotechnical assessment to fully ascertain the geotechnical characteristics of the tip. Consider implementing a retaining wall feature along the toe/base of the flank.	2	
General Remarks	<p>This tip is recorded as being comprised of colliery spoil material derived from the historical workings of Godre'r Graig higher level and Pentwyn No. 3 levels. The tip has been formed via end-tipping practices, having being constructed with a plateau and a densely vegetated, steeply sloping, south-east facing flank. A shallow, unlined cut-off channel runs parallel to the access track, located to the rear of the tip. However, the channel is ineffectively capturing some flows, with surface runoff migrating downslope along the access track. Notably, an incised watercourse conveys flows along the eastern boundary, before cascading onto the access track. These uncontrolled flows convey downslope along the access track, adjacent to the front drives/access tracks of residential properties. Additionally, several minor shallow surface slips are situated along the toe, located adjacent to the access track. Natural ground material is exposed along the slip surfaces, with a thin veneer of overlying spoil material evident.</p>

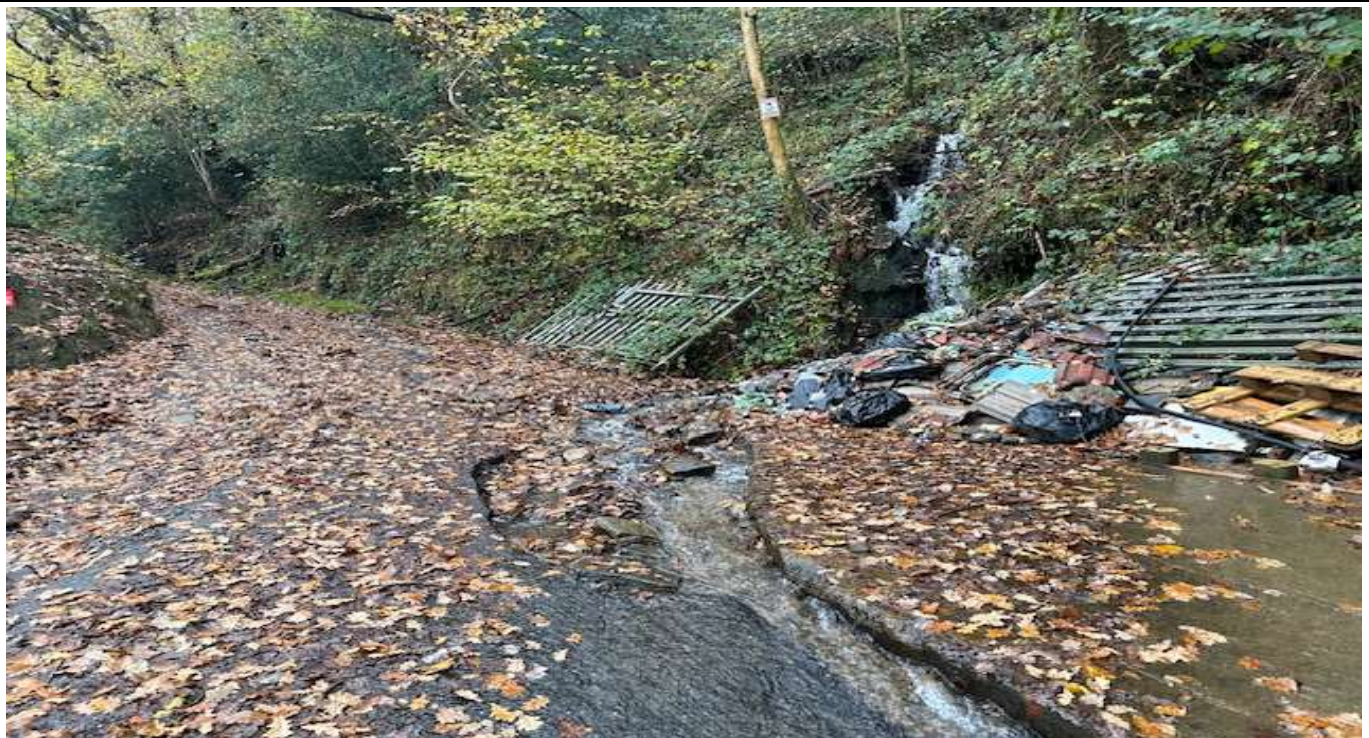
Photo No.	8	Comment	Scoured, undercut section of the toe, where the unnamed issue/watercourse cascades onto the access track. Associated scouring of the adjacent access track, induced by the downslope migration of uncontrolled flows. Fly-tipped material is evident.
Feature ID	23/G/06		
	23/G/08 23/L/04

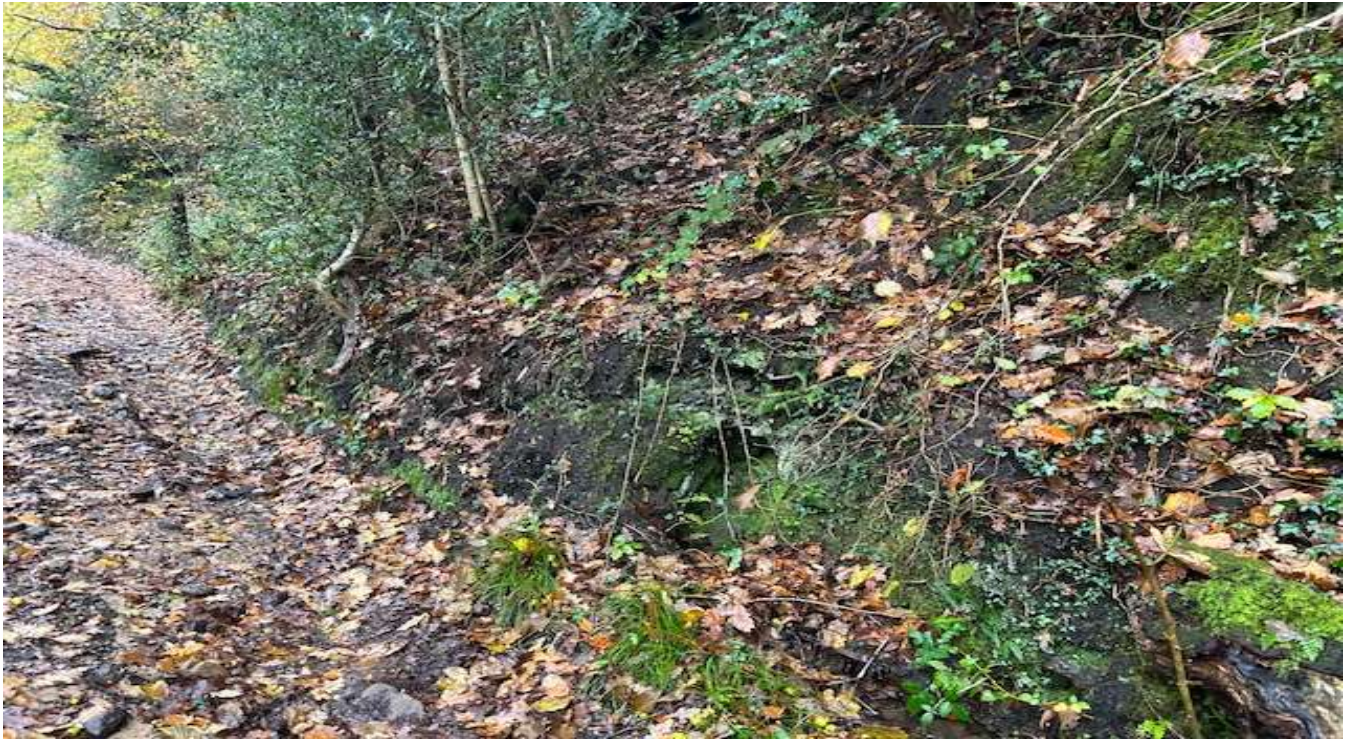
Photo No.	9	Comment	Seepages emanating from the base of the flank/toe, adjacent to the access track.
Feature ID	23/G/04

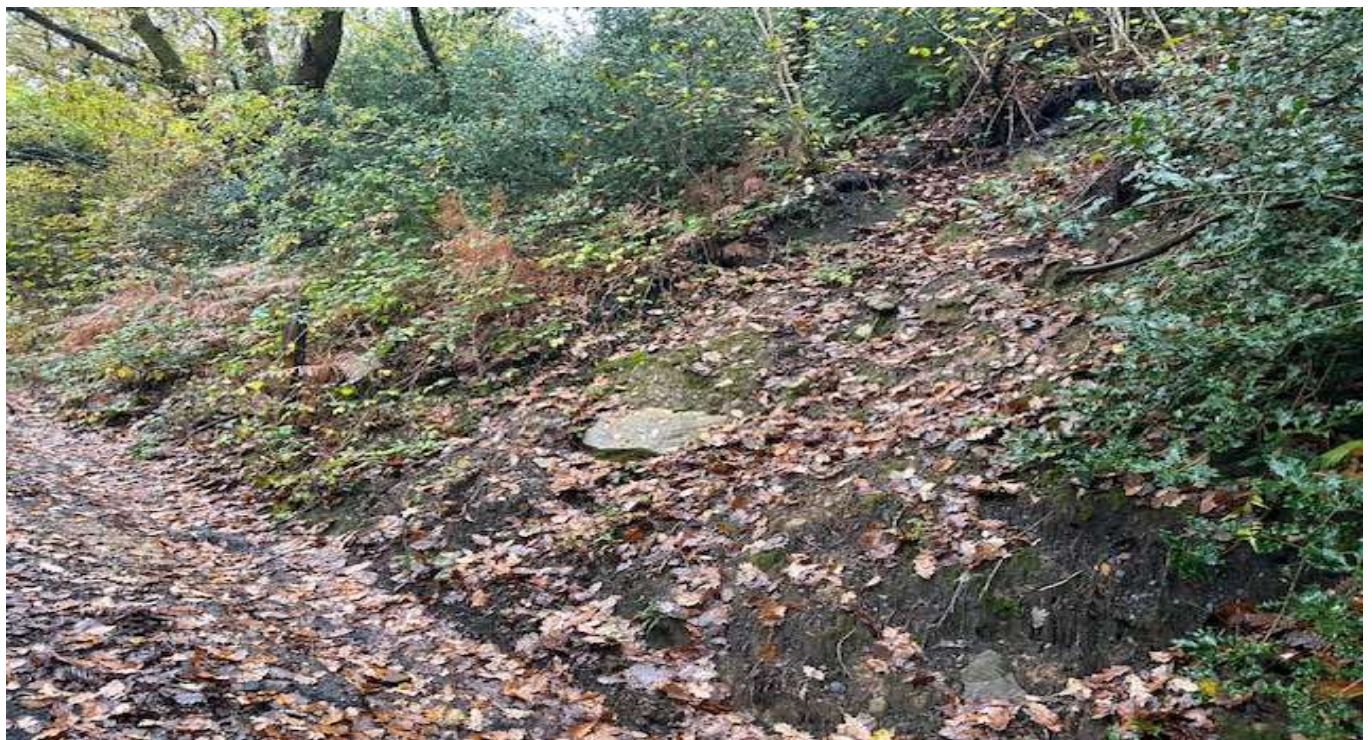
Photo No.	10	Comment	View looking across a minor, shallow surface slip situated along the toe, adjacent to the access track. Natural ground material has been exposed along the slip surface, with a thin veneer of overlying spoil material evident.
Feature ID	23/G/02
