Coal Tip Name	Godre'r-graig Quarry / Cilmaengwyn		UID	T37552	
Located in	Godre'r-graig, Neath-Port Talbot		Tip Category	D	
Inspection Led by		Date of Inspection	19/02/2026	Date of last Inspection	12/02/2025
Weather	Overcast		Wet	Calm	
Comments on access and any limitations	<p>Access to the site was gained via an access path situated just off the Pentwyn Farm access track. The access path extends up the hillside in a north-easterly direction, passing through Cwar Pentwyn Quarry before reaching a narrow, overgrown path which extends up-slope towards the site. This inspection was conducted jointly with representatives of ESP.</p> <p>It should be noted that this inspection was conducted without the benefit of a detailed site plan; whilst dense vegetation significantly limited accessibility and visual inspection. Therefore, instability within these areas could exist, but was not detectable at the time of the inspection. The densely overgrown nature of the site largely prevented/limited inspection of the spoil material; however, exposures within the immediate site boundary appear to be comprised of sandstone quarry waste material. However, historically the hillside has been extensively w

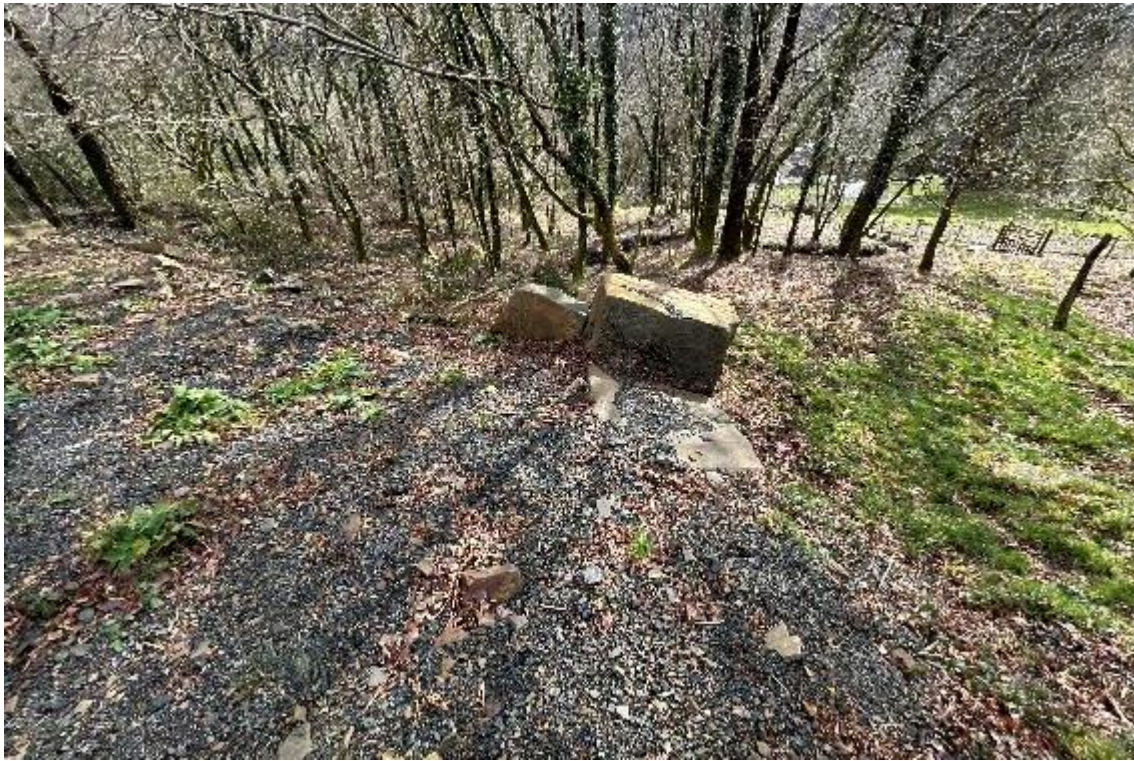
Photo No.	1	Comment	An example of an exposure of colliery spoil material downslope, located outside the currently provided site boundary.
Feature ID	N/A

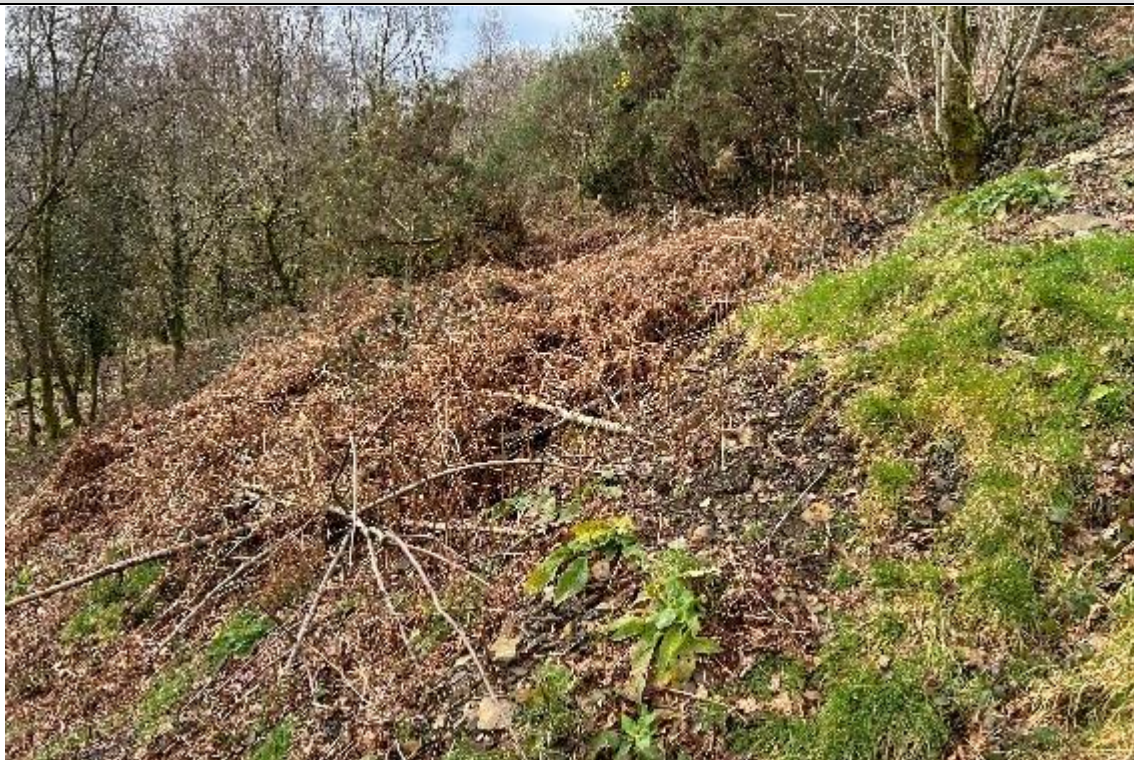
Photo No.	2	Comment	An example of an exposure of colliery spoil material downslope, located outside the currently provided site boundary.
Feature ID	N/A

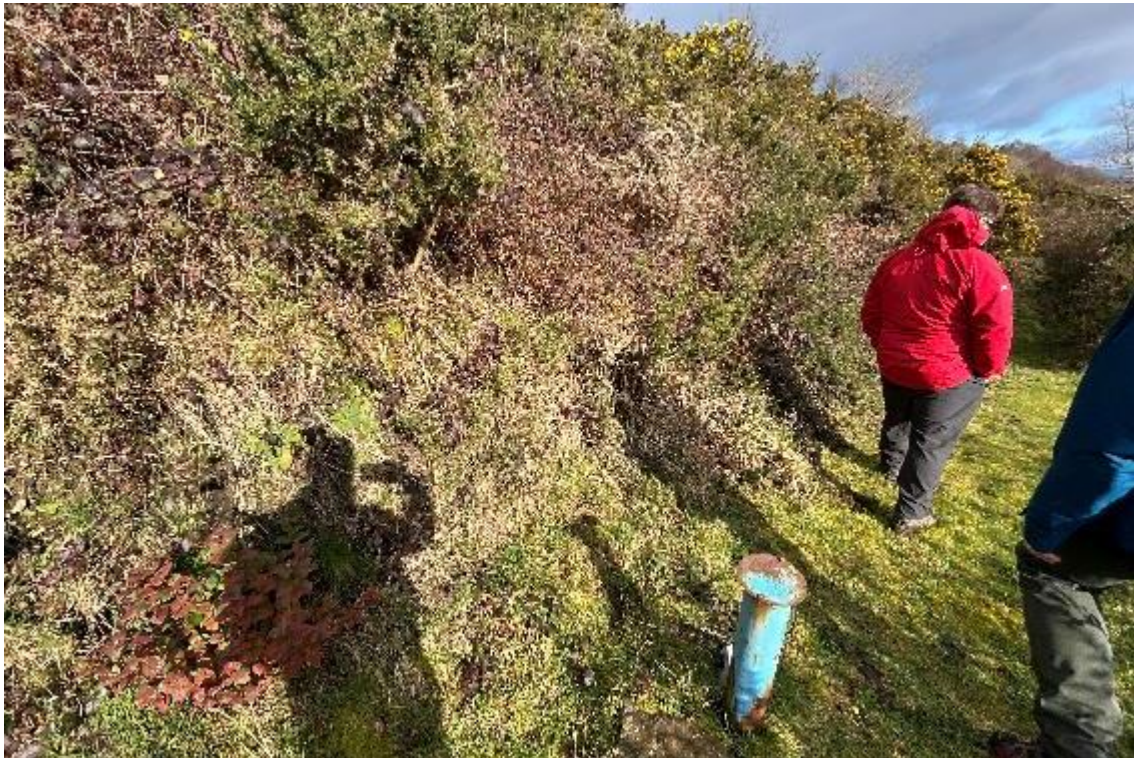
DRAINAGE				
ID	Feature	Location	Comment	Change to Condition (New, Worse, None or N/A)
N/A				N/A
Recommendations				
ENGINEERING INFRASTRUCTURE				
ID	Feature	Location	Comment	Change to Condition (New, Worse, None or N/A)
N/A				N/A
Recommendations				
INSTRUMENTATION & MONITORING				
ID	Feature	Location	Comment	Change to Condition (New, Worse, None or N/A)
25/IM/01	Piezometers & Inclinometers	E – 275048 N - 206996	Series of piezometer boreholes and monitoring wells, situated on the site access track. Inclinometers are recorded as being installed within some of the boreholes. These features are located outside the designated site boundary which has been	None

provided but appears to be within the wider site boundary delineated by ESP ground investigations and surveys.

Photo No.	3	Comment	Piezometer borehole located on the site access track, downslope (outside the currently provided site boundary).
Feature ID	25/IM/01

- Continue to utilise the monitoring equipment across the site.

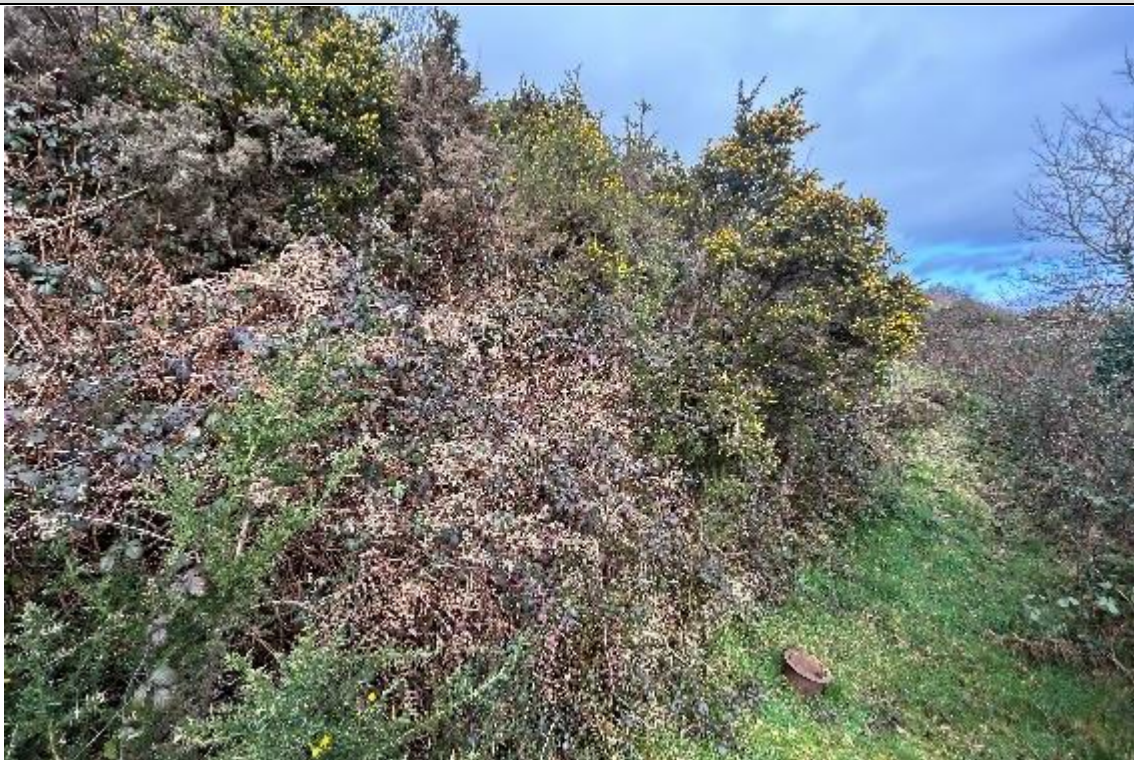
Photo No.	4	Comment	Monitoring well located on the site access track, downslope (outside the currently provided site boundary).
Feature ID	25/IM/01

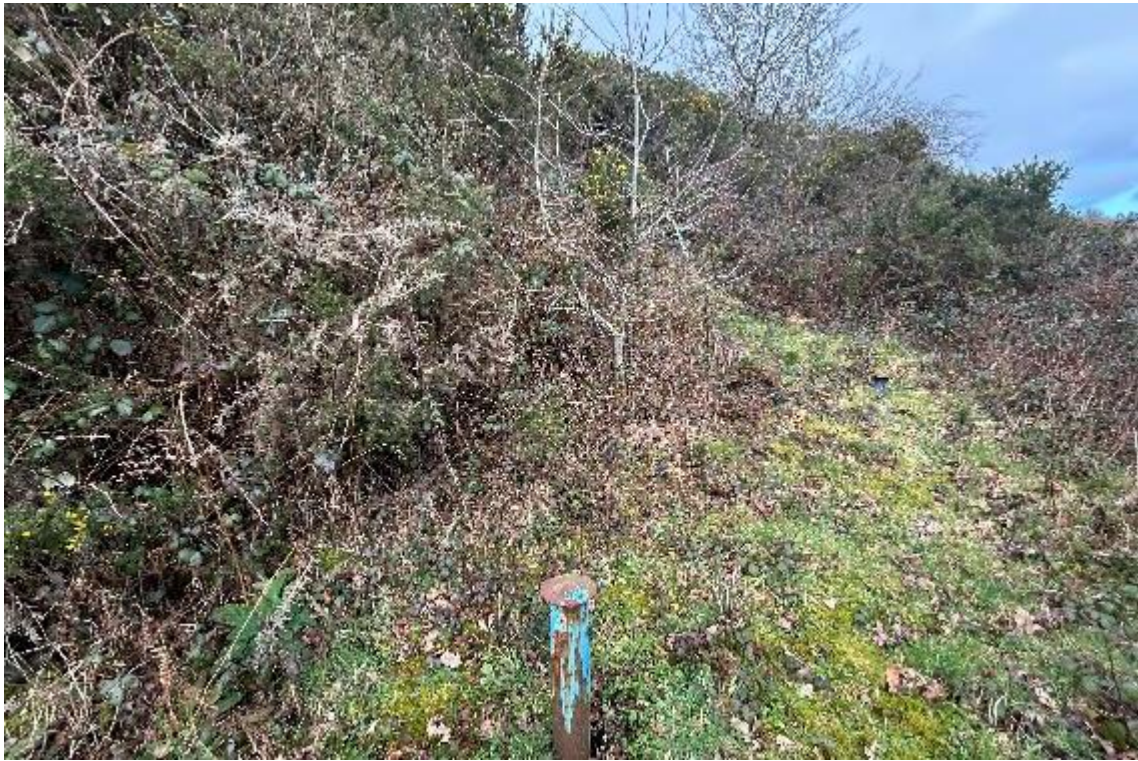
Photo No.	5	Comment	Piezometer borehole located on the site access track, downslope (outside the currently provided site boundary).
Feature ID	25/IM/01

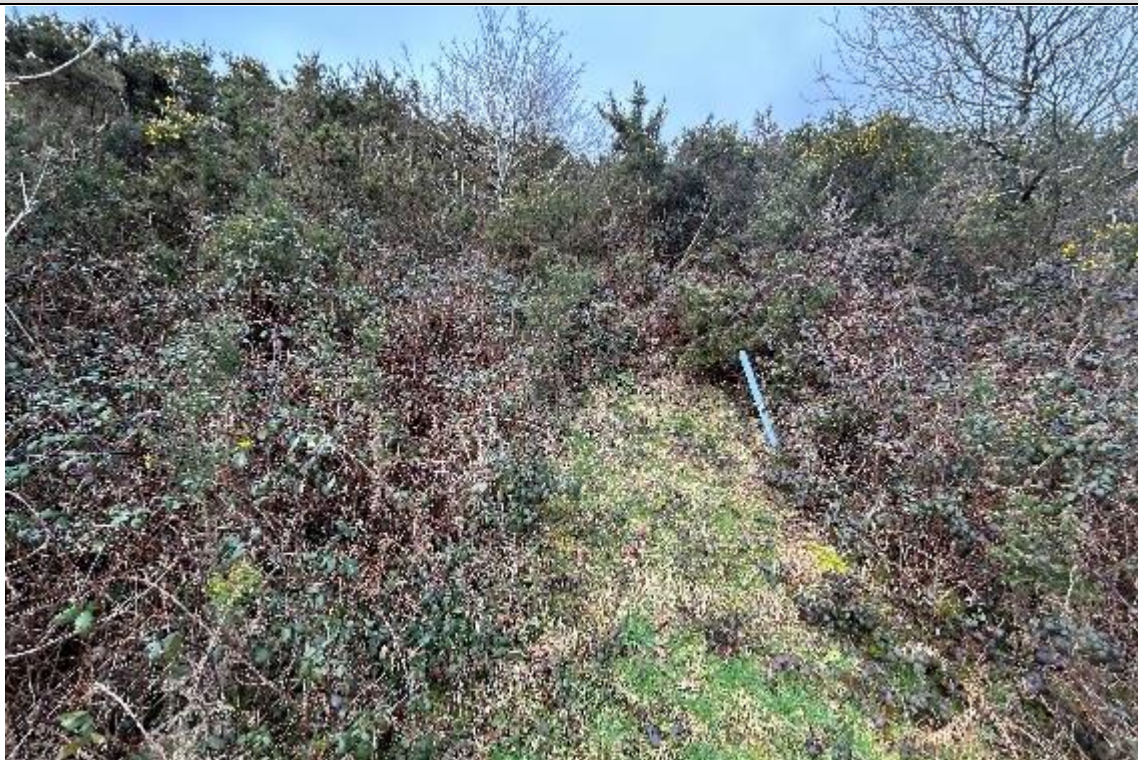
ID	Feature	Location	Comment	Change to Condition (New, Worse, None or N/A)
25/L/01	Vegetation Cover	E – 275025 N - 207030	The surfaces of the tip are densely vegetated with grass, bracken and gorse.	None
25/L/02	Signage	E – 274780 N - 206748	'Private Property Keep Out' signage situated on the access track which leads to Pentwyn Farm.	None

Photo No.	6	Comment	View looking towards the narrow, overgrown access path; of which extends up-slope off the main site access path, towards the site.
Feature ID	25/L/01

- Consider conducting vegetation clearance (clear pathways) to enable a more detailed inspection to be undertaken.

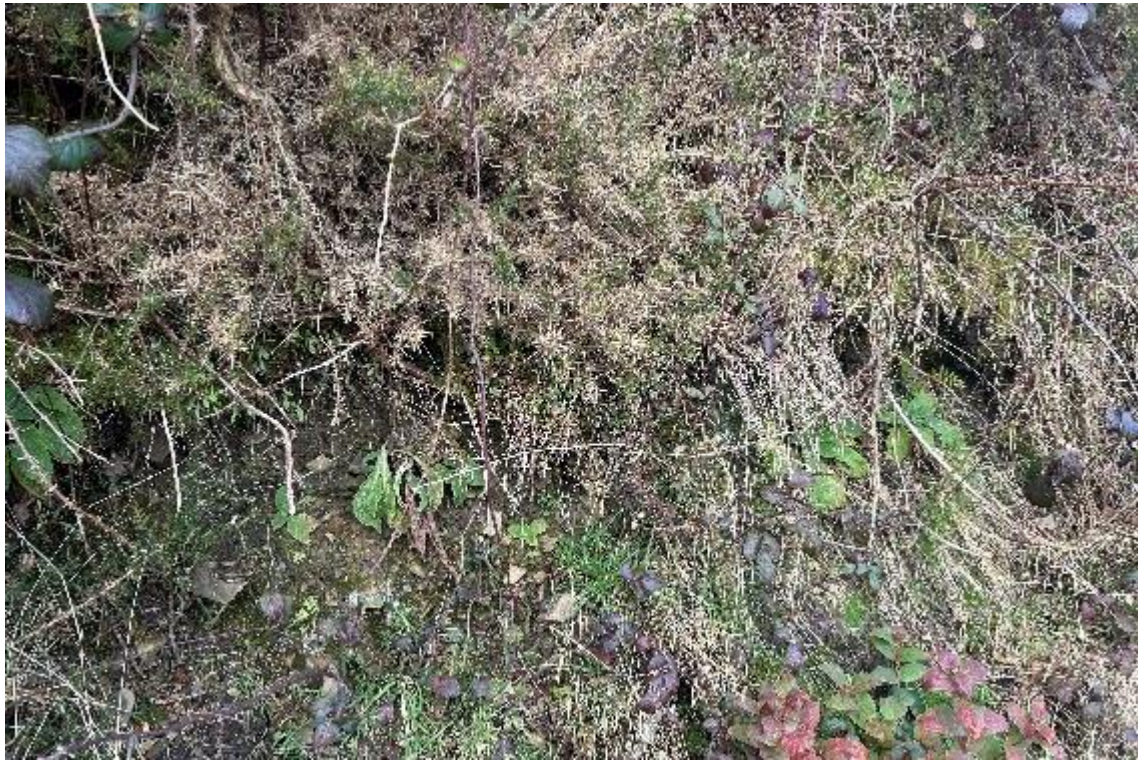
Photo No.	7	Comment	A small exposure of overburden and sandstone spoil material, adjacent to the site access track.
Feature ID	N/A
