# Investigation Report into Flooding Incident of 3<sup>rd</sup> September 2016 Cilmaengwyn Road, Cilmaengwyn and Graig Road, Godre'r-graig

## Highways and Drainage Services

Neath Port Talbot County Borough Council

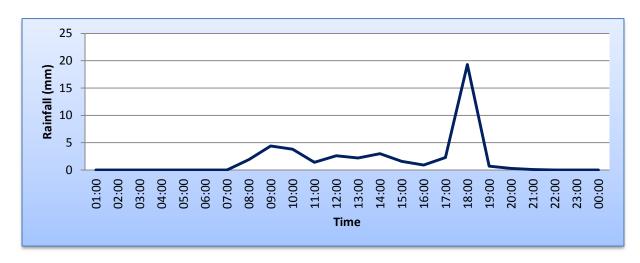
Figure 1, Rainfall in Godre'r-graig on 3rd September 2016 (Rainfall data provided by MetDesk Limited)

The graph identifies that between 18:00hrs and 19:00hrs the average rate of rainfall in Godre'r-graig was approximately 19.3mm/hr. However when studying the five minute rainfall radar over the same period, it was found that the peak rainfall intensity during that hour reached between 50-100mm/hr. A screenshot of the rainfall radar produced by NPTCBC's weather forecasters MetDesk Limited can be seen in Figure 2. The period where the rainfall

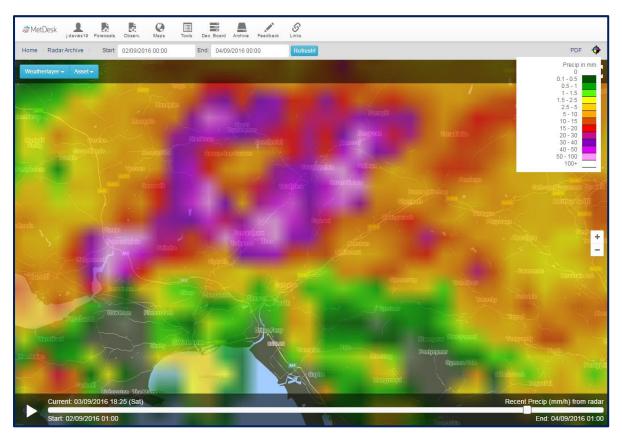
intensity peaked above 50mm/hr was the time that numerous communities throughout the North West of the County Borough began to suffer from surface water, ordinary watercourse and river flooding. After 19:00hrs the rainfall intensity significantly reduced until it stopped completely by 21:00hrs.

Figure 2, Screenshot of radar imagery showing precipitation levels at 18:25 on 3rd September 2016 (Provided by MetDesk Limited)

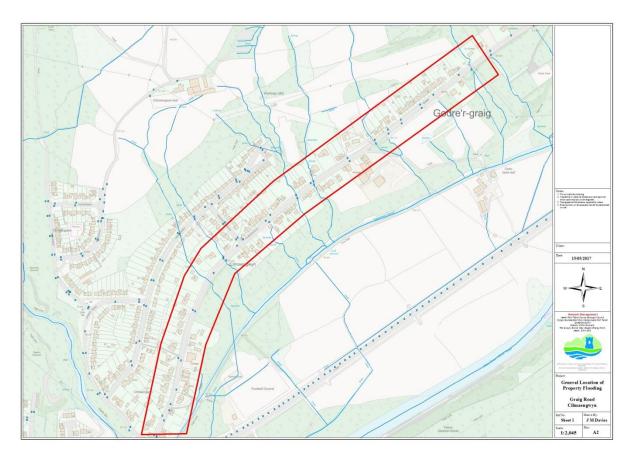
A number of properties suffered internal flooding on 3<sup>rd</sup> September at Graig Road, with many more experiencing flooding and erosion of their gardens and driveways. Figure 3 illustrates the general location of the properties that were affected as a result of the flooding.

Figure 3, General Location of Properties affected by the flood event on 3rd September 2016

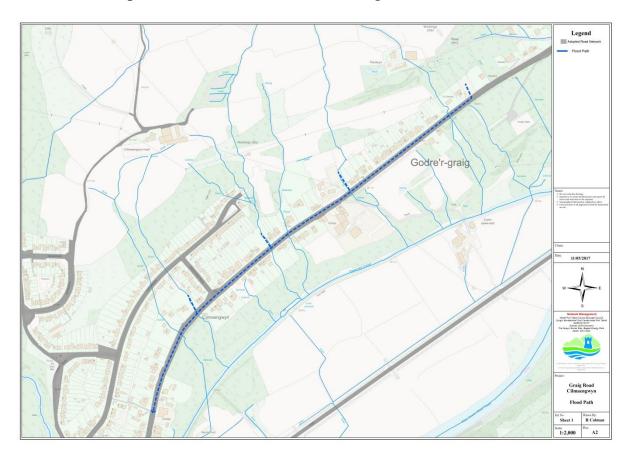
On 3<sup>rd</sup> September 2016, the hydraulic capacity of four of the culverts which convey ordinary watercourses from Mynydd Allt-y-grug underneath Cilmaengwyn and Graig Road was exceeded. This resulted in the ordinary watercourses spilling over onto the highway, causing water to flow down the road which travelled at a high velocity due to the roads gradient. The majority of the properties situated on the left hand side (when travelling down Cilmaengwyn and Graig road) are at a lower level than the road surface and this situation allowed flood water to enter private properties where solid boundary walls were not present to channel the water along the road.

Figure 4, Map showing the flow route of flood water affecting Cilmaengwyn and Graig Road

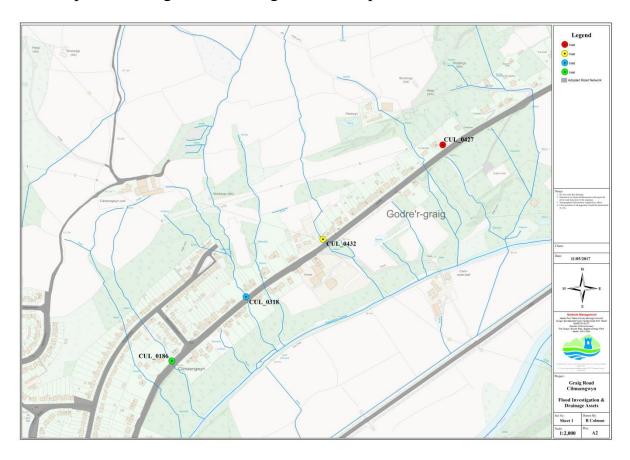
Investigations have determined that the flood water that affected the Roads emanated from four separate watercourses that convey water from Mynydd Allt-y-grug. Figure 5 identifies the location of the four watercourses where they pass under the highway. The four culverts indicated by the green, blue, yellow and red points on Figure 5 surcharged on 3<sup>rd</sup> September 2016.

Figure 5, Key assets along Cilmaengwyn and Graig Road

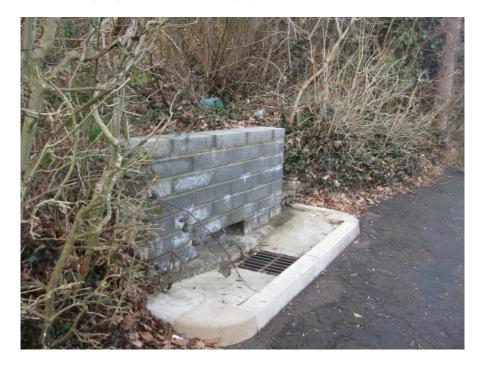
Culvert (ID: CUL\_0186) is indicated by the green point on Figure 5. The culvert is 300mm in diameter and as can be seen in Figure 6 has a concrete block headwall and an overflow system to convey flows should the intake structure become impeded. The high levels of flow in the watercourse caused a large amount of debris to be washed down to the culvert intake, partially blocking the pipe and limiting its hydraulic capacity. This, in combination with the general level of flow caused by the heavy rainfall, resulted in the

watercourse surcharging onto Cilmaengwyn Road.

Figure 6, Culvert intake structure (ID: CUL\_0186)

2.	NPTCBC as Highway Authority	Maintain highway culverts to maximise hydraulic capacity.	• Cyclic inspections, maintenance and clearance of any debris that has washed down to the intake structures highlighted in this report.

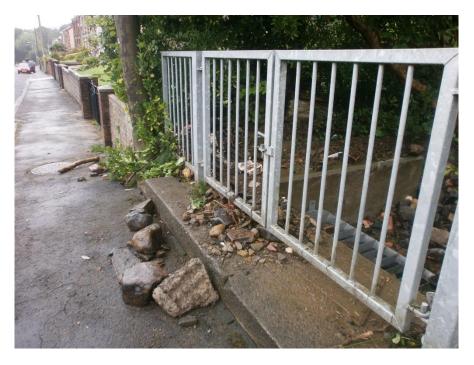
Culvert (ID: CUL\_0318) is indicated by the blue point on Figure 5. The culvert consists of two 600mm diameter circular pipes, a head wall and wing walls and a trash screen which can be seen in Figure 7.

Figure 7, Culvert intake structure (ID: CUL\_0318)

This watercourse surcharged onto Cilmaengwyn Road as the culverts capacity was exceeded in a similar way to culvert (ID: CUL\_0186). However the ordinary watercourse conveyed by this culvert is much larger, contributing to a greater amount of flood water. The photograph taken after the flood event (Figure 7) shows some of the stone that was washed down to the intake structure by the flood water.

3.	NPTCBC as Highway Authority	Consider improvements to highway culverts.	<ul> <li>Officers to investigate options for upgrading highway culverts where required.</li> <li>A new trash screen has already been constructed on Culvert (ID: CUL_0318).</li> </ul>

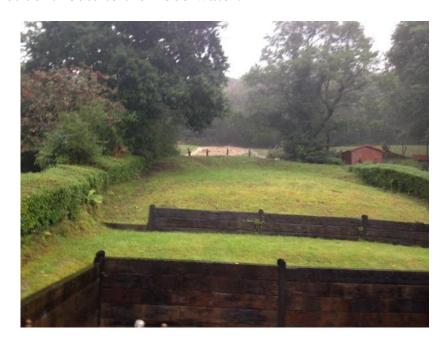
Figure 8 is a photograph that was taken by a resident during the flood event, showing overland flows coming off the steep sloping mountain side above the properties on Graig Road that were eventually conveyed to culvert CUL\_0432 which is indicated by the yellow point on Figure 5. There is a ditch present at the top of the field (Figure 9), which collects an ordinary watercourse and surface water run-off from Mynydd Allt-y-grug. The ditch conveys water to two separate pipes, which in turn convey the flows to two culverts that cross underneath Graig Road, one of which being the culvert mentioned above, the other did not contribute to the flood water.

Figure 8, Culvert intake structure (ID: CUL\_0432) during flood event

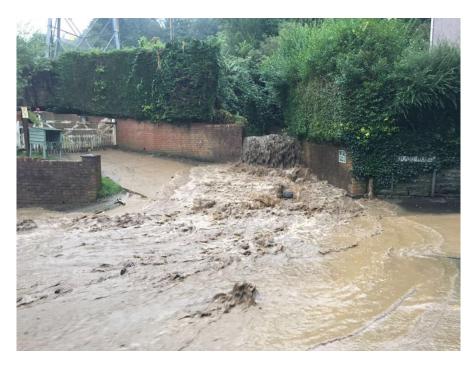
The intake structure of CUL\_0432 consists of a 350mm diameter pipe and a concrete headwall which has an overflow system built into it. As can be seen in Figure 9, the capacity of the culvert and the overflow system was far exceeded on 3<sup>rd</sup> September 2016, causing high levels of flood water to spill over onto Graig Road.

Figure 8, Overland flows that were conveyed to culvert (ID:  $CUL_0432$ )

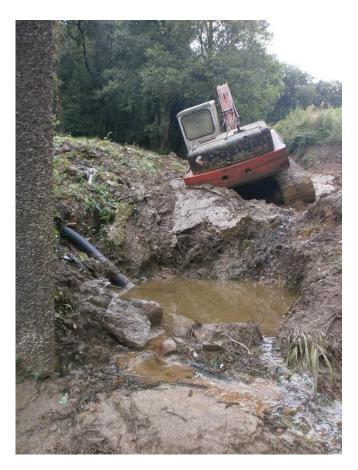
Culvert (ID: CUL\_0427) is indicated by the red point on Figure 5. The culvert is 400mm in diameter and includes a concrete headwall and trash screen.

Figure 9, Photograph of the location of culvert (ID:  $CUL_0427$ ) post flood event

Figure 10 is a photograph taken after the flood event showing the culvert intake. As can be seen from the photograph, the excavation and earth moving works that has been undertaken on the adjacent private land has caused the culvert to block and form a small pond. Any water that arrived at this culvert on 3<sup>rd</sup> September 2016 was unable to enter the culvert and consequently spilled over onto Graig Road.

4.	NPTCBC as LLFA	Land Drainage enforcement.	<ul> <li>Should there be a requirement the LLFA will implement its powers under common law to remove any obstructions in a watercourse.</li> <li>Monitor the work being undertaken on the land adjacent to the Culvert (ID: CUL_0427).</li> </ul>
