<b>Coal Tip Name</b>	Godre'r-Graig Higher / Pentwyn No. 3 Levels		<b>UID</b>	T42668	
<b>Located in</b>	Godre'r Graig, Neath Port Talbot		<b>Tip Category</b>	D	
<b>Inspection Led by</b>		<b>Date of Inspection</b>	18/07/2025	<b>Date of last Inspection</b>	12/02/2025
<b>Weather</b>	Overcast		Dry	Calm	
<b>Comments on access and any limitations</b>	<p>Access to the site gained via an access track situated just off Graig Road, which leads to Pentwyn Farm.</p> <p>It should be noted that this inspection was conducted without the benefit of a detailed site plan; whilst in certain areas vegetation limited accessibility and visual inspection. Therefore, instability within these areas could exist but was not detectable at the time of the inspection.</p>				
	<b>Description</b>				<b>Status</b>
<b>RAG Status: Capital &amp; Maintenance Works</b>	Consider implementing appropriate drainage infrastructure to effectively capture the uncontrolled flows associated with the outfall of issues. Consider formalising/lining the flow pathway of the issues, to prevent further scouring (25/G/01/06).				<b>2</b>

<b>Coal Tip Name</b>	Godre'r-Graig Higher / Pentwyn No. 3 Levels	UID	T42668
		Tip Category	D
Date

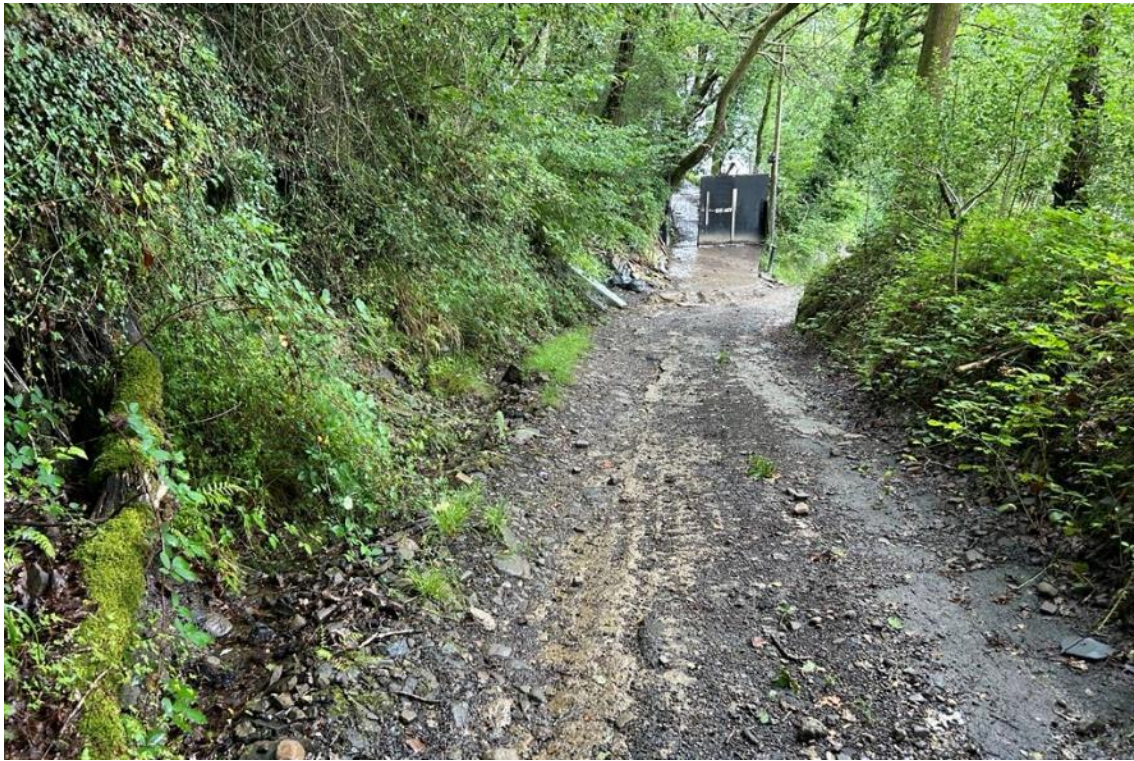
significantly scoured in places, indicating that flows escape the trackside channel during heavy rainfall (Photo 1).	
25/D/02	Culvert	E-274776, N-206736	Previously reported leaf litter obstructing flows from entering the trackside drain, located adjacent to the access track which spans just off the Western site perimeter. Leaf litter has since been removed (Photo 9).	N/A
<b>Recommendations</b>			N/A	
<b>ENGINEERING INFRASTRUCTURE</b>				
<b>ID</b>	<b>Feature</b>	<b>Location</b>	<b>Comment</b>	<b>Change to Condition</b> (New, Worse, None or N/A)
25/E/01	Retaining Wall	E-274907, N-206777	The retaining wall located along the property of Glanderi (located just east of the site) is in poor condition, with multiple minor seepages emanating from cracks/voids within the structure. Flows conveying along the base of this structure and enter an unlined, trackside channel. This has resulted in minor saturation along the base of the retaining wall (Photo 2).	None

<b>Photo No.</b>	01	<b>Comment</b>	Scoured access track leading to Pentwyn Farm. Flows visible on LHS of image, conveying along an unlined, trackside channel at the toe of the tip.
<b>Feature ID</b>	25/D/01

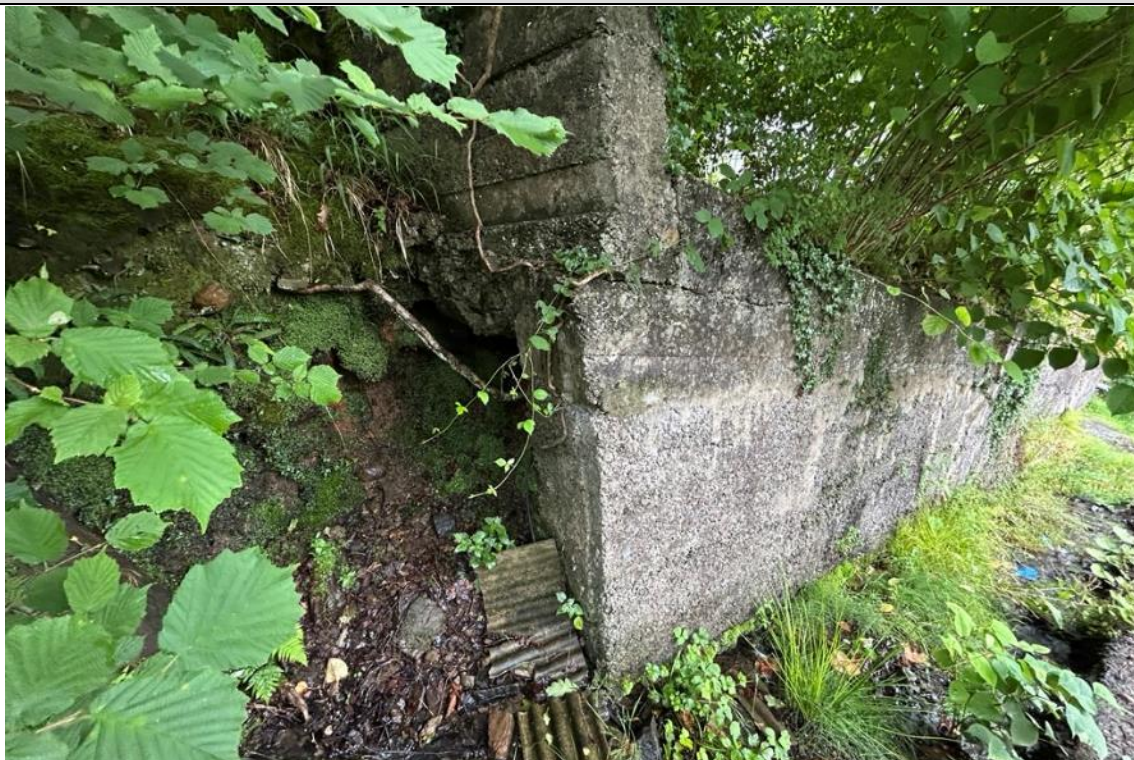
<b>Photo No.</b>	02	<b>Comment</b>	Minor seepages and saturated ground conditions observed adjacent to the retaining wall situated along the residential property of Glanderi, located just East of the site. This structure is in poor condition.
<b>Feature ID</b>	25/E/01

<b>Recommendations</b>			Continue to monitor the condition of the retaining wall structure associated with the residential property of Glanderi for a deterioration (25/E/01).	
<b>INSTRUMENTATION &amp; MONITORING</b>				
<b>ID</b>	<b>Feature</b>	<b>Location</b>	<b>Comment</b>	<b>Change to Condition</b> (New, Worse, None or N/A)
N/A				
<b>Recommendations</b>				
<b>LAND USE</b>				
<b>ID</b>	<b>Feature</b>	<b>Location</b>	<b>Comment</b>	<b>Change to Condition</b> (New, Worse, None or N/A)
25/L/01	Deposition	E-274890, N-206779	Pallets and other miscellaneous materials discarded below the outfall of flow path of issues which skirts the Eastern perimeter of the tip body. Material deposited on the driveway of the residential property Glanderi (Photo 3).	None
25/L/02	Fencing	E-274780, N-206745	The temporary fencing at the entrance to the access track which climbs the Western site perimeter has been re-erected (Photo 8).	New

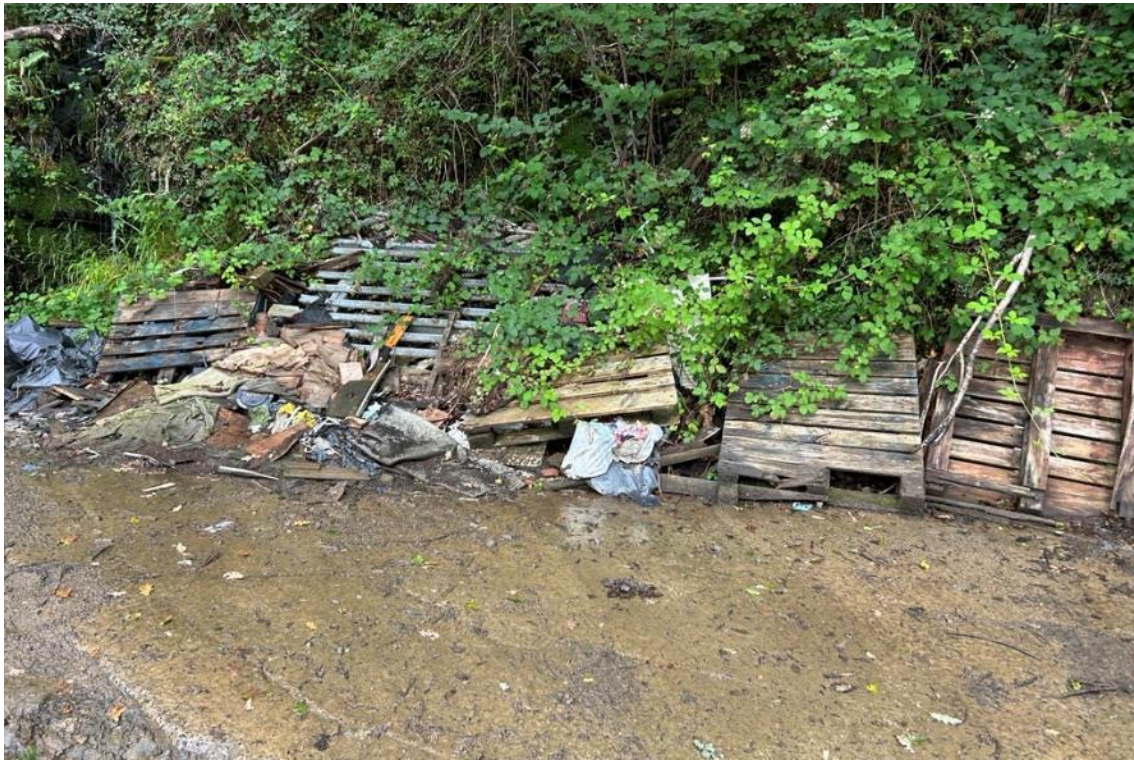
<b>Photo No.</b>	03	<b>Comment</b>	Pallets and other miscellaneous materials discarded below the outfall of flow path of issues which skirts the Eastern perimeter of the tip body. Material deposited on the driveway of the residential property Glanderri.
<b>Feature ID</b>	25/L/01

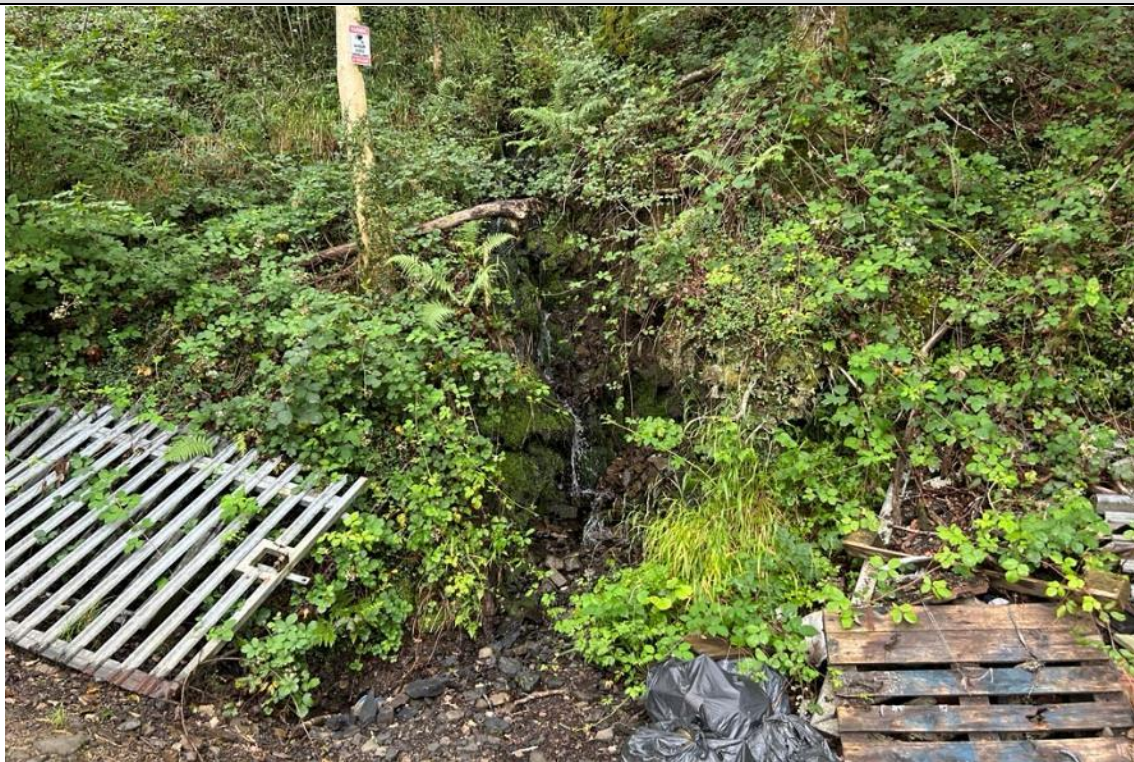
<b>Photo No.</b>	04	<b>Comment</b>	View looking towards the outfall of the flow path of issues which skirt the Eastern perimeter of the tip body located further upslope. A small amount of natural ground material has been eroded adjacent to the outfall.
<b>Feature ID</b>	25/G/01

25/G/04	Backscarp	E-274813, N-206763	Minor, arcuate backscarp approximately 5m in width located along the Western section of the toe of the tip, indicating the presence of a historical, superficial surface slip (Photo 7).	None
25/G/05	Saturated Ground	E-274845, N-206825	Saturated ground conditions marked by reed growth and minor ponding observed along the upper, north-eastern section of the tip body. This is a longstanding feature of the site (Photo 11).	None
25/G/06	Erosion	E-274853, N-206816	Minor erosion of the tip body by the flow pathway of issues which skirt a small section of the Eastern site perimeter. Flows emanate from the natural ground hillside to the rear, which presumably contains historic mine entries. Flows outfall from this pathway adjacent to the residential property of Glanderri, as displayed in image 4 (Photo 12-13).	None
<b>Recommendations</b>			Consider implementing appropriate drainage infrastructure to effectively capture the uncontrolled flows associated with the outfall of issues. Consider formalising/lining the flow pathway of the issues, to prevent further scouring (25/G/01/06).

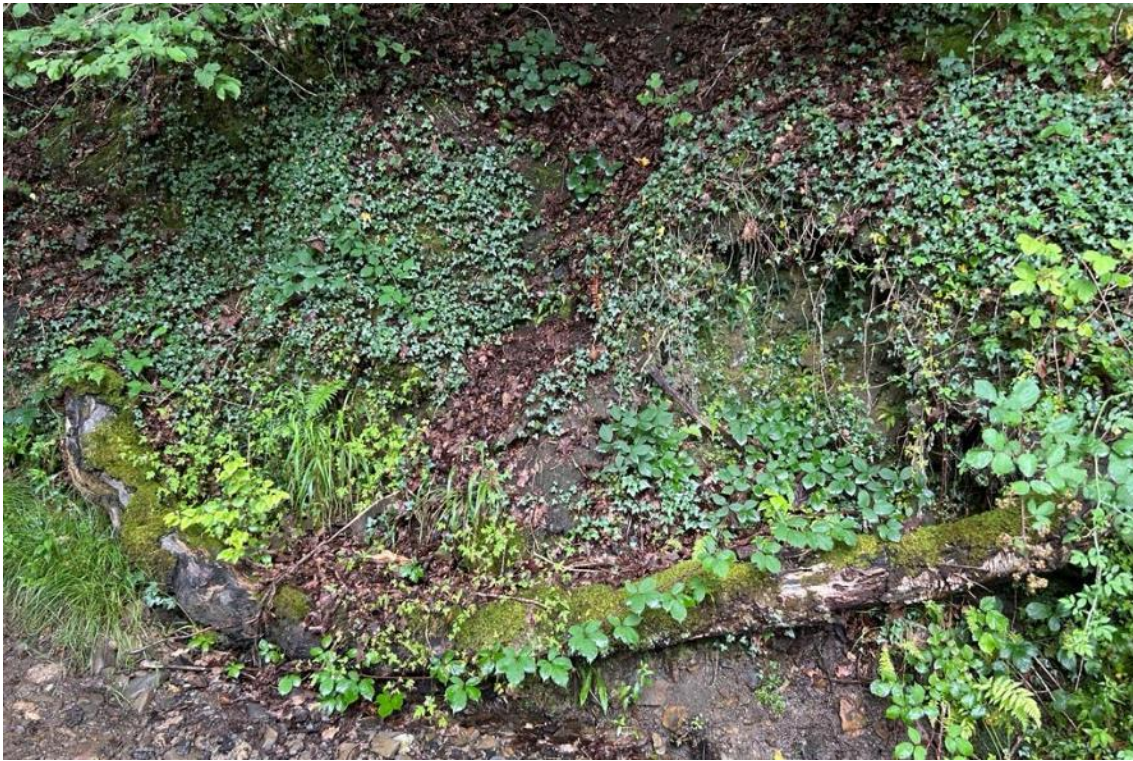
<b>Photo No.</b>	05	<b>Comment</b>	View from the access track which spans the toe, looking towards the small section of slumped material, likely associated with the uprooted tree visible at the base.
<b>Feature ID</b>	25/G/02

Consider the feasibility of implementing a retaining structure along the base of flank/toe of the tip, as it directly abuts an access track (25/G/02-03).	
<b>DRAINAGE</b>				
<b>ID</b>	<b>Feature</b>	<b>Location</b>	<b>Comment</b>	<b>Change to Condition (New, Worse, None or N/A)</b>
25/D/01	Channel	E-274919, N-206774	An unlined trackside channel spans the upper section of the access track leading to Pentwyn Farm. This access track is	None

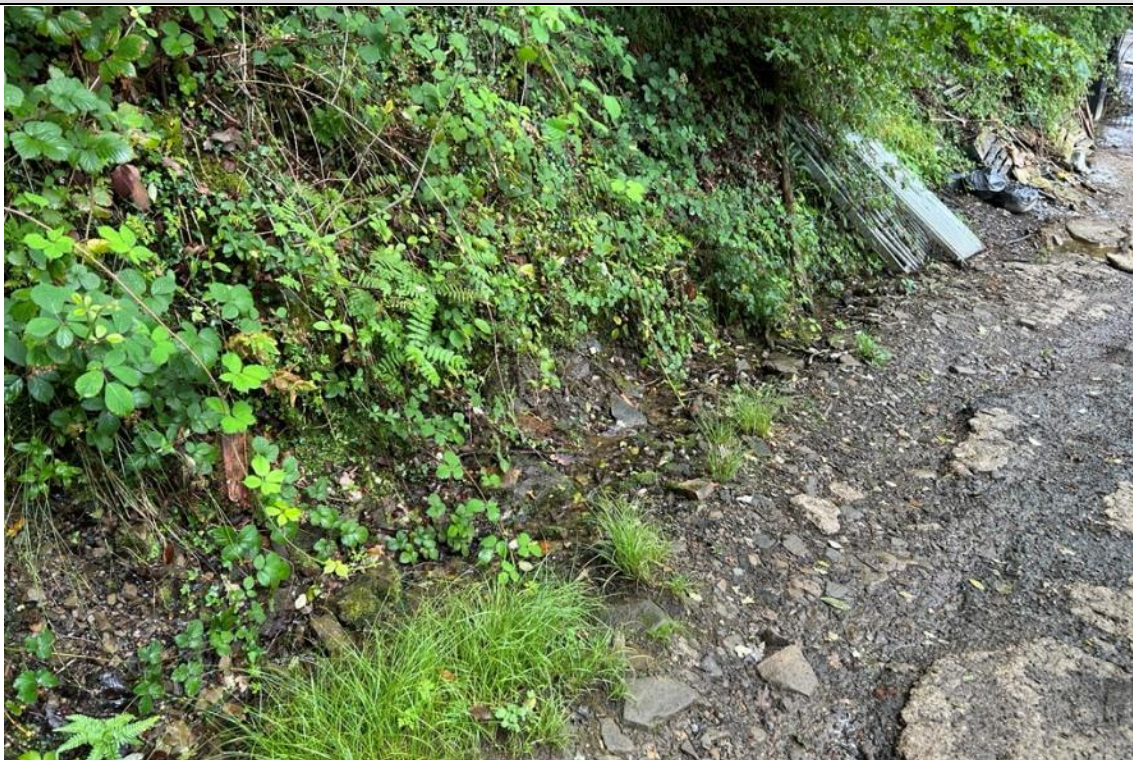
<b>OBSERVATIONS</b>				
<b>GEOTECHNICAL</b>				
<b>ID</b>	<b>Feature</b>	<b>Location</b>	<b>Comment</b>	<b>Change to Condition (New, Worse, None or N/A)</b>
25/G/01	Erosion	E-274886, N-206778	Minor erosion of natural ground noted at the outfall of the flow pathway of issues which skirt the Eastern perimeter of the tip body (Photo 4).	None
25/G/02	Slumping	E-274847, N-206774	A very small section of the toe of the tip has been subject to minor slumping, relating to a fallen, uprooted tree displacing a small amount of spoil material (Photo 5).	None
25/G/03	Minor Seepage	Toe of the Tip	Previously reported multiple, minor seepages emanating from the toe of the tip and conveying along the adjacent access track. At the time of inspection, no seepages were identified but it is assumed that they wax and wane depending on weather conditions. Very minor seepages present at time of inspection (Photo 6).	None

<b>Photo No.</b>	06	<b>Comment</b>	View from the access track, looking across the steep lower section and toe of the tip flank. Previously, multiple minor seepages have been identified along the toe, which wax and wane depending on weather conditions.
<b>Feature ID</b>	25/G/03

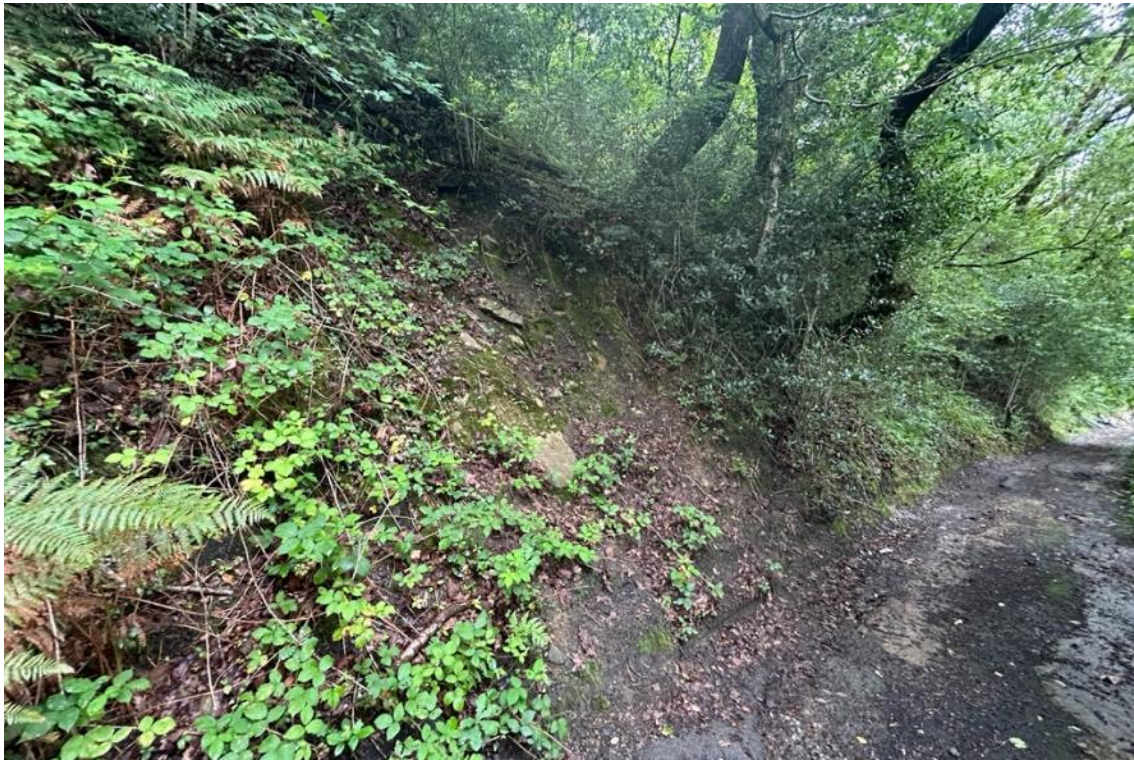
<b>Photo No.</b>	07	<b>Comment</b>	View from the toe, looking towards the minor, arcuate backscarp approximately 5m in width indicating the presence of a historical, superficial surface slip.
<b>Feature ID</b>	25/G/04

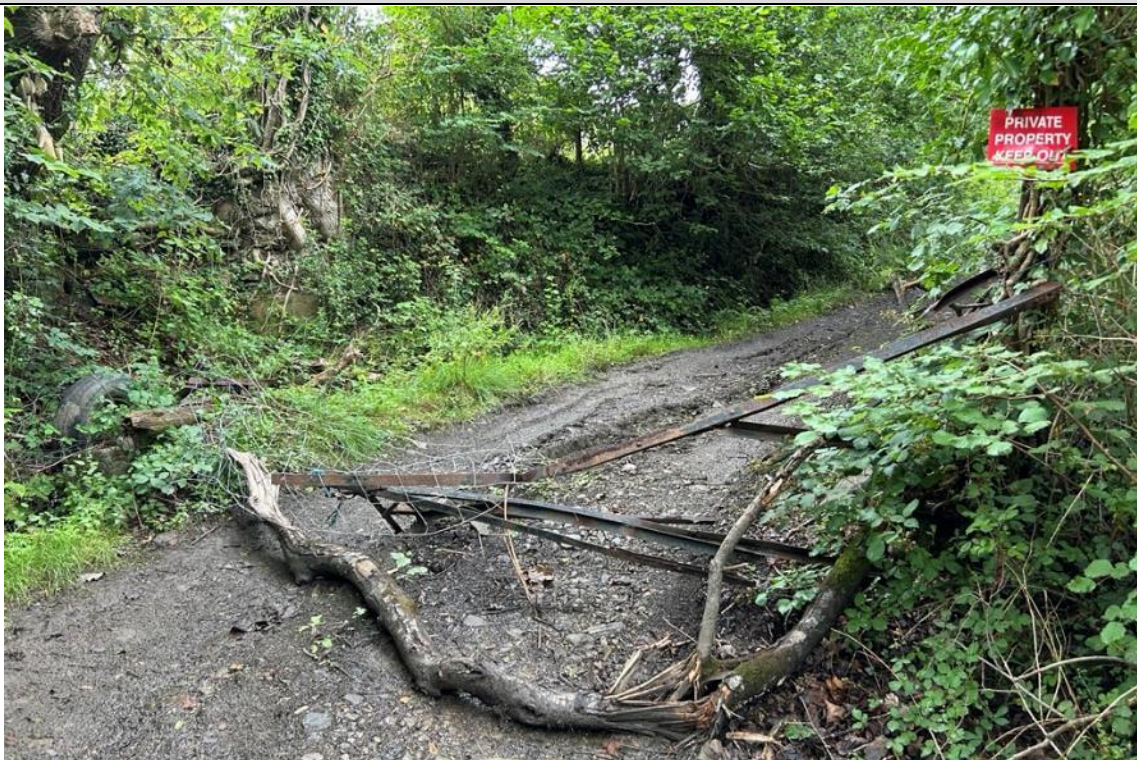
<b>Photo No.</b>	08	<b>Comment</b>	The temporary fencing at the entrance to the access track which climbs the Western site perimeter has been re-erected.
<b>Feature ID</b>	25/L/02

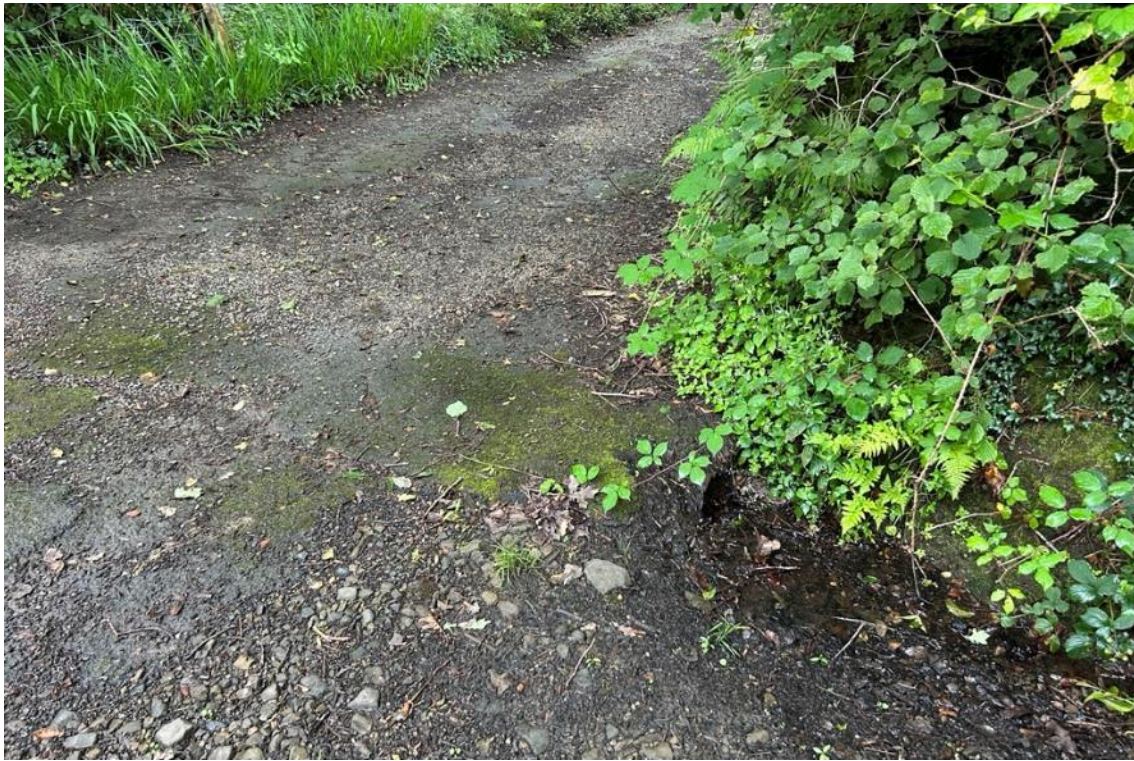
<b>Photo No.</b>	09	<b>Comment</b>	Trackside drain, located adjacent to the access track which spans just off the Western site perimeter is no longer obstructed by leaf matter.
<b>Feature ID</b>	25/D/02

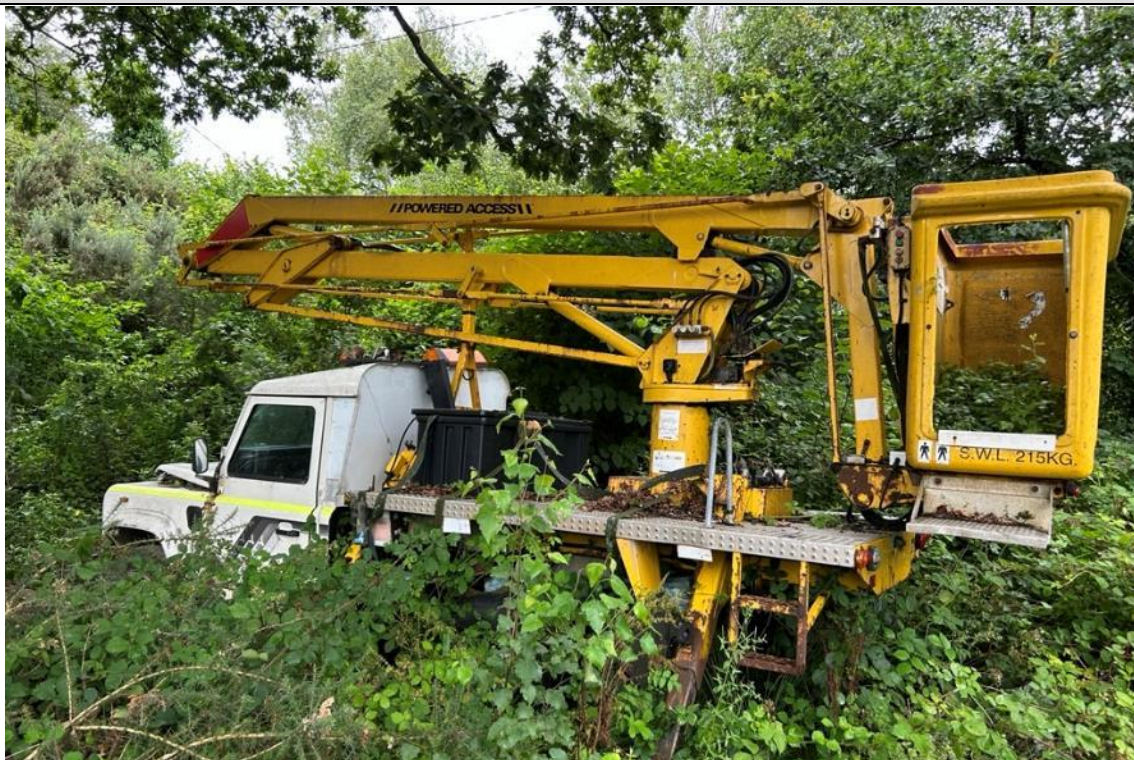
25/L/03	Deposition	E-274821, N-206794	Disused plant vehicle and associated equipment discarded on the north-western section of the tip plateau (Photo 10).	None

<b>Photo No.</b>	10	<b>Comment</b>	Disused plant vehicle and associated equipment discarded on the north-western section of the tip plateau.
<b>Feature ID</b>	25/L/03

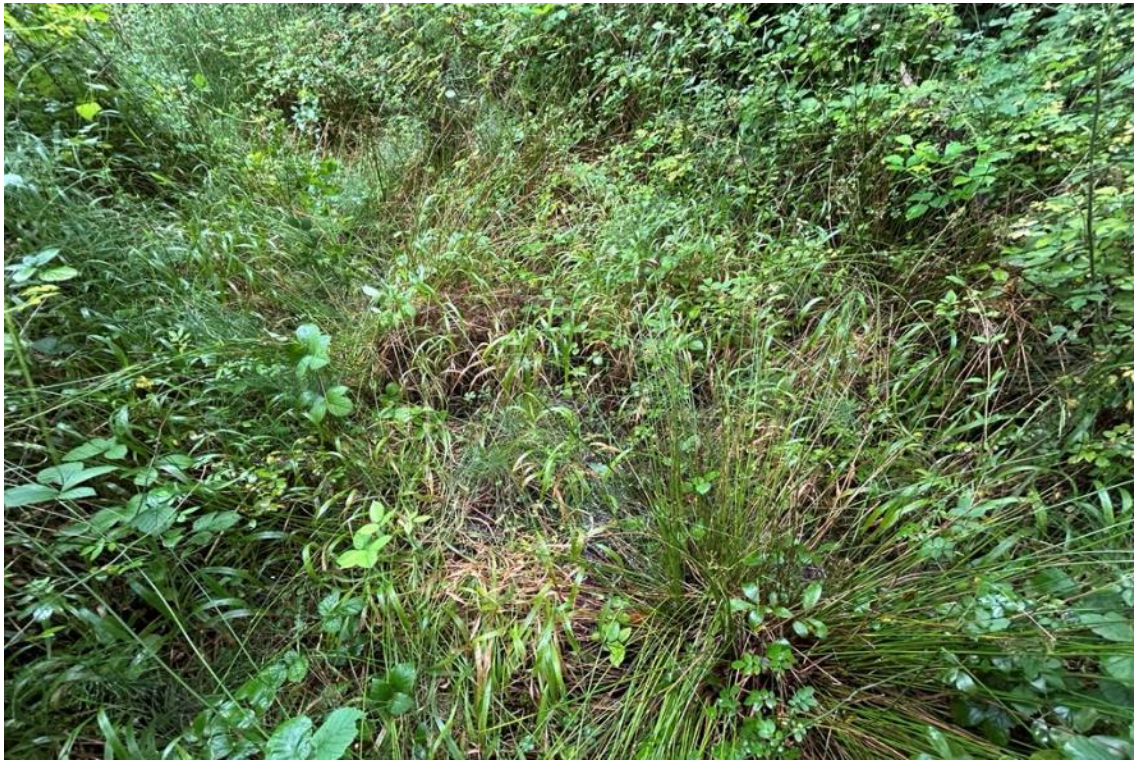
<b>Photo No.</b>	11	<b>Comment</b>	Saturated ground conditions marked by reed growth and minor ponding observed along the upper, north-eastern section of the tip body.
<b>Feature ID</b>	25/G/05

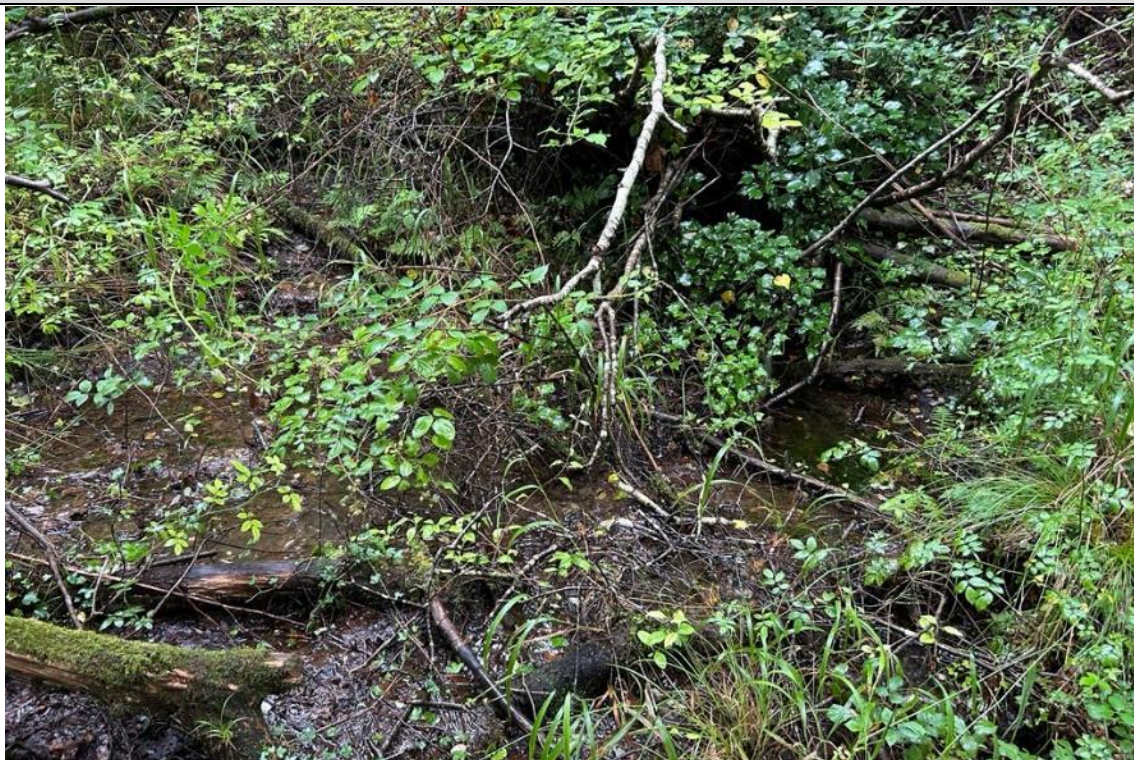
<b>Photo No.</b>	12	<b>Comment</b>	A moderate levels flows emanating from the hillside to the rear of the upper, north-eastern section of the site and potential historic mine entries convey along a partial length of the Eastern site perimeter, before conveying further downslope.
<b>Feature ID</b>	25/G/06

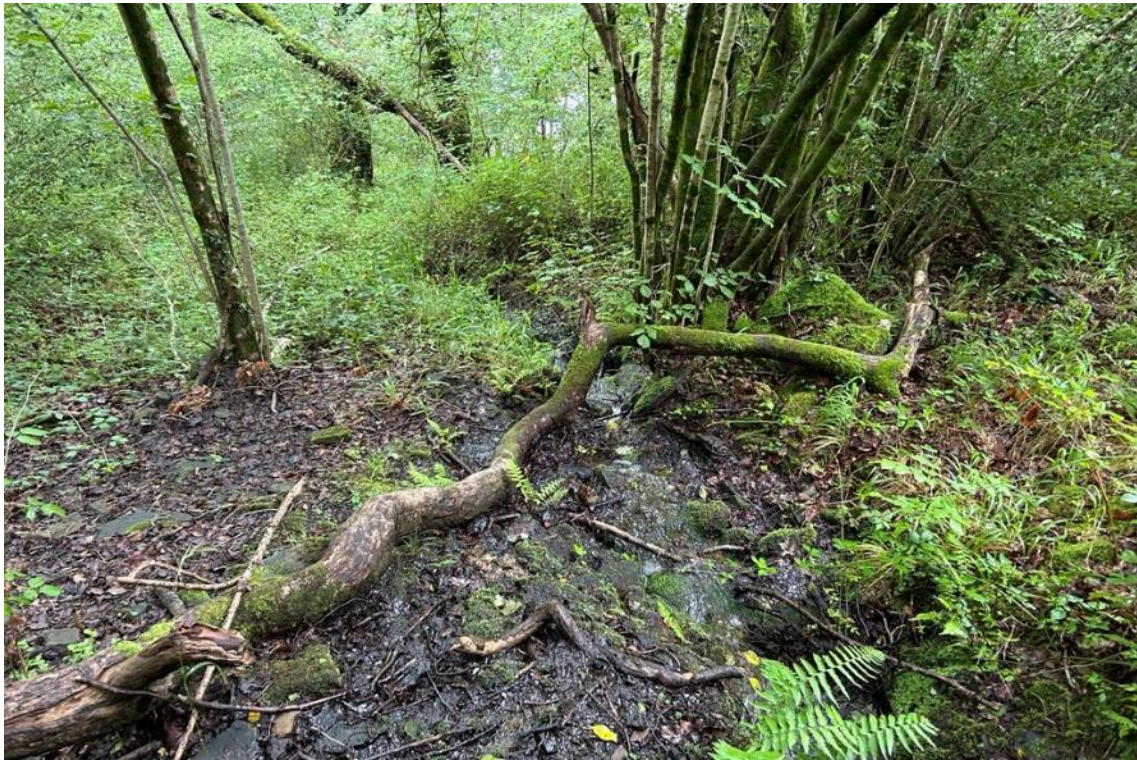
<b>Photo No.</b>	13	<b>Comment</b>	Flow pathway of issues which skirt a small section of the Eastern site perimeter, resulting in minor erosional scour.
<b>Feature ID</b>	25/G/06

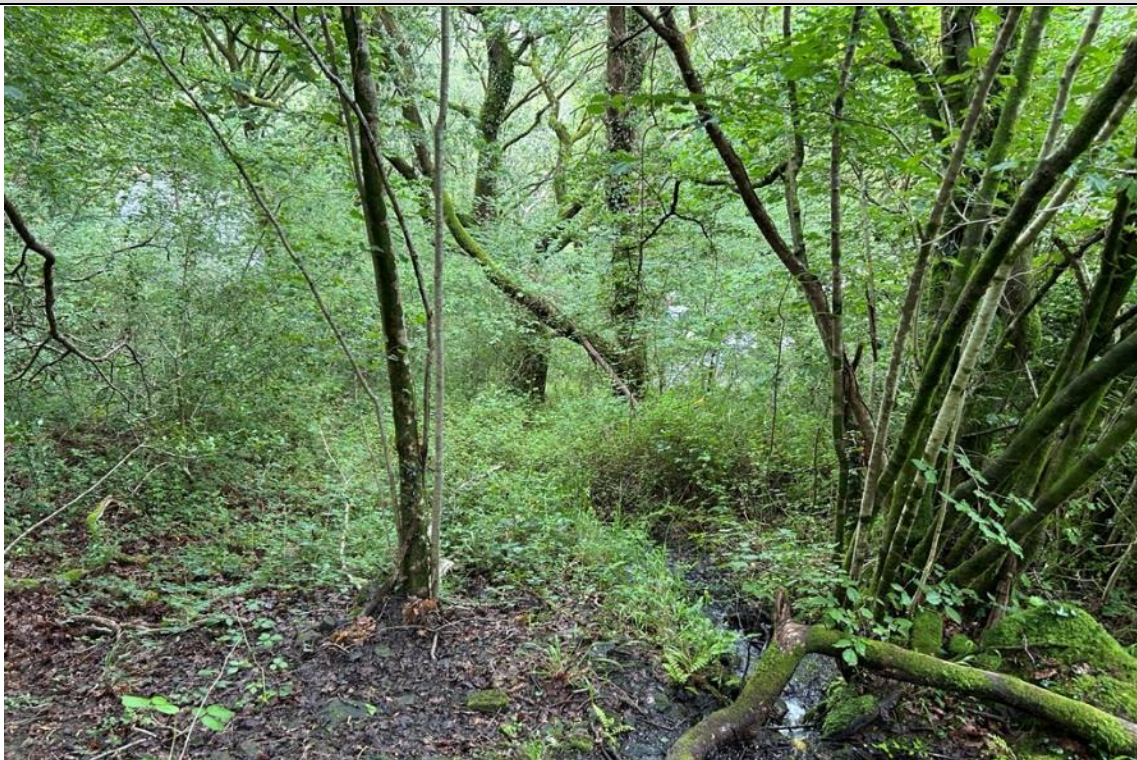
<b>Photo No.</b>	14	<b>Comment</b>	View from the upper slope, looking across the well-wooded tip body.
<b>Feature ID</b>	25/L/04

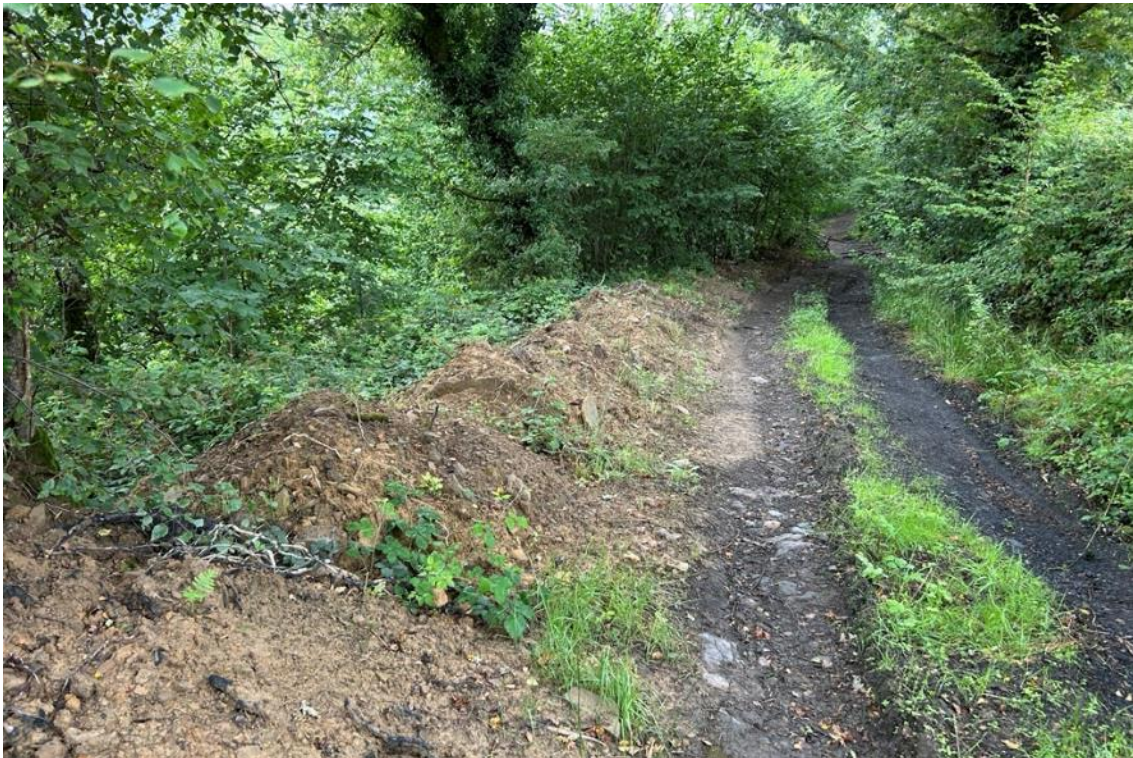
<b>Photo No.</b>	15	<b>Comment</b>	New observation. Shallow bund of natural ground material deposited along the NW section of tip crest, adjacent to the access track which spans to the rear of the site.
<b>Feature ID</b>	25/L/05

Desist from depositing natural ground material along the tip crest, as continued tipping has the potential to lead to structural instability across the slope below (25/L/05).				<b>2</b>
	<p>Consider the feasibility of implementing a retaining structure along the base of flank/toe of the tip, as it directly abuts an access track (25/G/02-03).</p> <p>Continue to monitor the condition of the retaining wall structure associated with the residential property of Glanderri for a deterioration (25/E/01).</p>				<b>3</b>
<b>General Remarks</b>	<p>An elongated lobe of colliery spoil material orientated north-east to south-west, formed by traditional loose-end tipping practice. The tip has been constructed with a plateau and a well-vegetated, steeply-sloping south-east facing flank. An access track abuts the toe of this flank. Most notably, issues emanating from the natural hillside to the rear of the site (which potentially contains historical mine entries) convey along the natural ground hillside just East of the site and skirt a partial length of the Eastern site perimeter, resulting in minor erosion via scour. These flows outfall at the access track at the toe of the tip resulting in instances of erosional scour along the access track, as the unlined trackside channel is ineffective in conveying flows. Just East of the toe of the tip, the residential property of Glanderri is located. The outfall of issues is located just off the driveway of the property, which has resulted in localised saturated ground conditions. The retaining wall associated with this property is also in poor condition, although not retaining tip material. Some evidence of minor, historical instability was noted along the toe of the tip, with minor seepages being reported previously. These seepages likely wax and wane depending on weather conditions. No evidence of recent ground movement observed at the time of inspection.</p>

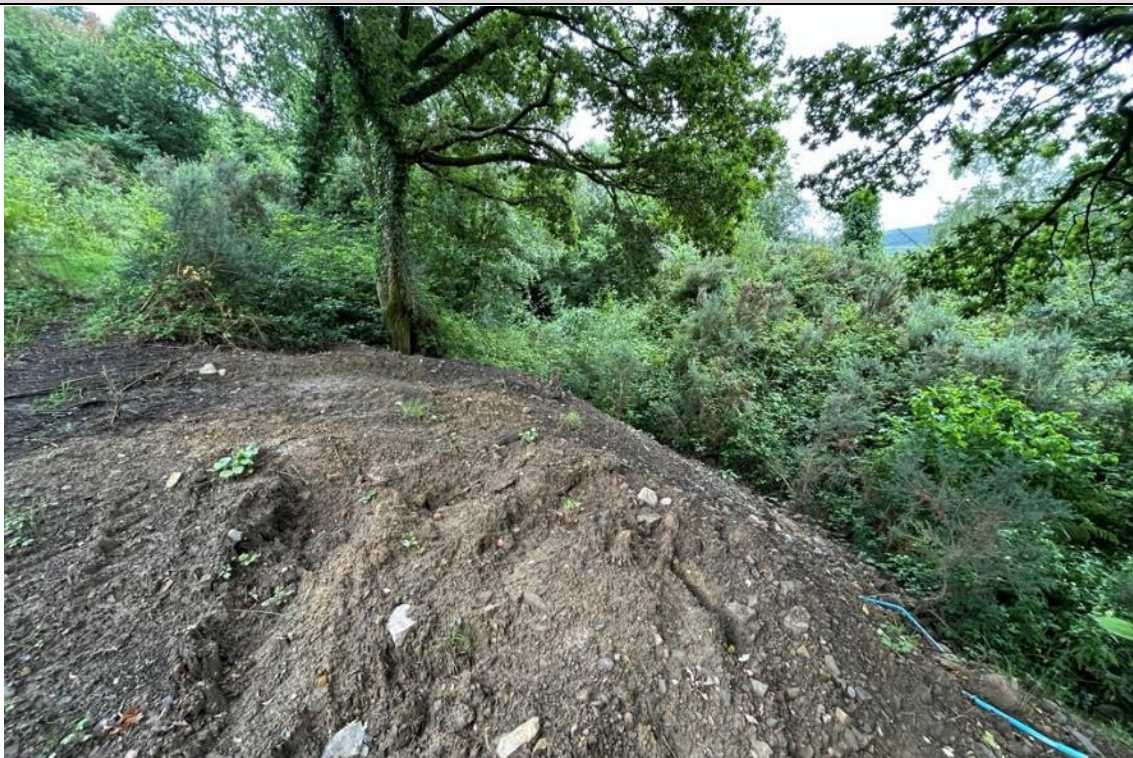
<b>Photo No.</b>	16	<b>Comment</b>	Larger quantity of natural ground material tipped to the rear of the tip crest, adjacent to the access track which spans to the rear of the site.
<b>Feature ID</b>	25/L/05

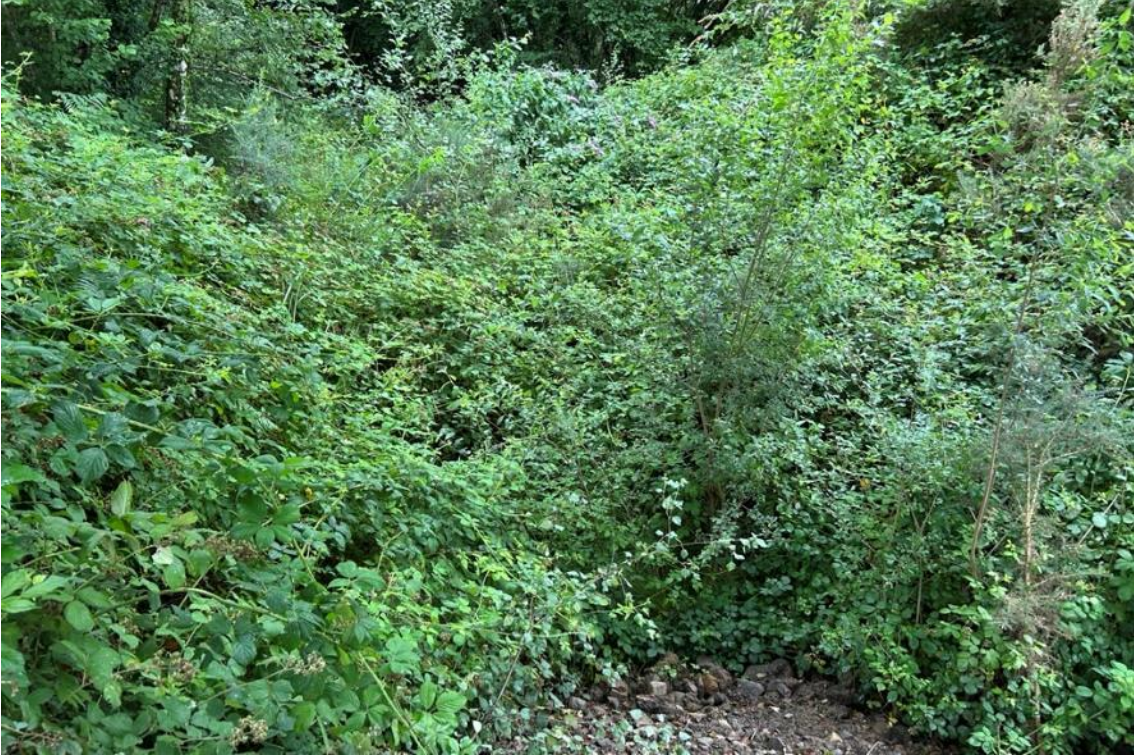
<b>Photo No.</b>	17	<b>Comment</b>	Access point to the upper section of the site is overgrown, which may pose future accessibility issues.
<b>Feature ID</b>	25/L/04
