Godre'r Graig Primary School Executive Summary; Preliminary Investigation and Additional Assessment

Neath Port Talbot County Borough Council

Report Reference: ESP.7234e.02.3339

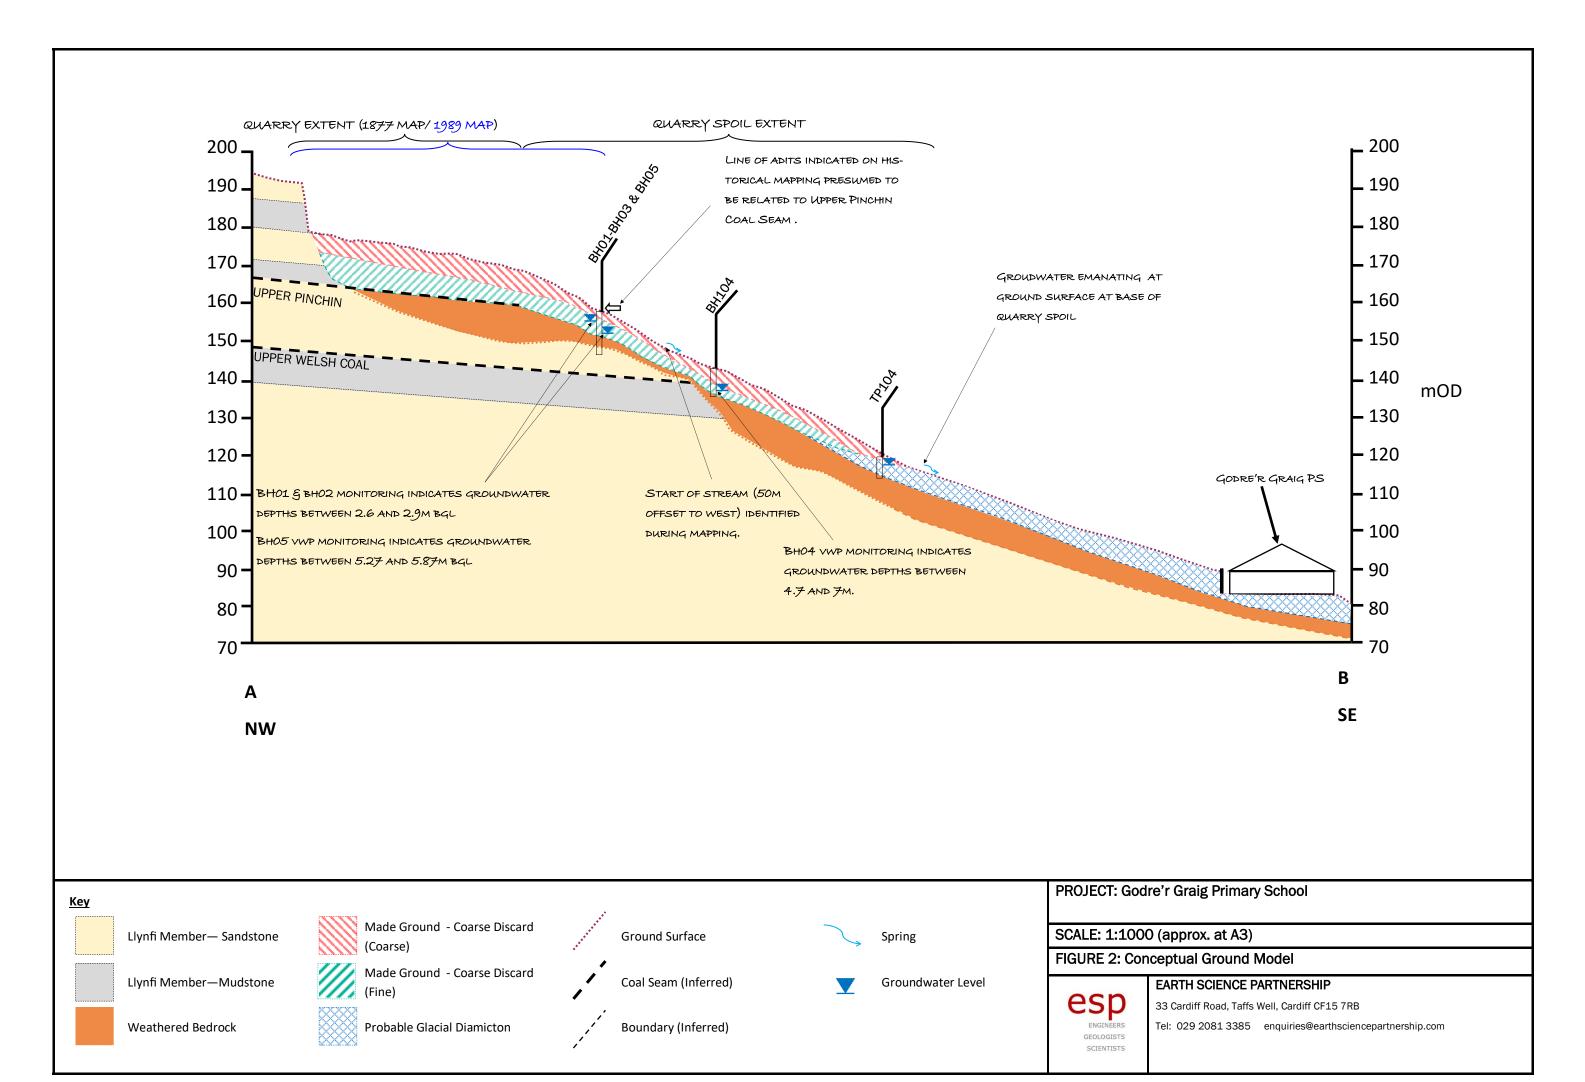
The investigation allowed the Ground Model, as shown in Figure 2, to be updated and the below provides a summary of the findings.

The Quarry Spoil Tip was found to comprises two separate strata, both are classed as Coarse Discard, i.e. generally cobbles and gravel of sandstone, but there is a lower unit with a higher fine-grained component (clay, silts). Below the Quarry Spoil, Glacial Diamicton has been found which overlies weathered and intact bedrock.

Groundwater has been observed in the Quarry Spoil Tip and monitoring has shown a variable head of water in the tip.
