Neath Canal

Tennant Canal

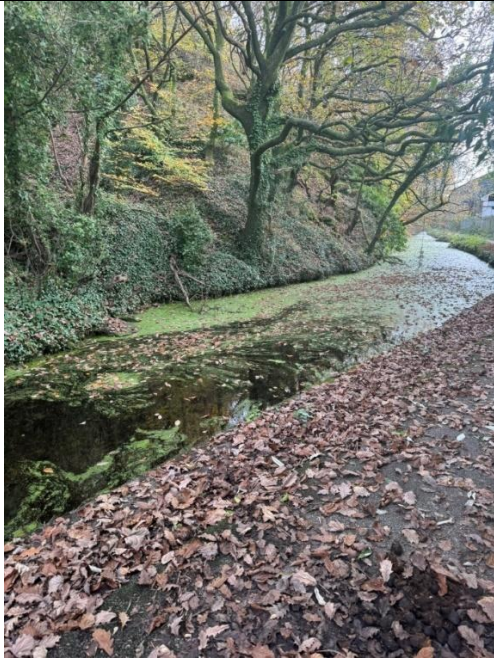
Image 1 – Pipe Bridge - Evidence of Neath canal condition

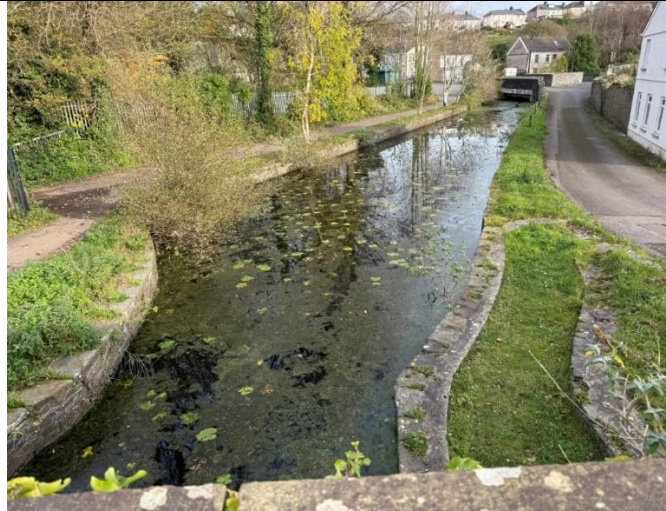
Image 2 – Canal viewed from Diamond Bridge showcasing structure and canal condition

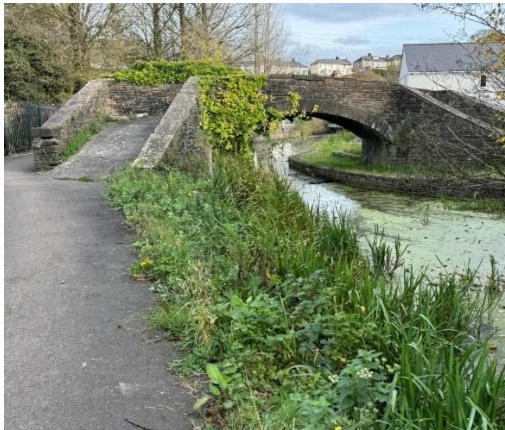
Image 3 – Giants Grave turnover Bridge with vegetation on embankment

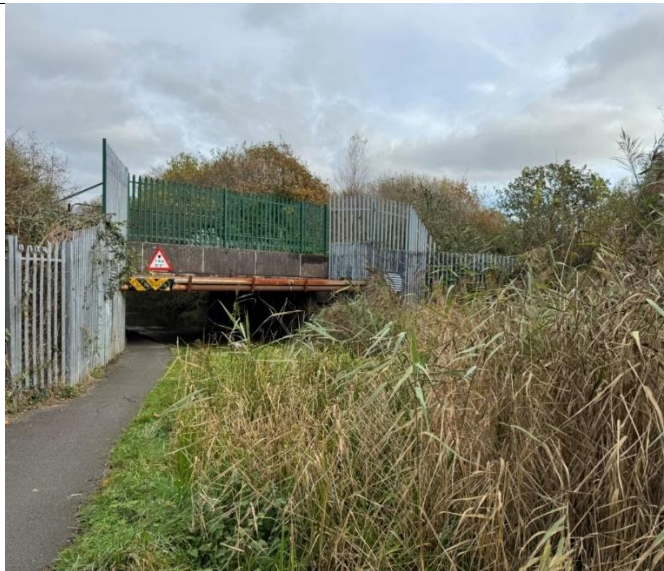
Image 7 – Landfill Site Bridge with low headroom but sufficient for canal

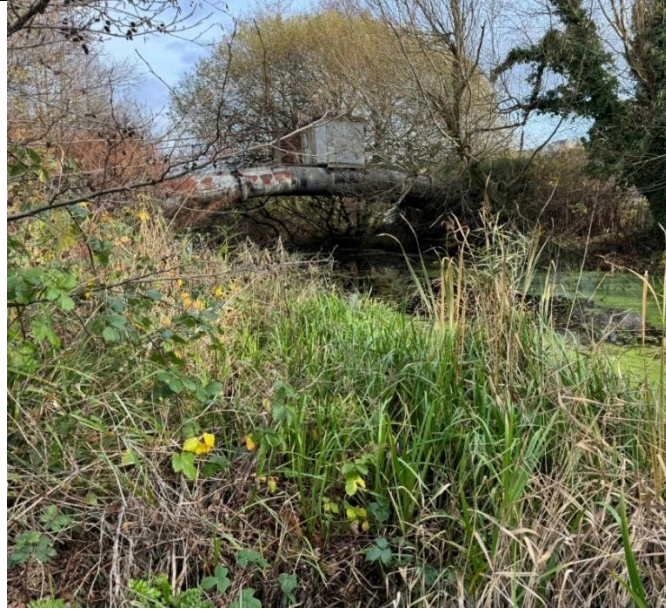
Image 9 - Neath Junction Rail Bridge highlighting low headroom (5'3) for pedestrians but sufficient for canal navigation

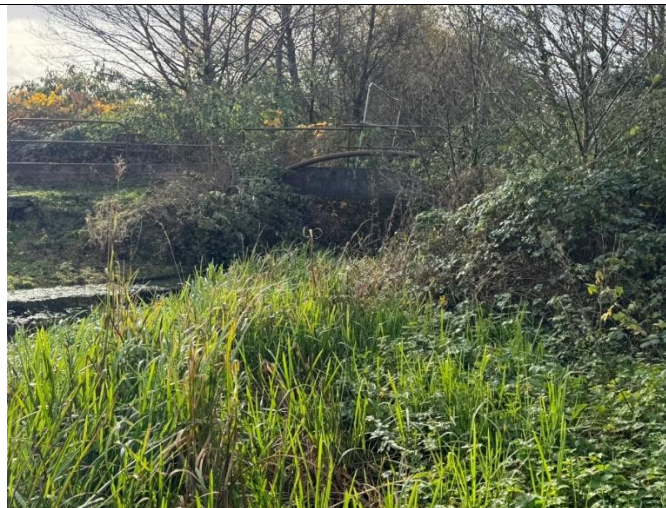
Image 11 – Pipe Bridge with some vegetation on side bank with path in good condition

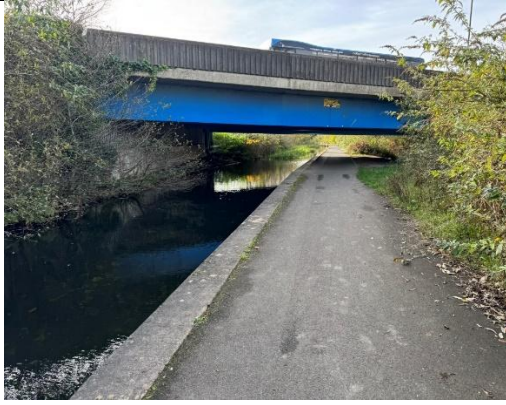
Image 20 – Link Road Bridge

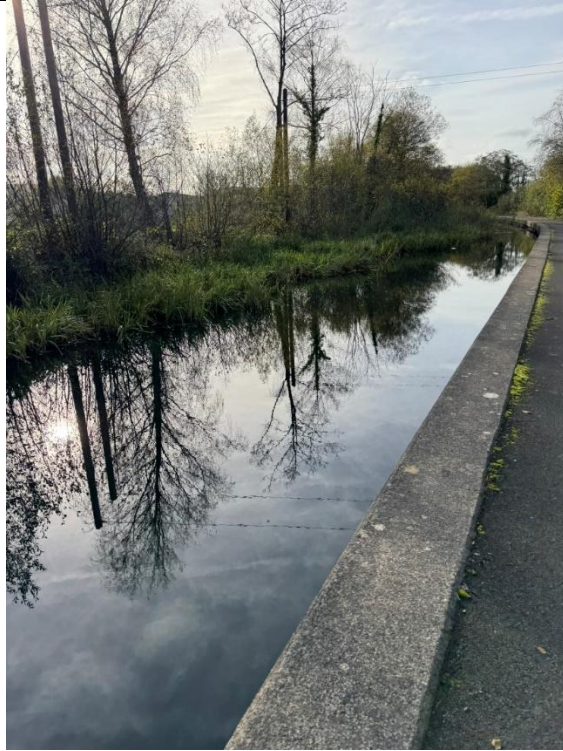
Image 21 – Link Road Bridge side view with path in good condition

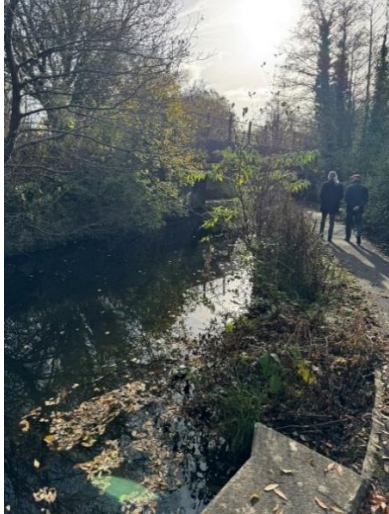
Image 22 – Canal in good condition near Link Road Bridge

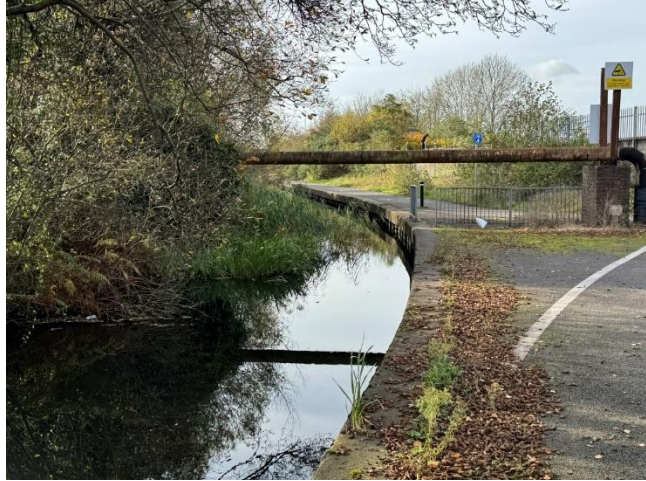
Image 23 – Section of the canal near Link Road Bridge with light vegetation on banks

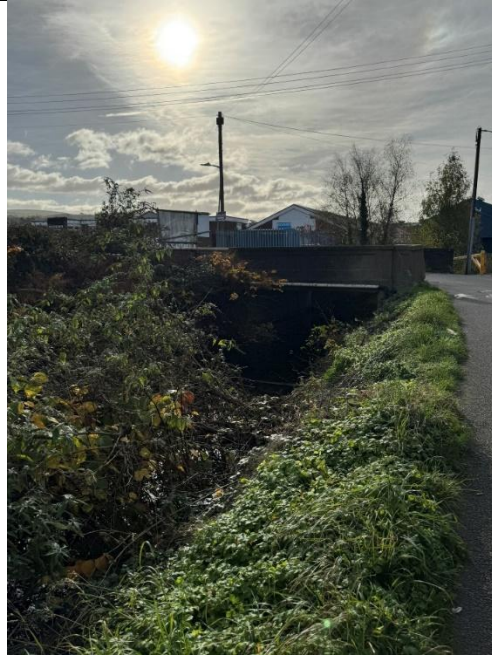
Image 25- Pipe Bridge footpath and canal in relatively good condition

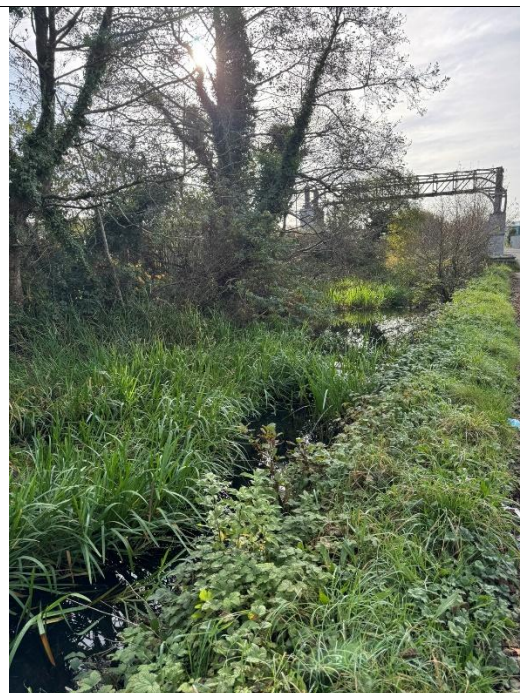
Image 27 – Canal section near Milland Road Bridge with trees overhanging

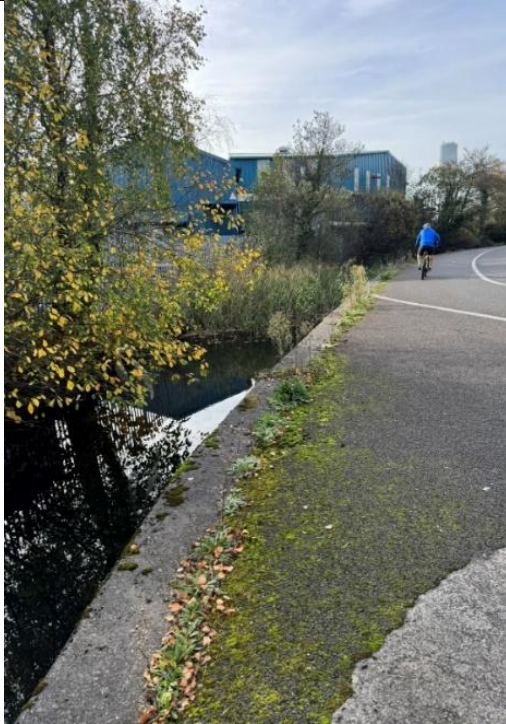
Image 28 – Pipe bridge with surrounding truss structure and overgrown canal

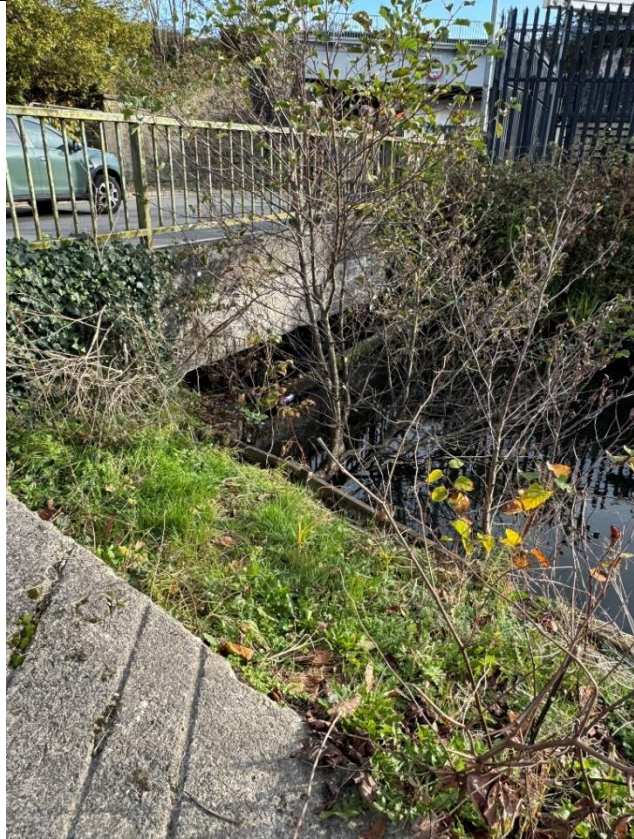
Image 29 – Canal section near Pipe Bridge clogged with reeds and overhanging tree

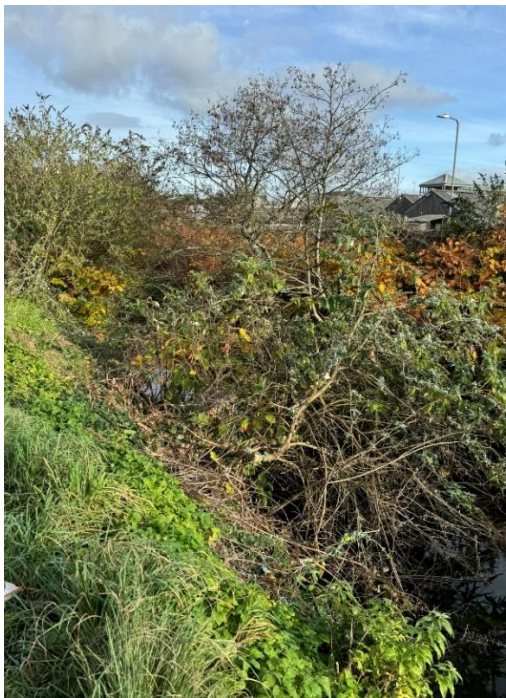
Image 30 – Bridge Street Bridge with low head room unsuitable for navigation

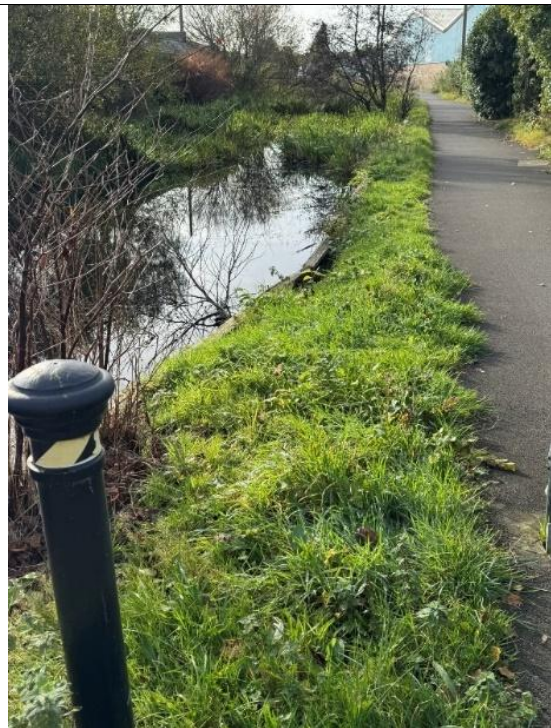
Image 31 – Bridge Street Bridge canal condition with large vegetation and trees overhanging water

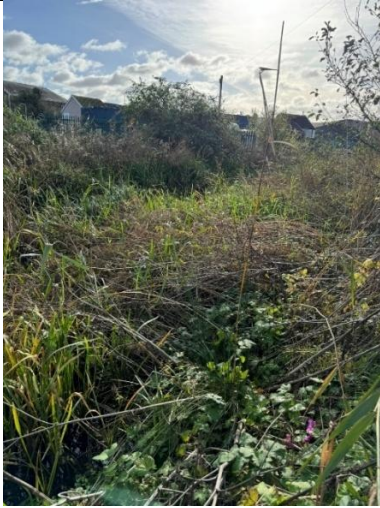
Image 32 – Bridge Street Bridge canal condition with rotten wood supporting canal embankment

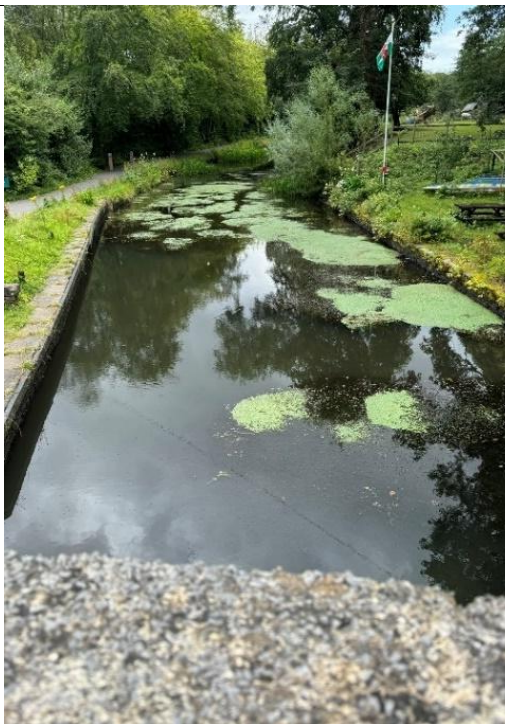
Image 34 – Canalside bridge with low vegetation on embankment

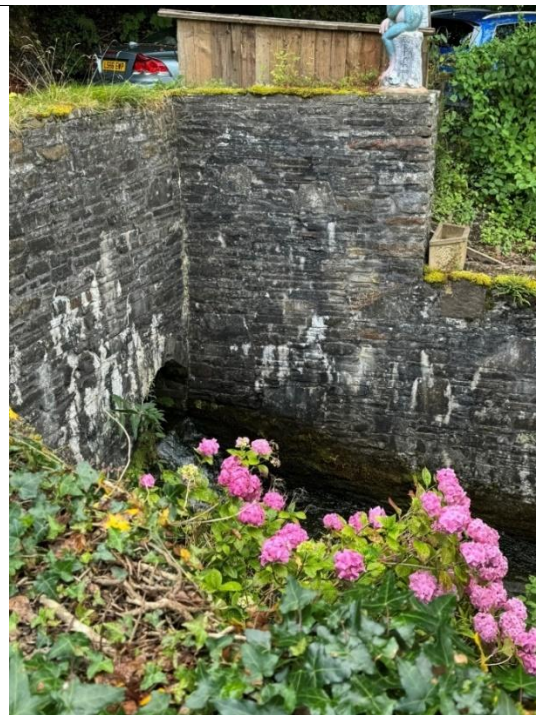
Image 35 – View from Tonna Lock Bridge with algal blooms in canal

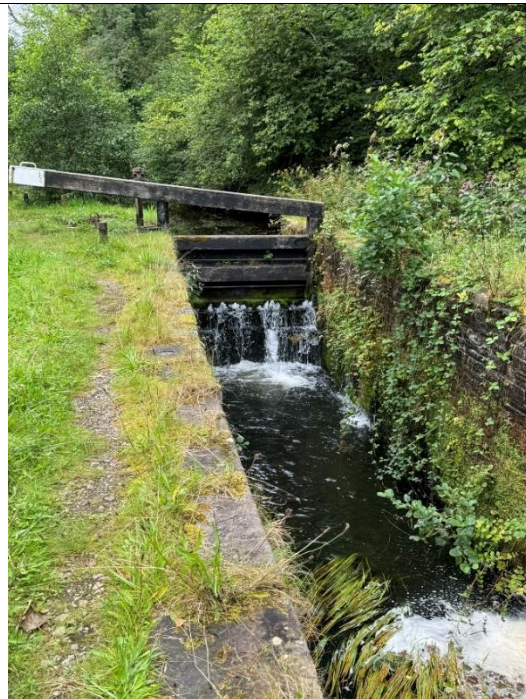
Image 51 – Lock Machin Bridge with buddleia growing on one abutment

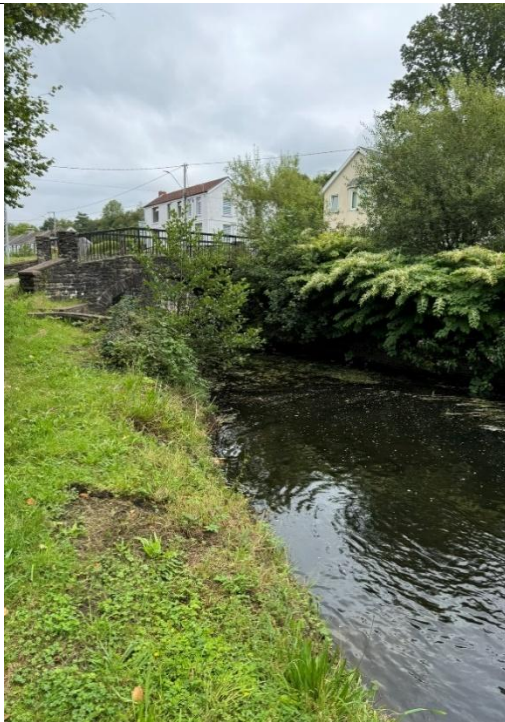
Image 58 – Spillway in footpath to River Neath near Ynysnedd Bridge

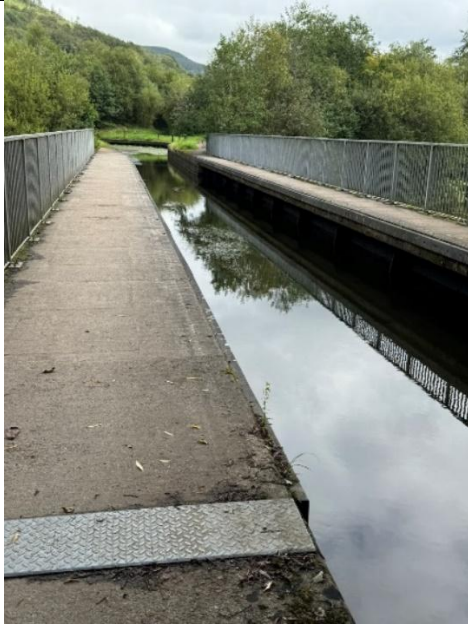
Image 68 – Ynysbwlllog Aqueduct with well-
maintained footpath

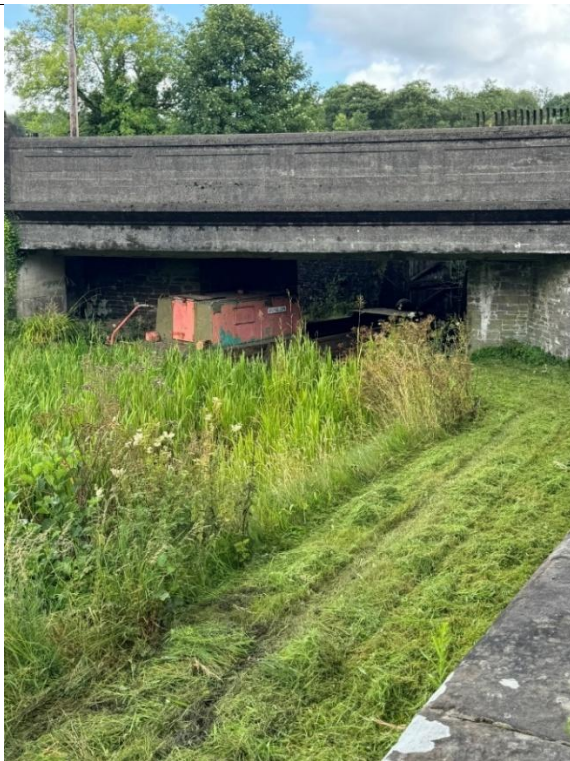
Image 2 – Aberdulais Lock currently inoperable

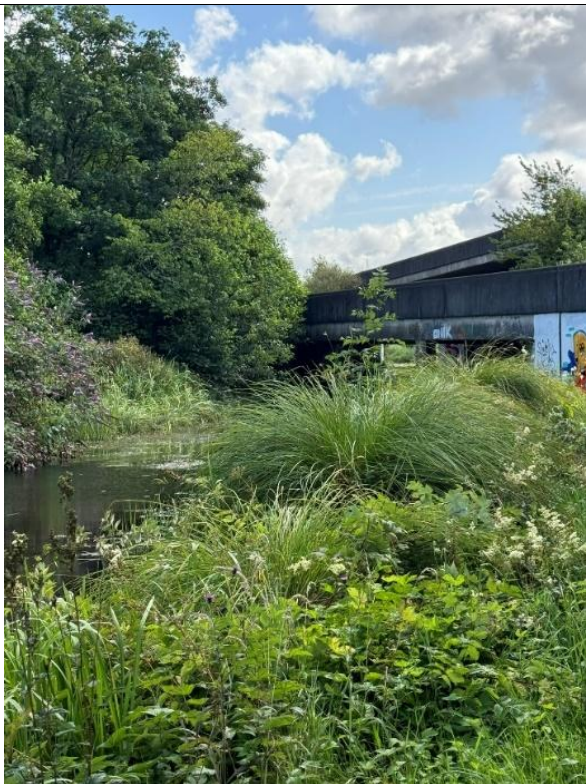
Image 14 - Bridge Street Bridge Canal section with small reeds on embankment.

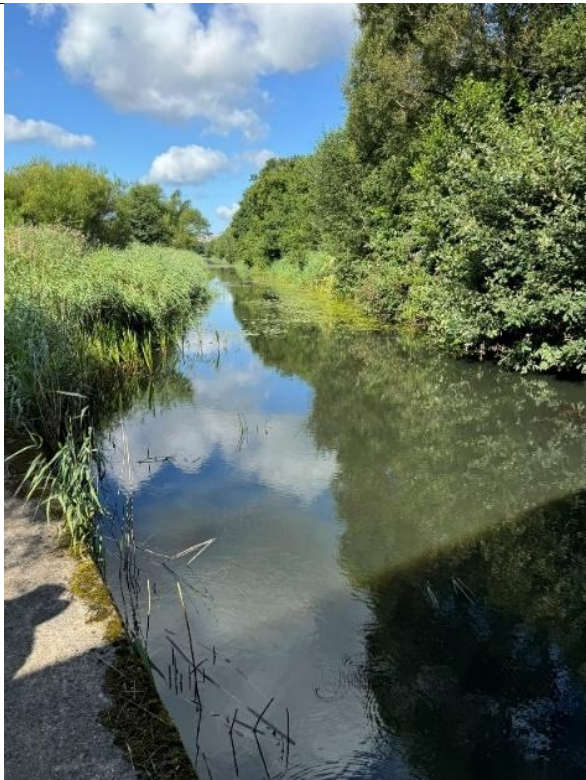
Image 18 – A465 approach bridge with narrow pedestrian path

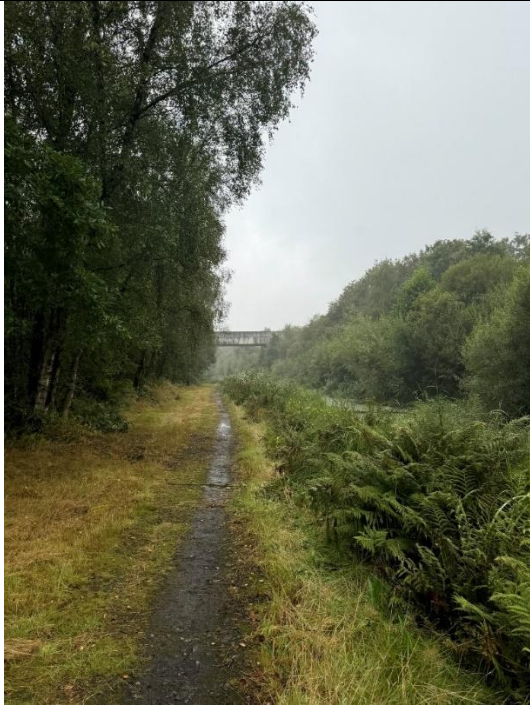
Image 36 – M4 Bridge canal section with minor footpath flooding

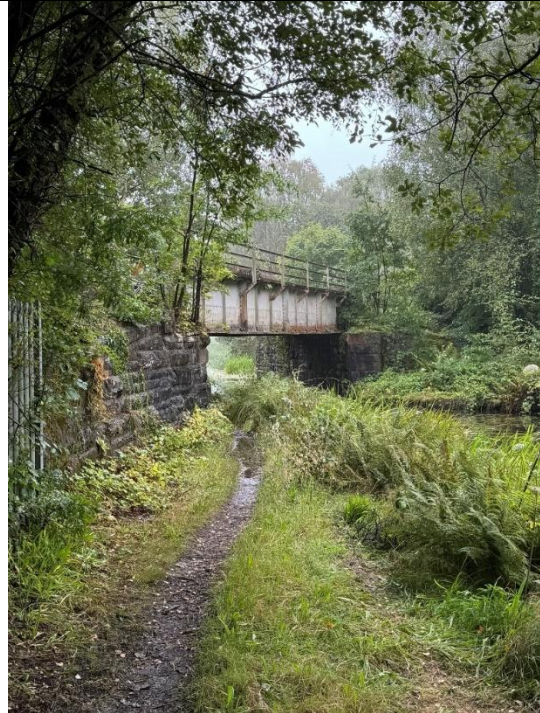
Image 37 – Gas works bridge with narrow footpath

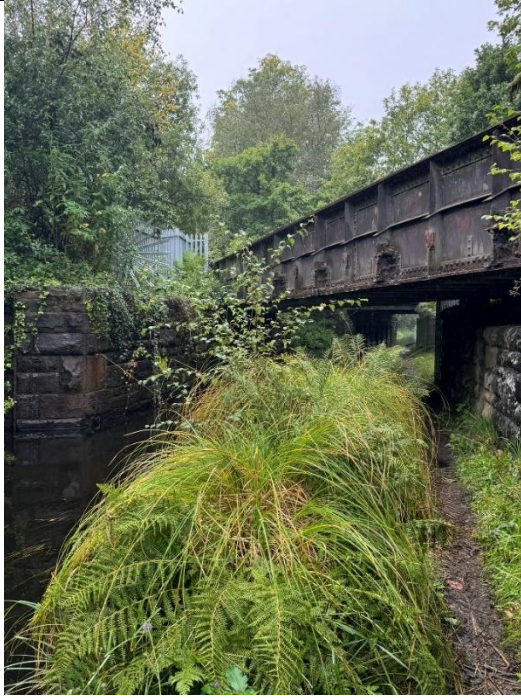
Image 40 – Quarry Bridge with shrubs on embankments

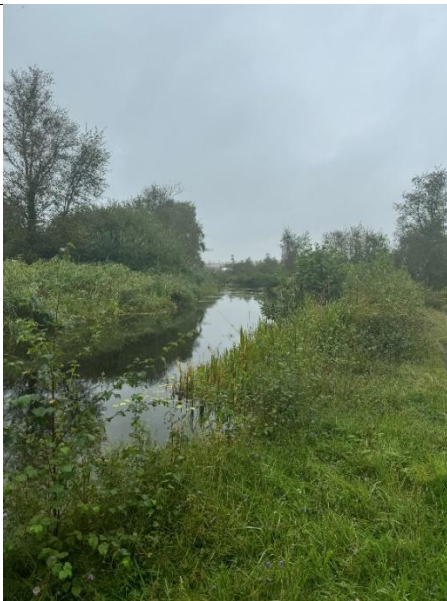
Image 42 – Jersey Marine Bridge with grassy shrubs surrounding

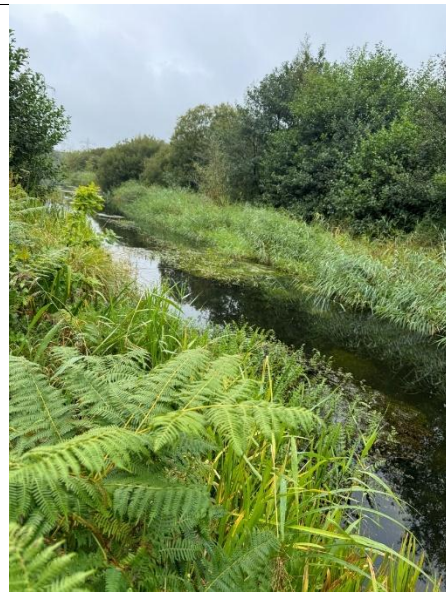
Image 43 - Jersey Marine Bridge canal section in moderately good condition
