<b>Coal Tip Name</b>	<b>Cwar Pentwyn Quarry / Cilmaengwyn</b>		<b>Tip Ref Number</b>	<b>T11695</b>		
			<b>Ownership Status</b>	<b>Private</b>		
<b>Located In</b>	<b>Godre'r Graig, Neath-Port Talbot</b>		<b>Tip Category</b>	<b>D</b>		
<b>Inspection Led By</b>		<b>Date of Inspection</b>	<b>09/09/2024</b>	<b>Date of last Inspection</b>	<b>08/11/2023</b>	
<b>Weather</b>	<b>Sun</b>		<b>Dry</b>		<b>Calm</b>	
<b>General Remarks</b> (e.g. access, limitations)	<p>Access to the site was gained via an access track situated just off Graig Road, which leads to Pentwyn Farm.</p> <p>It should be noted that this inspection was conducted without the benefit of a detailed site plan. Dense vegetation significantly limited accessibility and visual inspection. Therefore, instability within these areas could exist, but was not detectable at the time of the inspection. The location of the tip on privately owned land also limited the coverage of this inspection.</p>

<b>Coal Tip Name</b>	Cwar Pentwyn Quarry / Cilmaengwyn	Tip Ref Number	T11695
		Tip Category	D
Date of Inspection	09/09/2024	Inspection led by

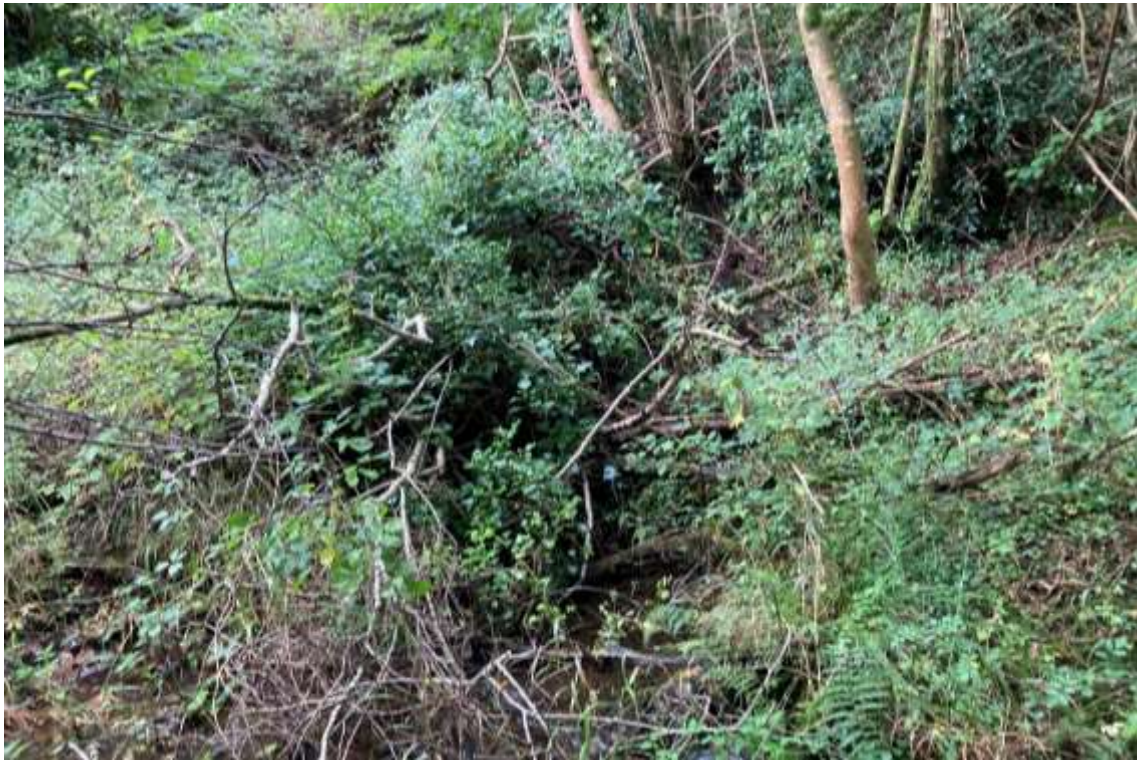
<b>Photo No.</b>	1	<b>Comment</b>	Adit located just to the south-west of the site boundary; associated with the 'Godre'r-Graig Higher / Pentwyn No. 3 Levels' coal tip.
------------------	---	----------------	---

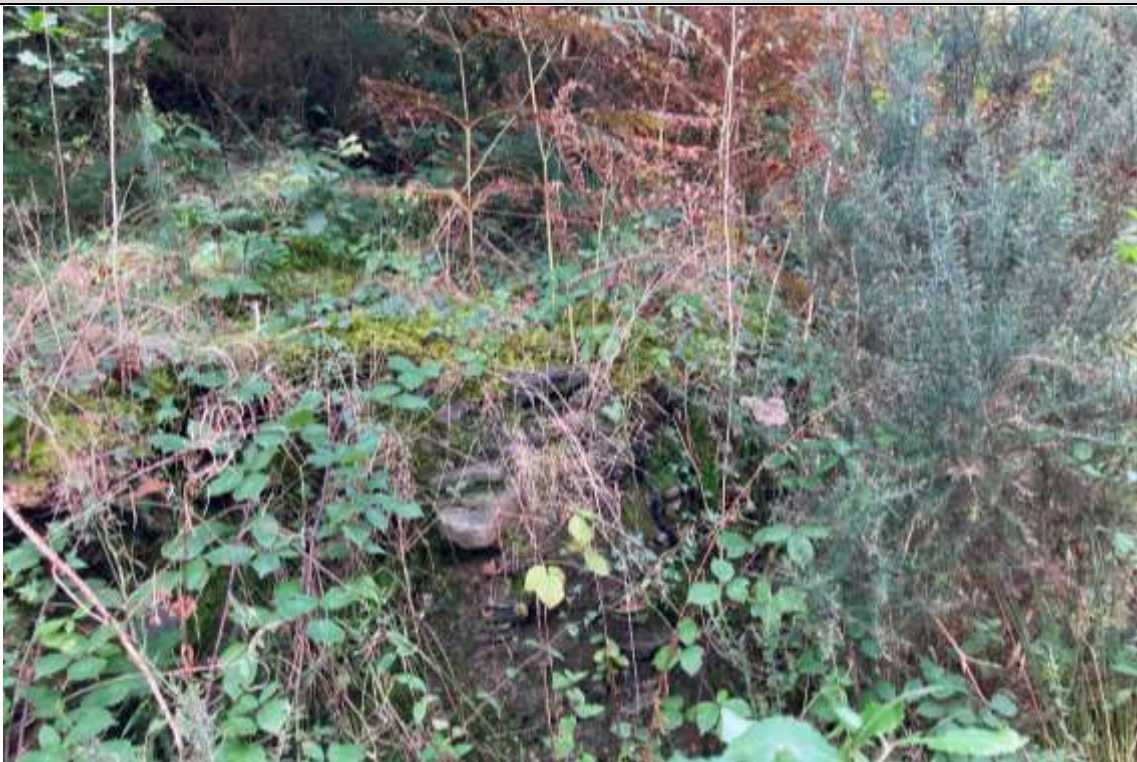
<b>Photo No.</b>	2	<b>Comment</b>	View looking towards a small exposure of sandstones, shales and clays; situated within the densely vegetated western extent of the site.
------------------	---	----------------	--

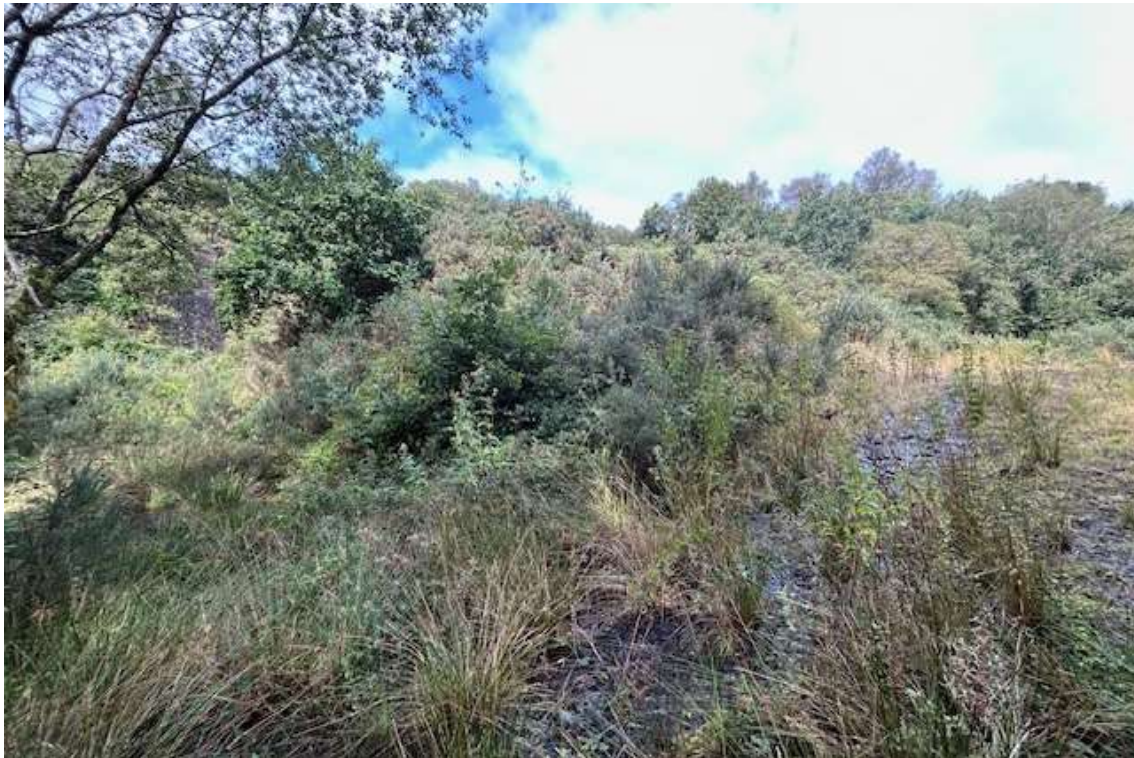
<b>Photo No.</b>	3	<b>Comment</b>	Flows convey towards the flat-lying ground/quarry floor, adjacent to the northern perimeter of the western section of the site.
------------------	---	----------------	---

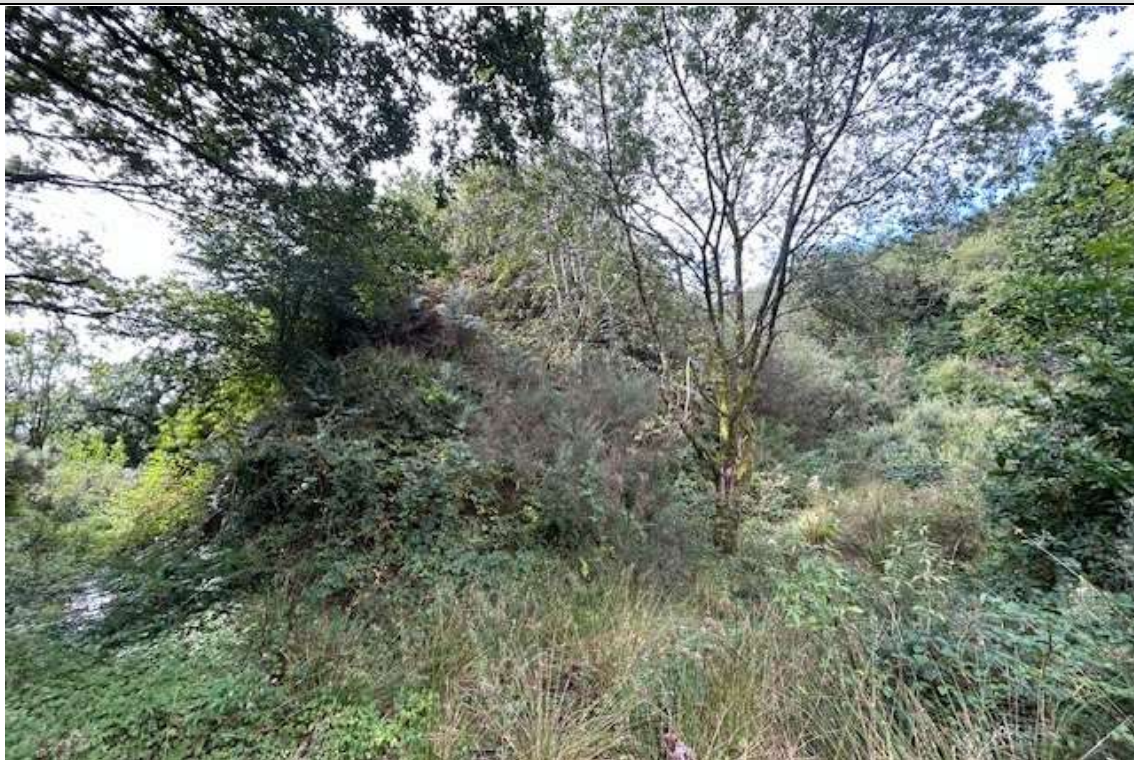
<b>Photo No.</b>	4	<b>Comment</b>	View looking towards the densely vegetated western extent of the site. Minor ponding and associated saturated ground conditions present.
------------------	---	----------------	--
