Coal Tip Name	Godre'r-Graig Higher / Pentwyn No. 3 Levels		UID	T42668	
Located in	Godre'r Graig, Neath Port Talbot		Tip Category	D	
Inspection Led by		Date of Inspection	19/02/2026	Date of last Inspection	18/07/2025
Weather	Overcast		Dry	Calm	
Comments on access and any limitations	<p>Access to the site gained via an access track situated just off Graig Road, which leads to Pentwyn Farm.</p> <p>It should be noted that this inspection was conducted without the benefit of a detailed site plan; whilst in certain areas vegetation limited accessibility and visual inspection. Therefore, instability within these areas could exist but was not detectable at the time of the inspection.</p>				
	Description				Status
RAG Status: Capital & Maintenance Works	Consider implementing appropriate drainage infrastructure to effectively capture the uncontrolled flows associated with the outfall of issues. Consider formalising/lining the flow pathway of the issues, to prevent further scouring (25/G/01/06).				2

Coal Tip Name	Godre'r-Graig Higher / Pentwyn No. 3 Levels	UID	T42668
		Tip Category	D
Date of Inspection	19/02/26	Inspection led by

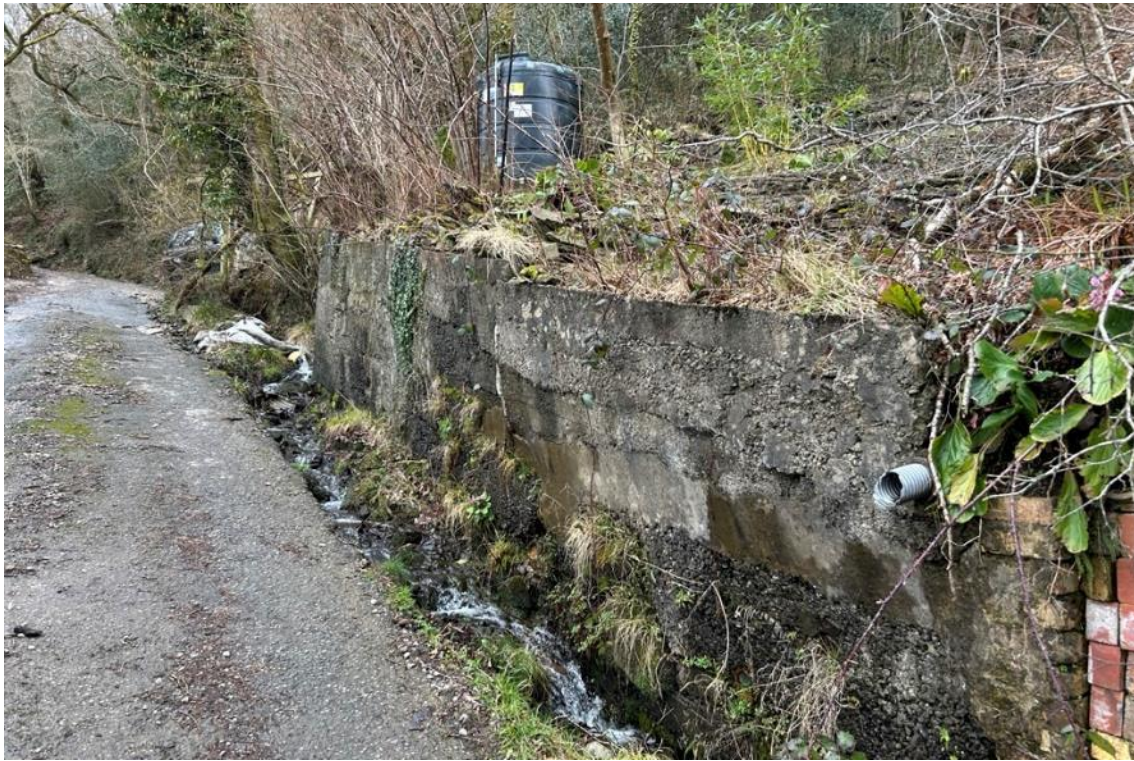
DRAINAGE				
ID	Feature	Location	Comment	Change to Condition (New, Worse, None or N/A)
25/D/01	Channel	E-274919, N-206774	An unlined trackside channel spans the upper section of the access track leading to Pentwyn Farm. This access track is significantly scoured in places, indicating that flows escape the trackside channel during heavy rainfall (Photo 1).	None

Photo No.	01	Comment	Scoured access track leading to Pentwyn Farm. Flows visible on RHS of image convey along an unlined, trackside channel just beyond the site perimeters. Flows convey along base of retaining wall.
Feature ID	25/D/01

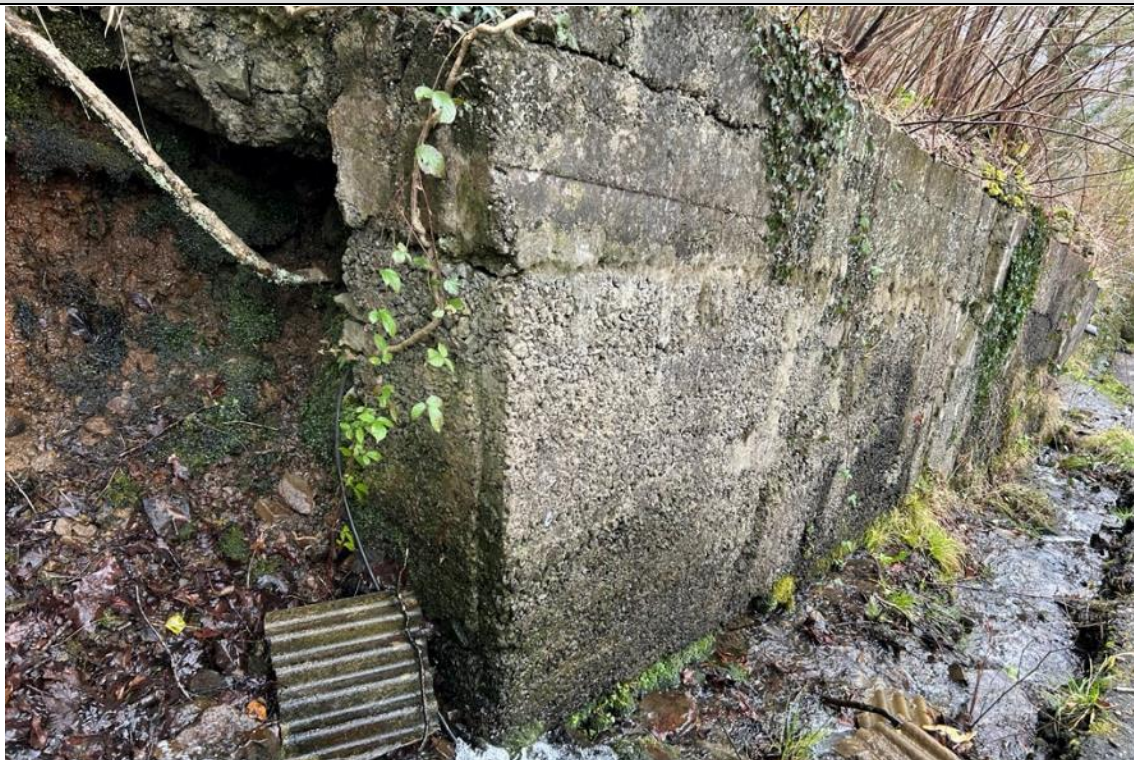
Photo No.	02	Comment	Minor seepages and saturated ground conditions observed adjacent to the retaining wall situated along the residential property of Glanderi, located just East of the site. This structure is in poor condition.
Feature ID	25/E/01

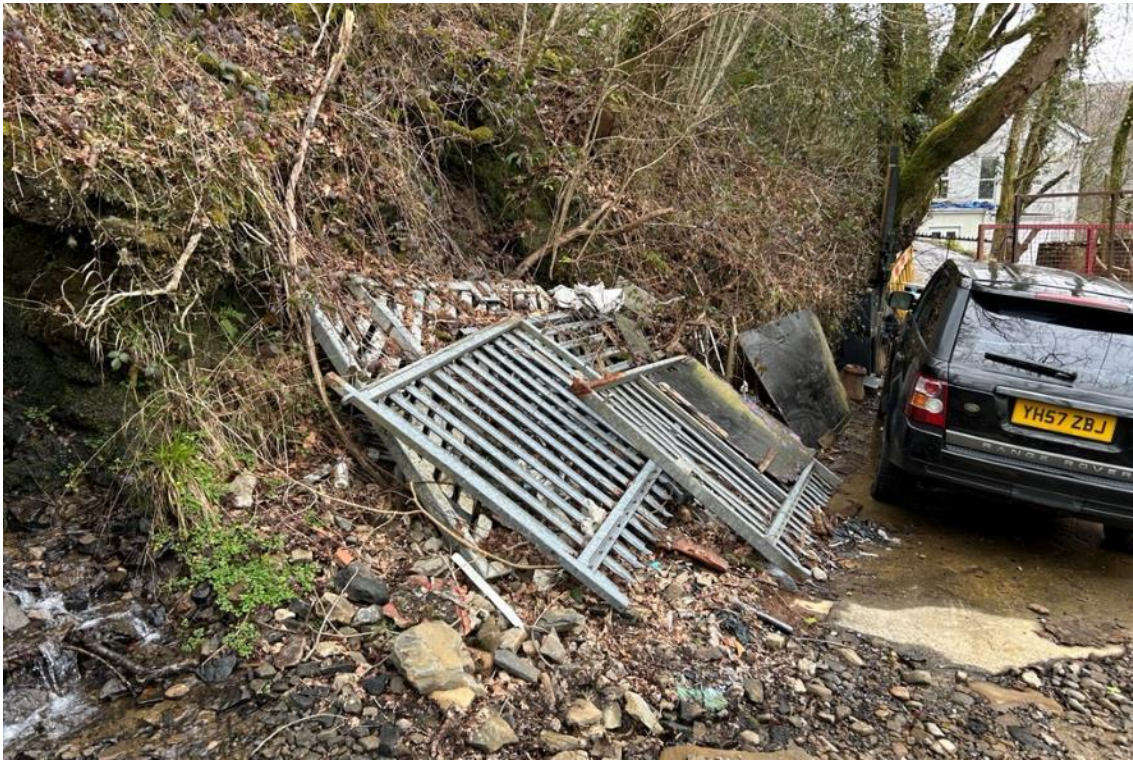
Photo No.	03	Comment	Pallets and other miscellaneous materials discarded below the outfall of flow path of issues which skirts the Eastern perimeter of the tip body. Materials sit on the driveway of the residential property Glanderri.
Feature ID	25/L/01

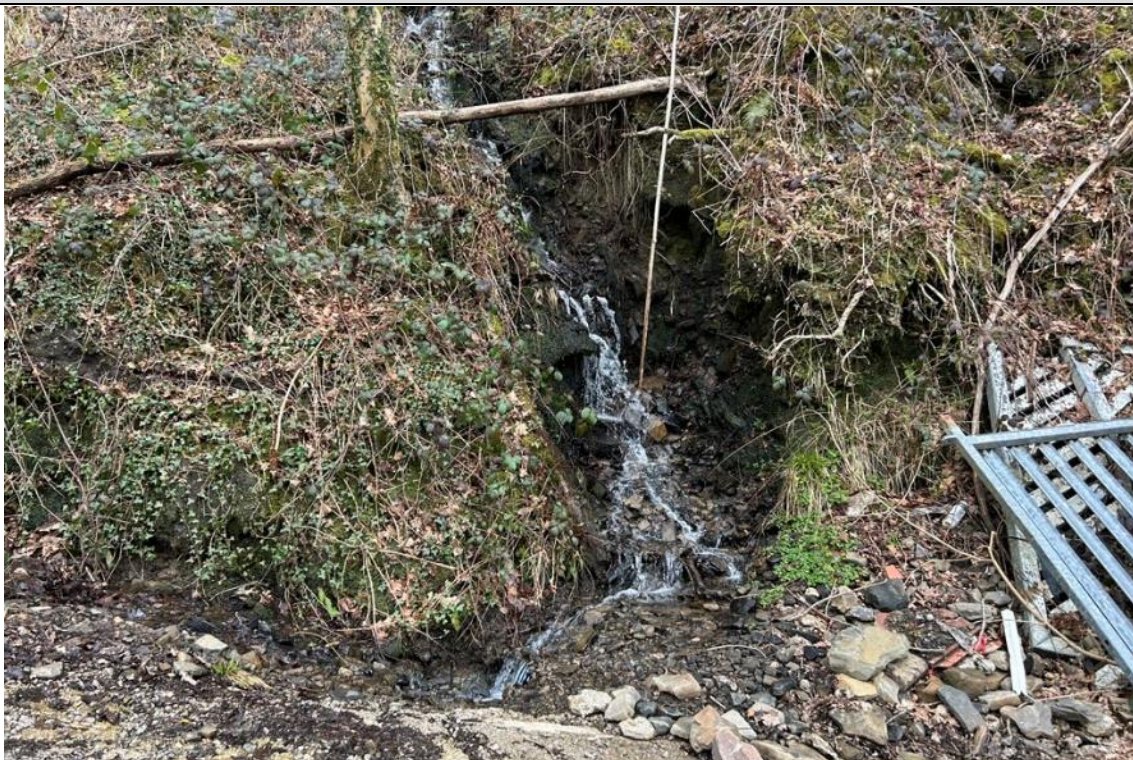
OBSERVATIONS				
GEOTECHNICAL				
ID	Feature	Location	Comment	Change to Condition (New, Worse, None or N/A)
25/G/01	Erosion	E-274886, N-206778	Minor erosion of natural ground noted at the outfall of the flow pathway of issues which skirt the Eastern perimeter of the tip body (Photo 4).	None
25/G/02	Slumping	E-274847, N-206774	A very small section of the toe of the tip has been subject to minor slumping, relating to a fallen, uprooted tree displacing a small amount of spoil material (Photo 5).	None
25/G/03	Minor Seepage	Toe of the Tip	Previously reported multiple, minor seepages emanating from the toe of the tip and conveying along the adjacent access track. At the time of inspection, no seepages were identified but it is assumed that they wax and wane depending on weather conditions (Photo 6).	None
25/G/04	Backscarp	E-274813, N-206763	Minor, arcuate backscarp approximately 5m in width located along the Western section of the toe of the tip, indicating the presence of a historical, superficial surface slip (Photo 7).	None

Photo No.	04	Comment	View looking towards the outfall of the flow path of issues which skirt the Eastern perimeter of the tip body located further upslope. A small amount of natural ground material has been eroded adjacent to the outfall.
Feature ID	25/G/01

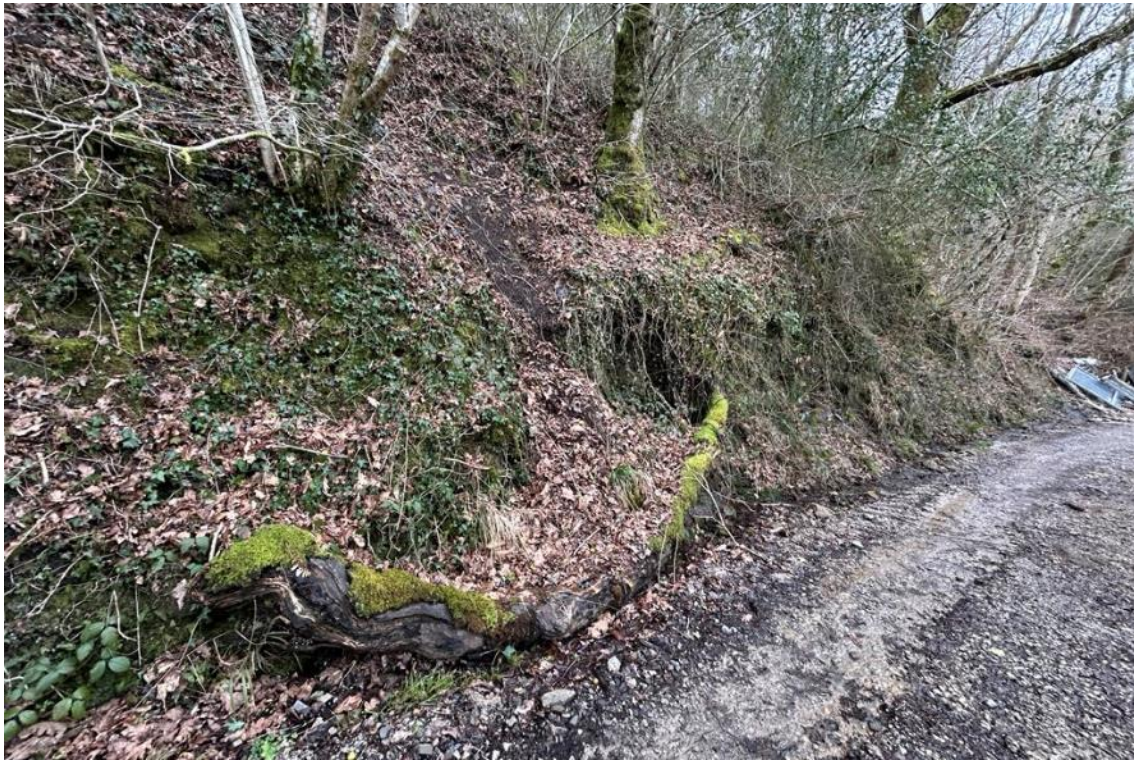
Photo No.	05	Comment	View from the access track which spans the toe, looking towards the small section of slumped material, likely associated with the uprooted tree visible at the base.
Feature ID	25/G/02

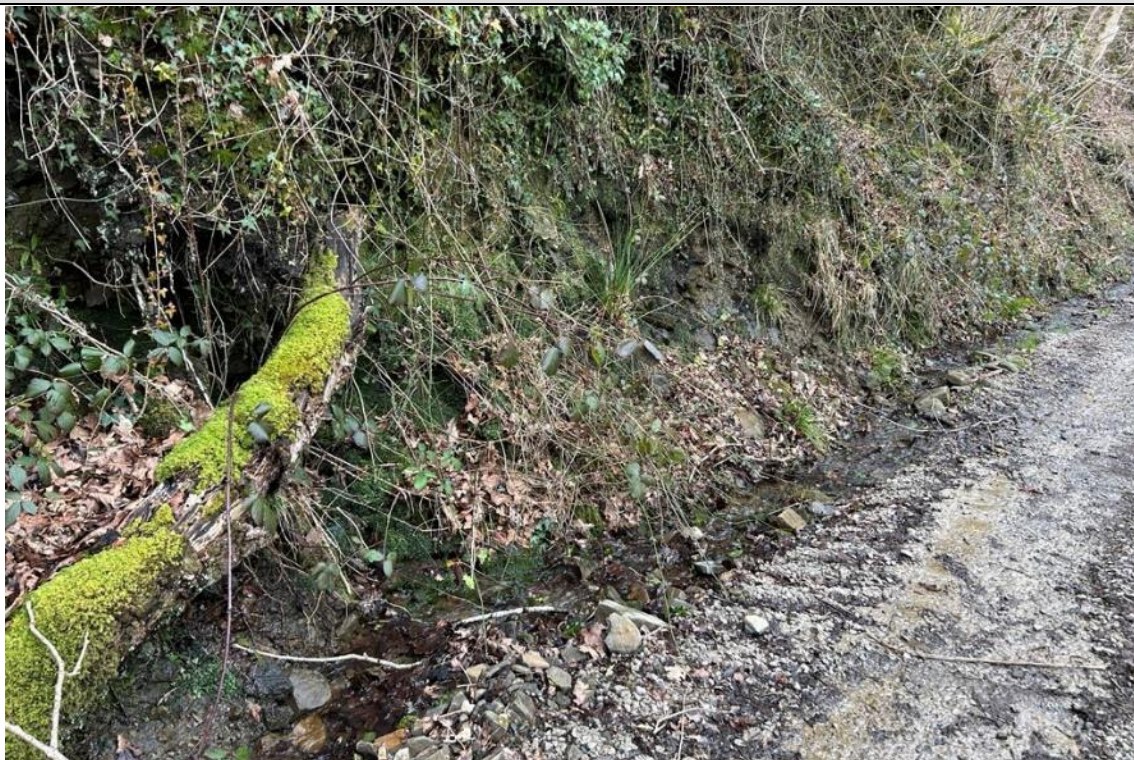
Photo No.	06	Comment	View from the access track, looking across the steep lower section and toe of the tip flank. Previously, multiple minor seepages have been identified along the toe, which wax and wane depending on weather conditions.
Feature ID	25/G/03

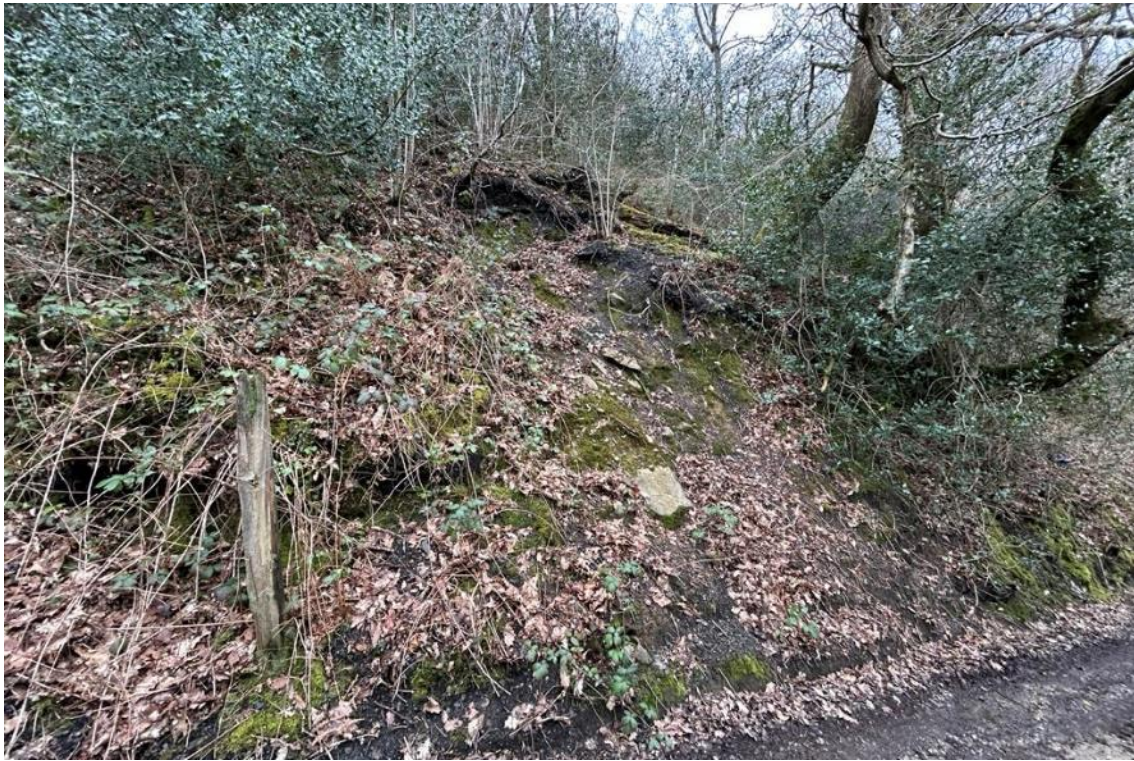
Photo No.	07	Comment	View from the toe, looking towards the minor, arcuate backscarp approximately 5m in width indicating the presence of a historical, superficial surface slip.
Feature ID	25/G/04

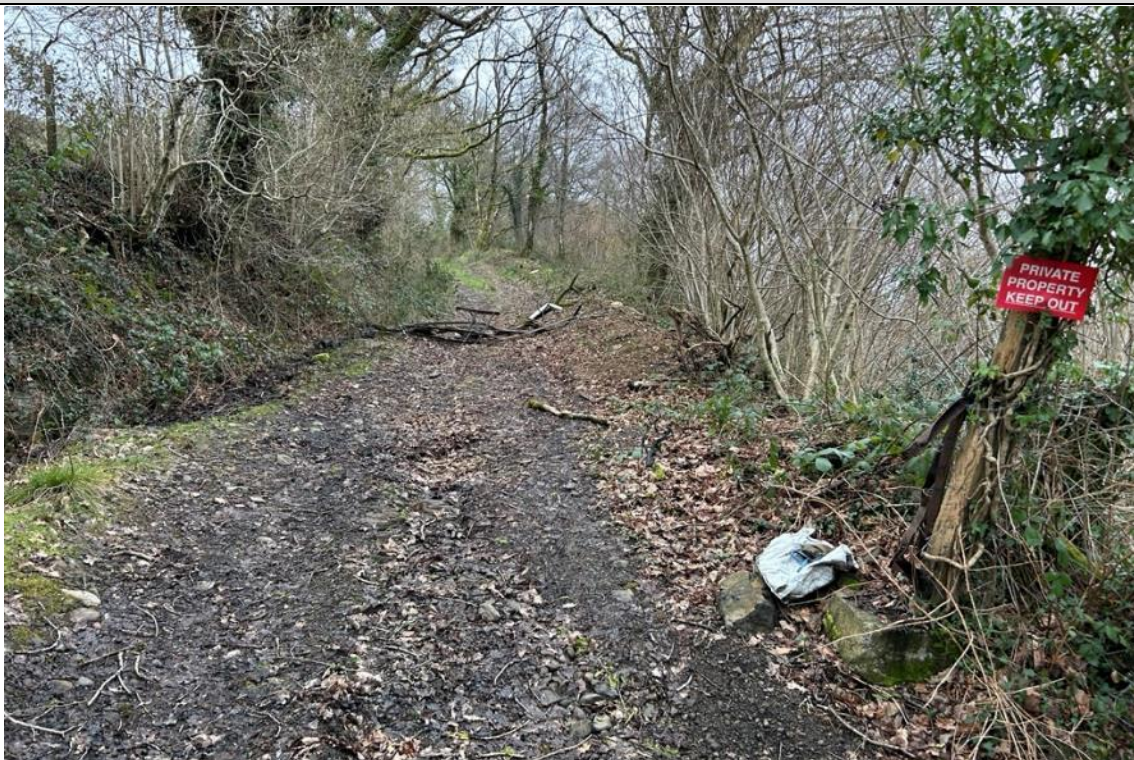
Photo No.	08	Comment	The temporary fencing at the entrance to the access track which climbs the Western site perimeter has fallen.
Feature ID	25/L/02

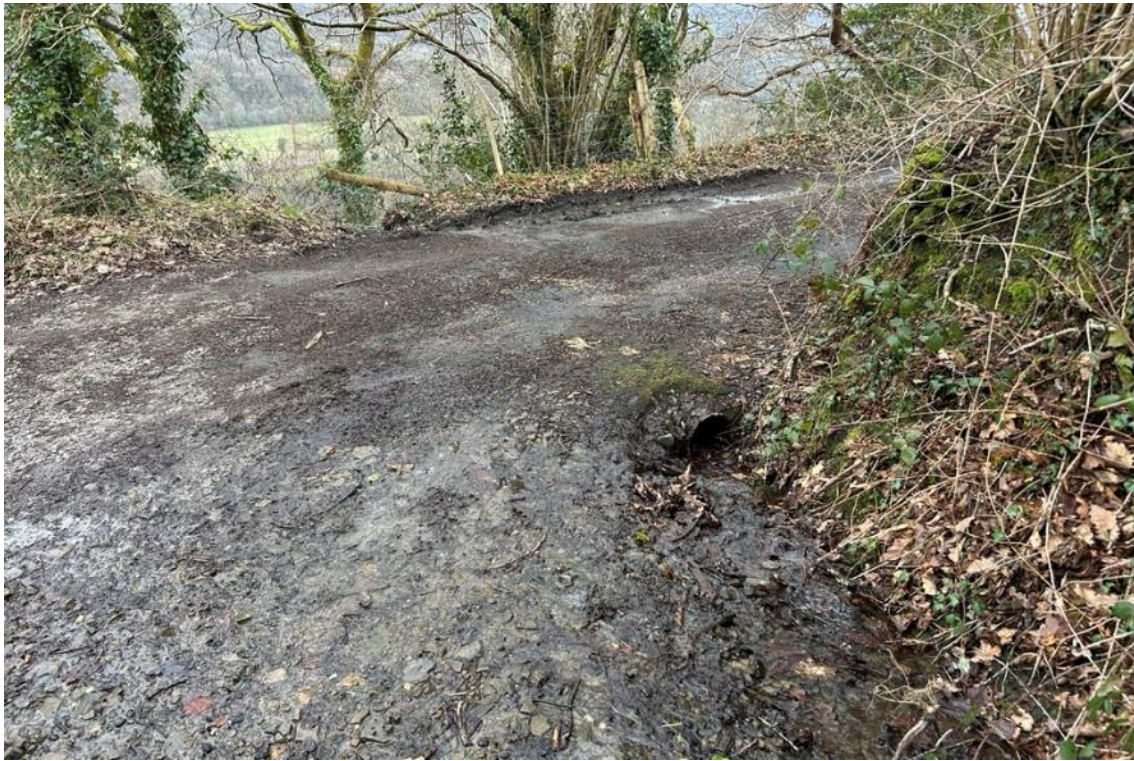
25/D/02	Culvert	E-274776, N-206736	Previously reported leaf litter obstructing flows from entering the trackside drain, located adjacent to the access track which spans just off the Western site perimeter. Leaf litter has since been removed (Photo 9).	N/A
Recommendations			N/A	
ENGINEERING INFRASTRUCTURE				
ID	Feature	Location	Comment	Change to Condition (New, Worse, None or N/A)
25/E/01	Retaining Wall	E-274907, N-206777	The retaining wall located along the property of Glanderri (located just east of the site) is in poor condition, with multiple minor seepages emanating from cracks/voids within the structure. Flows conveying along the base of this structure and enter an unlined, trackside channel. This has resulted in minor saturation along the base of the retaining wall (Photo 2).	None
Recommendations			Continue to monitor the condition of the retaining wall structure associated with the residential property of Glanderri for a deterioration (25/E/01).

Photo No.	09	Comment	Trackside drain, located adjacent to the access track which spans just off the Western site perimeter is no longer obstructed by leaf matter.
Feature ID	25/D/02

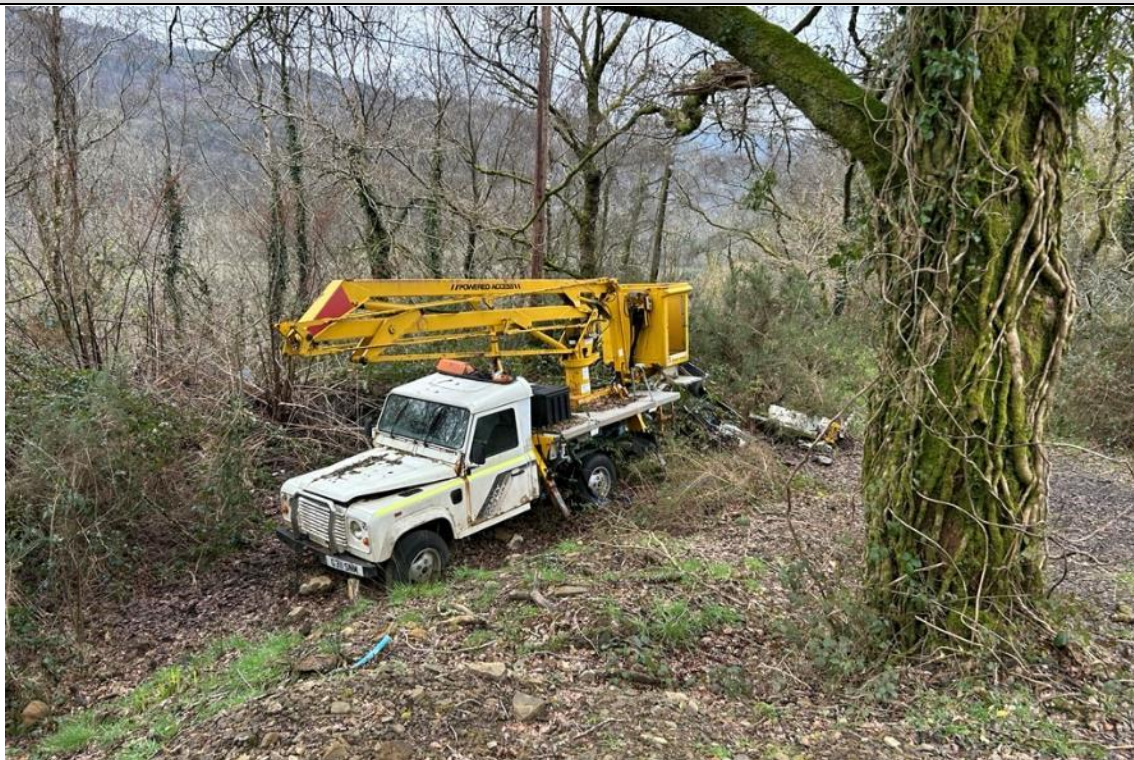
Photo No.	10	Comment	Disused plant vehicle and associated equipment discarded on the north-western section of the tip plateau.
Feature ID	25/L/03

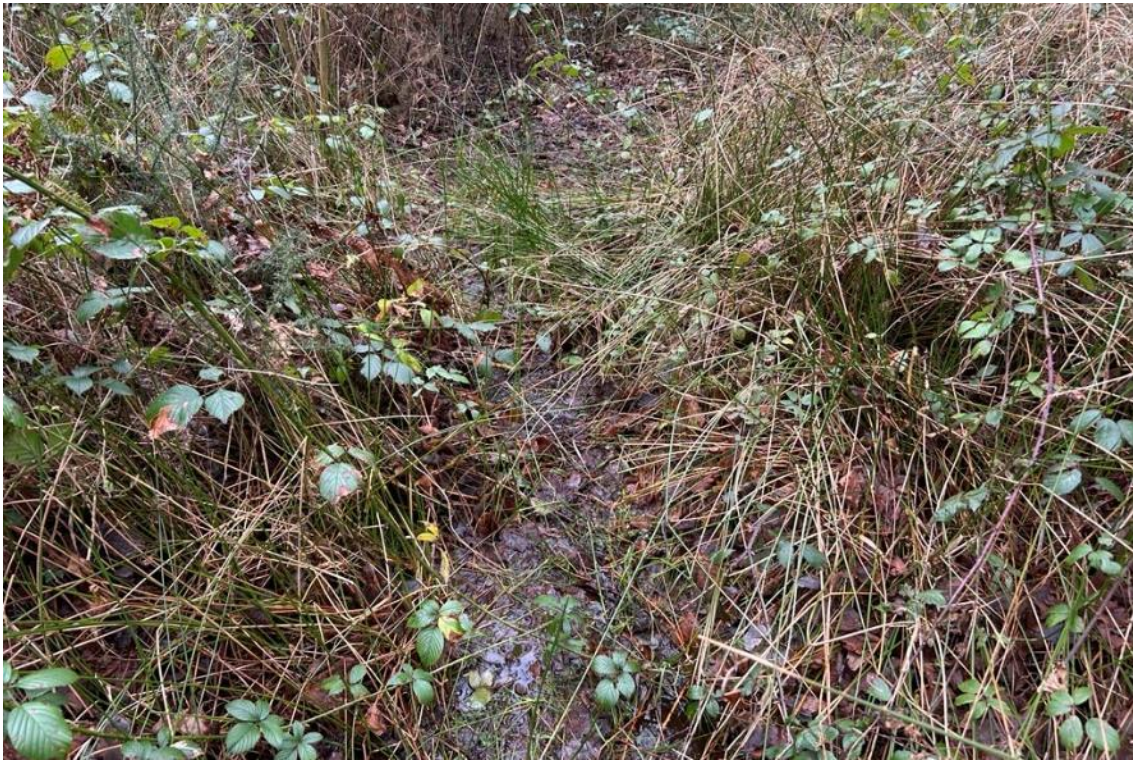
25/G/05	Saturated Ground	E-274845, N-206825	Saturated ground conditions marked by reed growth and minor ponding observed along the upper, north-eastern section of the tip body. This is a longstanding feature of the site (Photo 11).	None
25/G/06	Erosion	E-274853, N-206816	Minor erosion of the tip body by the flow pathway of issues which skirt a small section of the Eastern site perimeter. Flows emanate from the natural ground hillside to the rear, which presumably contains historic mine entries. Flows outfall from this pathway adjacent to the residential property of Glanderri, as displayed in image 4 (Photo 12-13).	None
Recommendations			Consider implementing appropriate drainage infrastructure to effectively capture the uncontrolled flows associated with the outfall of issues. Consider formalising/lining the flow pathway of the issues, to prevent further scouring (25/G/01/06).	
			Consider the feasibility of implementing a retaining structure along the base of flank/toe of the tip, as it directly abuts an access track (25/G/02-03).

Photo No.	11	Comment	Saturated ground conditions marked by reed growth and minor ponding observed along the upper, north-eastern section of the tip body.
Feature ID	25/G/05

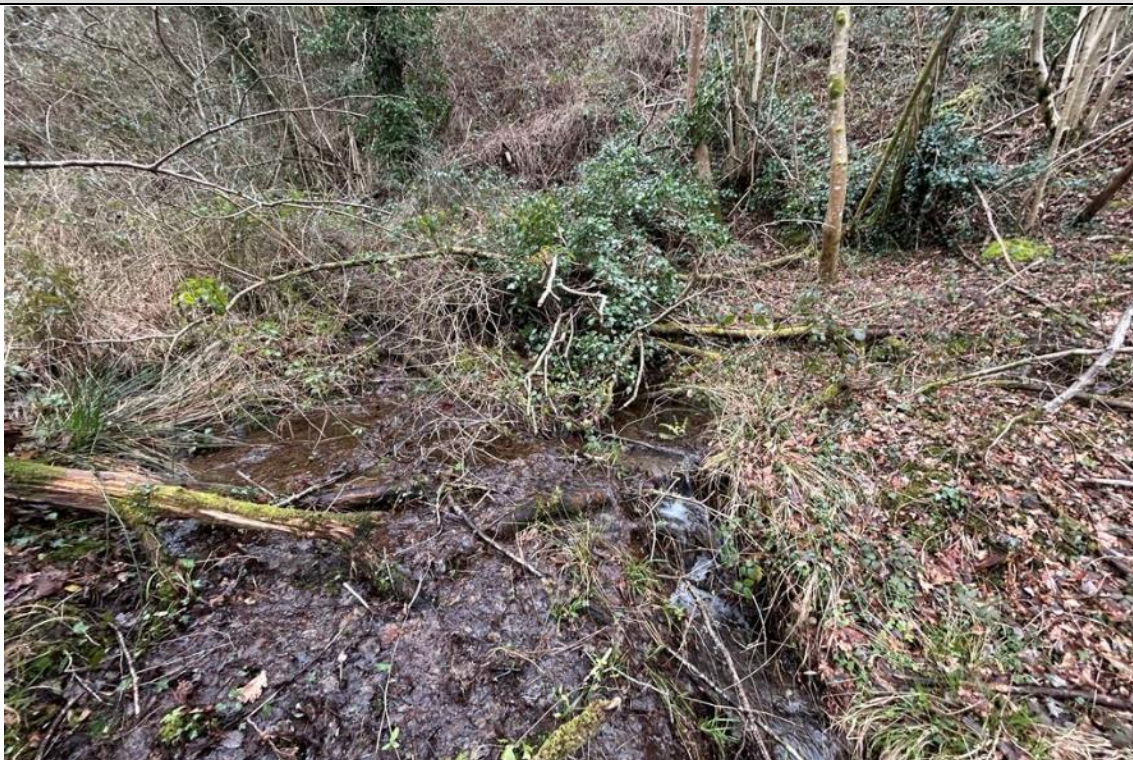
Photo No.	12	Comment	A moderate levels flows emanating from the hillside to the rear of the upper, north-eastern section of the site and potential historic mine entries convey along a partial length of the Eastern site perimeter, before conveying further downslope.
Feature ID	25/G/06

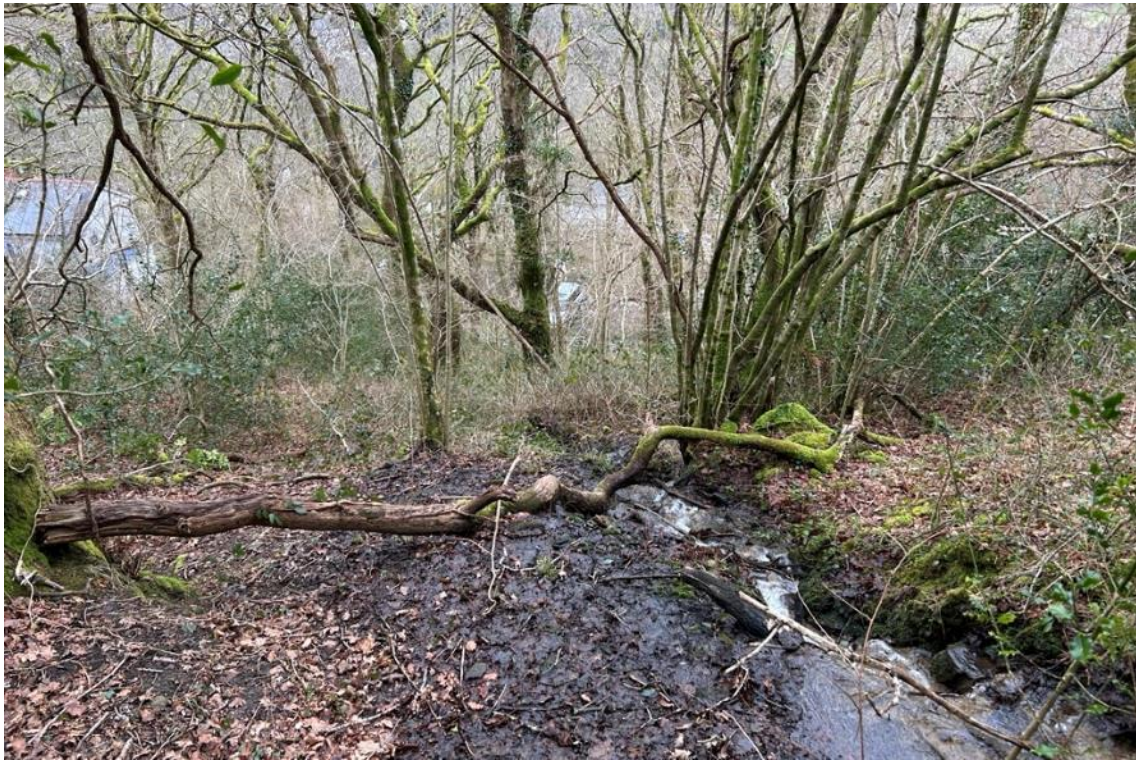
Photo No.	13	Comment	Flow pathway of issues which skirt a small section of the Eastern site perimeter, resulting in minor erosional scour.
Feature ID	25/G/06

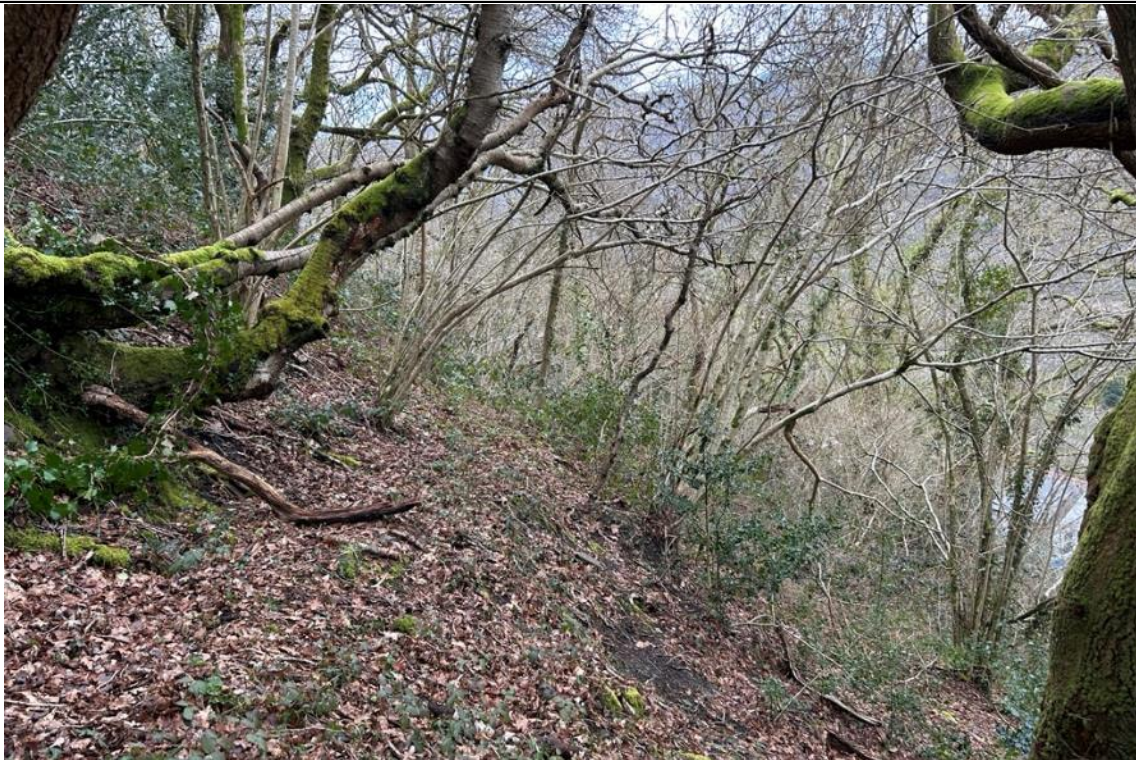
Photo No.	14	Comment	View from the upper slope, looking across the well-wooded tip body.
Feature ID	25/L/04

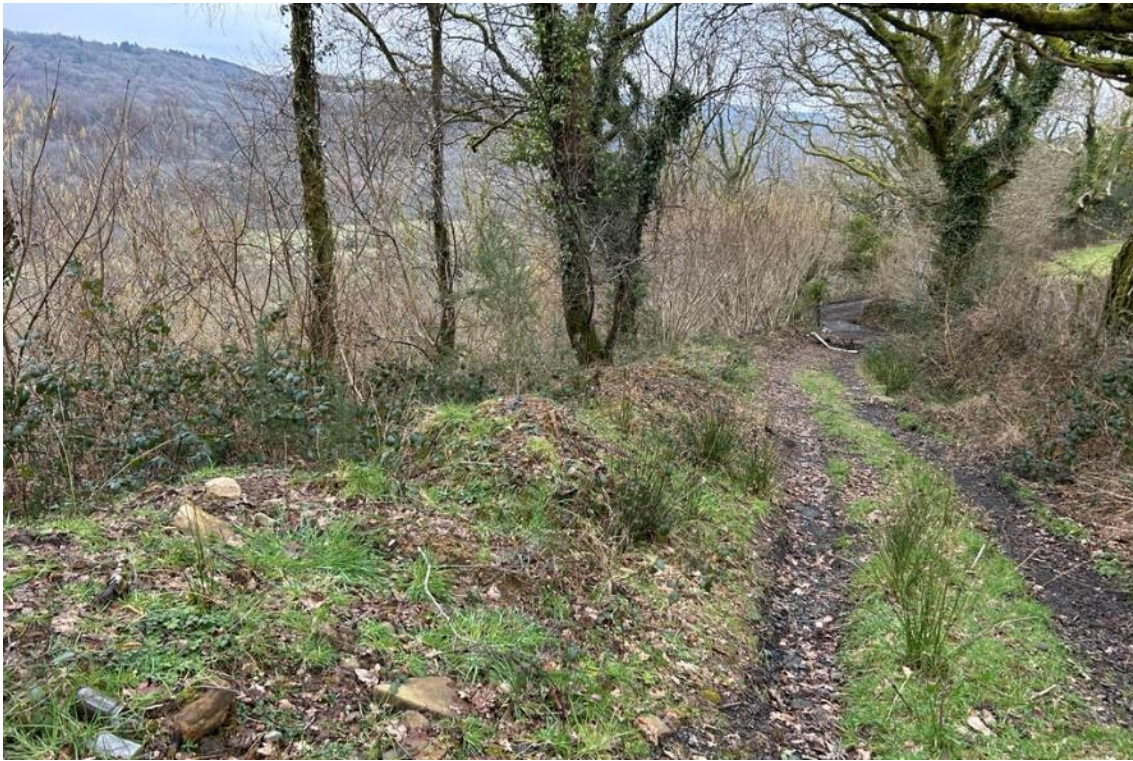
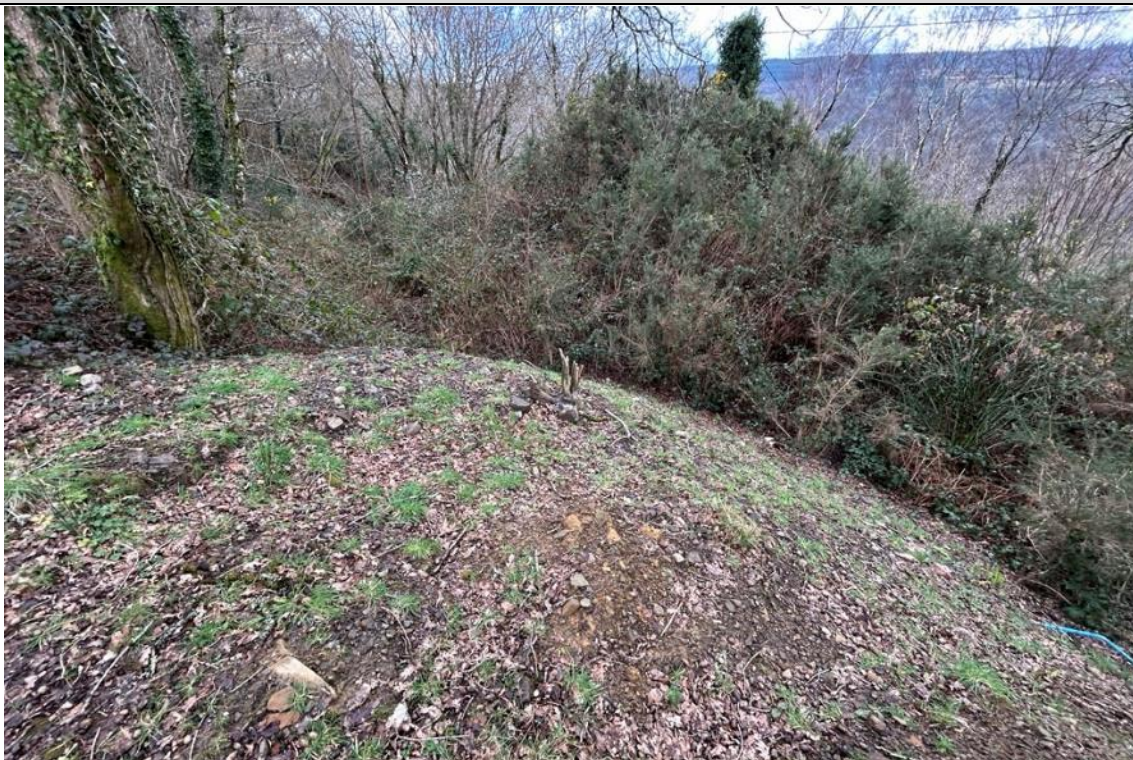
to the upper section of the site is overgrown, which may result in future accessibility issues.	
25/L/05	Deposition	E-274824, N-206804	Bund of natural ground material deposited along the tip crest at the NW section of the site, adjacent to the access track which skirts the rear of the site. A larger quantity of natural ground material has been deposited further along the access track. Observation noted in Summer 2025. The origin of this material is unknown but does not appear to have been removed from within the site boundaries (Photo 15-16).	None
26/L/06	Other - Tree	E-274822, N-206770	Large, mature tree protruding from tip flank and overhanging the single lane access track below the site - potentially unstable. Recommended removal (Photo 17).	New
Recommendations			Desist from depositing natural ground material along the tip crest, as continued tipping has the potential to lead to structural instability across the slope below (25/L/05). Consider removing the mature tree which overhangs the single lane access track below the site (26/L/06).

Photo No.	15	Comment	Shallow bund of natural ground material deposited along the NW section of tip crest, adjacent to the access track which spans to the rear of the site. This observation was made during the last inspection. No further tipping observed.
Feature ID	25/L/05

Photo No.	16	Comment	Larger quantity of natural ground material tipped to the rear of the tip crest, adjacent to the access track which spans to the rear of the site. no further tipping observed since initial observation in Summer 2025.
Feature ID	25/L/05

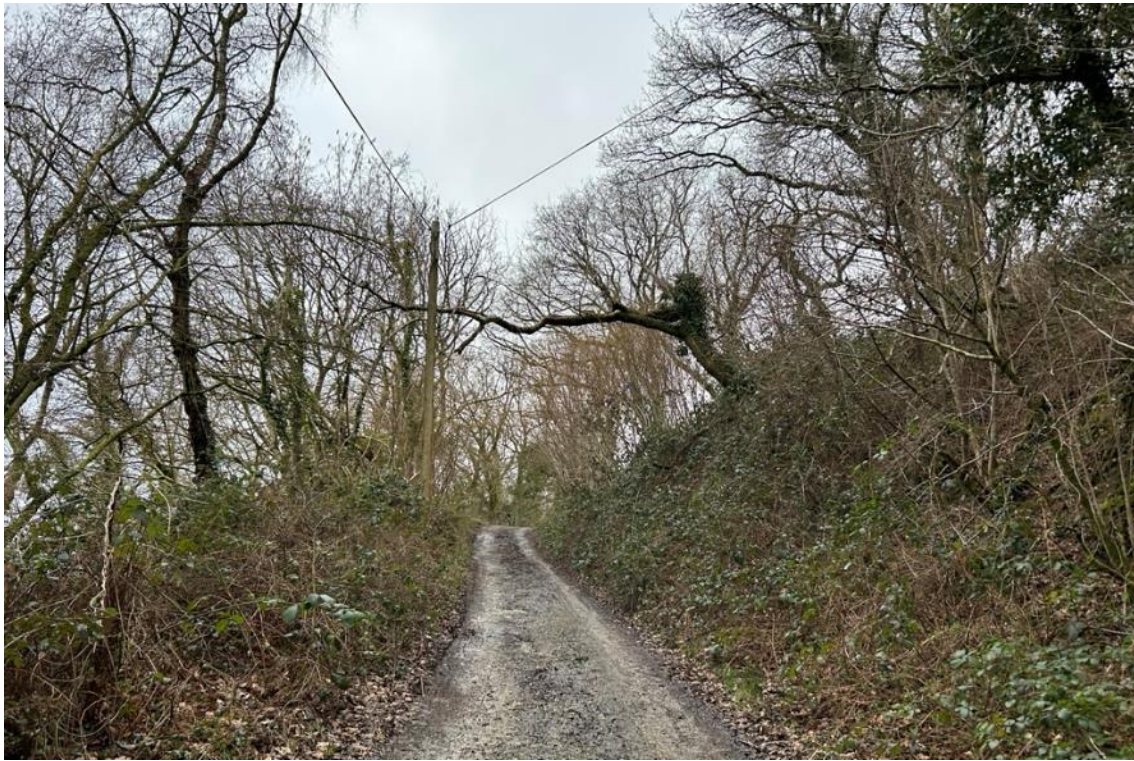
Photo No.	17	Comment	Large, mature tree overhanging the single lane access track below the site - potentially unstable.
Feature ID	26/L/06

Consider removing the mature tree which overhangs the single lane access track below the site (26/L/06).				
	Desist from depositing natural ground material along the tip crest, as continued tipping has the potential to lead to structural instability across the slope below (25/L/05).				2
	Consider the feasibility of implementing a retaining structure along the base of flank/toe of the tip, as it directly abuts an access track (25/G/02-03). Continue to monitor the condition of the retaining wall structure associated with the residential property of Glanderri for a deterioration (25/E/01).				3
General Remarks	<p>An elongated lobe of colliery spoil material orientated north-east to south-west, formed by traditional loose-end tipping practice. The tip has been constructed with a plateau and a well-vegetated, steeply-sloping south-east facing flank. An access track abuts the toe of this flank. Most notably, issues emanating from the natural hillside to the rear of the site (which potentially contains historical mine entries) convey along the natural ground hillside just East of the site and skirt a partial length of the Eastern site perimeter, resulting in minor erosion via scour. These flows outfall at the access track at the toe of the tip resulting in instances of erosional scour along the access track, as the unlined trackside channel is ineffective in conveying flows. Just East of the toe of the tip, the residential property of Glanderri is located. The outfall of issues is located just off the driveway of the property, which has resulted in localised saturated ground conditions. The retaining wall associated with this property is also in poor condition,</p>
