| Coal Tip Name | Cwar Pentwyn Quarry / Cilmaengwyn | | UID | T11695 | |
| Located in | Godre'r Graig, Neath-Port Talbot | | Tip Category | D | |
| Inspection Led by | | Date of Inspection | 19/02/2026 | Date of last Inspection | 18/07/2025 |

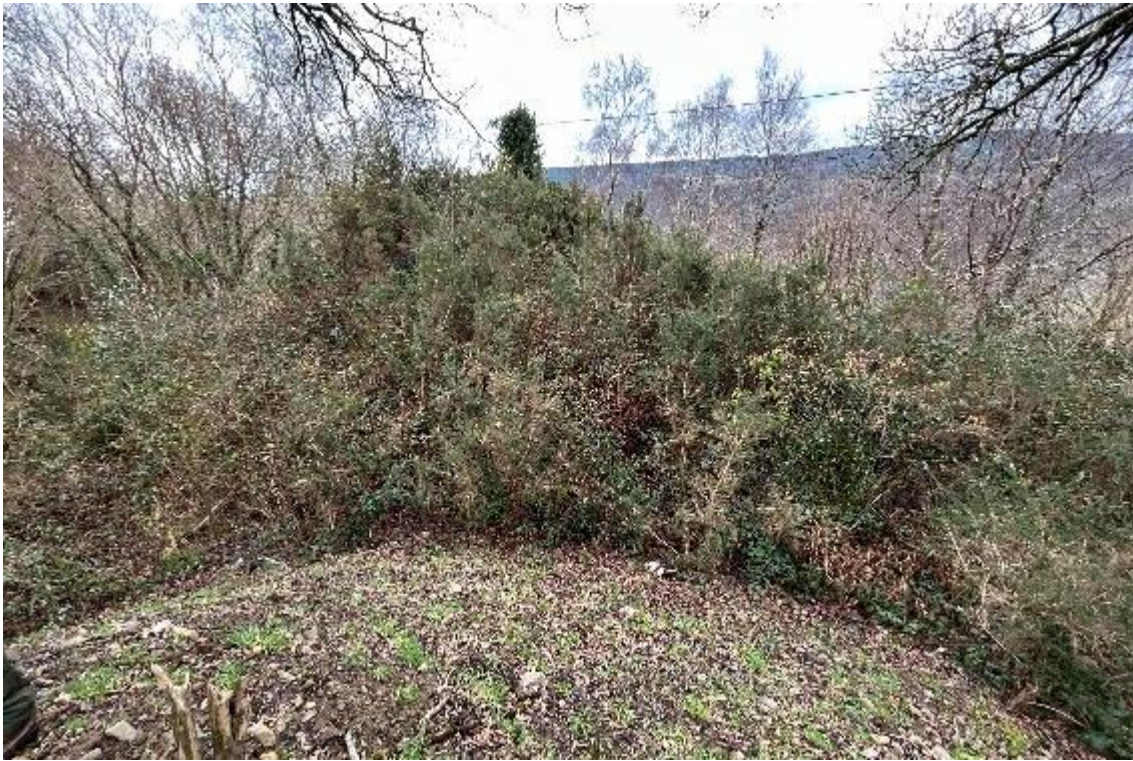
| 25/L/03 | Land Use | E – 274880 N - 206890 | Previously noted quarrying activity; with machinery and mounds of excavated material present. Sandstone quarry waste material has been deposited on the north-eastern section of 'Godre'r Graig Higher / Pentwyn No. 3 Levels' coal tip, located just downslope (approx. 50 m). Further, previously noted excavated material has been tipped here, however no obvious evidence of further quarrying activity was identified on the site. | No Change |

| Photo No. | 1 | Comment | Sandstone quarry waste material deposited on the north-eastern section of 'Godre'r Graig Higher / Pentwyn No. 3 Levels' coal tip, located just downslope. |
| Feature ID | 25/L/03 | | |

| Recommendations | | | <ul style="list-style-type: none"> - Consider conducting targeted vegetation clearance to improve accessibility and visual inspection. - Investigate ownership of the site and establish what measures, if any, have been taken with regard to placing recent materials over historic spoil. - Investigate activity within Cwar Pentwyn to establish if planning or quarry regulations have been breached. | |

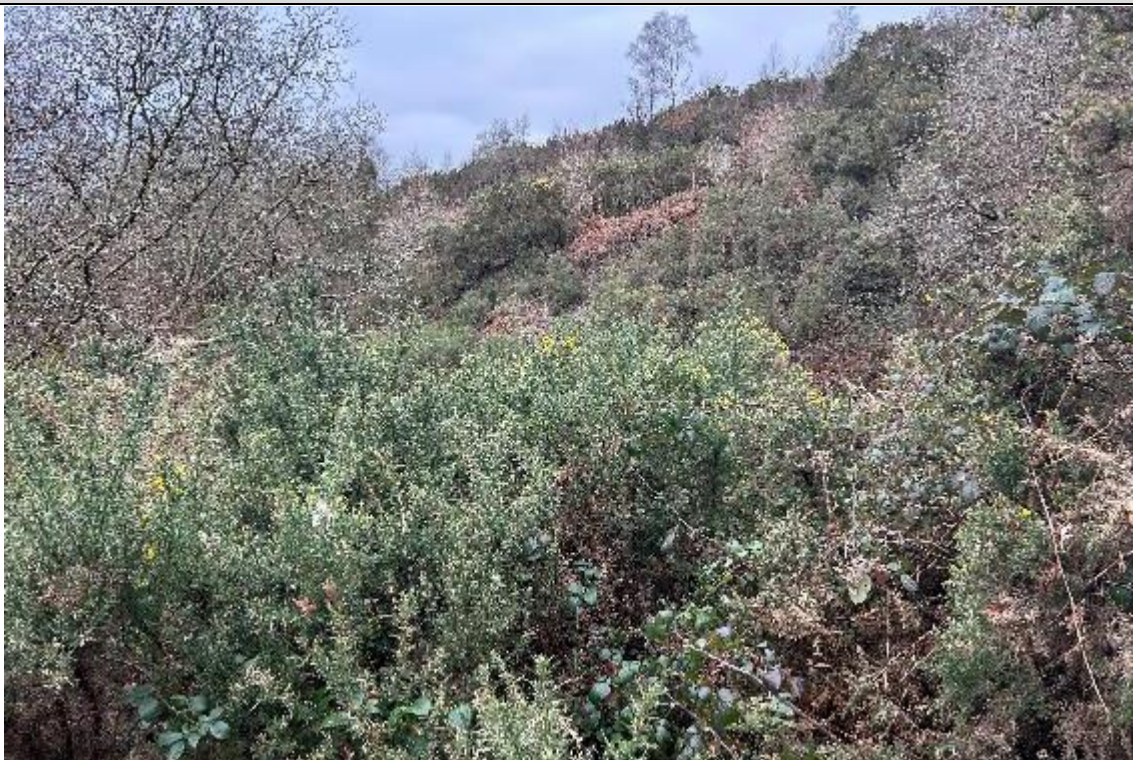
| OBSERVATIONS | | | | |
|---|---|---|--|--|
| 25/L/01 | Vegetation Cover | E – 274877 N - 206856 | The surfaces of the site are densely vegetated with grass, bracken, brambles, gorse and trees; making access across the site impassable in places. | Worse |

| Photo No. | 2 | Comment | Thick gorse preventing access to the north-eastern section of the site. |
| Feature ID | 25/L/01 | | |

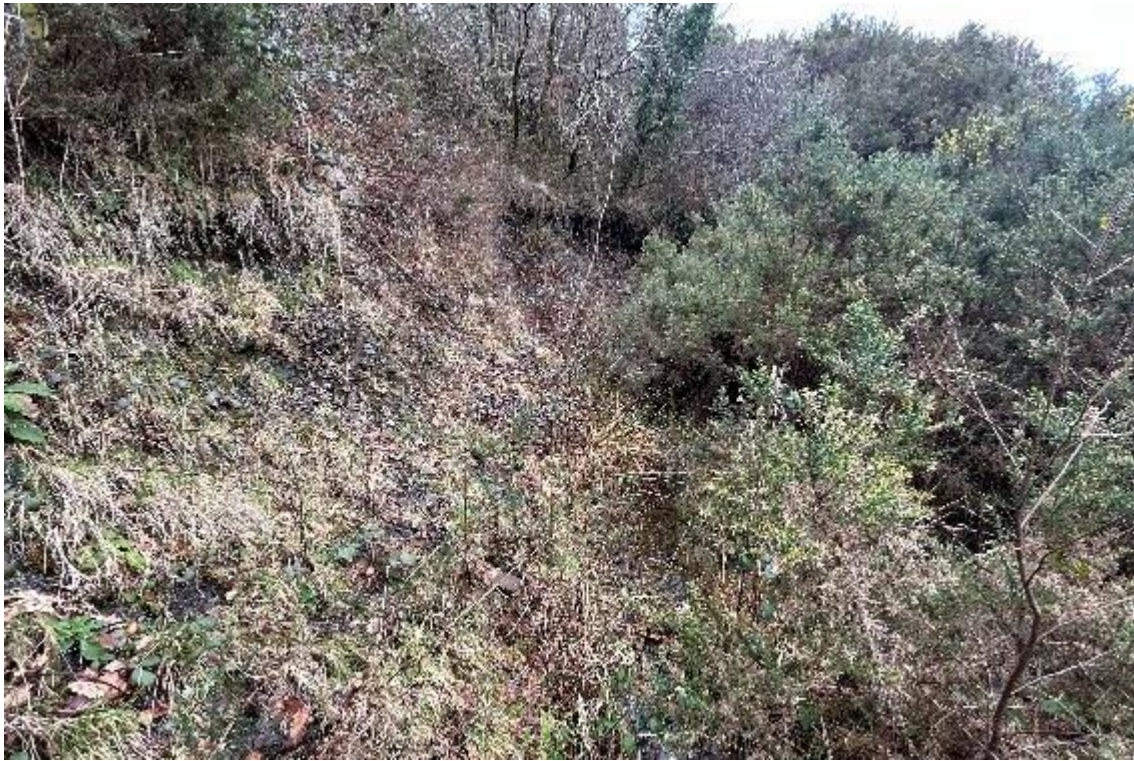
| OBSERVATIONS | | | | |
|---|---|---|--|--|
| 25/G/01 | Ponding | E – 274845 N - 206869 | Issues (E - 274889, N – 206911) convey over an excavated face to the North of the site boundary. Flows convey towards the flat-lying ground/quarry floor, adjacent to the northern perimeter of the western section of the site. Resultant minor ponding and associated saturated ground conditions present. | No Change |

| Photo No. | 3 | Comment | Issues convey over an excavated face to the North of the site boundary. Flows convey towards the flat-lying ground/quarry floor. |
| Feature ID | 25/G/01 | | |

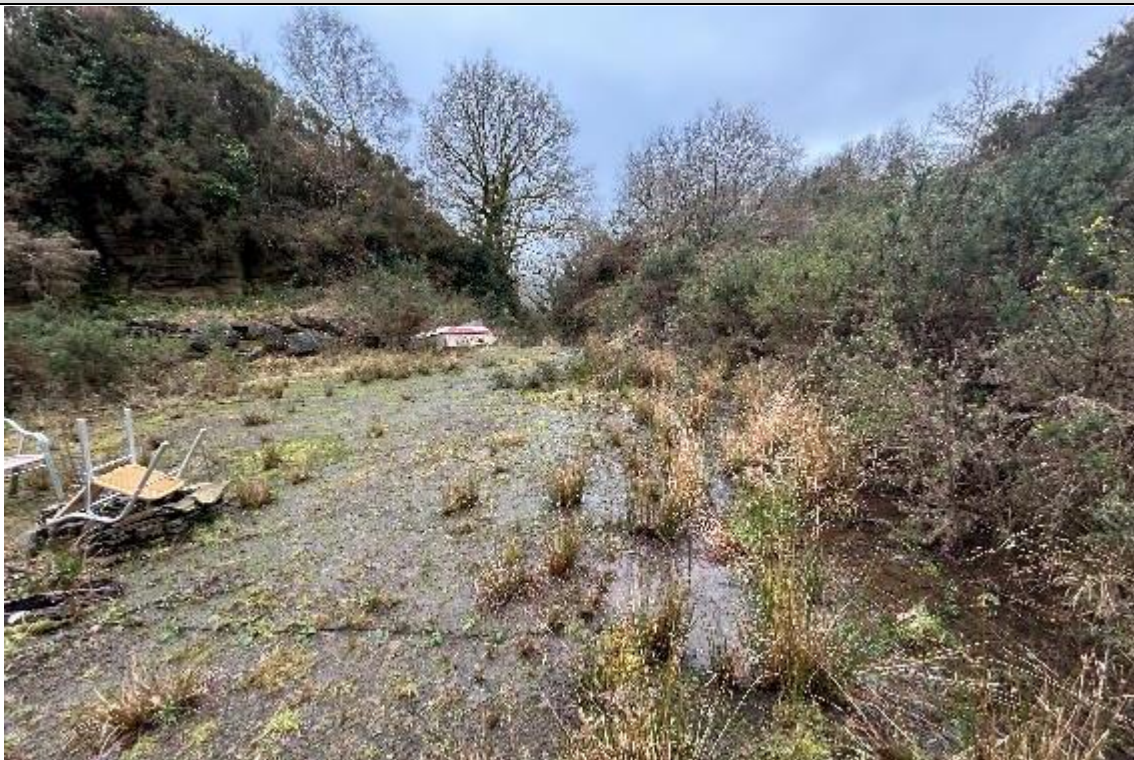
| 25/L/04 | Land Use | E – 274868 N - 206891 | Evidence of human activity within the Quarry floor, with the presence of machinery, chairs, a boat and electricity extension cables leading downslope (previously recorded as extending downslope towards the properties named 'Glander' and 'Darren View'). | No Change |

| Photo No. | 4 | Comment | Flows convey towards the flat-lying ground/quarry floor, adjacent to the northern perimeter of the western section of the site. Evidence of human activity within the Quarry floor; abandoned boat. |
| Feature ID | 25/G/01 | | |

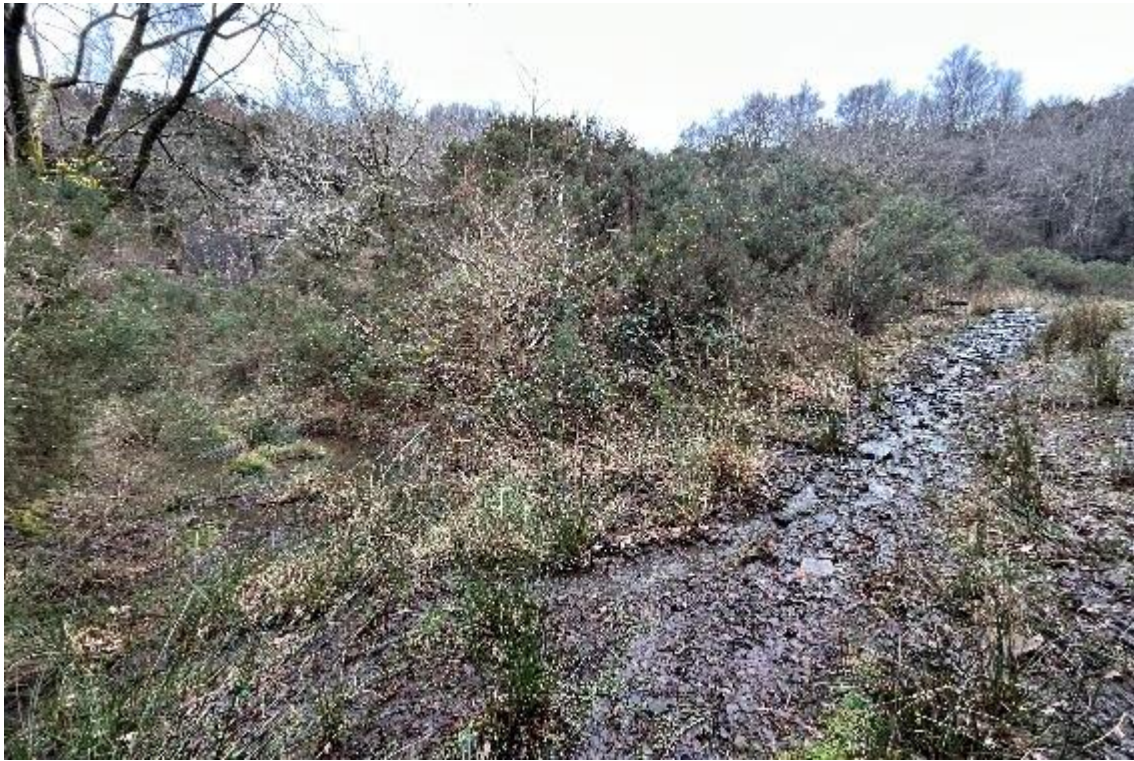
| Photo No. | 5 | Comment | Flows convey towards the flat-lying ground/quarry floor, adjacent to the northern perimeter of the western section of the site. |
| Feature ID | 25/G/01 | | |

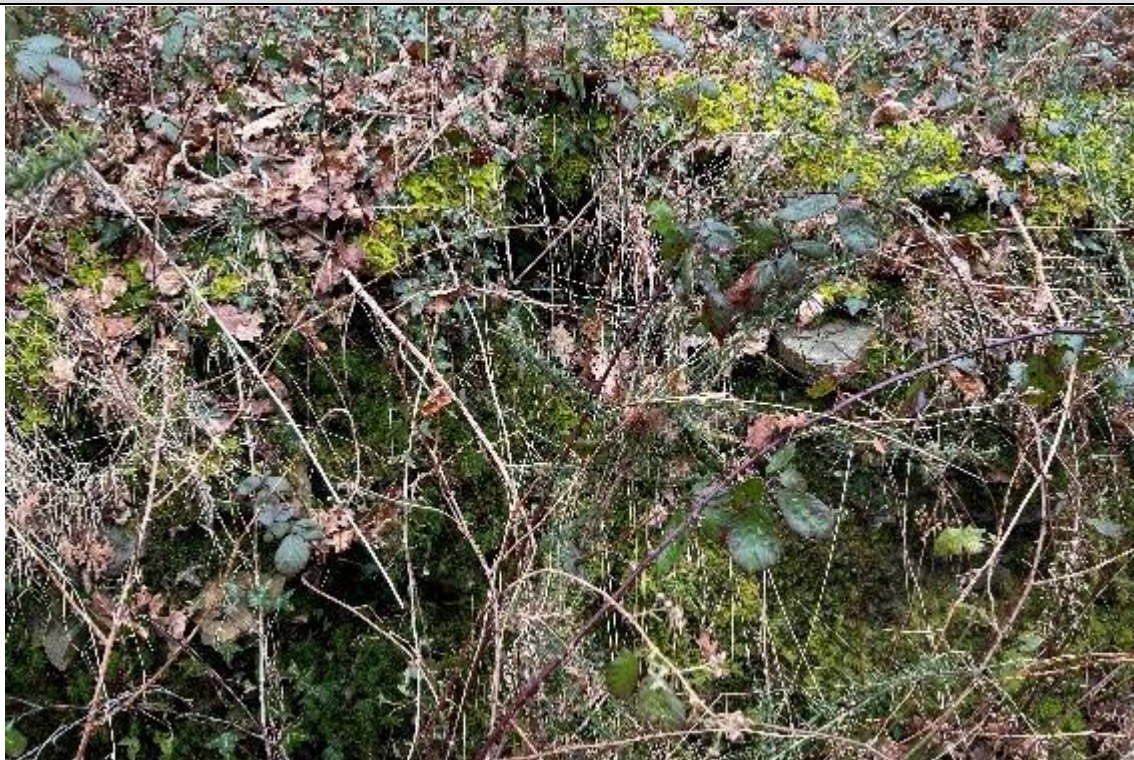
| Feature ID | N/A | | |

| Photo No. | 6 | Comment | View looking towards a small exposure of sandstones, shales and clays; situated within the densely vegetated northern extent of the site. |
