<b>Coal Tip Name</b>	<b>Godre'r-graig Quarry / Cilmaengwyn</b>		<b>Tip Ref Number</b>	<b>L044A</b>	
			<b>Ownership Status</b>	<b>Private</b>	
<b>Located In</b>	<b>Godre'r-graig, Neath-Port Talbot</b>		<b>Tip Category</b>	<b>D</b>	
<b>Inspection Led By</b>		<b>Date of Inspection</b>	<b>24/07/2023</b>	<b>Date of last Inspection</b>	<b>13/06/2019 (TCA)</b>
<b>Weather</b>	<b>Overcast</b>		<b>Damp</b>		<b>Calm</b>
<b>General Remarks</b> (e.g. access, limitations)	<p>Access to the site was gained via an access path situated just off the Pentwyn Farm access track. The access path extends up the hillside in a north-easterly direction, passing through Cwar Pentwyn Quarry before reaching a narrow, overgrown path which extends up-slope towards the site. It should be noted that this inspection was conducted without the benefit of a detailed site plan; whilst dense vegetation significantly limited accessibility and visual inspection. Therefore, instability within these areas could exist, but was not detectable at the time of the inspection. The densely overgrown nature of the site prevented inspection of the spoil material; it is presumed that the site is comprised of sandstone quarry waste ma

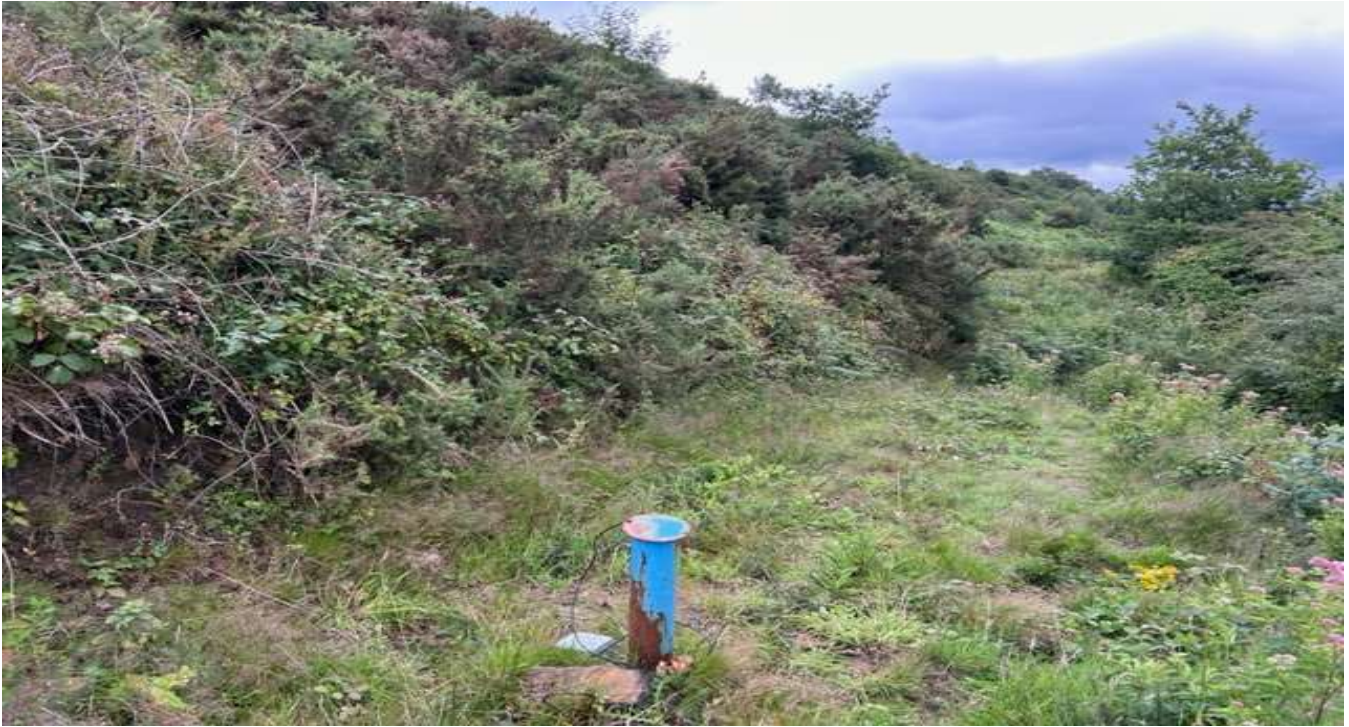
<b>Photo No.</b>	1	<b>Comment</b>	Piezometer borehole located on the site access track, downslope of the tip.
------------------	---	----------------	---

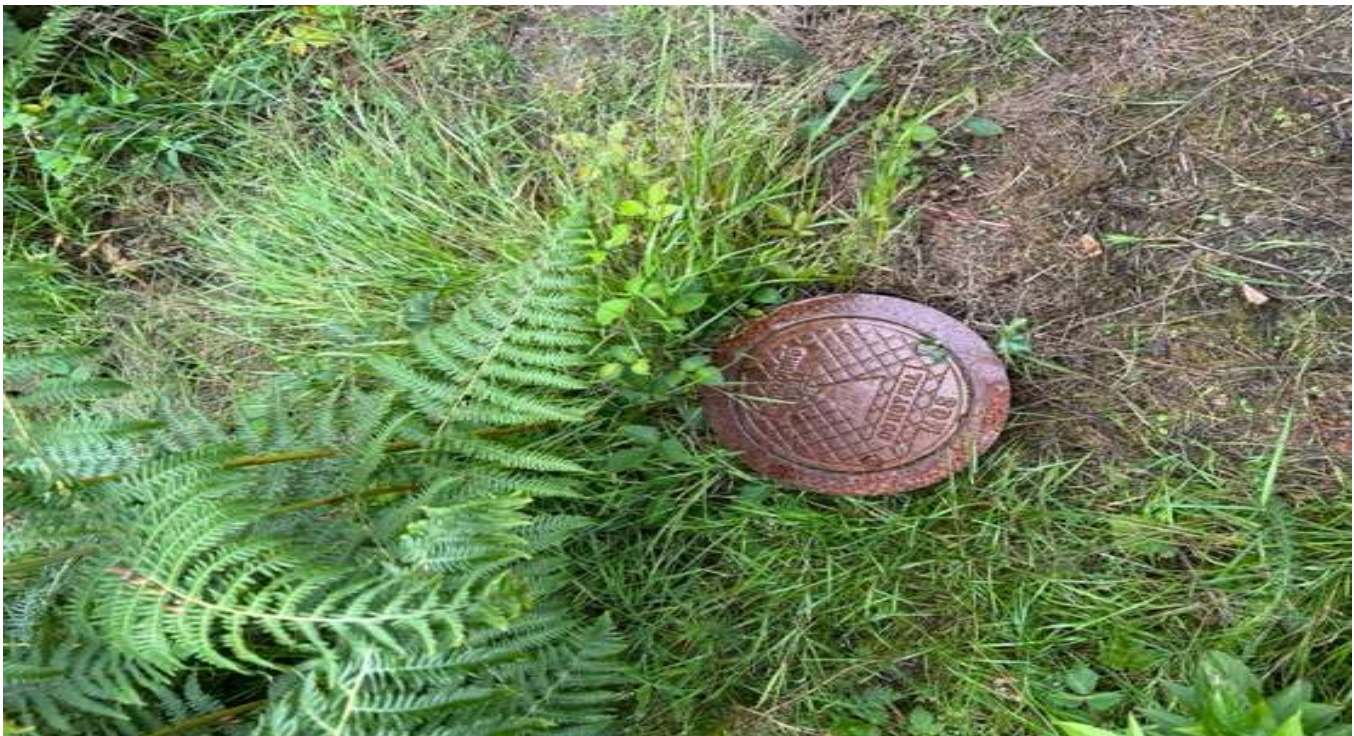
<b>Photo No.</b>	2	<b>Comment</b>	Monitoring well located on the site access track, downslope of the tip.
------------------	---	----------------	---

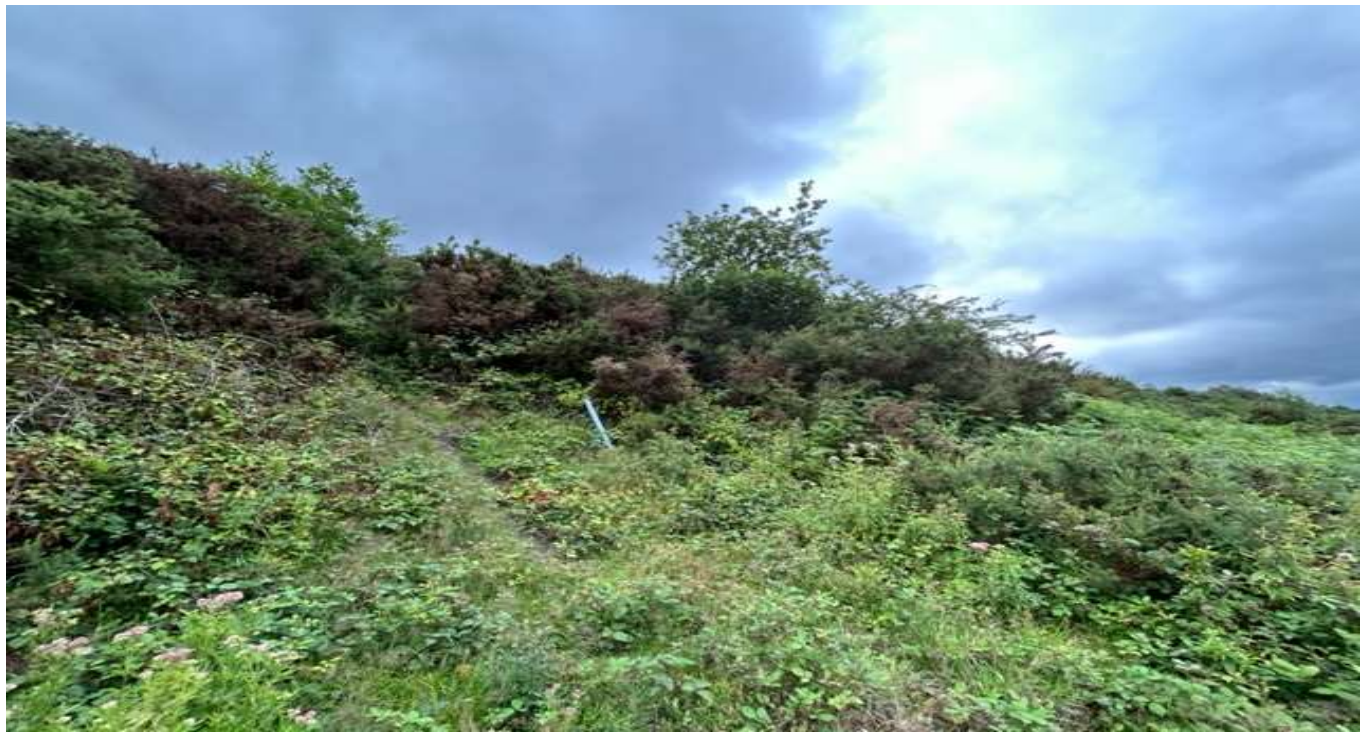
<b>Photo No.</b>	3	<b>Comment</b>	Minor surface erosion exposing bare spoil material along a narrow, overgrown access path; of which extends up-slope off the main site access path, towards the site.

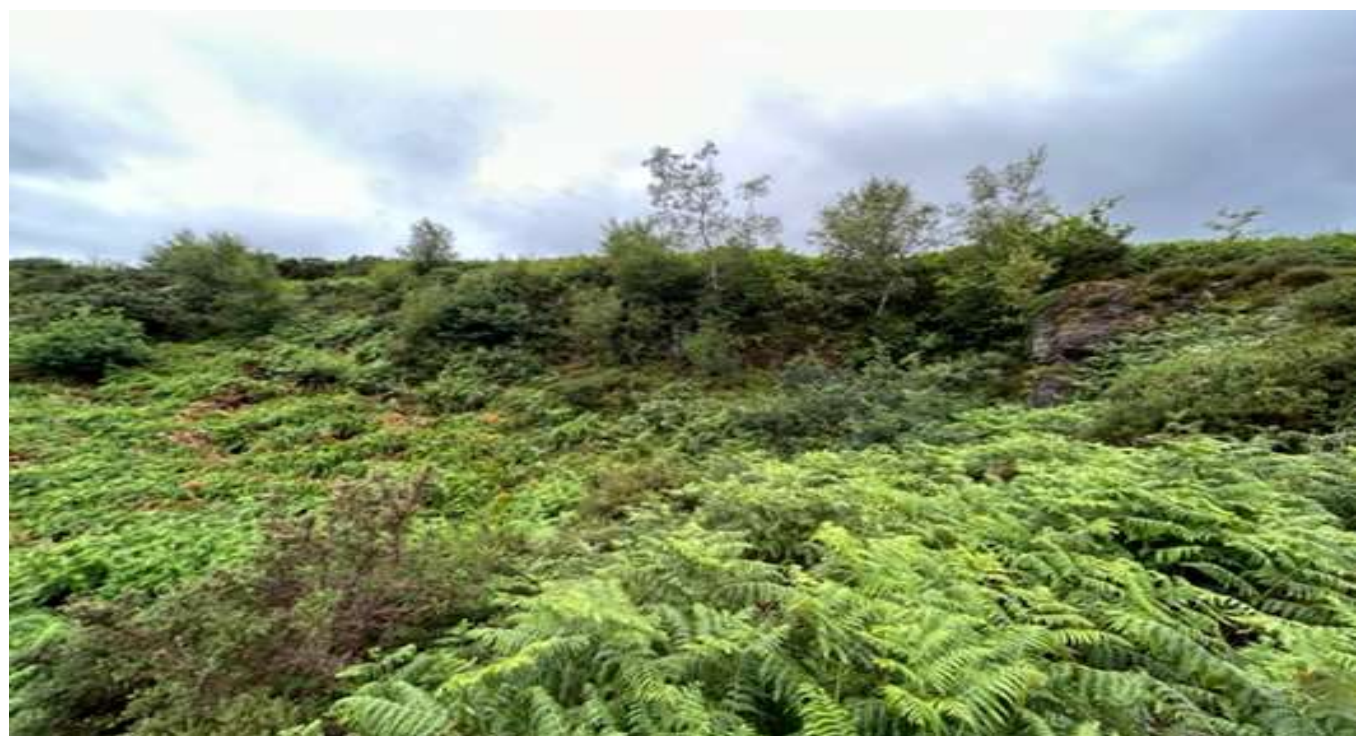
<b>Photo No.</b>	4	<b>Comment</b>	View looking towards an outcrop of bedrock at the rear of the tip; likely the quarry high wall.

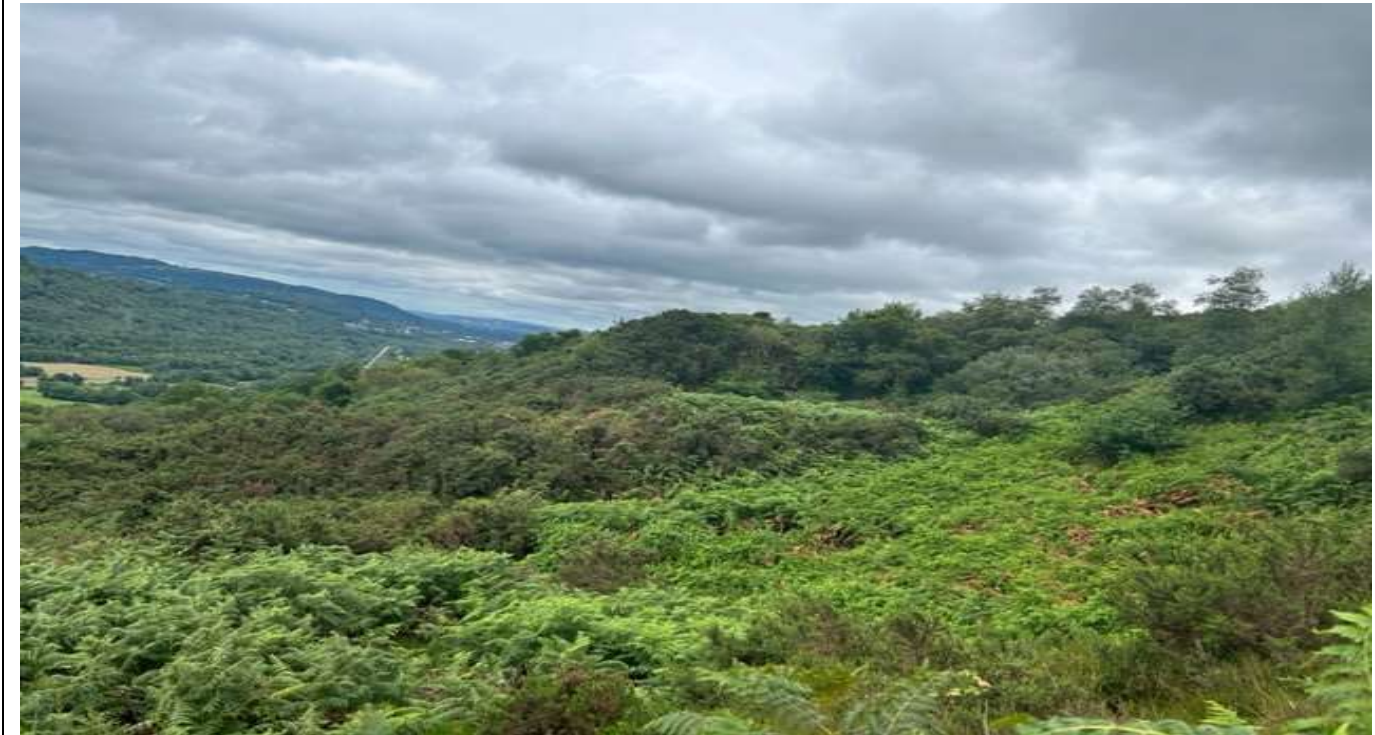
<b>Photo No.</b>	5	<b>Comment</b>	View looking south-west across the very densely vegetated lobes of tip material. Image conveys associated accessibility issues.
