## Pantteg Landslide, Pantteg

Interpretative Report; Hazard and Risk Assessment Report Reference: ESP.5859e.09.2930 Volume 2

## Pantteg Landslide, Pantteg Interpretative Report; Hazard and Risk Assessment

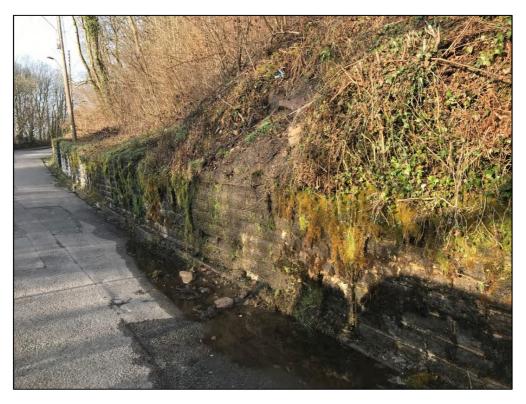
Surface water was present seeping through the retaining wall (Retaining Wall 1) on the western side of Graig Road (Insert 1) in April 2018. This has been observed constantly during the site works, only not present following a dry period in the peak of summer. Works were implemented by NPTCBC in 2018 to address/divert this flow of water.

Insert 1 Photograph showing area of excess surface water on the northern retaining wall of Graig Road. Colluvium present on top of the retaining wall. Photograph taken looking south-west on  $9^{th}$  April 2018.

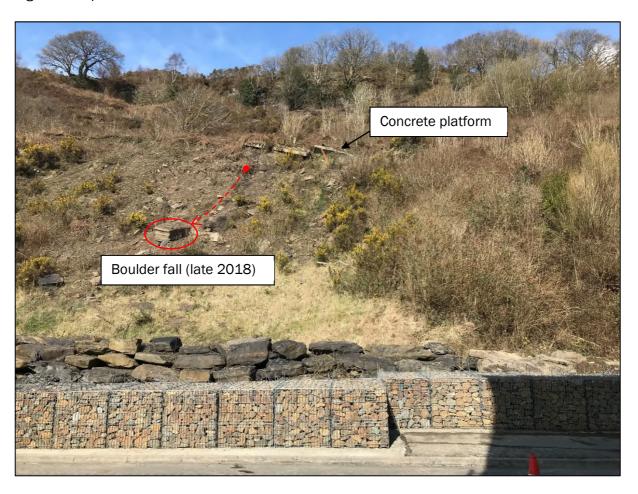
This instability continues to the present day, with evidence of regression of the back of slope to the north-west, undermining of a concrete platform (presumably associated with the tunnel in the area) and boulders falling downslope (Hazard type 5). Passive protection measures, in the form of a boulder barrier and gabion baskets, have been constructed by NPTCBC. The current state of the regraded slope is shown in Insert 2.

Insert 2 - Photograph of slope regraded by Jacobs 2013 taken on 9th April 2018 looking north-east.

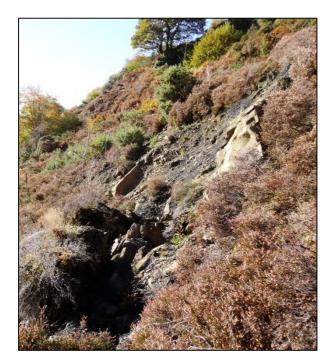
Insert 3 - Photograph of tension cracking on the break of slope above Pantteg Chapel exposing boulders of Llynfi Sandstone. Aerial photographic interpretation has identified several landslides to occur along this break in slope. Hazard Type 2 and 6. Photograph taken 28th October 2015 looking south-west

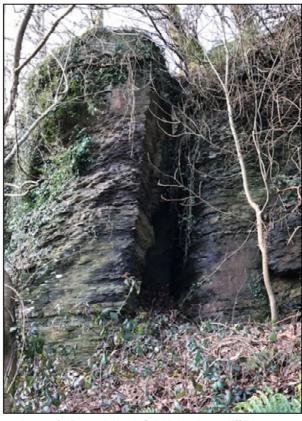
Insert 4 - Potential rock fall block along cliff-line

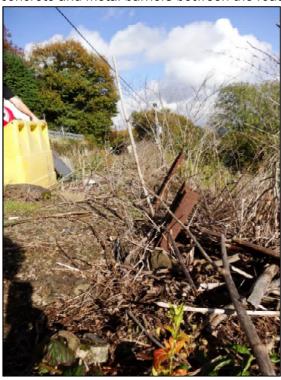
Possible signs of movement are evident along Graig-y-Merched, and within the slope that is designated a cut slope hazard west of Cyfyng Road. Signs of movement including an inclined telephone mast (insert 6), cracks within the road parallel to the break in slope and inclined concrete and metal barriers between the road and the slope (insert 7).

Insert 7 - Inclined barrier east of Graig-y-Merched opposite No. 12 and 13 Graig-y-Merched. Photograph taken 28<sup>th</sup> October 2015 looking north.

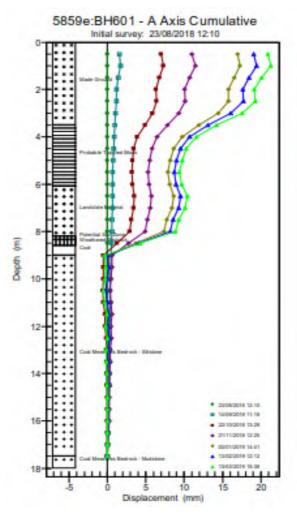
Insert 13 - BH601 Inclinometer (Cumulative)

The inclinometer shows movement from above a depth of 8.5m to 9m and approximately 21mm of cumulative downslope movement has occurred. The movement appears to be greater in the top 4m, which is noted to be Made Ground, less movement is noted below this depth, which is within a suspected rotated block.

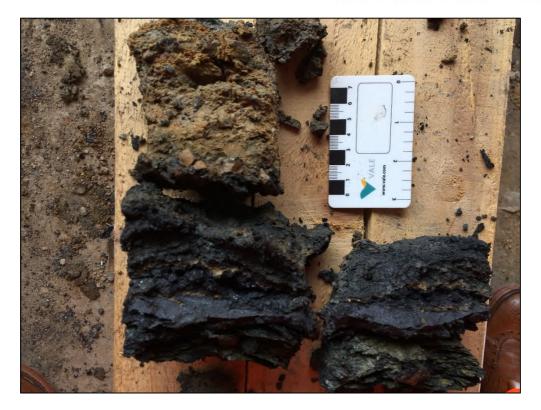
Insert 31 - Silty clay infill in BH602. Interpreted as a shear surface.

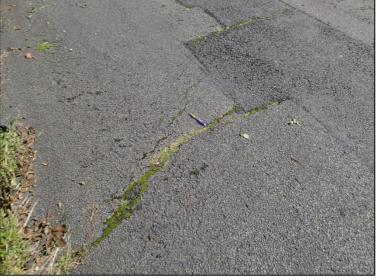
Insert 37 - Left stepping en-echelon distress in Graig Road crossing recent repairs (15/8/17)

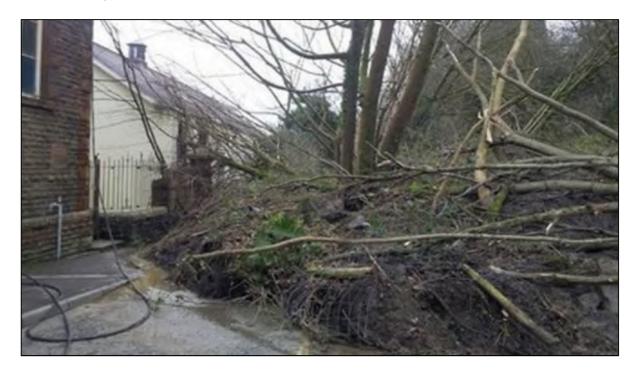
Insert 38 - 2012 Landslide (http://www.bbc.co.uk/news/uk-wales-south-west-wales-21409439

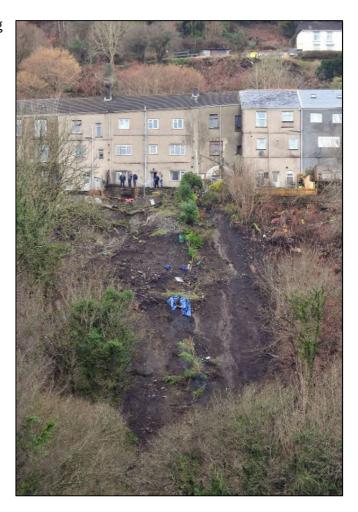
These are located in the terrain below Cyfyng Road and are associated with Made Ground placed above the crest of oversteep, former river slopes. This hazard type is represented in the landslide inventory by the 2017 landslide (Insert 39) with headward progression potentially undermining buildings and infrastructure. There is limited information with respect to the type and depth of foundations for the houses, the thickness and extent of the Made Ground. the subsurface geology and the hydrogeological conditions in this area. The largest extent upslope, from the over steep terrain that bounds the lower part of this Made Ground, that a landslide has extended is approximately 40m. A 40m buffer has therefore been tentatively adopted upslope of the break in slope forming the over steep terrain to indicate the possible extent of this hazard. Associated movement velocities are likely to be rapid (5x10<sup>1</sup> mm/s to 5x10<sup>-1</sup> mm/s i.e., 1.8m/hr to 3m/min). However, given their location, these are likely to have a relatively moderate risk to life but could result in structural damage if they regress upslope and undermine building foundations.

Insert 39 - 2017 landslide at rear of No. 86 Cyfyng Road (http://www.walesonline.co.uk/news/wales-news/homes-evacuated-after-swansea-valley-12680597)

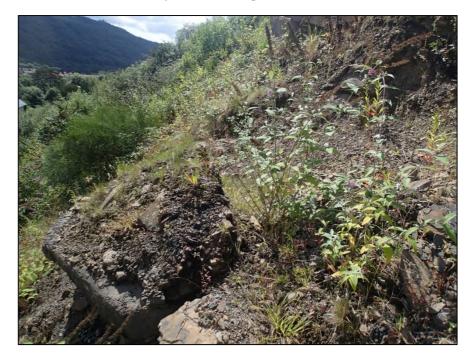
- 1. Small unrecorded landslides resulting in boulders being ejected from landslide debris and traveling further down slope;
- 2. Rock blocks being eroded by surface water, particularly in the areas of distress (Insert 40) or

Insert 40 - Tension crack behind block exposed block of sandstone in are modified following the 2012 landslide (15/8/17)

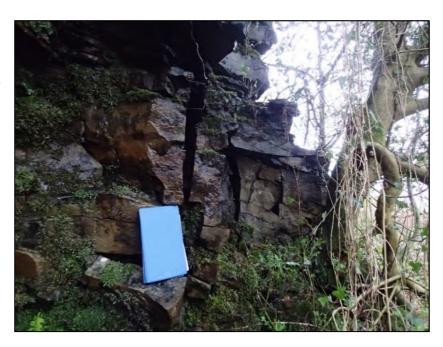
Insert 42 - Dilated rock blocks within the Llynfi Beds (19/2/17)

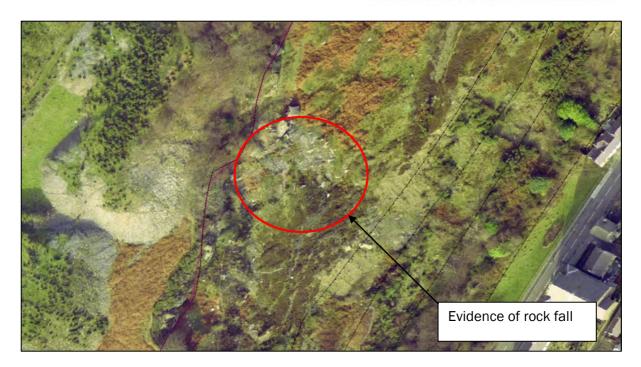
However, to impact on elements at risk a significant run out is required, and a large number of blocks have previously come to rest on the bench below the Llynfi Beds (Insert 43).

Insert 43 - Rock fall from the former quarry face/back scar
