Coal Tip Name	Godre'r-Graig Higher / Pentwyn No. 3 Levels		Tip Ref Number	L044C	
			Ownership Status	Unknown	
Located In	Godre'r-Graig Higher, Neath-Port Talbot		Tip Category	D	
Inspection Led By		Date of Inspection	16/02/2023	Date of last Inspection	07/07/2022
Weather	Overcast – Rain & Fog		Wet		Calm
General Remarks (e.g. access, limitations)	Access to the site was gained via an access track situated just off Graig Road, which leads to Pentwyn Farm. It should be noted that this inspection was conducted without the benefit of a detailed site plan. In certain areas, dense vegetation significantly limited accessibility and visual inspection. Therefore, instability within these areas could exist, but was not detectable at the time of the inspection. The location of the tip on privately owned land also limited the coverage of this inspection.				
Features Causing Concern			Description

Coal Tip Name	Godre'r-Graig Higher / Pentwyn No. 3 Levels	Tip Ref Number	L044C
		Tip Category	D
Date of Inspection	16/02/2023	Inspection led by

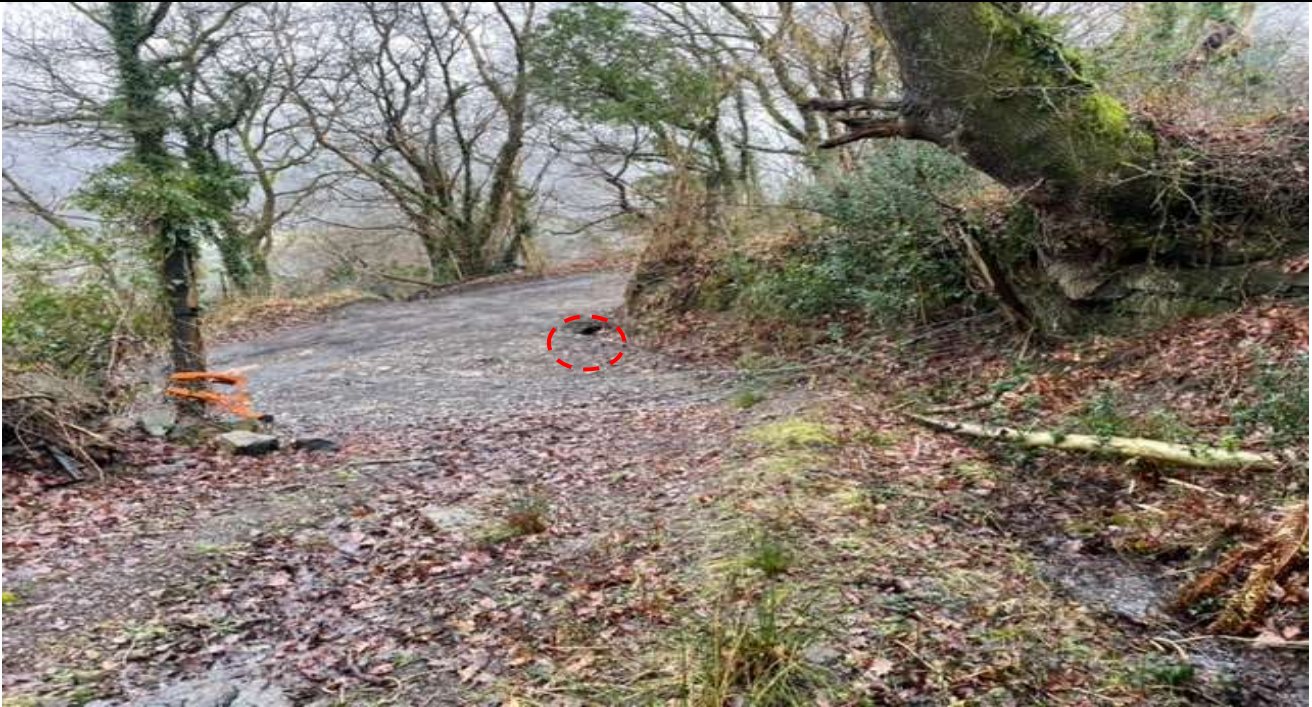
Photo No.	1	Comment	Vegetation and silt debris partially obstructing the shallow, unlined cut-off channel which runs parallel to the access track, located to the rear of the tip. Channel ineffectively capturing some flows (LHS), surface runoff migrating downslope, resulting in scouring of the access track. Some flows being conveyed towards the associated small diameter, cast iron culvert inlet (dashed red outline) as intended.

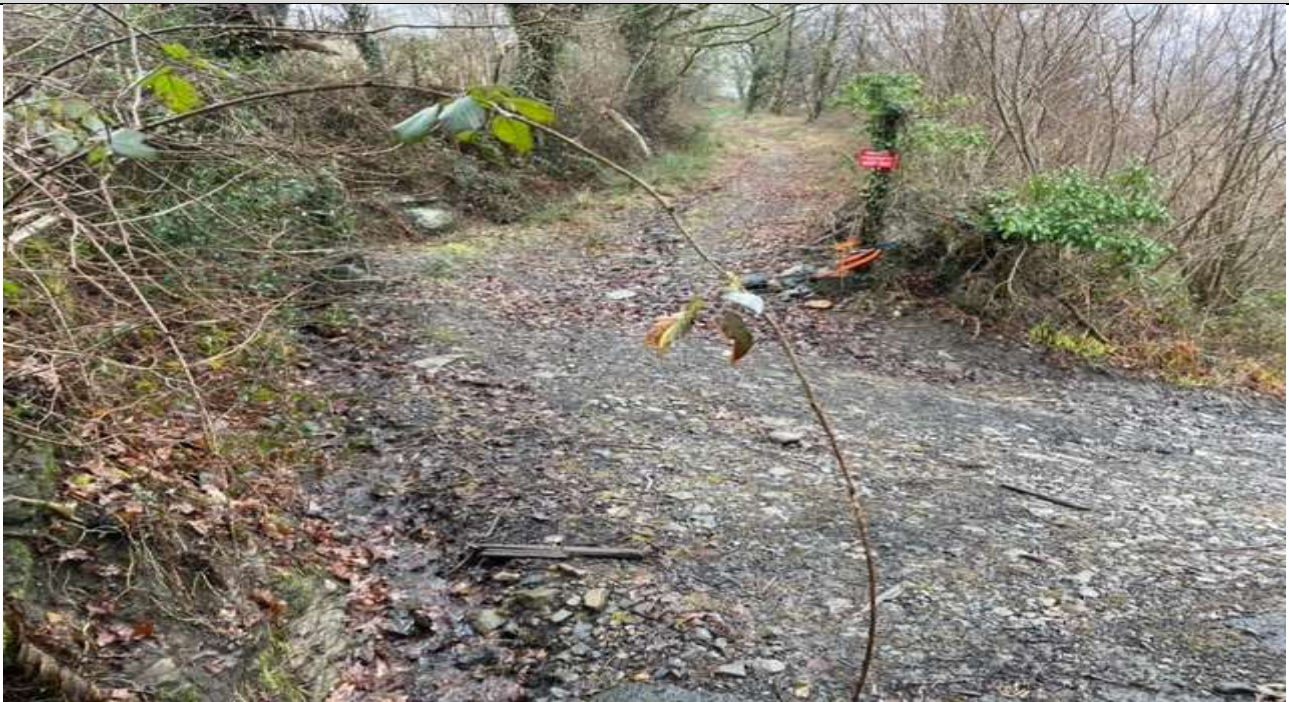
Photo No.	2	Comment	Vegetation and silt debris partially obstructing the shallow, unlined cut-off channel which runs parallel to the access track, located to the rear of the tip. Channel ineffectively capturing some flows, surface runoff migrating downslope, resulting in scouring of the access track. Private property signage present.

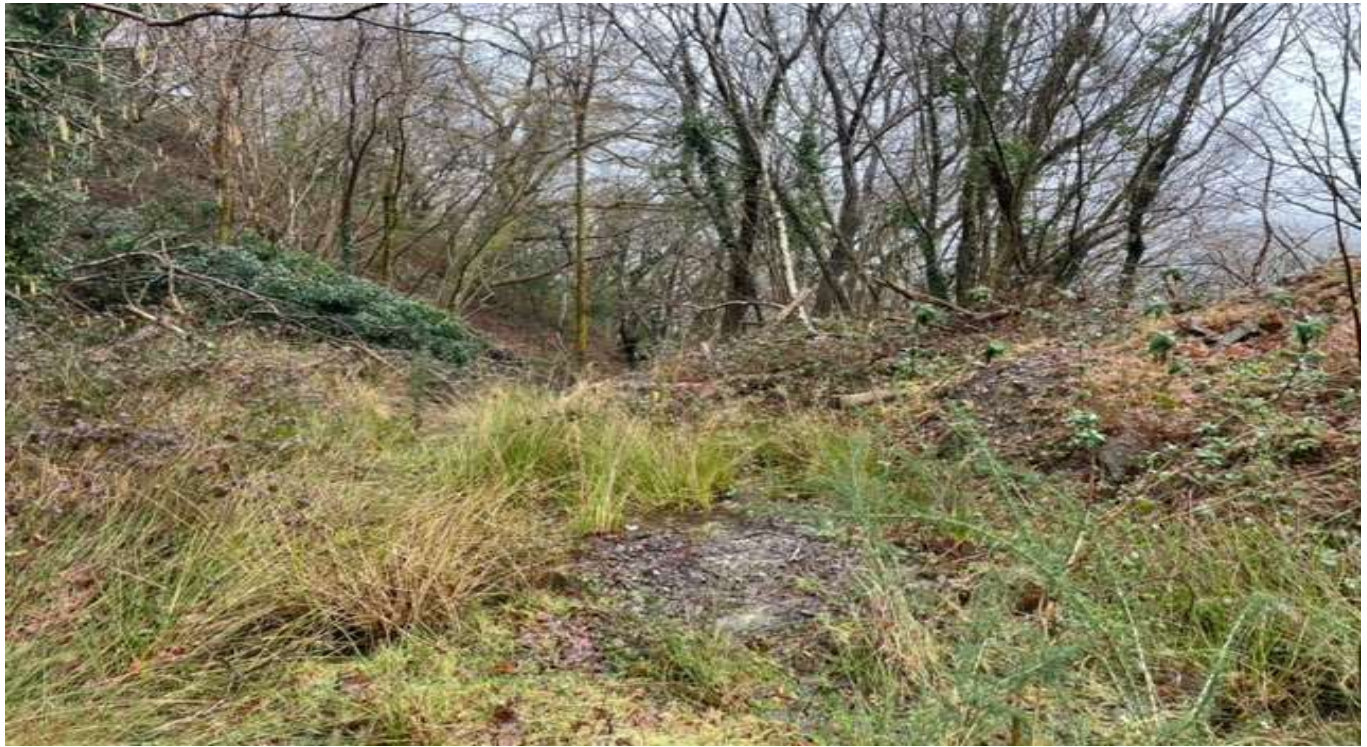
Photo No.	3	Comment	Multiple seepages situated on the north-eastern section of the tip plateau, associated saturated ground conditions. Sandstone quarry waste material deposited on the plateau (RHS).

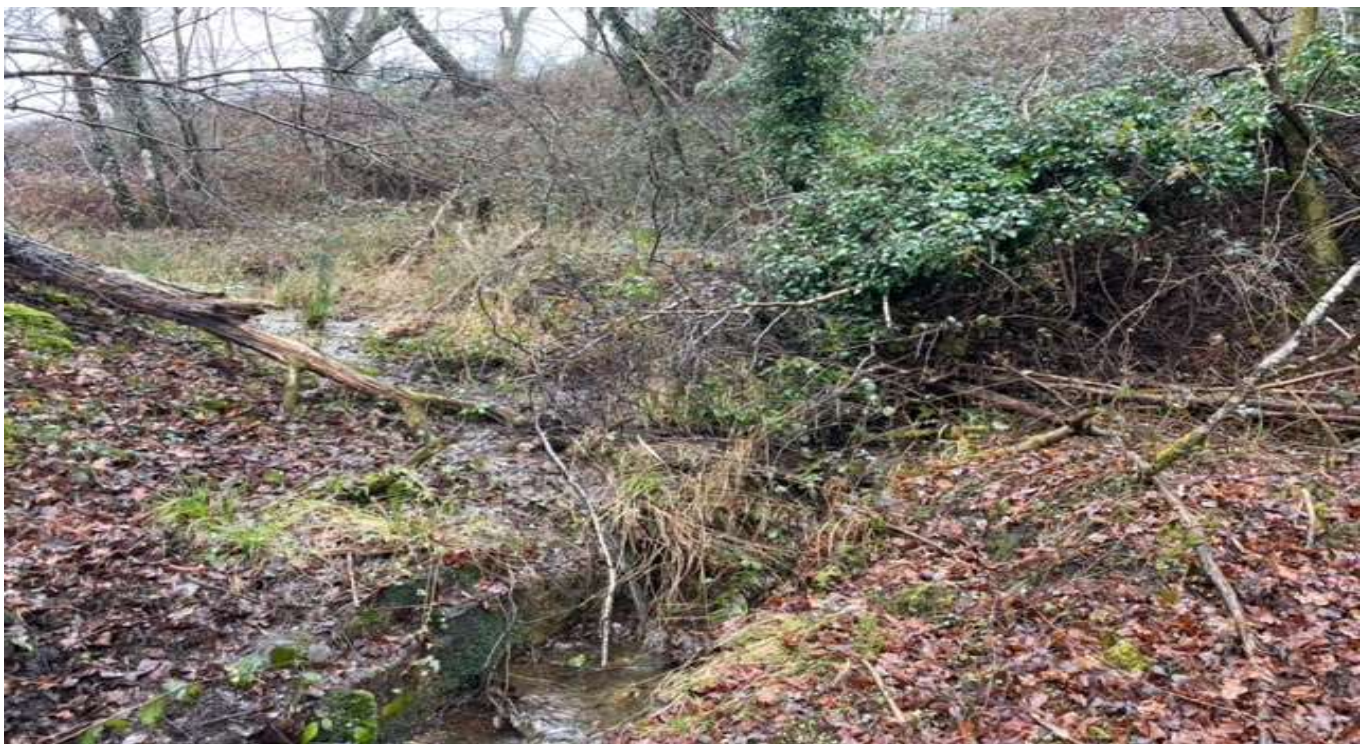
Photo No.	4	Comment	Seepages conveying from the north-eastern section of the plateau, towards the incised channel which skirts the eastern boundary.

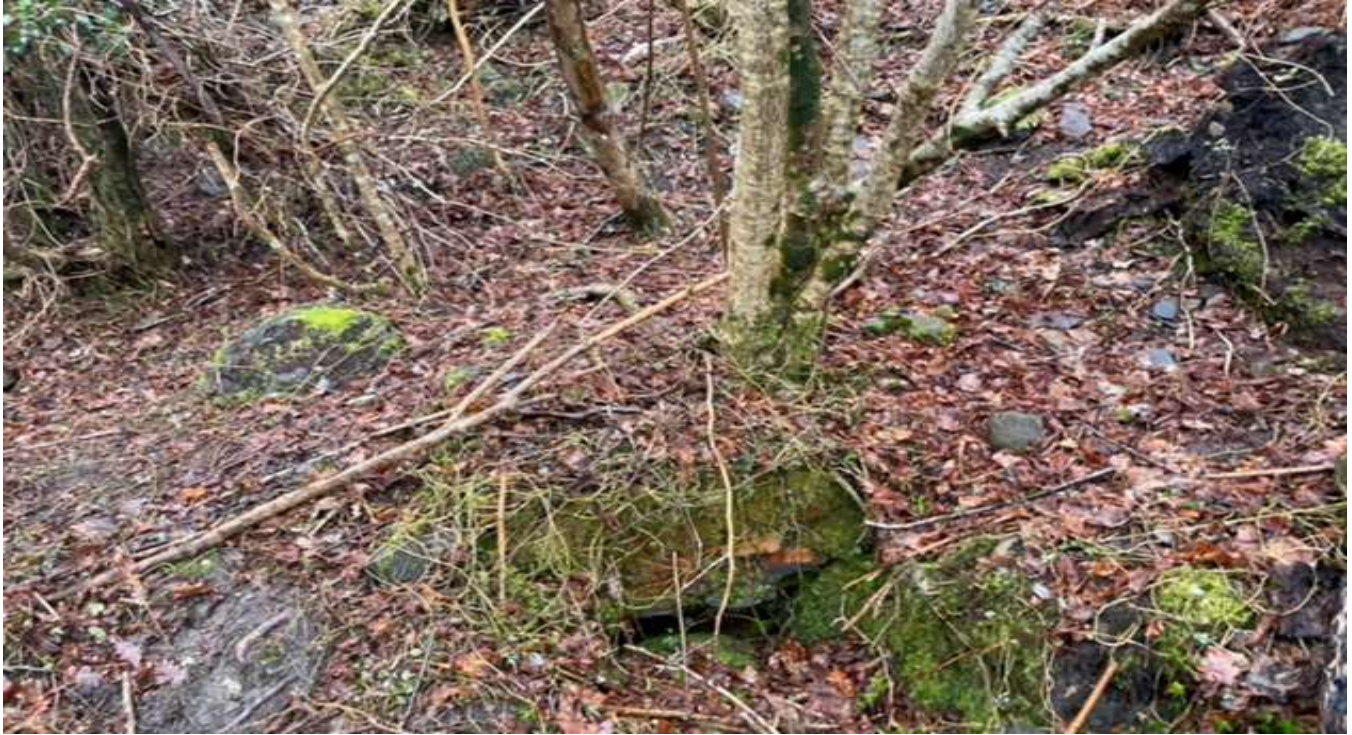
Photo No.	5	Comment	Seepage/flows emanating from an unknown brick structure, located directly adjacent to the incised channel which skirts the eastern perimeter.

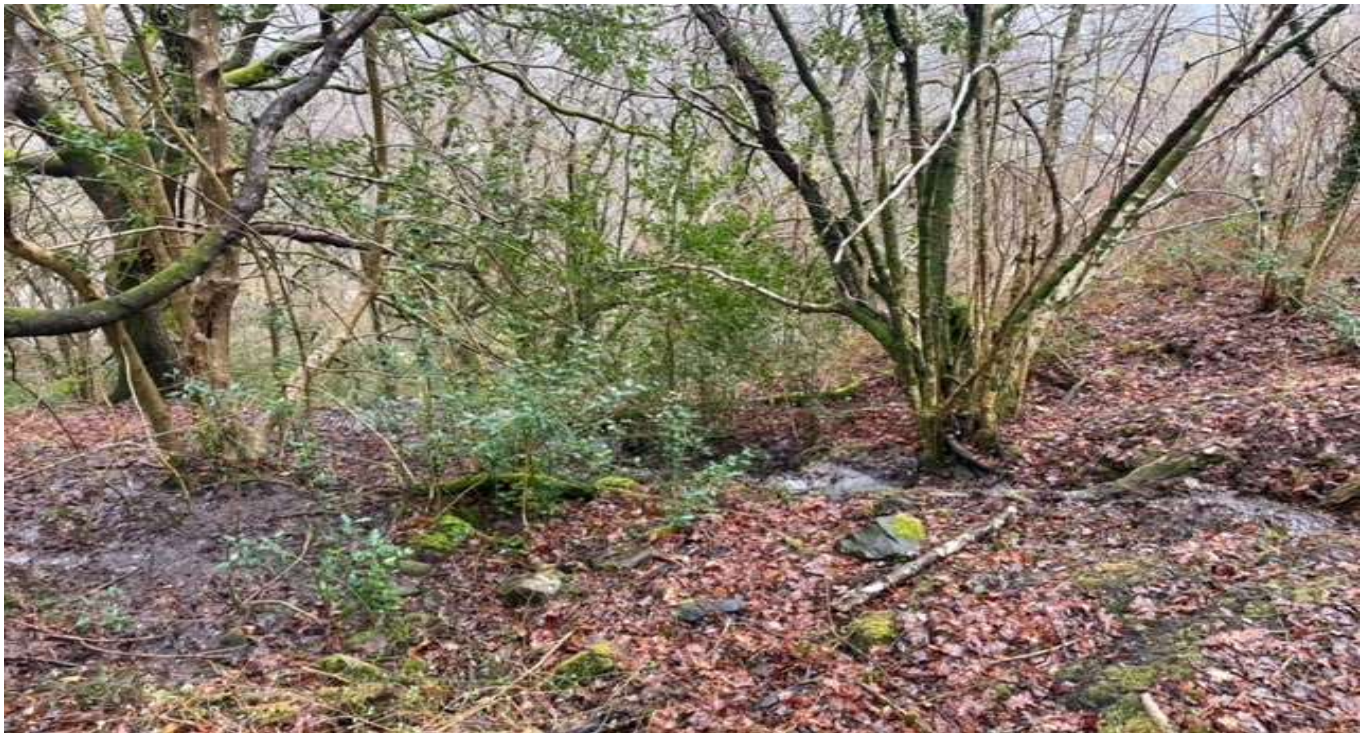
Photo No.	6	Comment	Strong flows associated with the unnamed issue/watercourse, conveying along the eastern boundary. Seepage/flows (LHS) emanating from an unknown brick structure, conveying towards the incised channel.

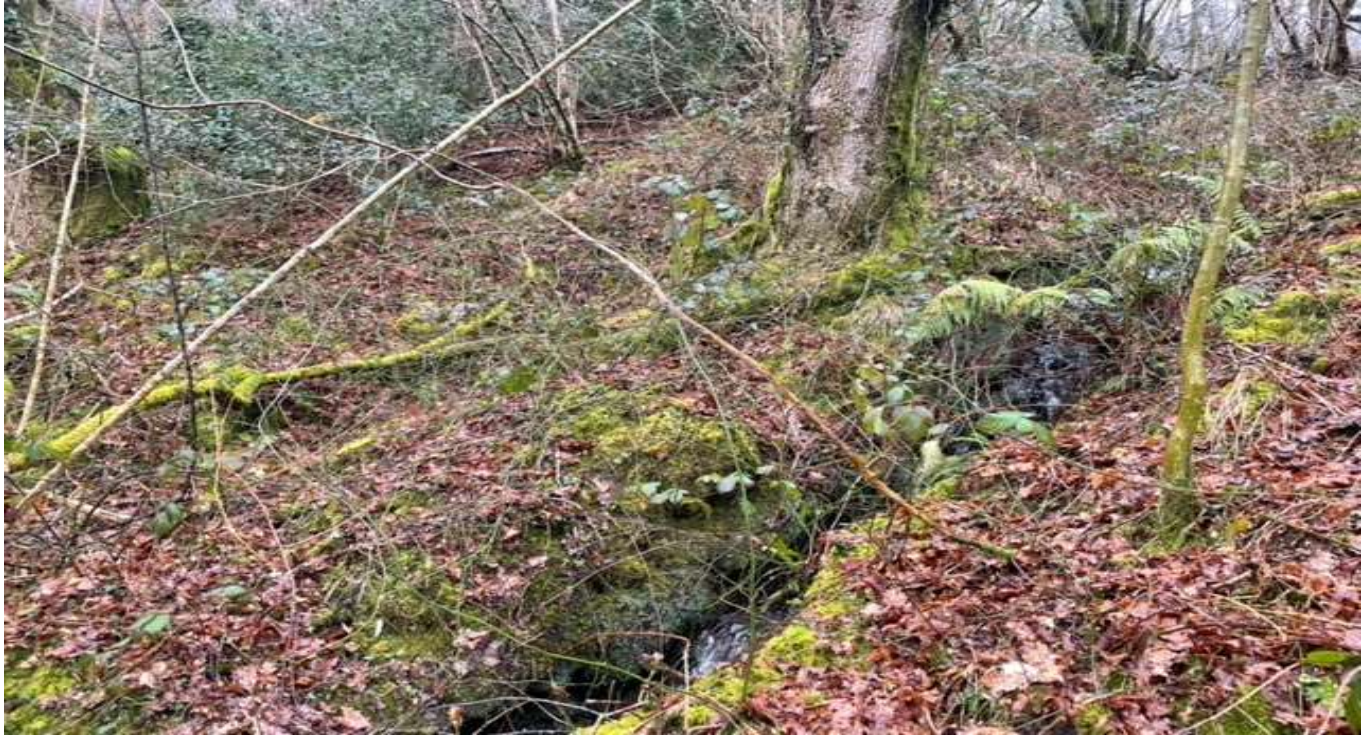
Photo No.	7	Comment	Incised scouring along the eastern boundary, induced by strong flows associated with the unnamed issue/watercourse.

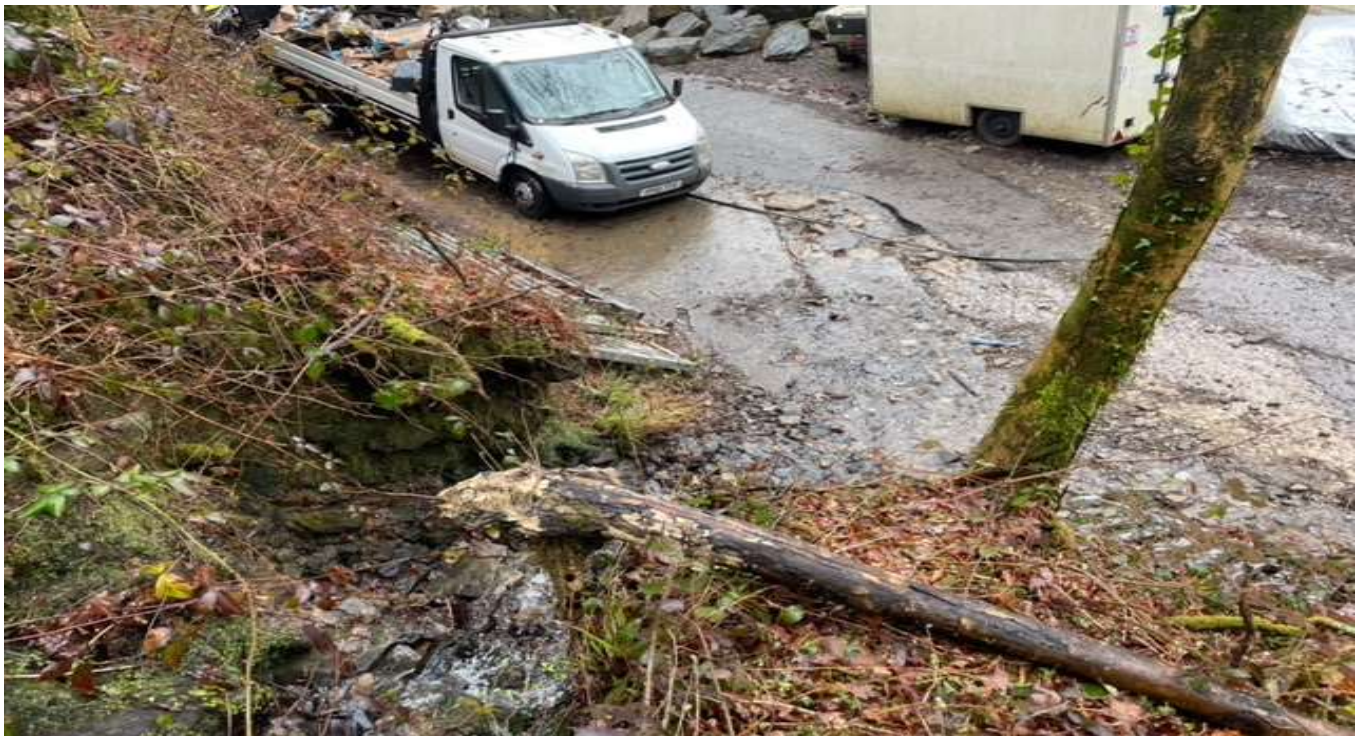
Photo No.	8	Comment	Incised scouring along the eastern boundary, where the flows associated with the unnamed issue/watercourse cascade onto the access track.

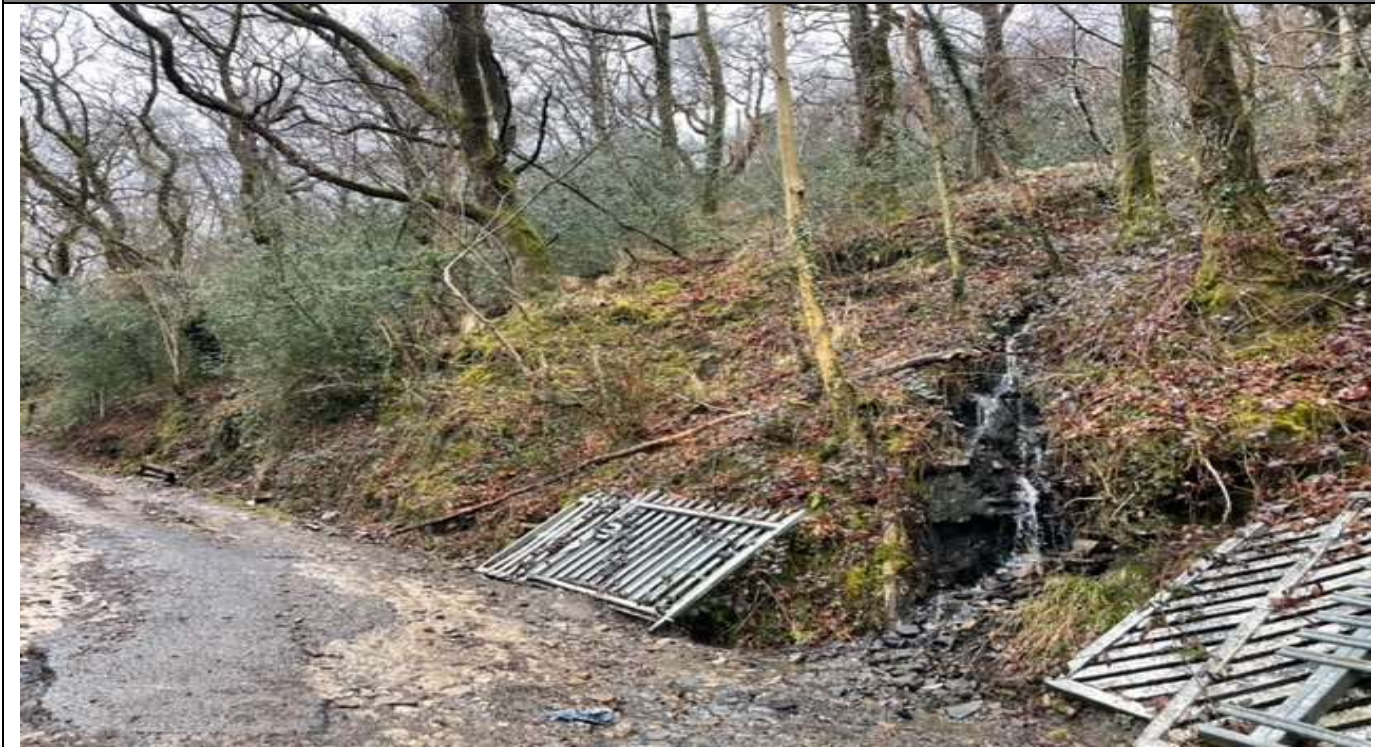
Photo No.	9	Comment	View looking north-west across the densely vegetated tip flank. Scoured, undercut section of the toe, where the unnamed issue/watercourse cascades onto the access track. Associated scouring of the adjacent access track, induced by the downslope migration of uncontrolled flows.

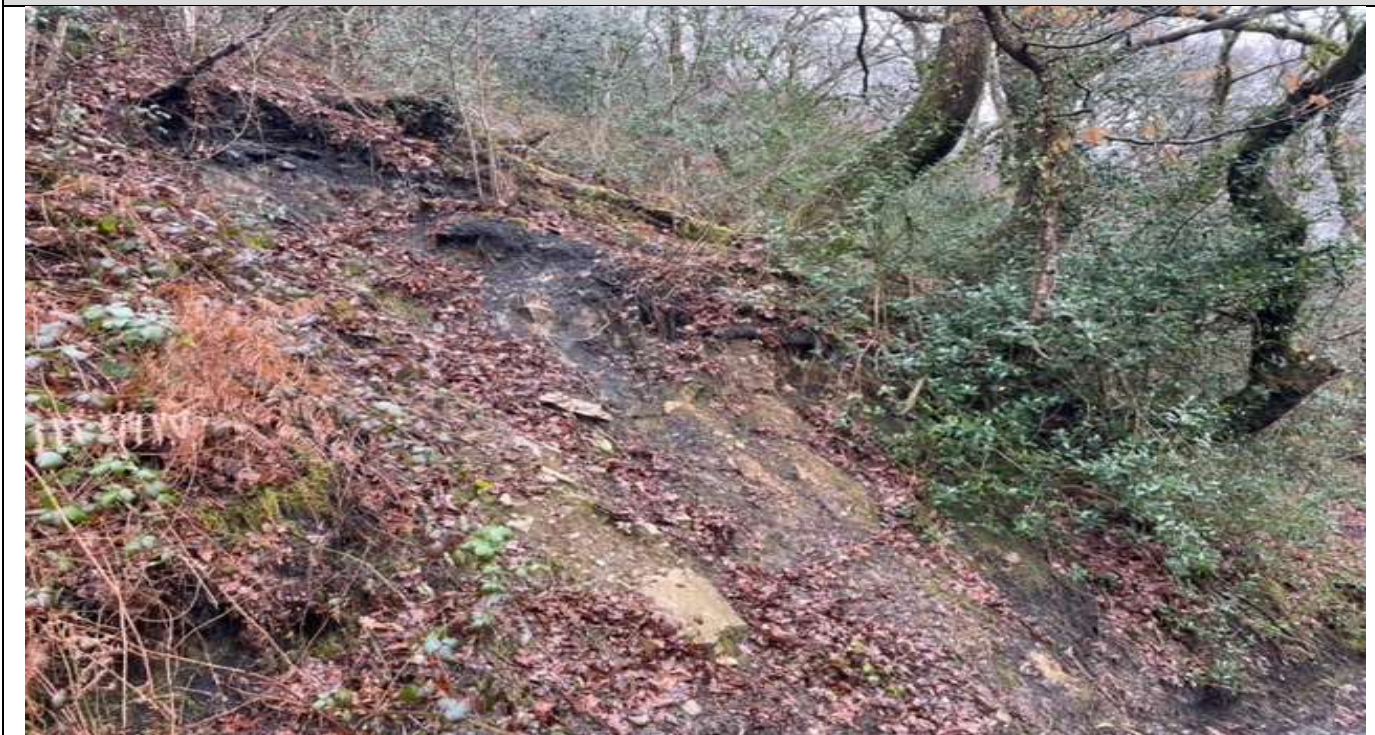
Photo No.	10	Comment	View looking across a minor, shallow surface slip situated along the toe, adjacent to the access track. Natural ground material has been exposed along the slip surface, with a thin veneer of overlying spoil material evident.
