## **Pantteg and Godre'r-Graig Landslips Slope Stability Review**

**December 2013**

**Report No: B15974EX / 12858 / R5095**

**Project:** Pantteg and Godre'r-Graig Landslips  
**Client:** Neath Port Talbot County Borough Council **Project No:** B15974EX  
**Document title:** Slope Stability Review  
**Ref. No:** B15974EX / 12858 / R5095

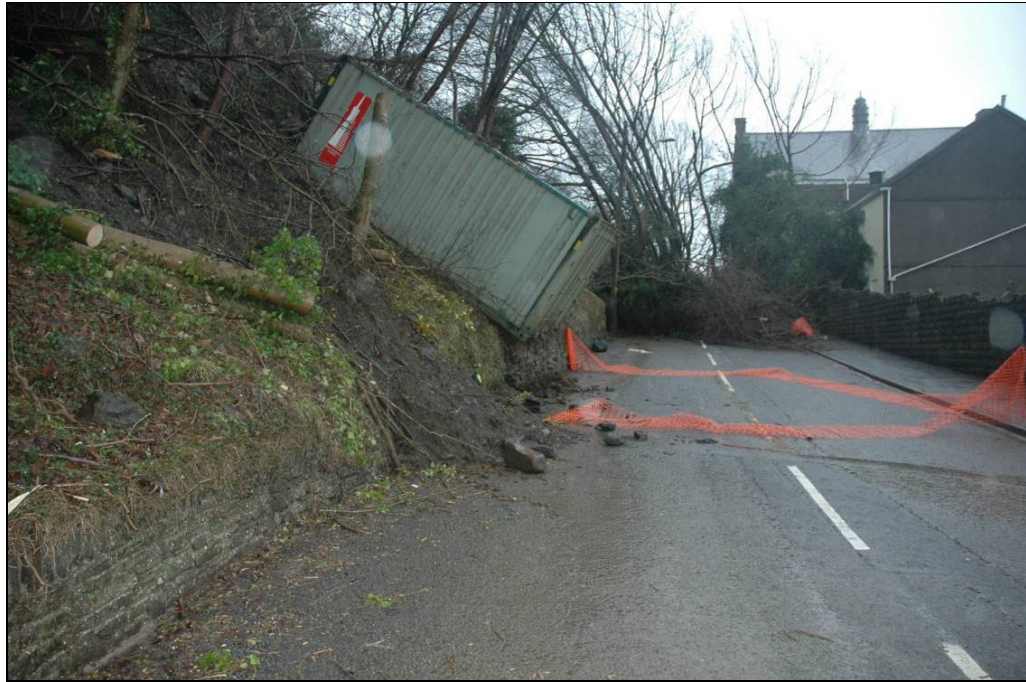
*Plate A-1: Pantteg, landslide December 2012, looking north-east towards the chapel.*

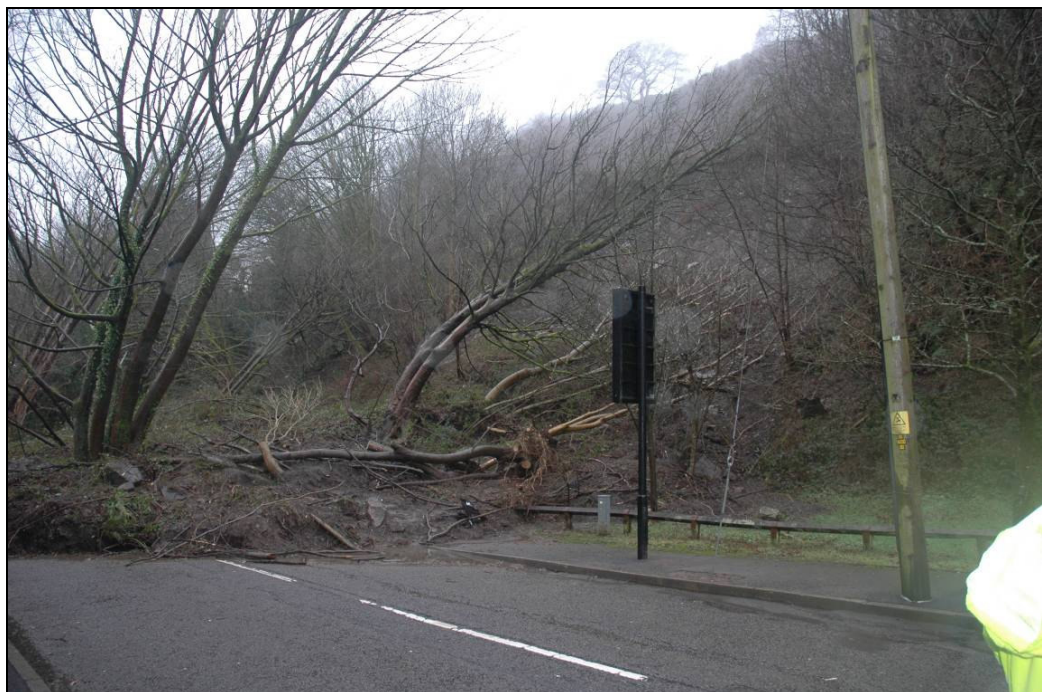
*Plate A-2: Pantteg, landslide December 2012, looking south-west at the chapel.*

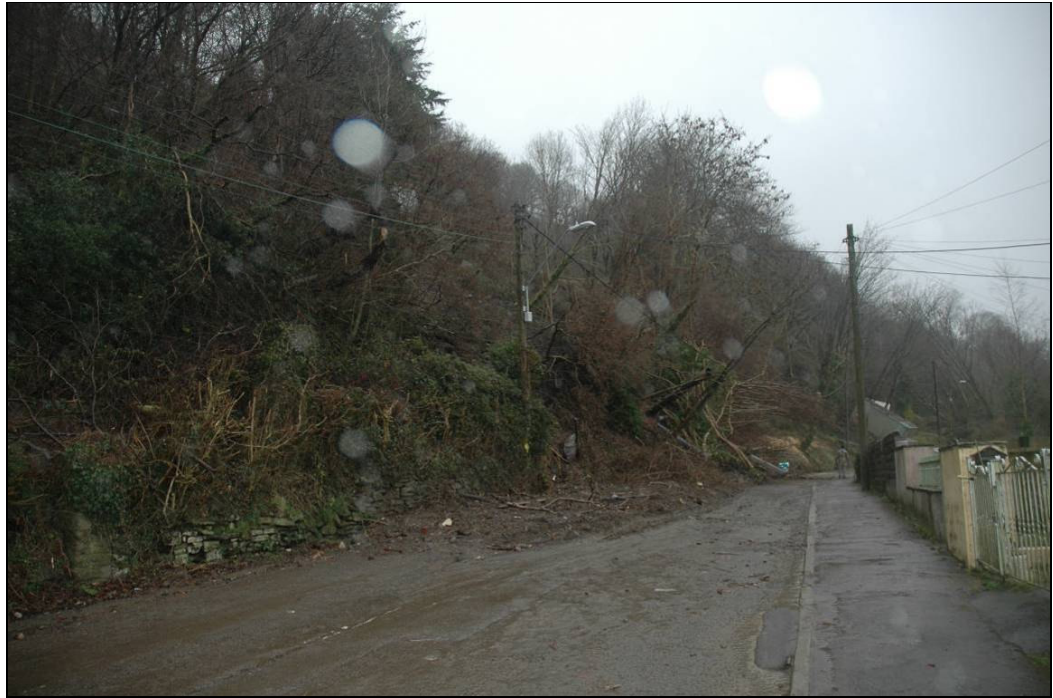
***Plate A-3: Pantteg, landslide December 2012, looking north-east towards the chapel hall***

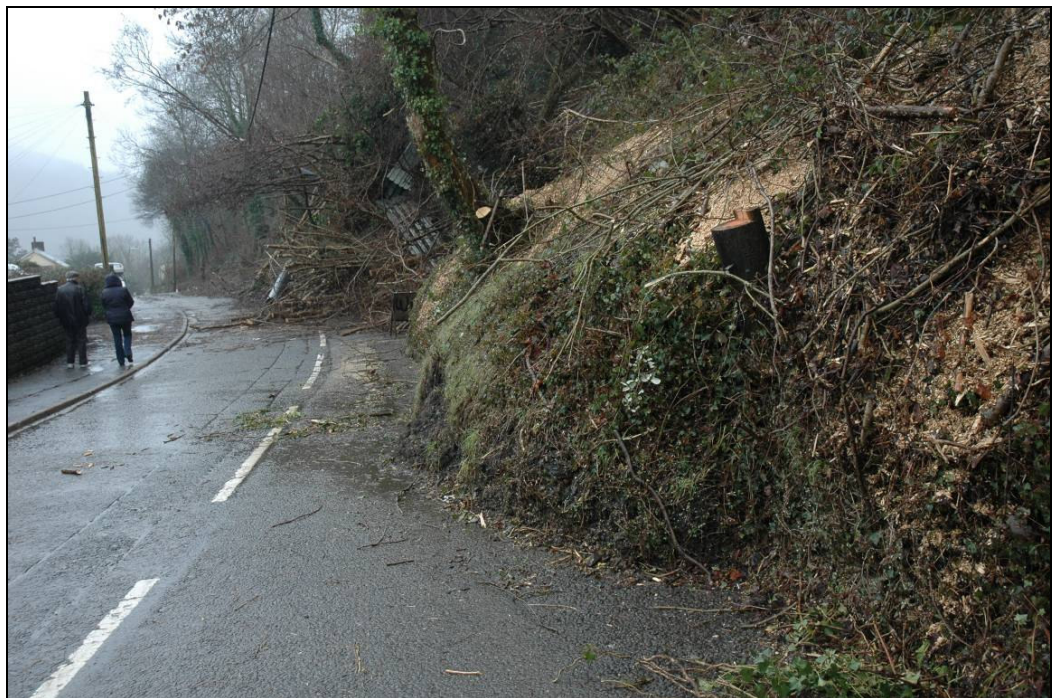
***Plate A-4: Pantteg, landslide December 2012, looking south-west from the chapel hall***

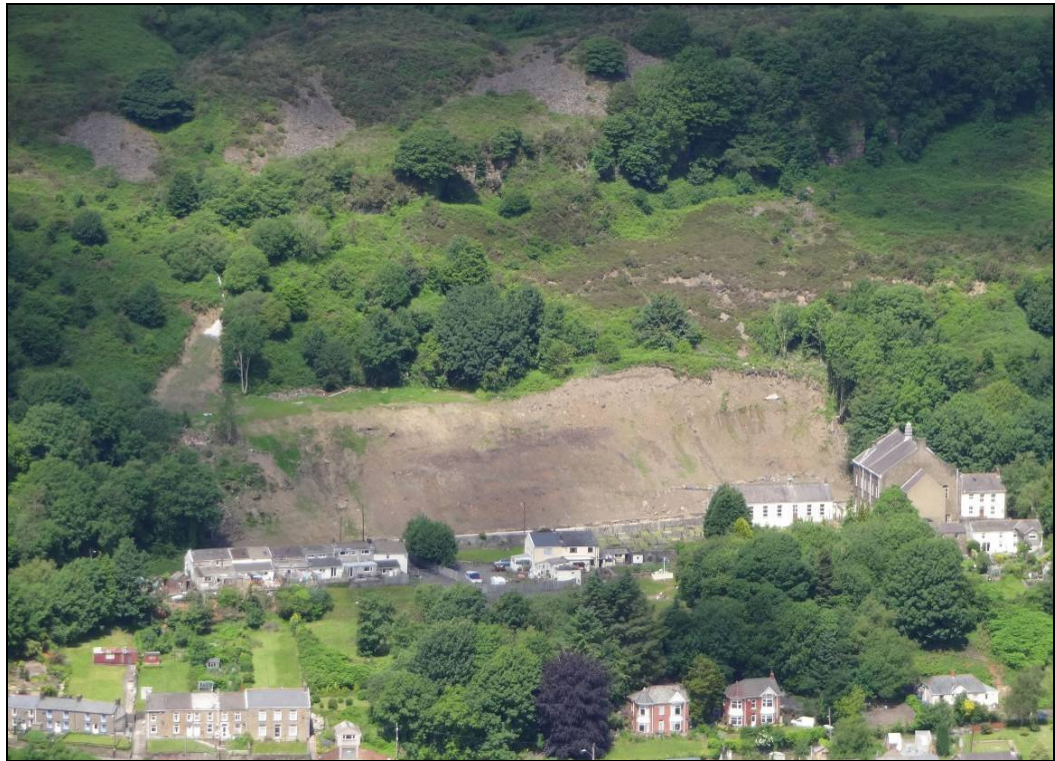
This is confirmed by the seepage line revealed following the regrading works in early 2013, as highlighted by dark staining and vegetation on Plates, A-5, A-11 and B-5.

***Plate A-5: Pantteg – overall view of 2013 regrading works***

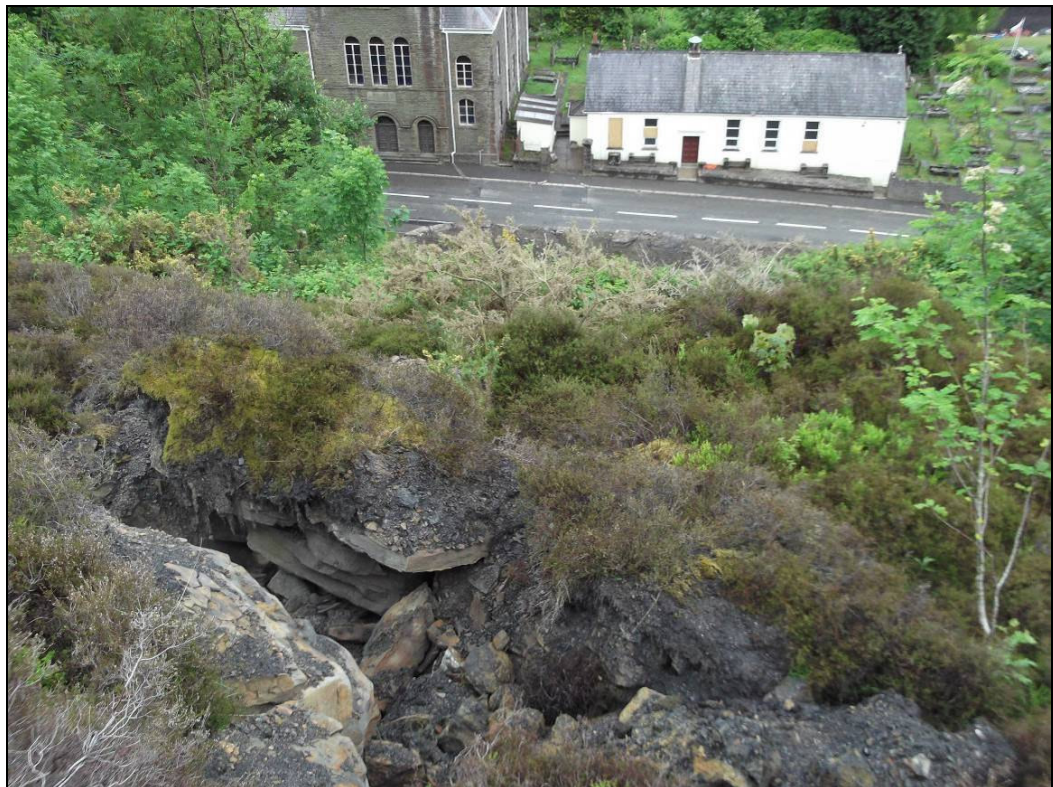
There were open fissures in the ground above the ledge, indicating downslope movement on the steep slope, which extended for a length of about 100m along the slope, opposite Pantteg Chapel and Hall; see Plates A-8 to A-10 in Appendix A. It appears that the fissuring extends beyond the northern extent of the recent failure and to the rear of numbers 21, 23 and 25 Pantteg, roughly corresponding to the

**Plate A-8: View down to Pantteg chapel from fissures above 2012 failure**

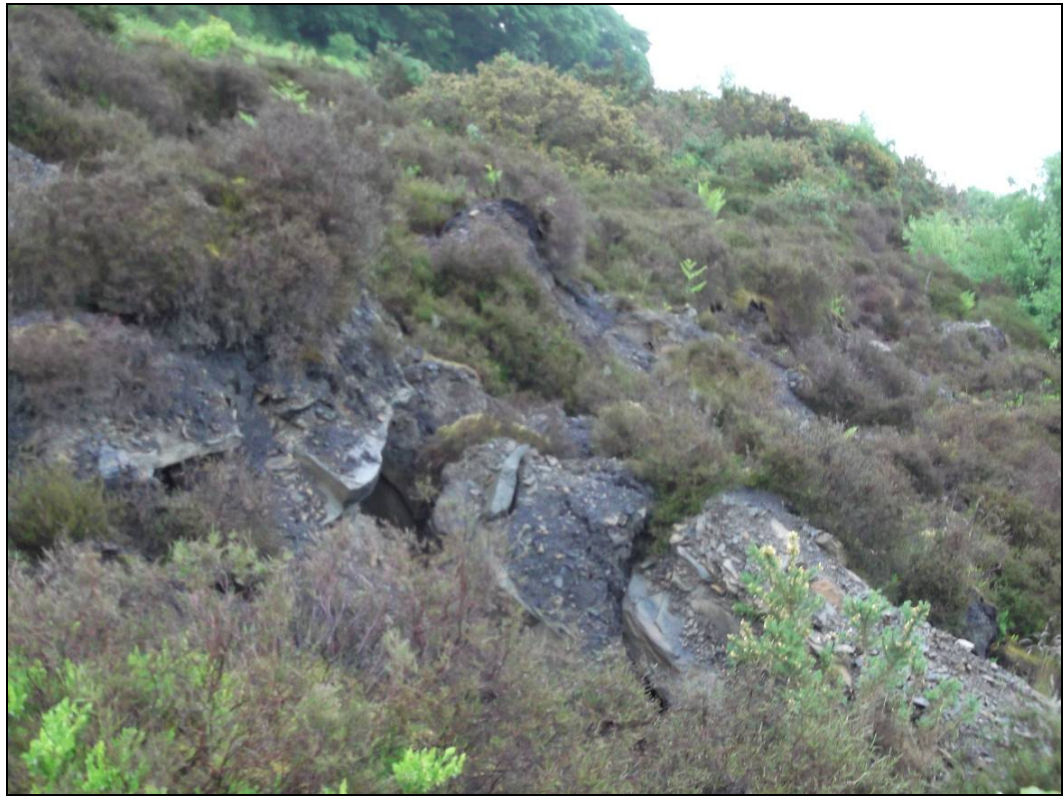
A client inspection the on 7 August 2013, following heavy rain, revealed movement of the ledge opposite the chapel at Pantteg, as anticipated during the walk over. Comparison photographs are presented in Appendix A (Plates A-9 and A-10), which show the failure of the vegetation grown ledge at the top of the regraded slope. The

***Plate A-9: Fissures in the slope above Pantteg Chapel***

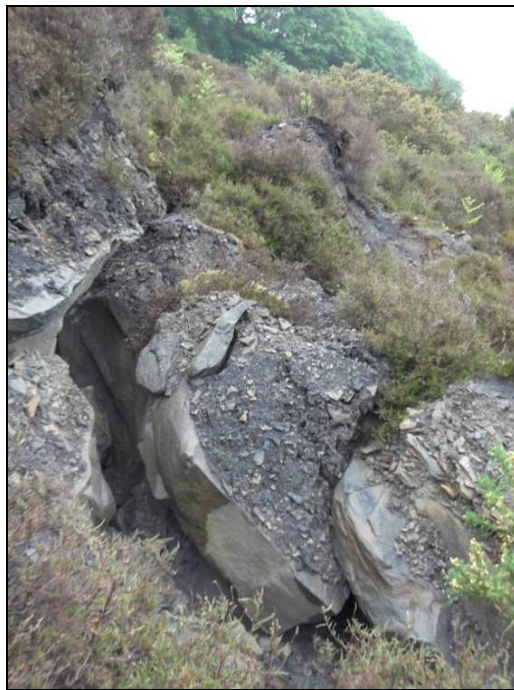
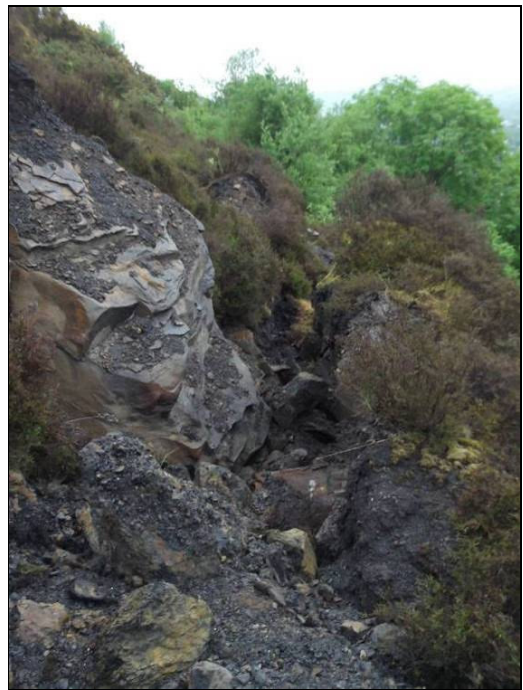
***Plate A-10: Fissures in the slope above Pantteg Chapel***

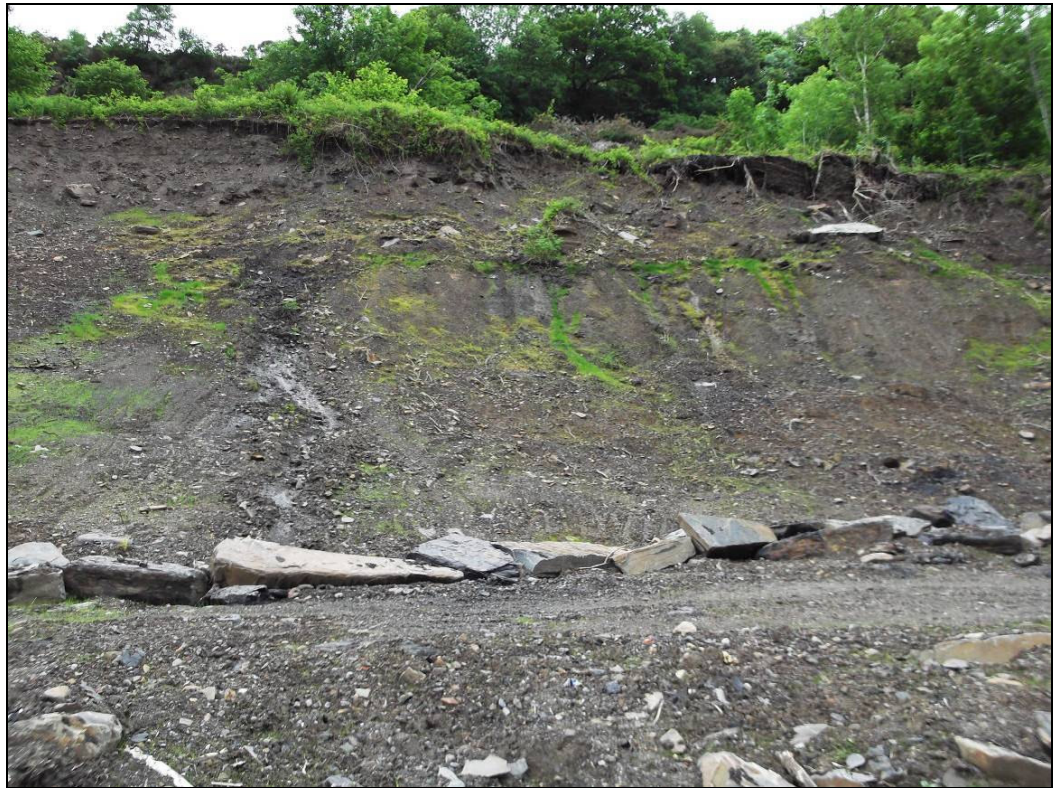
**Plate A-11: Remediated area opposite the Chapel (11-06-13)**

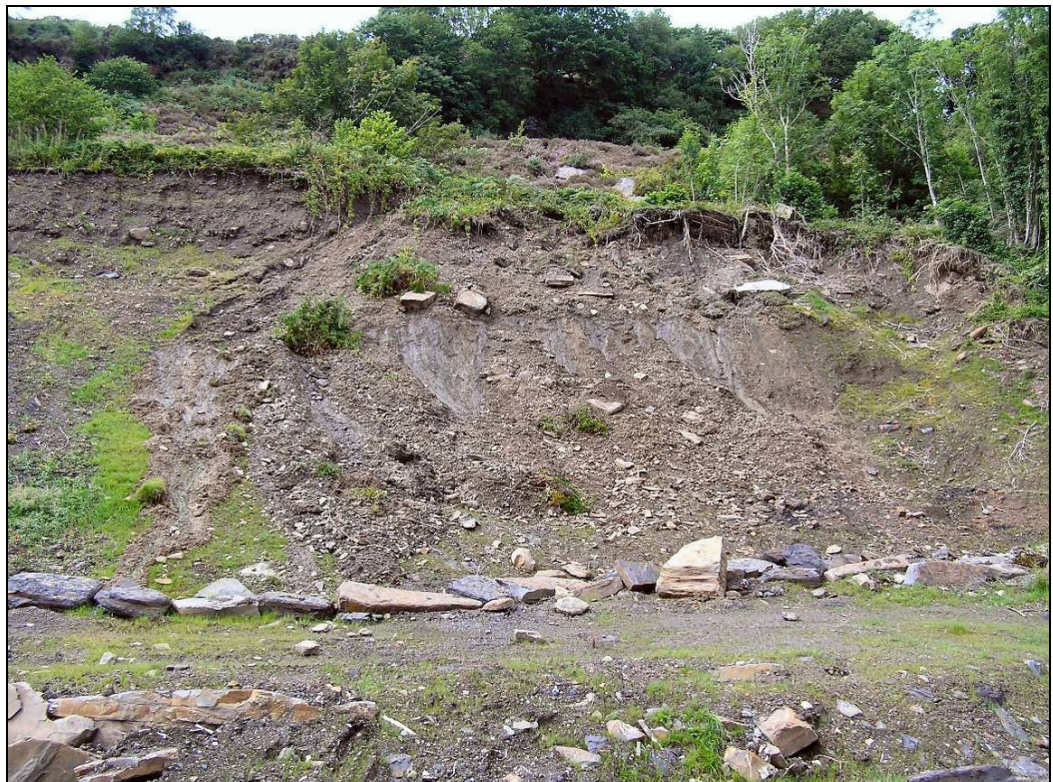
failure appears to be relatively small, only affecting the top 4 to 5m (approximately) of the regraded slope.

**Plate A-12: The same area as above on 07-08-13, showing movement of the ledge.**

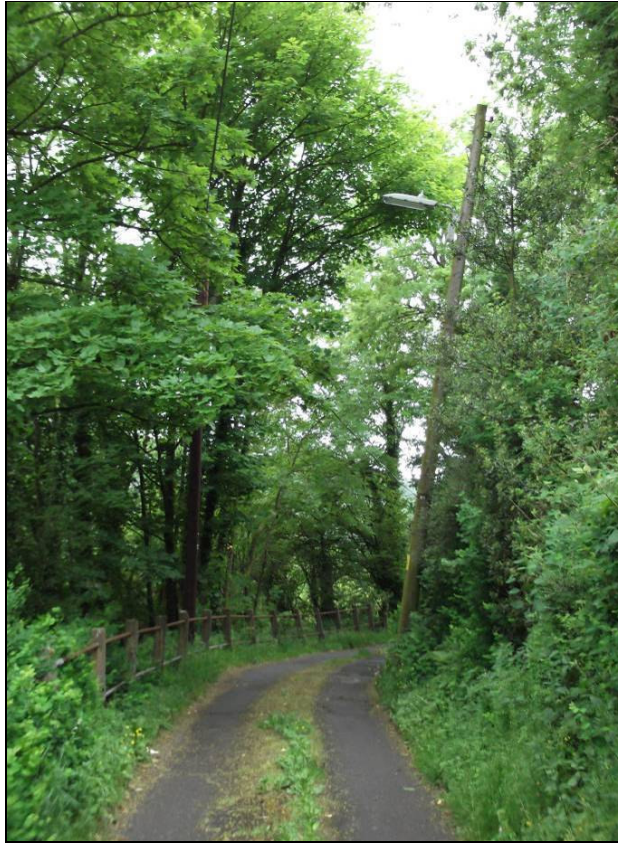
**Plate A-13: Graig-y-Merched, looking south-west**

New telegraph pole on the left, approximately vertical.

On the right is the old telegraph pole, also supporting the streetlight. This is leaning at an angle. This lean is caused by the tightness of the power cables, which have pulled the pole over into the radius of the curve, providing evidence of ground movement.

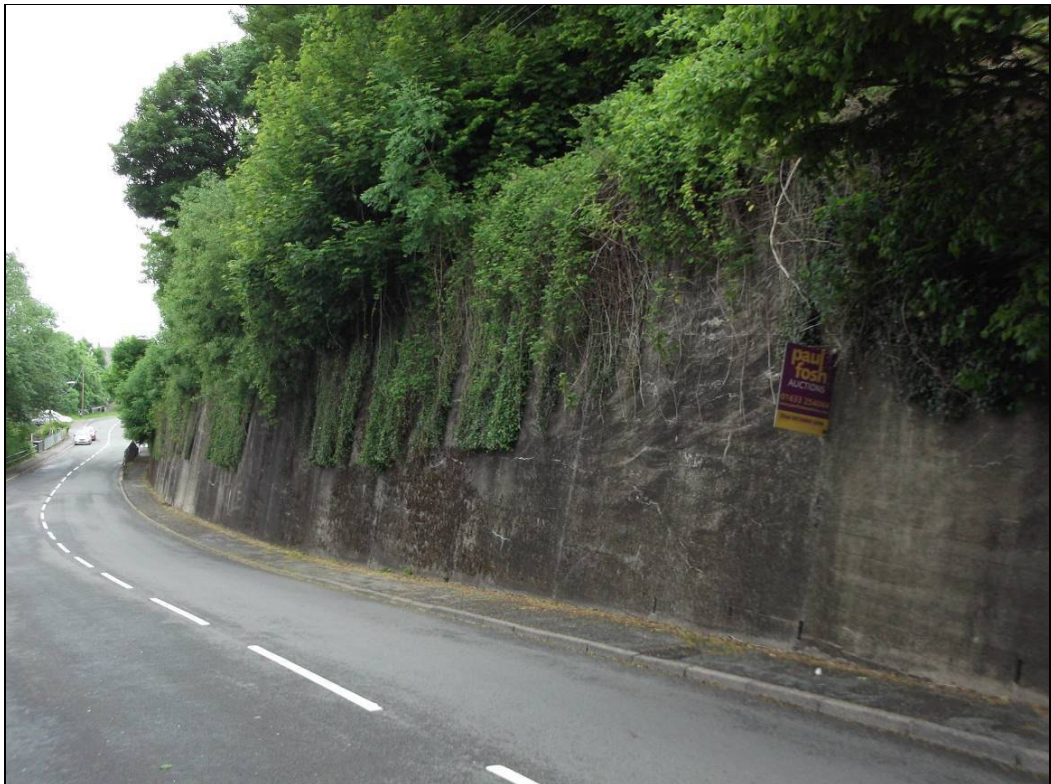
**Plate A-14: Cyfyng Road retaining wall, looking south-west – no visual evidence of distress.**

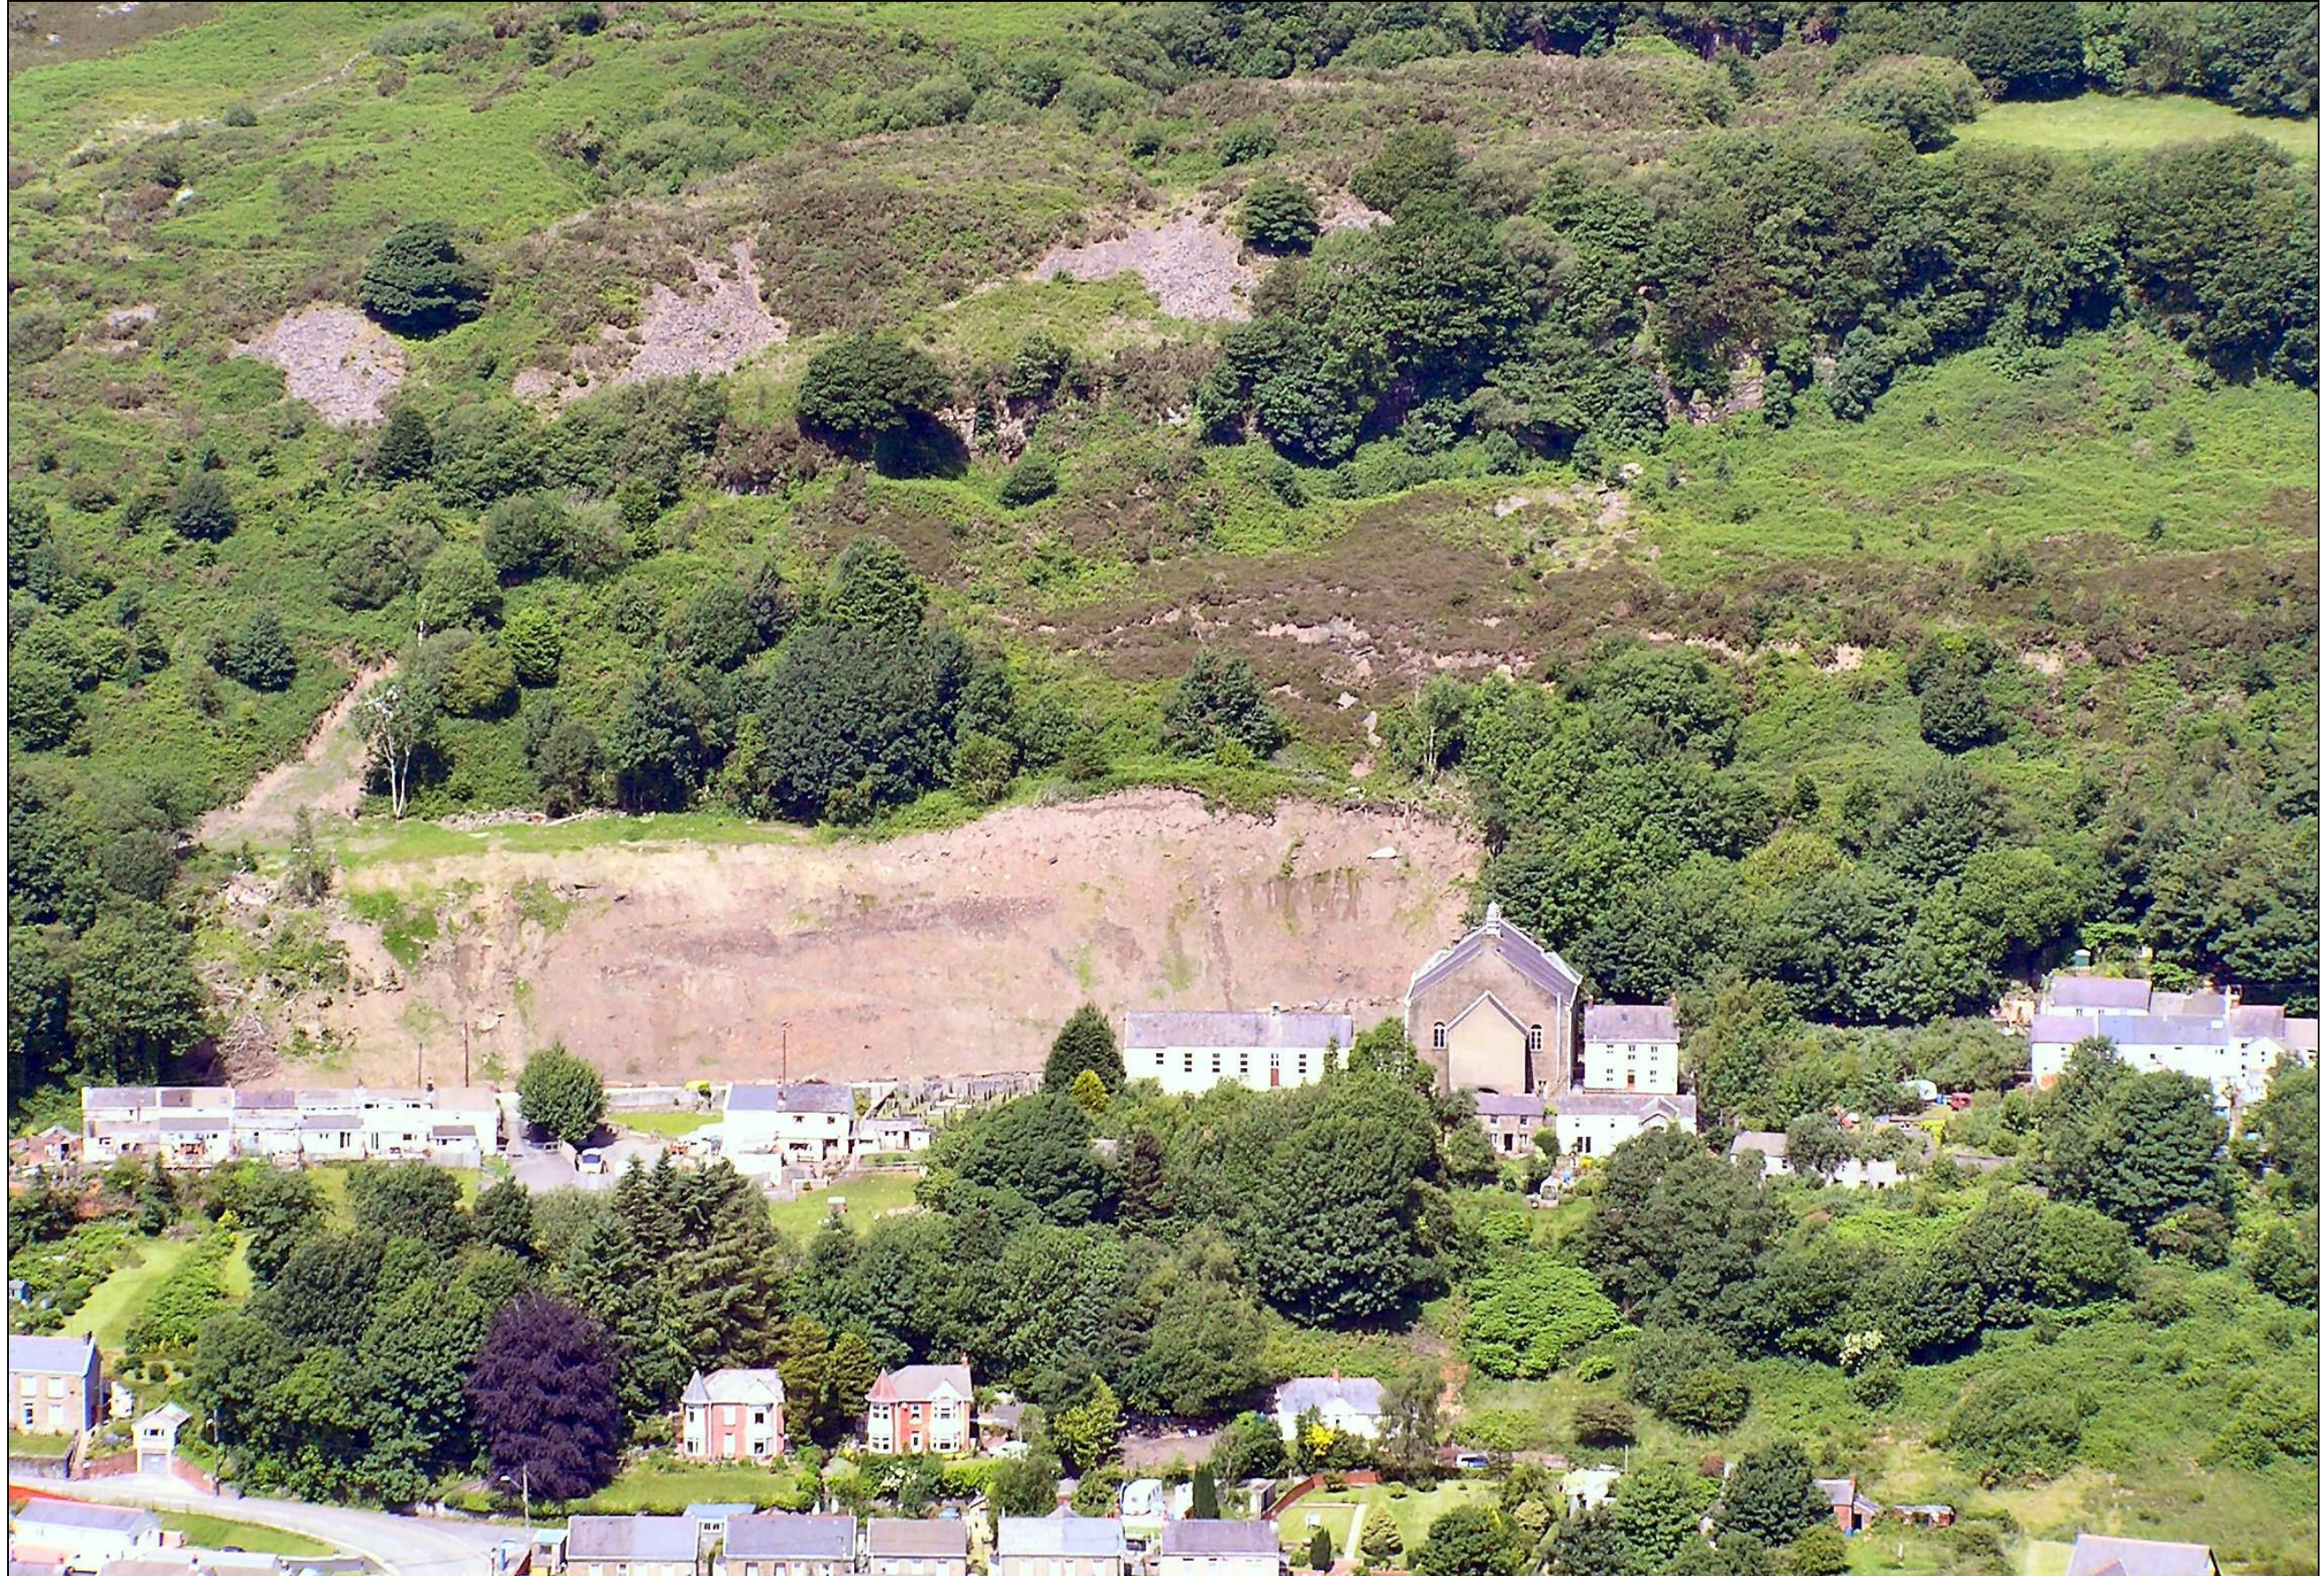
*Plate B-5: Pantteg Landslip area, showing extent of 2013 regrading works.*

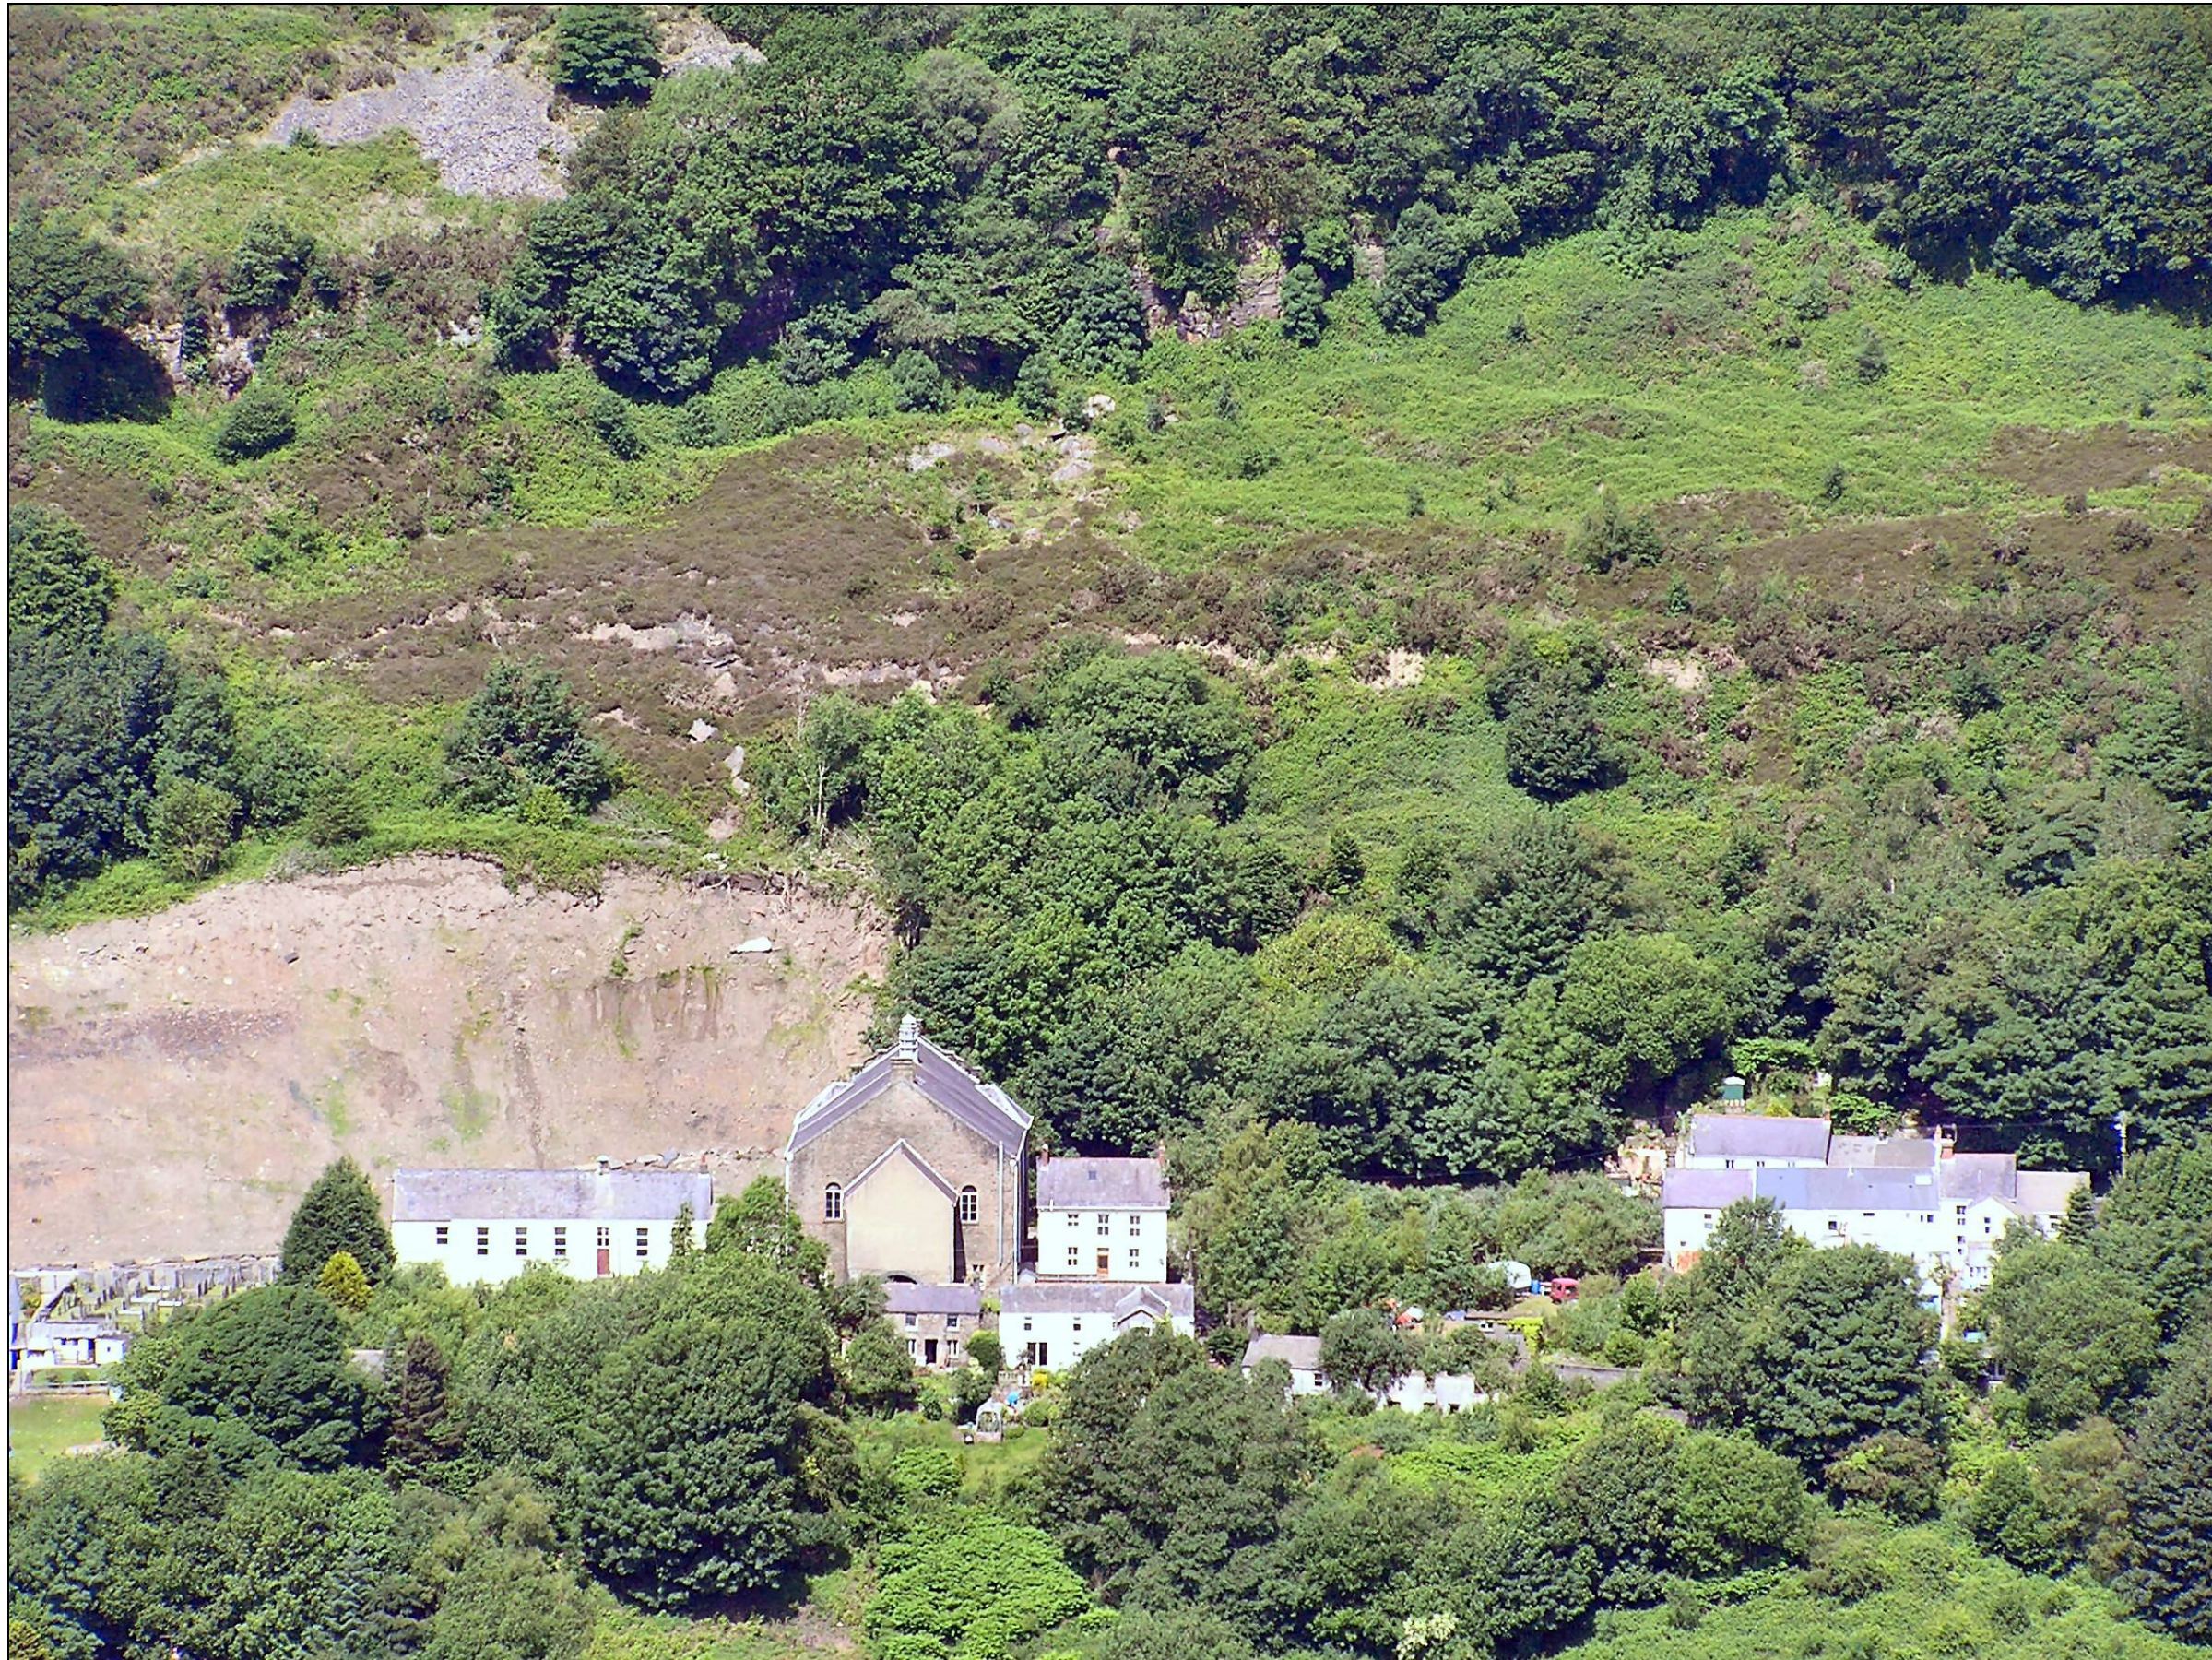
extent of the High Hazard area on the 1997 map. This can be seen on Plate B-6 in Appendix B. The fissures appear to mark the boundary between the Upper and Lower landslide systems.

*Plate B-6: Pantteg Landslip area, showing extent of the fissuring on the hillside above the 2013 regrading.*

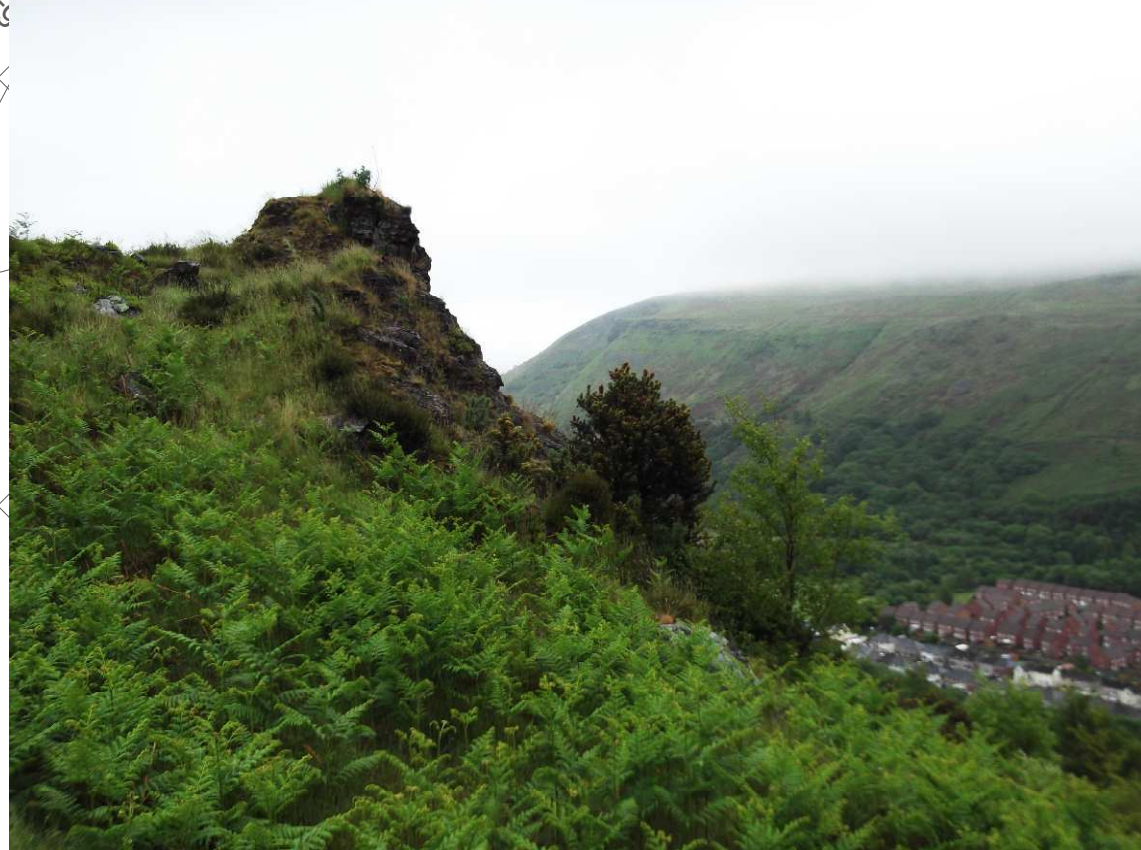
UNSTABLE SANDSTONE OUTLIER

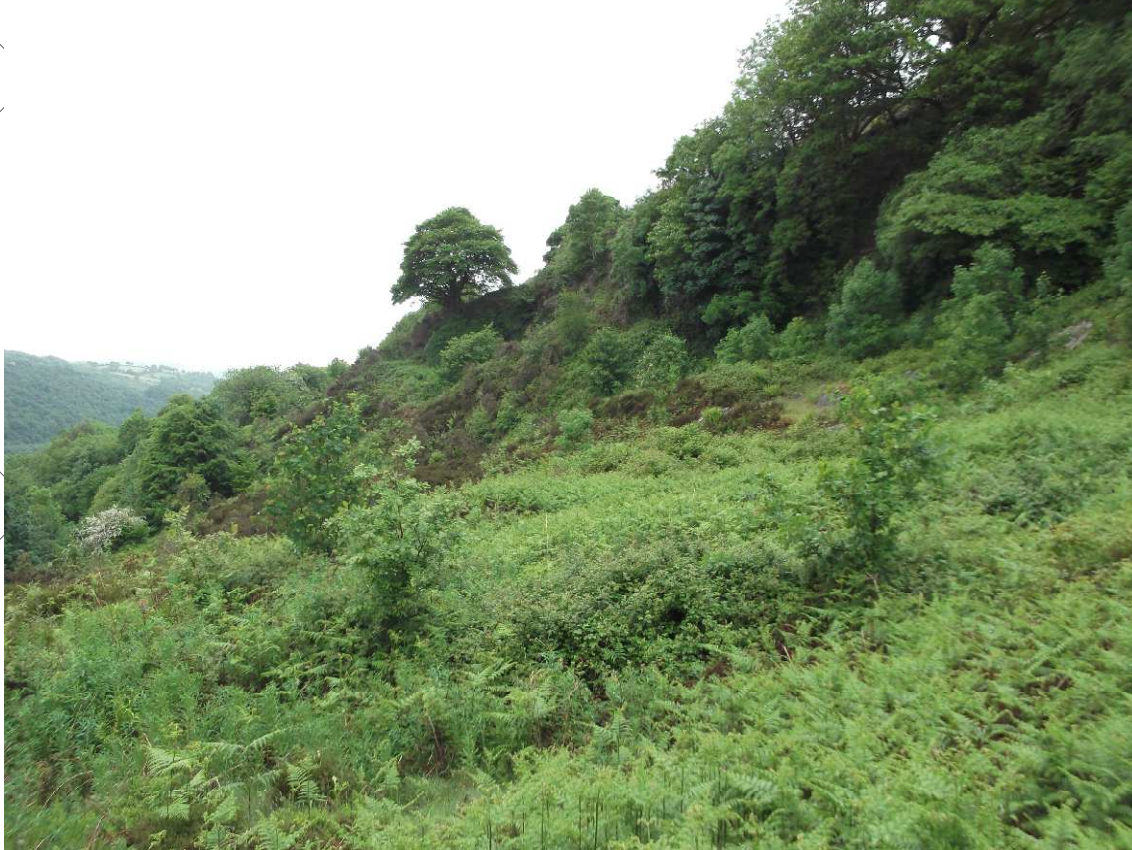
UPPER LANDSLIP SYSTEM TERRACE. NOTE CLIFFS IN LLYNFI ROCK SANDSTONE

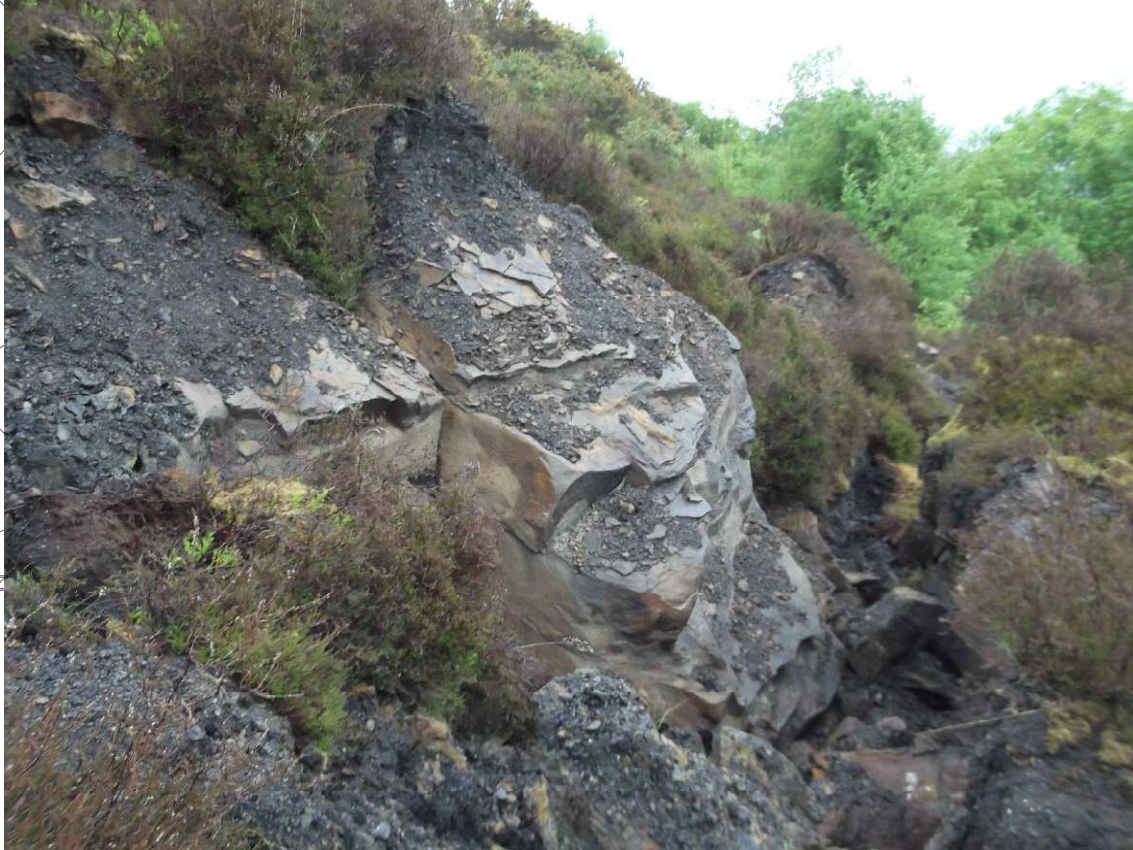
FISSURES IN TERRACE ABOVE 2012 FAILURE AREA

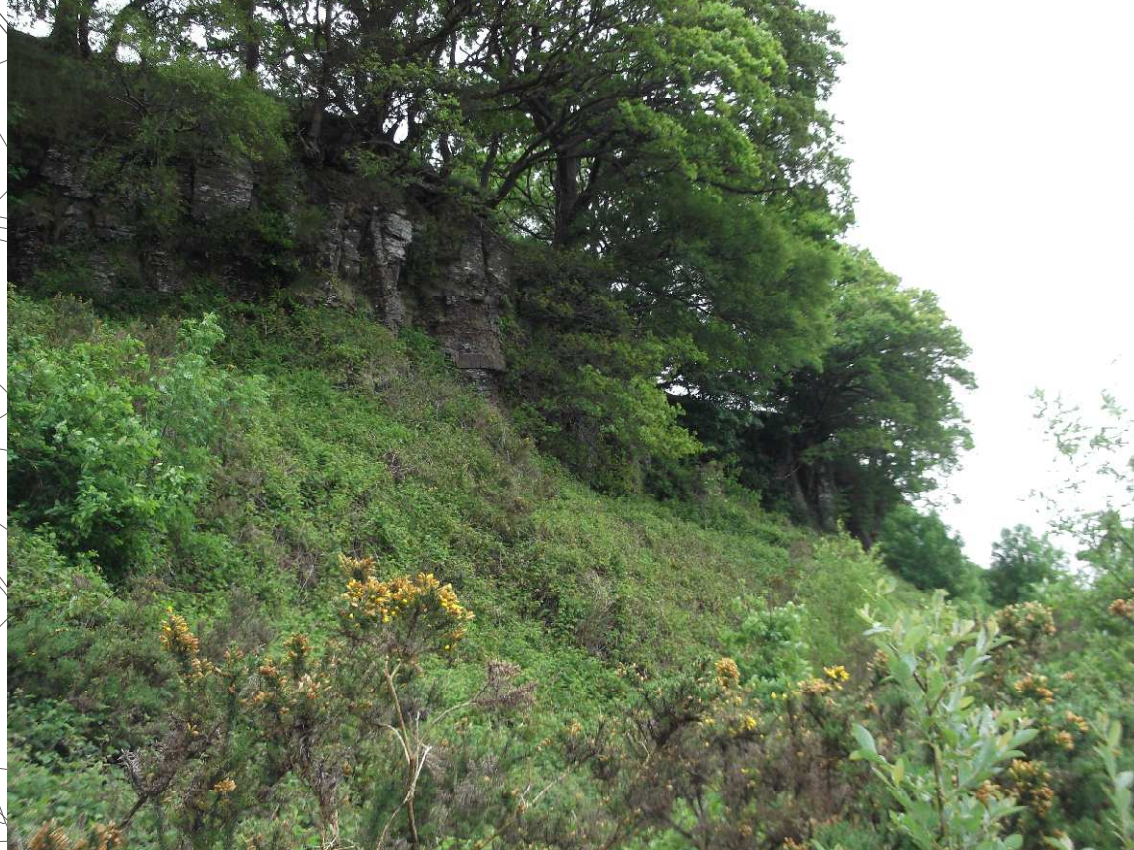
CLIFFS OF LLYNFI ROCK SANDSTONE AT BACKSCARP OF PANTTEG LANDSLIP

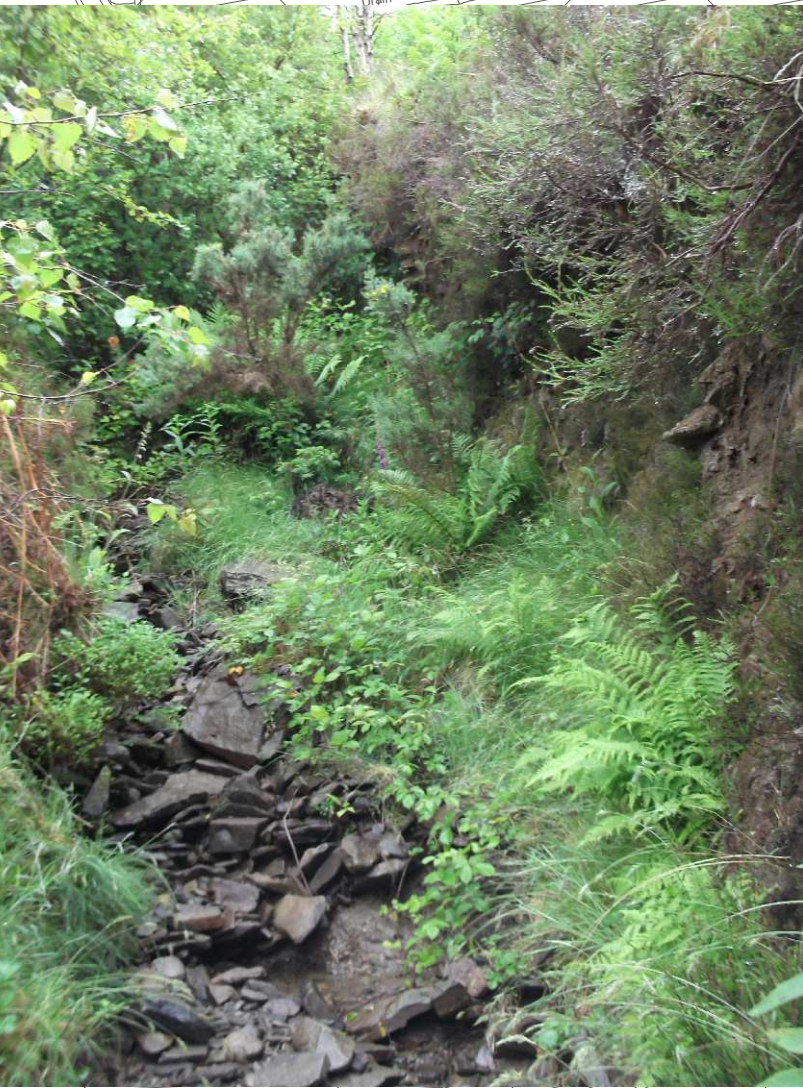
DEEPLY ERODED CILBRWYN STREAM AT FOOTPATH

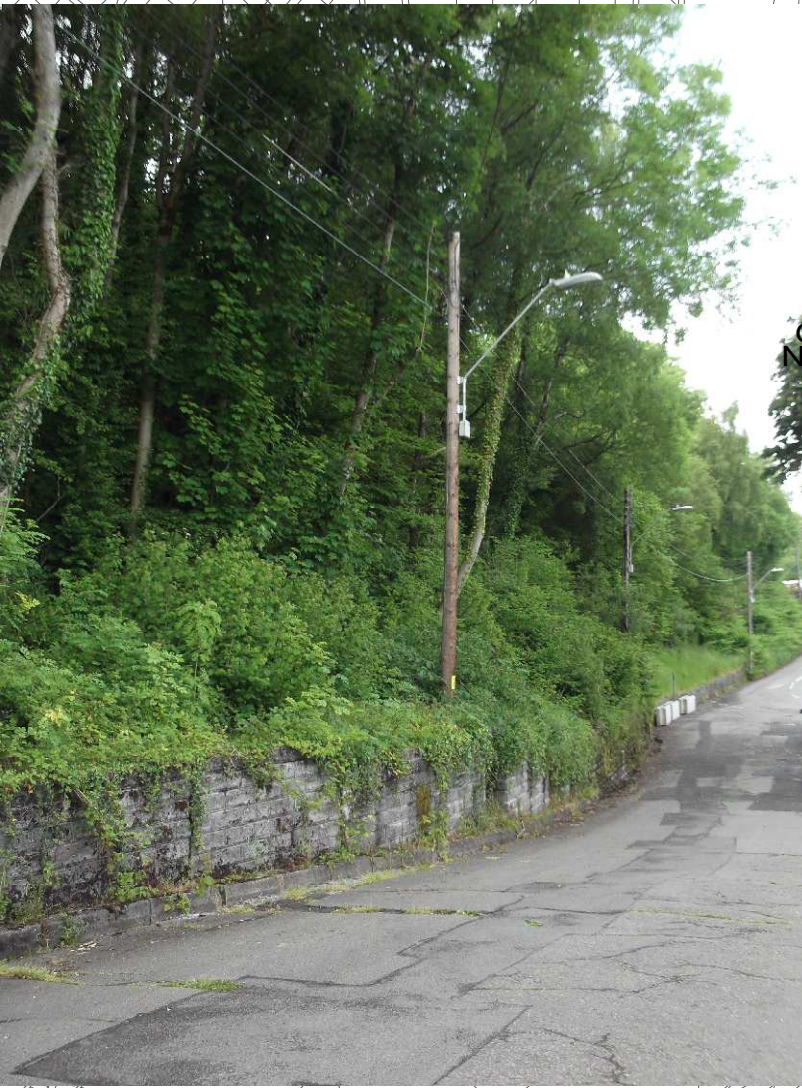
EAST END OF GRAIG ROAD, HEAVILY OVERGROWN, WET AND BULGING
