## **Pantteg and Godre'r-Graig Landslips Slope Stability Review**

**December 2013**

**Report No: B15974EX / 12858 / R5095**

**Project:** Pantteg and Godre'r-Graig Landslips  
**Client:** Neath Port Talbot County Borough Council **Project No:** B15974EX  
**Document title:** Slope Stability Review  
**Ref. No:** B15974EX / 12858 / R5095

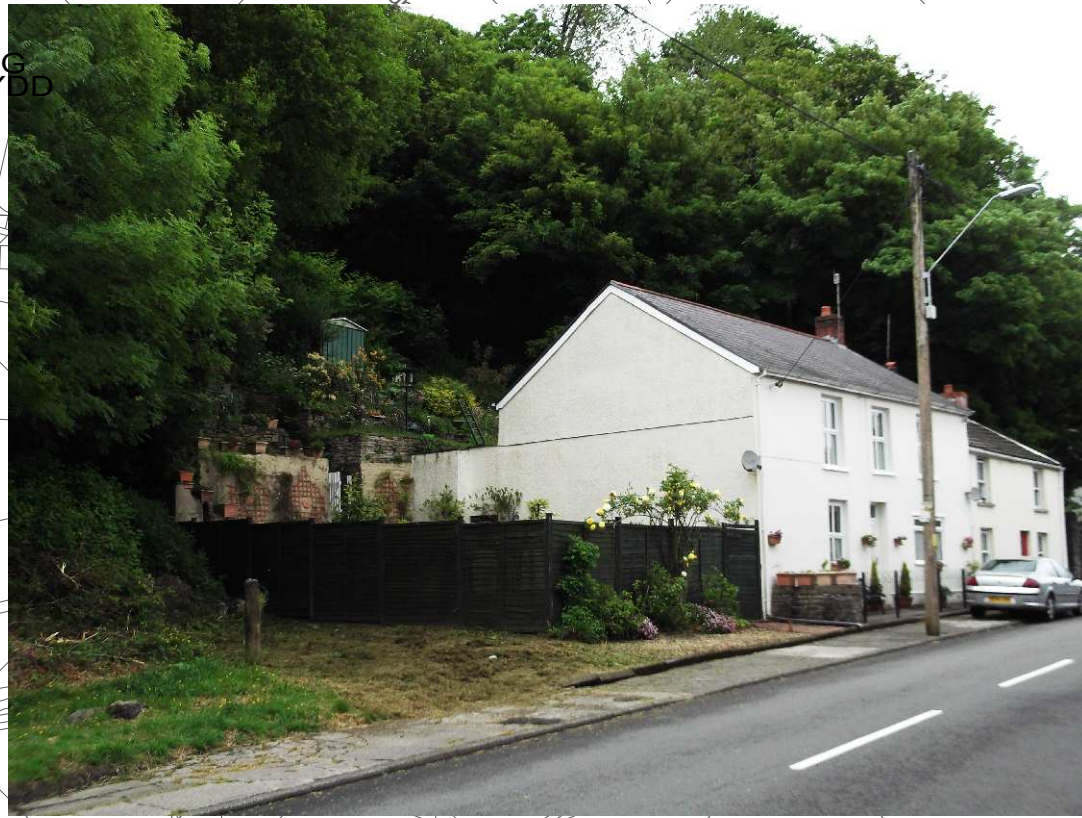
21-27 PANTTEG, SHOWING PROXIMITY OF SLOPE TO REAR OF PROPERTIES

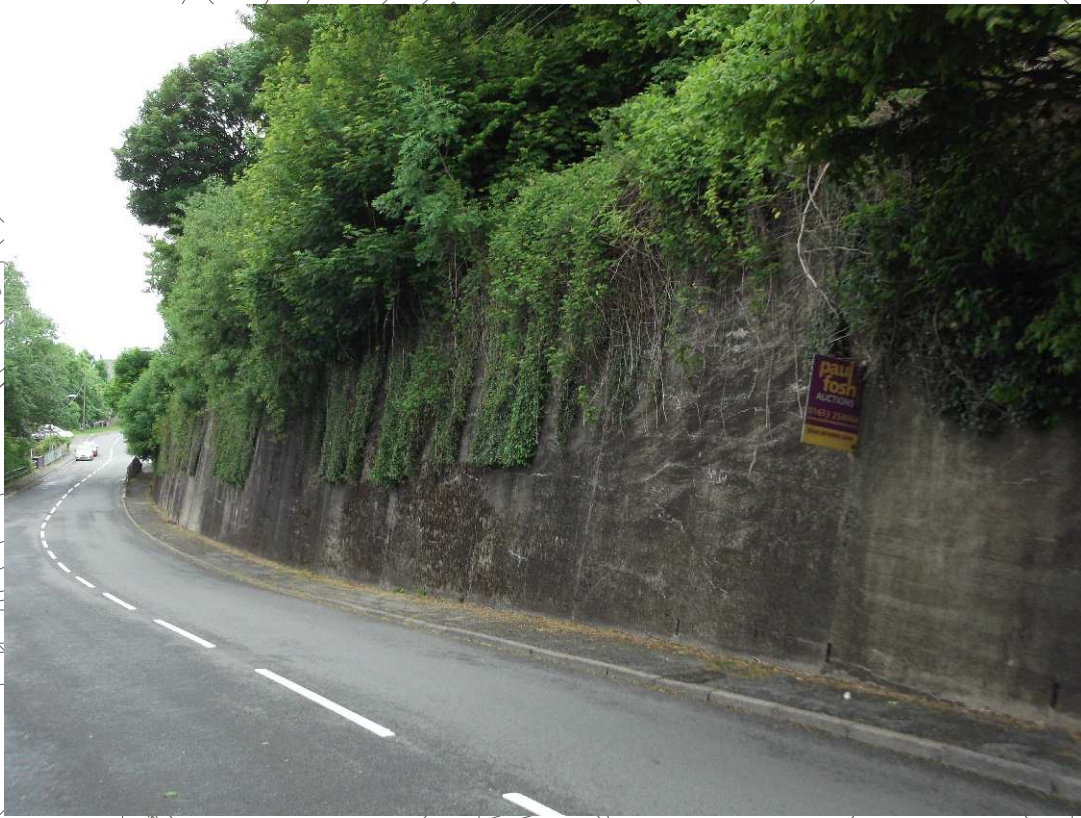
CYNFYNG ROAD RETAINING WALL (NO SIGNS OF DISTRESS)

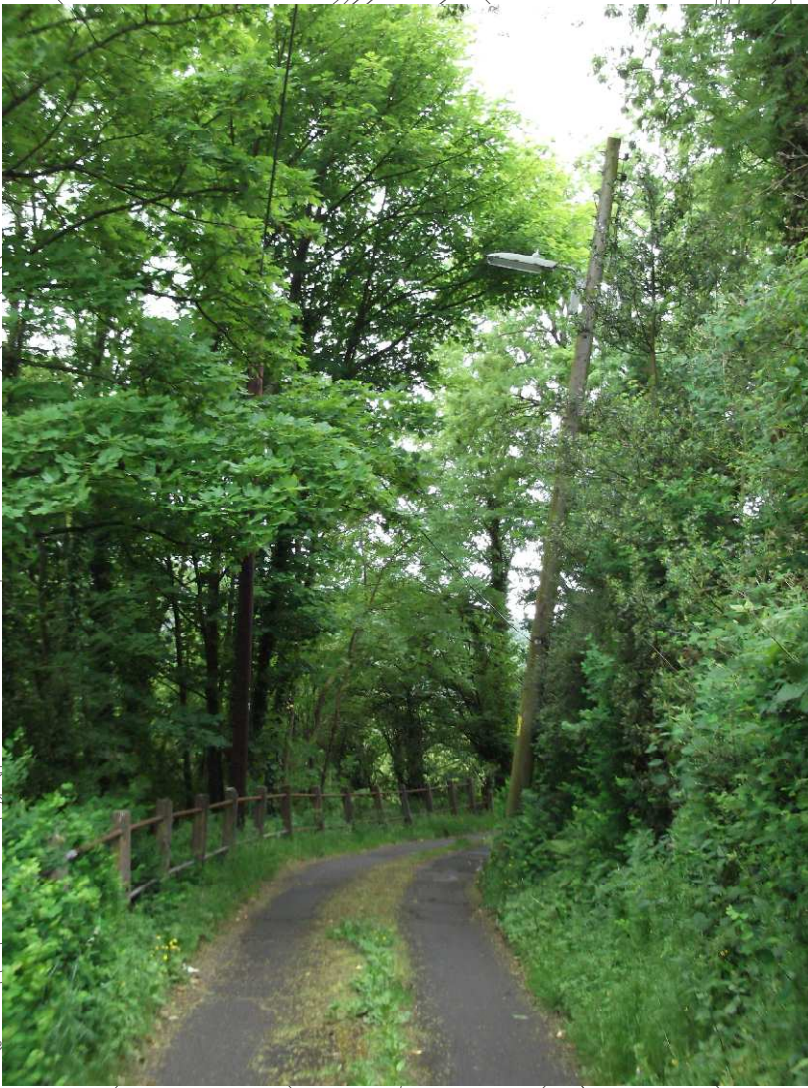
LEANING TELEGRAPH POLE ON GRAIG-Y-MERCHED CAUSED BY GROUND MOVEMENT
