**The Coal  
Authority**

## **Site Inspection Report**

### **Pen y Graig Quarry, Ystalyfera**

**Date: January 2018**

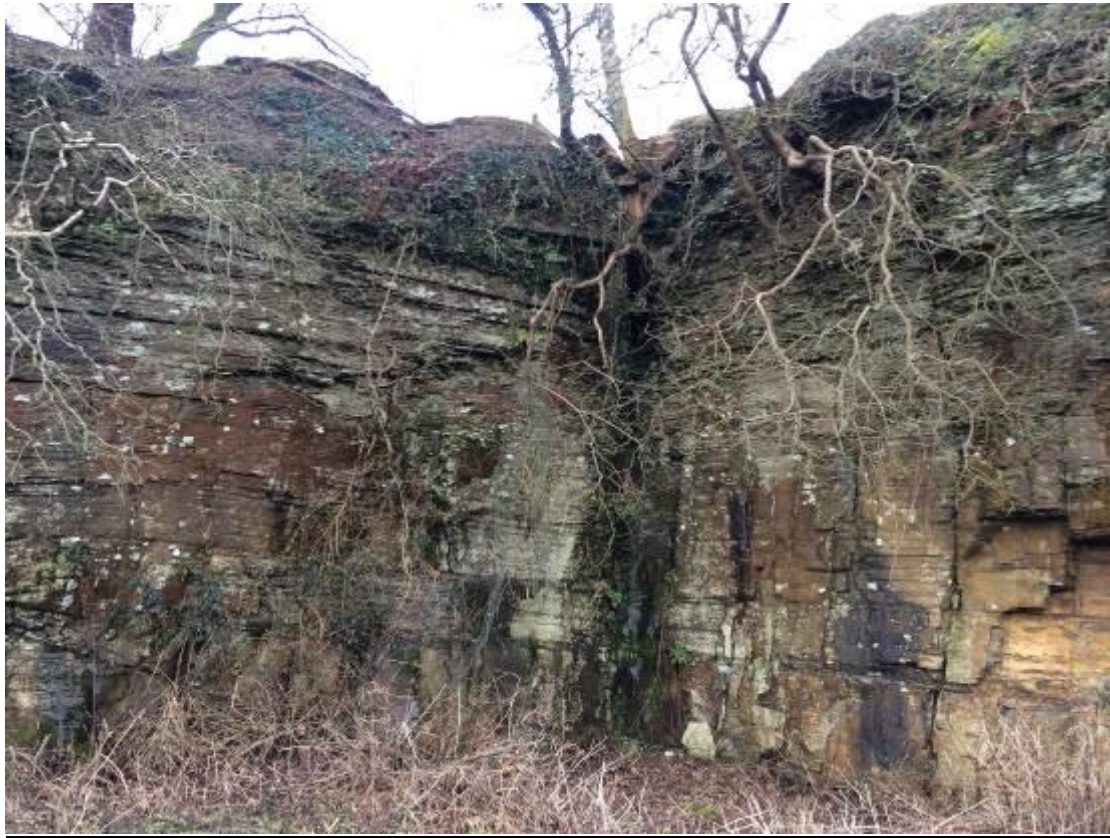
There was no evidence of significant loose or overhanging blocks other than areas where fallen trees have disturbed the strata. Numerous seepages were noted from the high wall face, generally at the interface of sandstone / siltstone units (Photograph 3). An area of uprooted and fallen trees was observed at the mid-point just below the crest (Photograph 6). These features were observed during the previous inspection and have not altered significantly.

**Photograph 3 – Quarry high wall showing seepages**

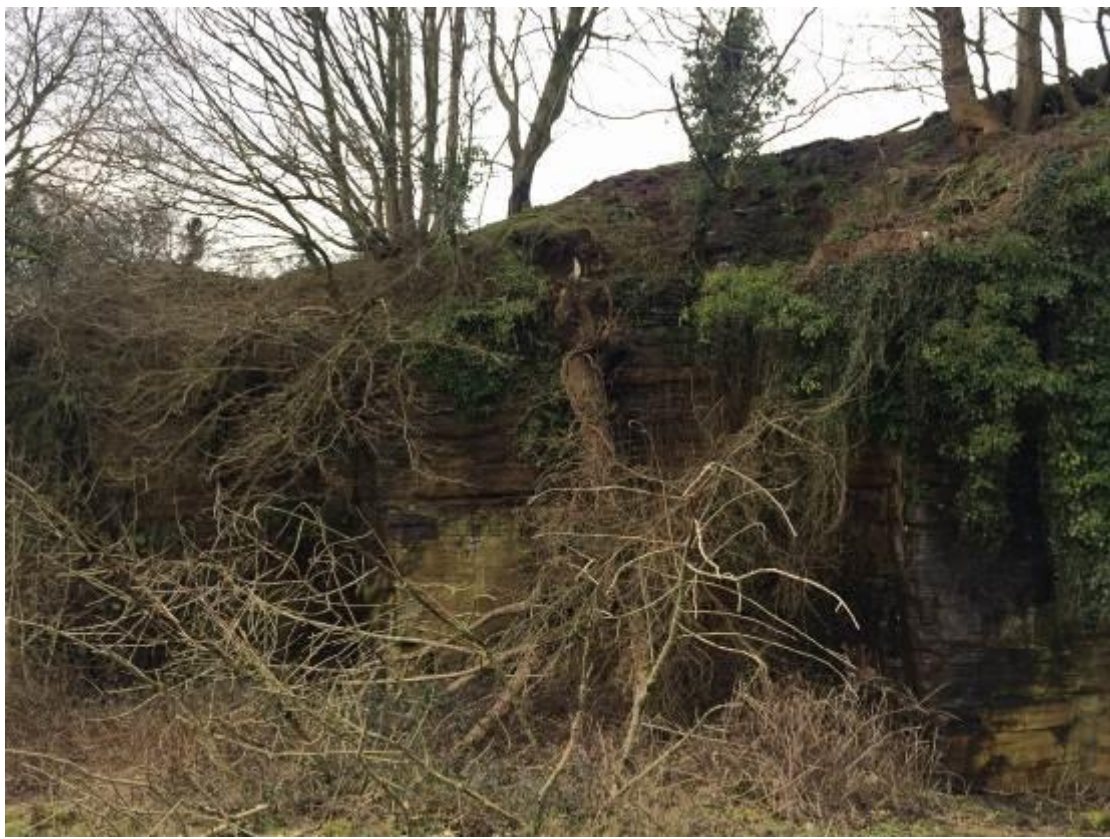
**Photograph 6 – Fallen trees at crest of high wall**

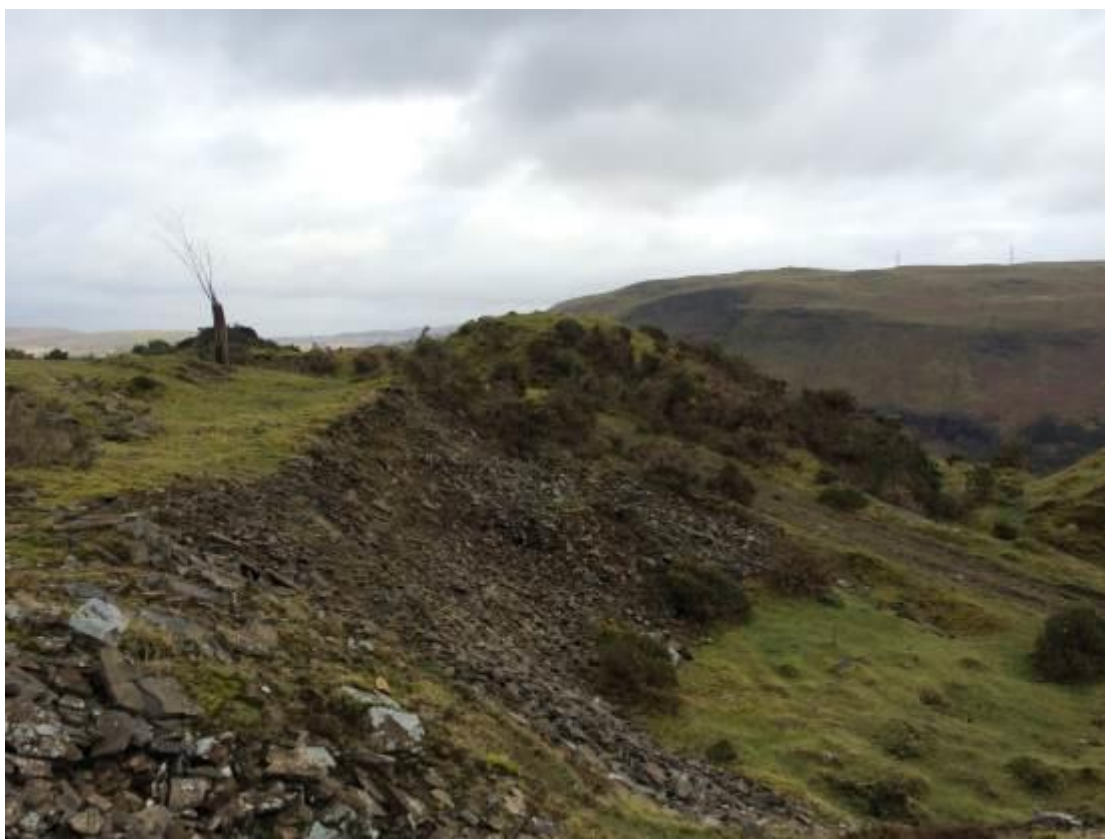
**Photograph 10 – Bare spoil mounds at northern edge perimeter of site**

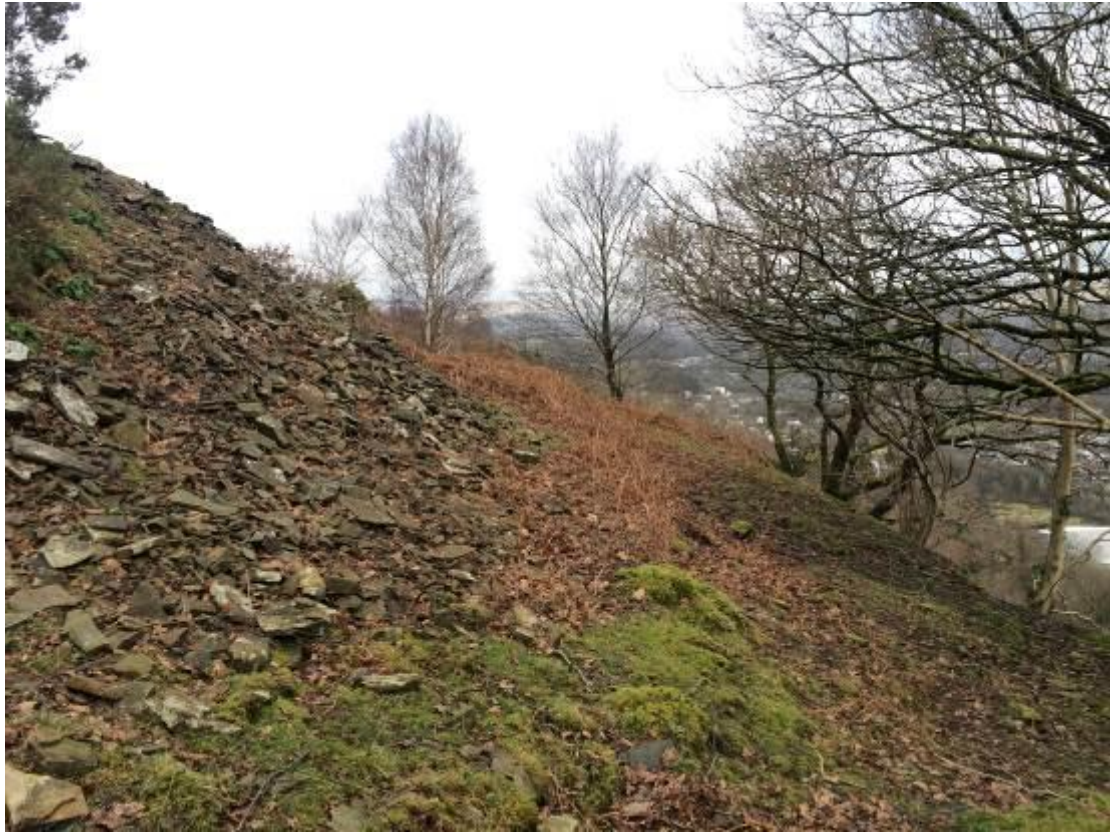
**Photograph 13 – Toe of spoil mound along cliff edge**

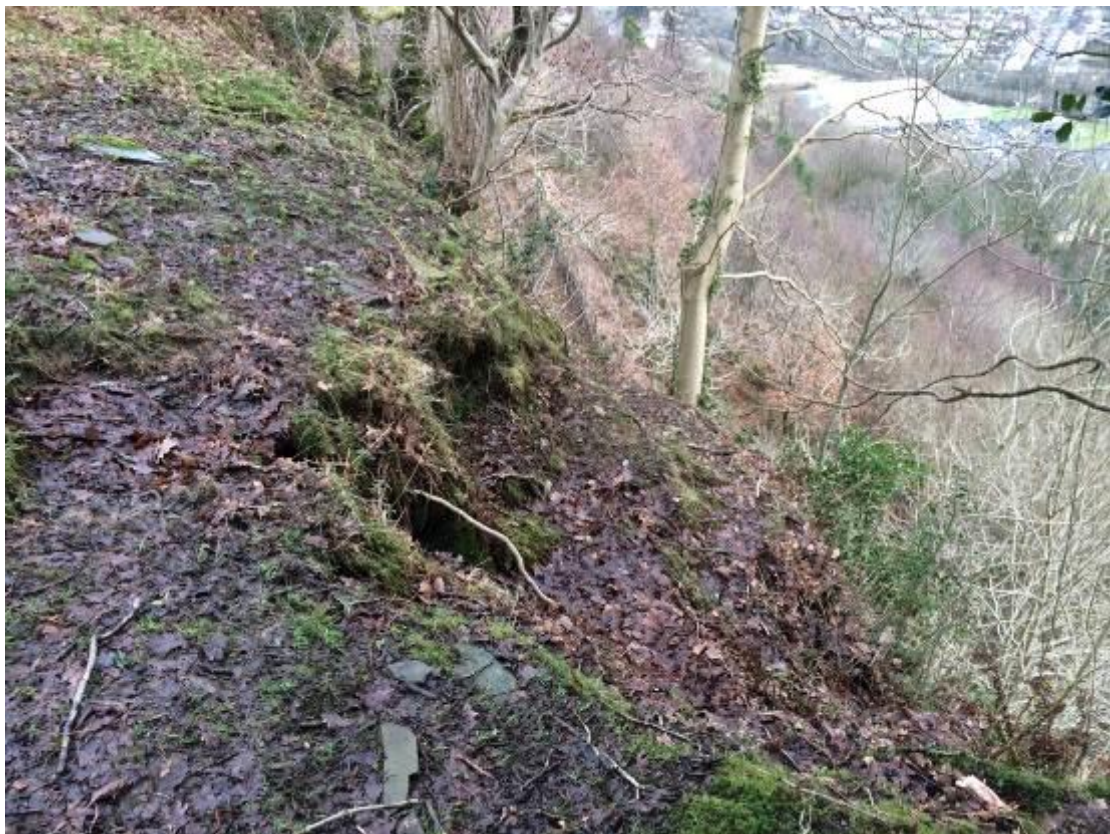
Following recent vegetation clearance, a small shallow circular slip was evident at the south east corner, at the crest of the cliff face (Photographs 14 & 15). The slip appears to be fresh and is likely to be a consequence of surface water flows emanating from the toe of the adjacent rock tip. A minor flow of water from the toe was evident during inspection.

Localised spalling and surface erosion of the bare spoil mound sections adjacent the cliff edge may result in small amounts of spoil escaping over the cliff edge during extreme weather events. As described above, there was visual evidence of slumping at the south east corner at the crest of the cliff edge to support this scenario.

**Photograph 14 – Minor slumping at crest of cliff to south east corner**

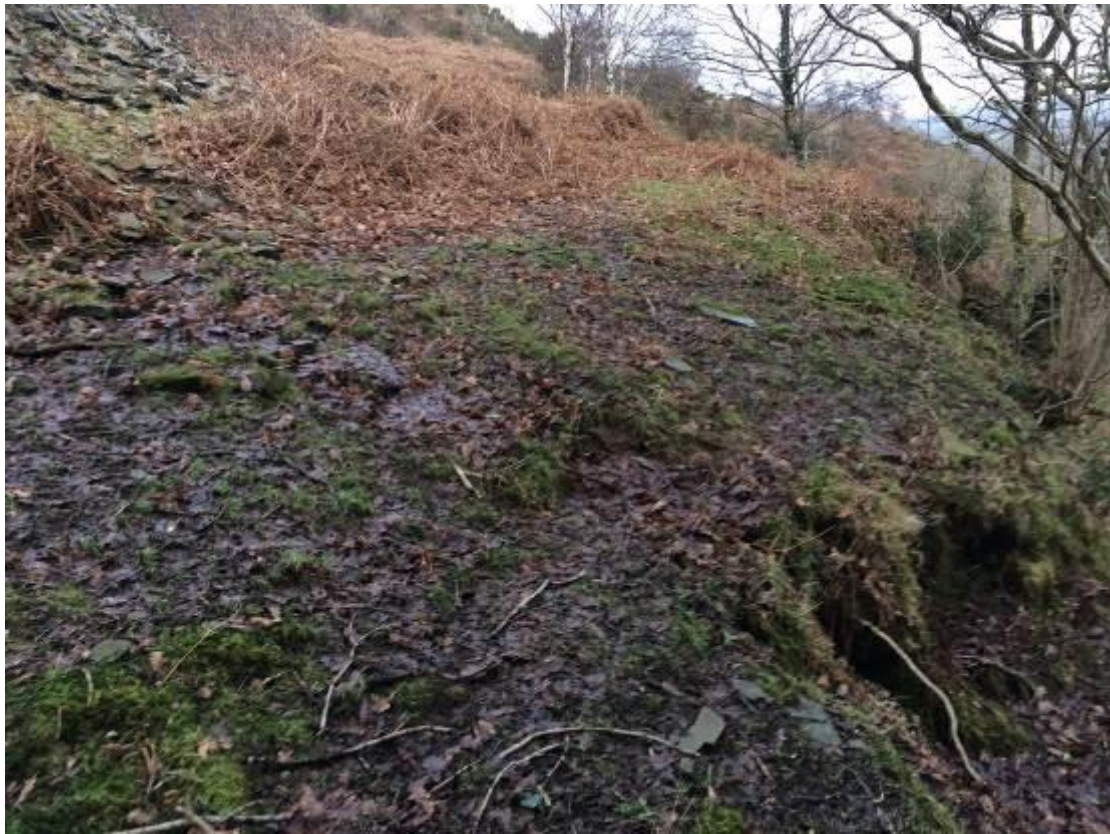
**Photograph 15 – Flow of water from toe causing cliff edge slumping**

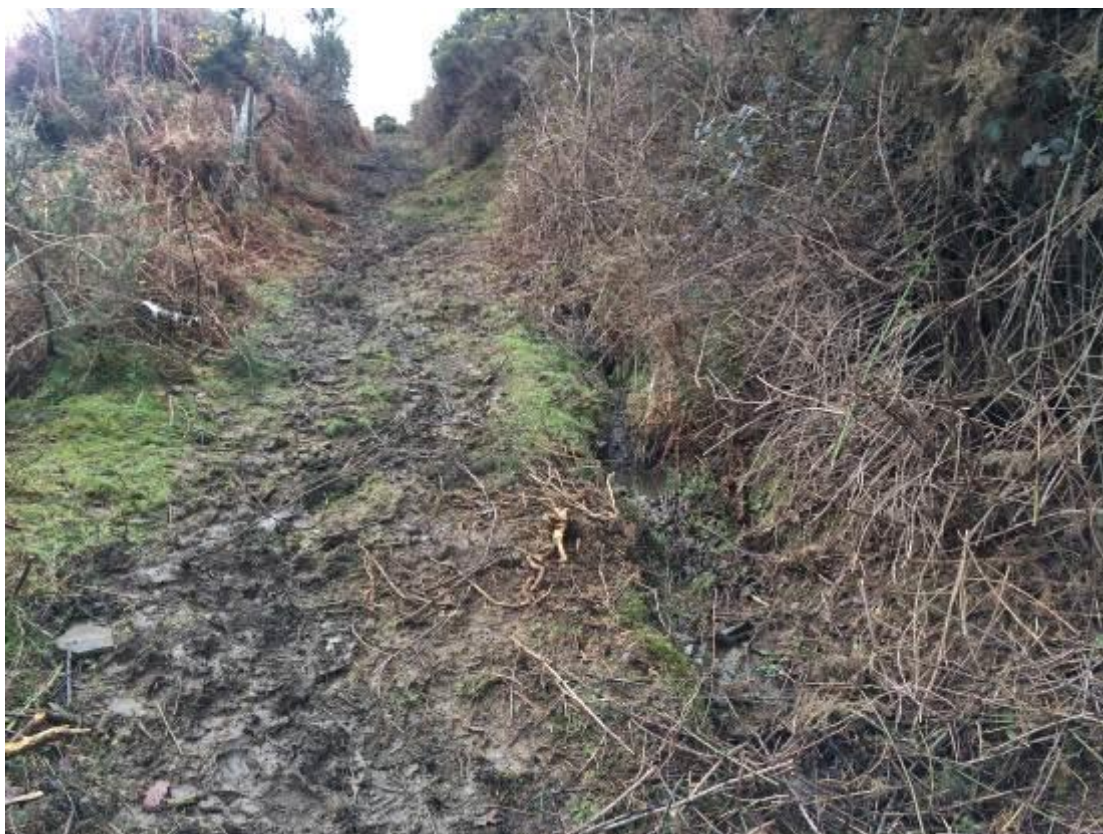
A small issue of ground water was observed emanating at the northern edge of the recently cut access track, flowing over the track and disappearing to ground approximately 50m to the south (Photographs 18, 19 & 20).

**Photograph 18 – Small issue of water alongside access track**

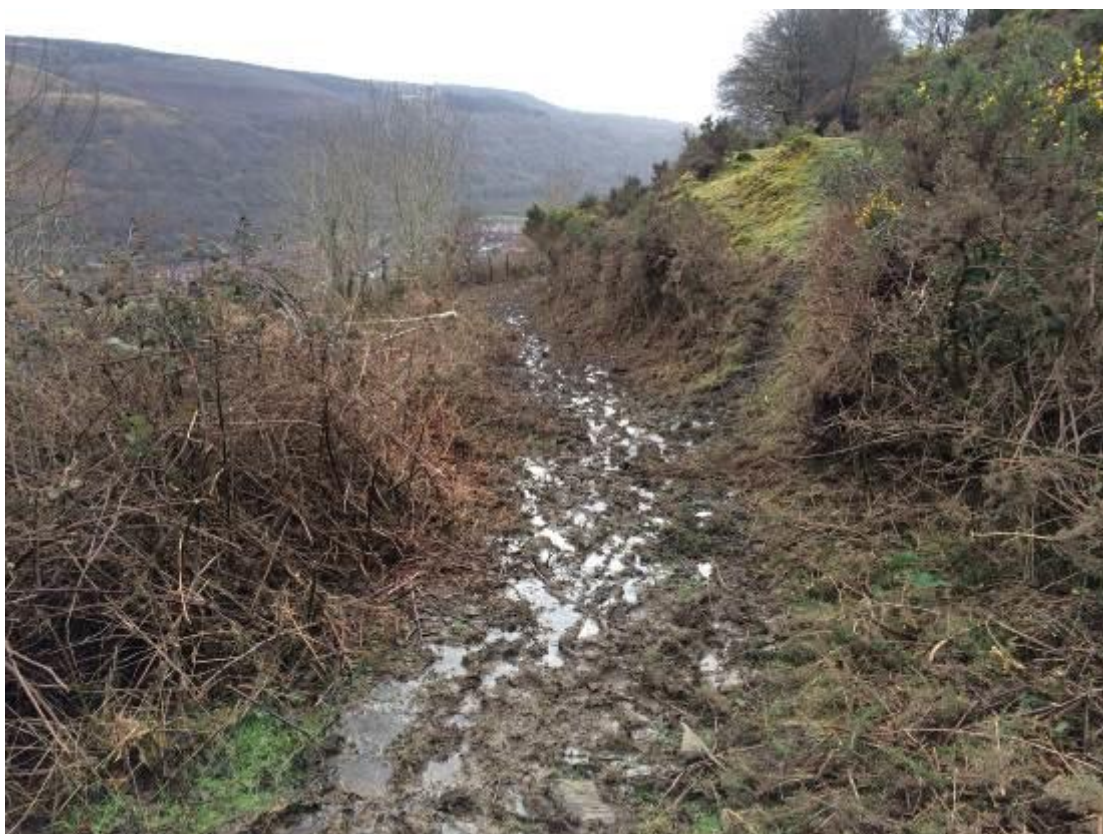
**Photograph 19 – Water flowing along route of access track**

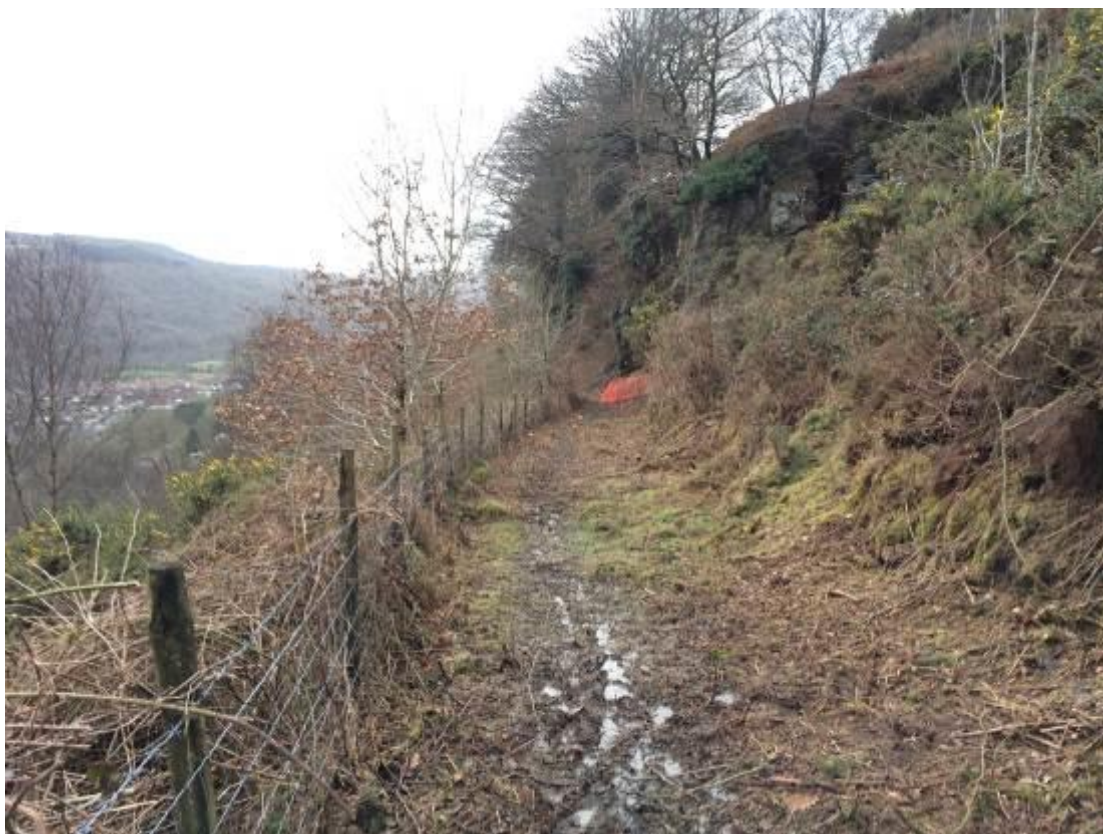
**Photograph 20 – Surface water flows disappearing to ground**

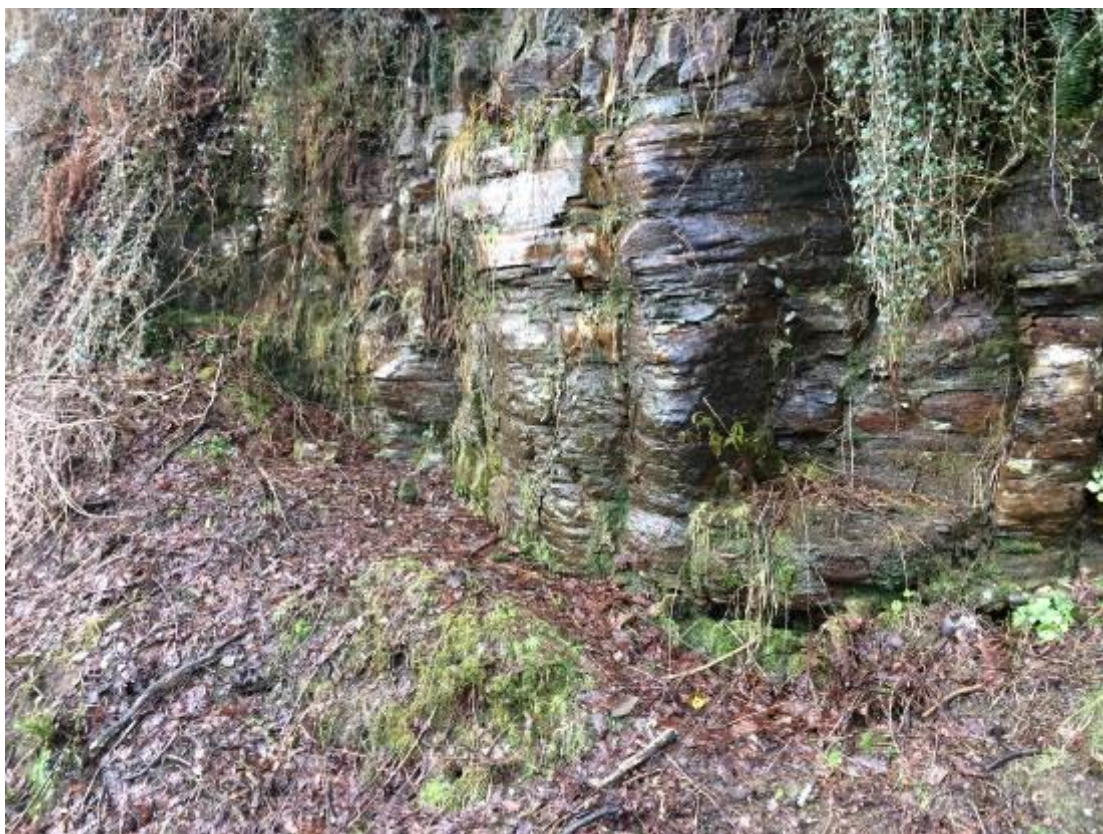
A moderate to strong seepage of groundwater was observed emanating at the mid-point of the cliff face. Flows were disappearing to ground at the base of the cliff, with no ponding present (Photograph 22).

**Photograph 22 – Moderate seepage from cliff face**

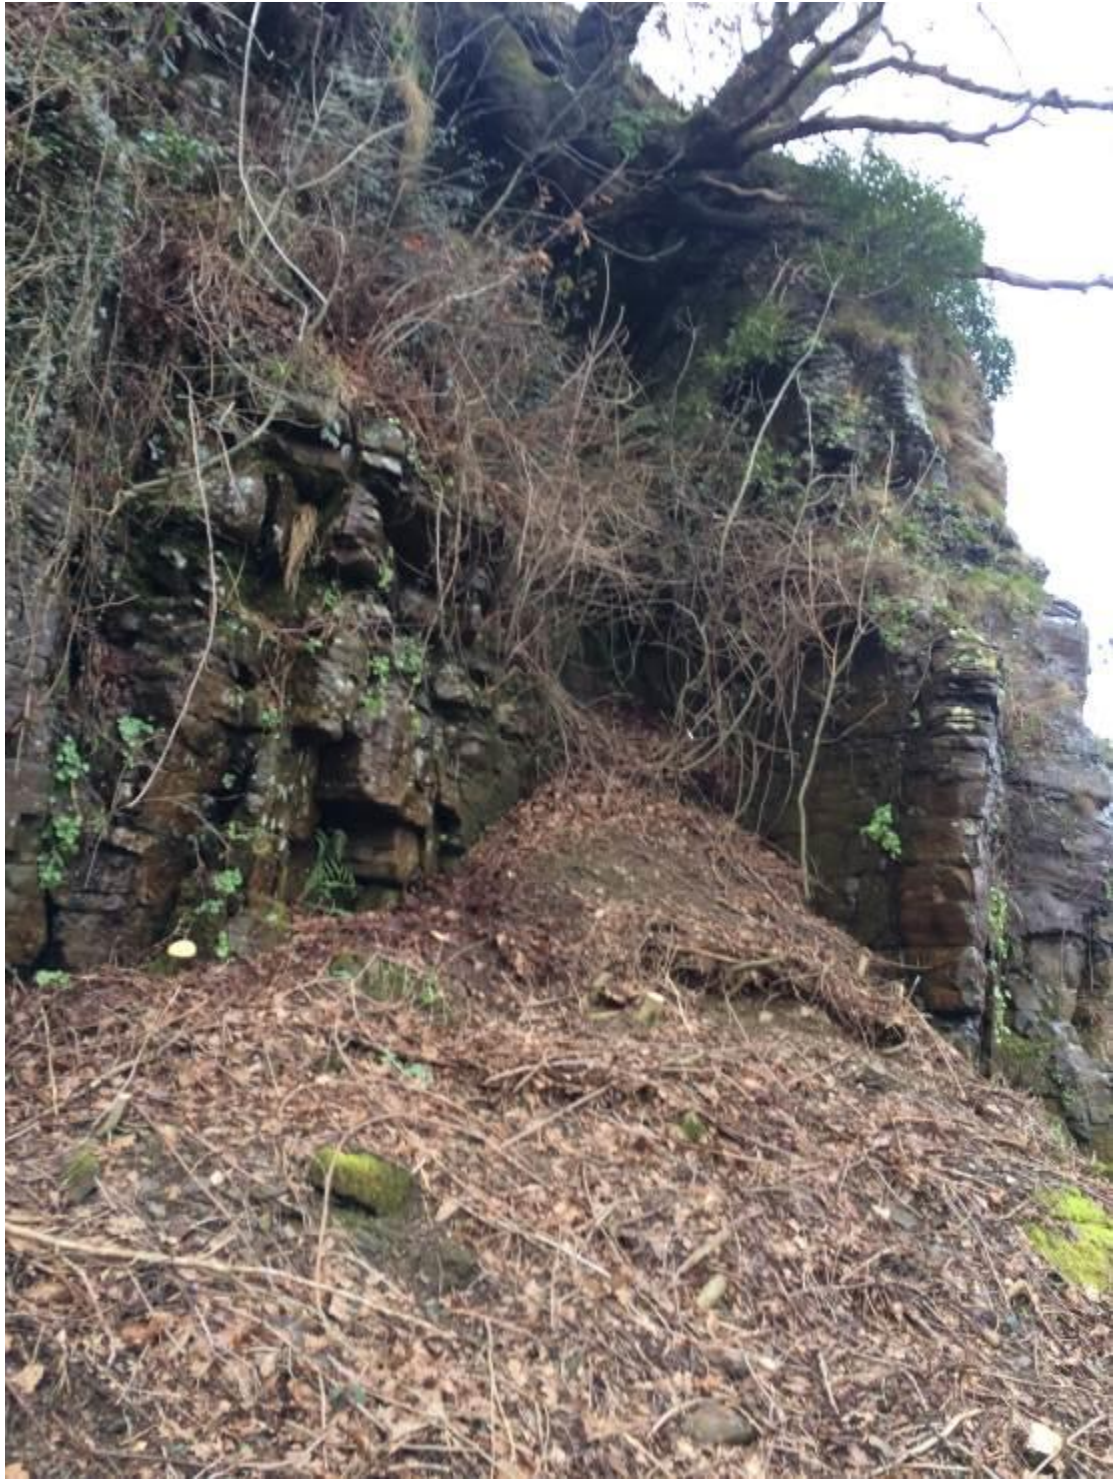
Minor recent slumping of rock debris was observed at the base of the cliff, with the majority of the cliff base being masked by historic scree material (Photograph 23).

**Photograph 23 – Slumping of debris from crest to toe**

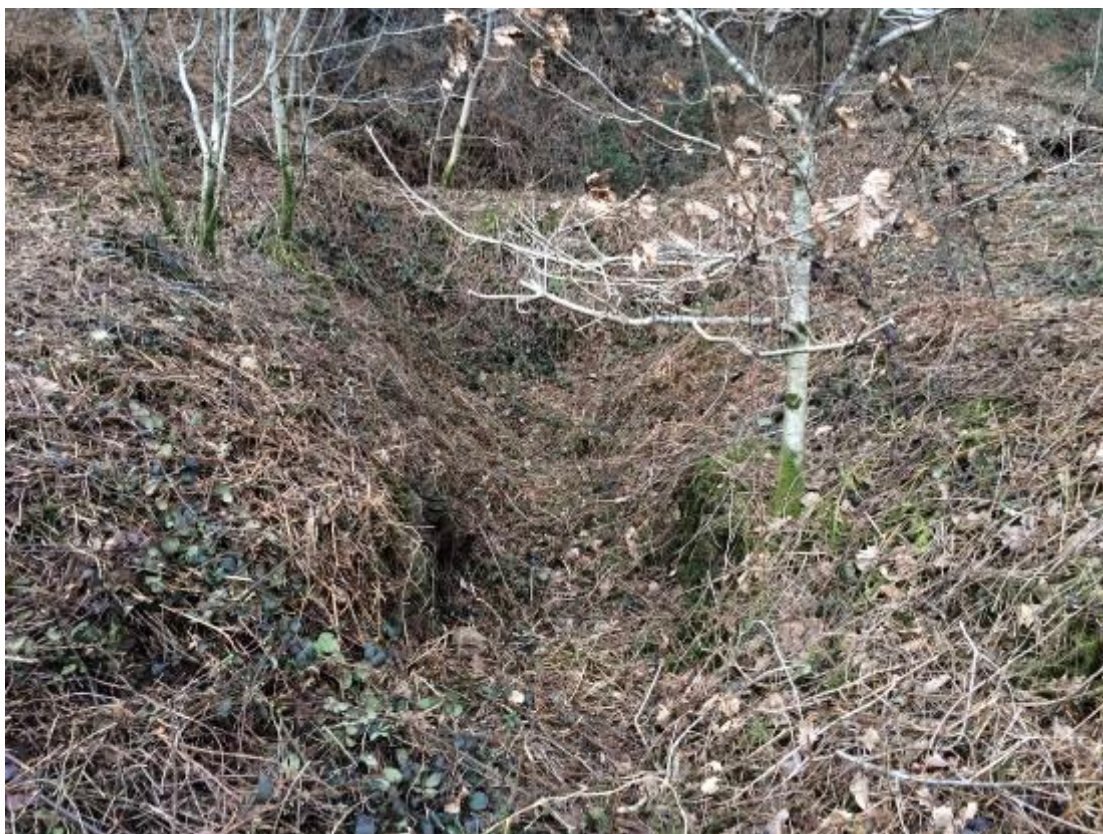
The position of a recorded adit at the base of the cliff was inspected, with the feature evidently having collapsed at some time in the past. There was no water discharging from the adit position (Photograph 27).

**Photograph 27 – Location of adit ref: 276208-040**

Further vegetation clearance of the next bench in the sequence is required to allow inspection of the remaining adit positions.
