<b>Coal Tip Name</b>	Cwar Pentwyn Quarry / Cilmaengwyn	<b>UID</b>	T11695
<b>Located in</b>	Godre'r Graig, Neath-Port Talbot	<b>Tip Category</b>	D
<b>Inspection Led by</b>		<b>Date of Inspection</b>	18/07/2025
		<b>Date of last Inspection</b>	12/02/2025
<b>Weather</b>	Overcast	Damp	Calm
<b>Comments on access and any limitations</b>	<p>Access to the site was gained via an access track situated just off Graig Road, which leads to Pentwyn Farm.</p> <p>It should be noted that this inspection was conducted without the benefit of a detailed site plan. Dense vegetation significantly limited accessibility and visual inspection. Therefore, instability within these areas could exist, but was not detectable at the time of the inspection. The location of the tip on privately owned land also limited the coverage of this inspection.</p>		
	<b>Description</b>	<b>Status</b>	
<b>RAG Status: Capital &amp; Maintenance Works</b>	Investigate ownership of the site and establish what measures, if any, have been taken with regard to placing recent materials over historic spoil.	2

<b>Coal Tip Name</b>	Cwar Pentwyn Quarry / Cilmaengwyn	UID	T11695
		Tip Category	D
Date of Inspection	18/07/2025	Inspection led

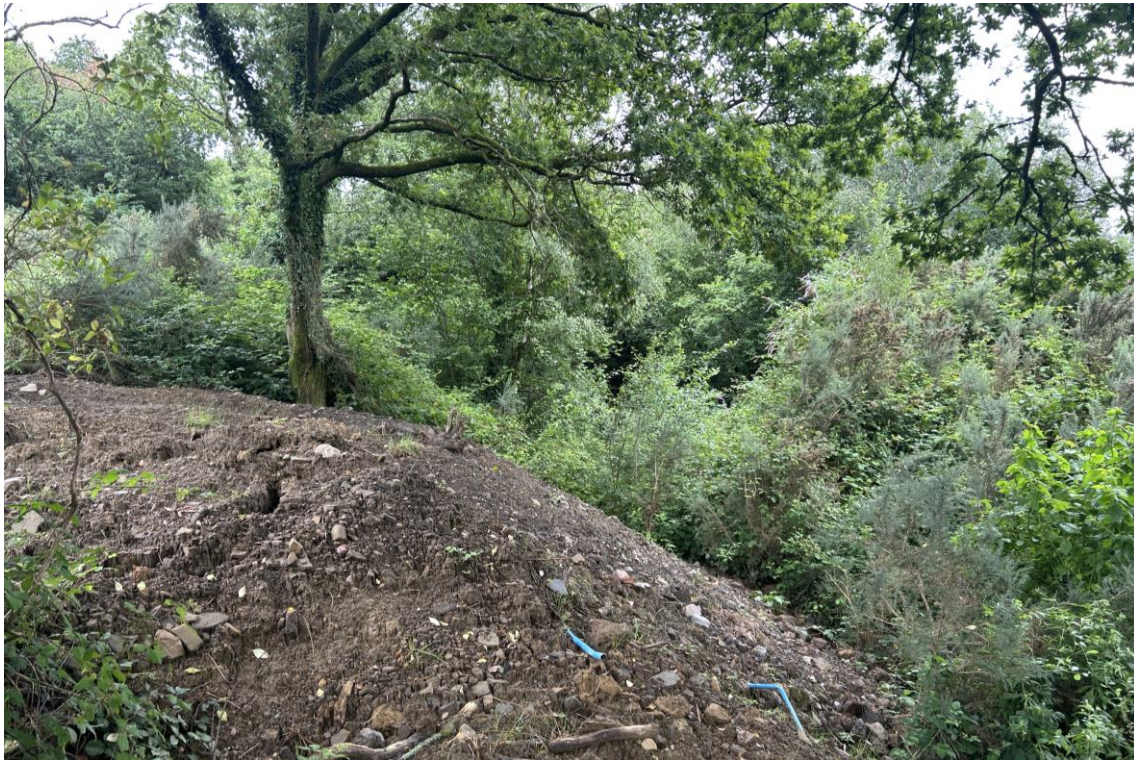
25/L/02	Signage	E – 274774 N - 206738	'Private Property Keep Out' signage situated on the access track which leads to Pentwyn Farm.	None
25/L/03	Land Use	E – 274880 N - 206890	Relatively recent quarrying activity; with machinery and mounds of excavated material present. Sandstone quarry waste material has been deposited on the north-eastern section of 'Godre'r-Graig Higher / Pentwyn No. 3 Levels' coal tip, located just downslope (approx. 50 m). Further excavated material has been tipped here, however no obvious evidence of further quarrying activity was identified on the site.	New
25/L/04	Land Use	E – 274868 N - 206891	Evidence of human activity within the Quarry floor, with the presence of machinery, chairs, a boat and electricity extension cables leading downslope (previously recorded as extending downslope towards the properties named 'Glander' and 'Darren View').	None
<b>Recommendations</b>			<ul style="list-style-type: none"> <li>- Investigate ownership of the site and establish what measures, if any, have been taken with regard to placing recent materials over historic spoil.</li> <li>- Investigate activity within Cwar Pentwyn to establish if planning or quarry regulations have been breached.</li> </ul>

<b>Photo No.</b>	1	<b>Comment</b>	Further excavated material been tipped on the north-eastern section of 'Godre'r-Graig Higher / Pentwyn No. 3 Levels' coal tip, located just downslope (approx. 50 m).
<b>Feature ID</b>	25/L/03

Investigate activity within Cwar Pentwyn to establish if planning or quarry regulations have been breached.	2	
<b>General Remarks</b>	<p>This site comprises of a disused spoil tip located tip located downslope and adjacent to Cwar Pentwyn Quarry. Relatively recent quarrying activity appears to have been operated for the extraction of road building material, as evidenced by the spoil mounds and relatively recently re-furbished access track. The densely overgrown nature of the site significantly limited (and in most cases prevented) accessibility and visual inspection of the composition of the spoil material. The eastern extent of the site was completely overgrown and inaccessible. The limited exposures of the spoil accounting for the western extent of the site appeared to comprise of clays, sandstone and shale material; likely being associated with the adjacent Quarry as opposed to coal workings. However, there are three recorded adits located just to the south-west of the site boundary; as well as the closely associated 'Godre'r-Graig Higher / Pentwyn No. 3 Levels' coal tip just downslope (approx. 50 m). Therefore, despite no evidence of colliery spoil material being identified (during this visit) within the given site boundary; the poor accessibility means that the possibility of the presence of colliery spoil material cannot be completely discounted.</p>

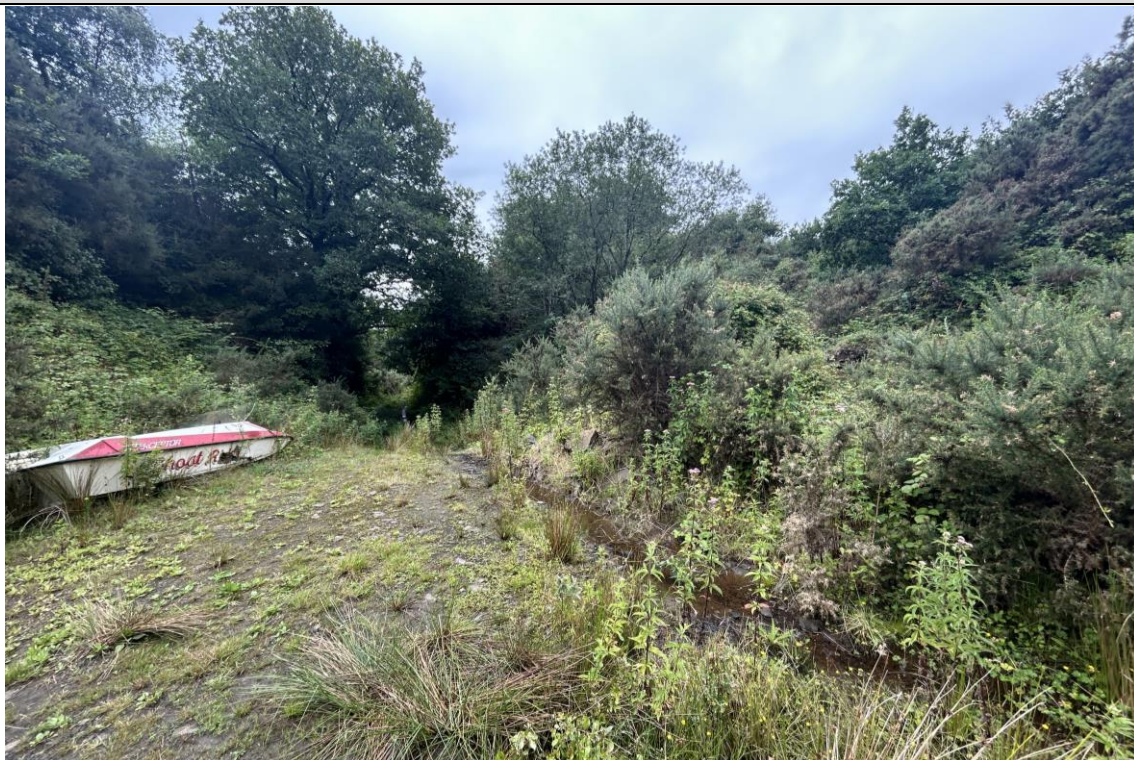
<b>OBSERVATIONS</b>				
<b>GEOTECHNICAL</b>				
<b>ID</b>	<b>Feature</b>	<b>Location</b>	<b>Comment</b>	<b>Change to Condition (New, Worse, None or N/A)</b>
25/G/01	Ponding	E – 274845 N - 206869	Issues (E - 274889, N – 206911) convey over an excavated face to the North of the site boundary. Flows convey towards the flat-lying ground/quarry floor, adjacent to the northern perimeter of the western section of the site. Resultant minor ponding and associated saturated ground conditions present.	None
<b>Recommendations</b>				
<b>DRAINAGE</b>				
<b>ID</b>	<b>Feature</b>	<b>Location</b>	<b>Comment</b>	<b>Change to Condition (New, Worse, None or N/A)</b>
N/A				
<b>Recommendations</b>				
<b>ENGINEERING INFRASTRUCTURE</b>				
<b>ID</b>	<b>Feature</b>	<b>Location</b>	<b>Comment</b>	<b>Change to Condition (New, Worse, None or N/A)</b>
N/A				
<b>Recommendations</b>				
<b>INSTRUMENTATION &amp; MONITORING</b>

<b>Photo No.</b>	2	<b>Comment</b>	Flows convey towards the flat-lying ground/quarry floor, adjacent to the northern perimeter of the western section of the site. Evidence of human activity within the Quarry floor; abandoned boat.
<b>Feature ID</b>	25/G/01

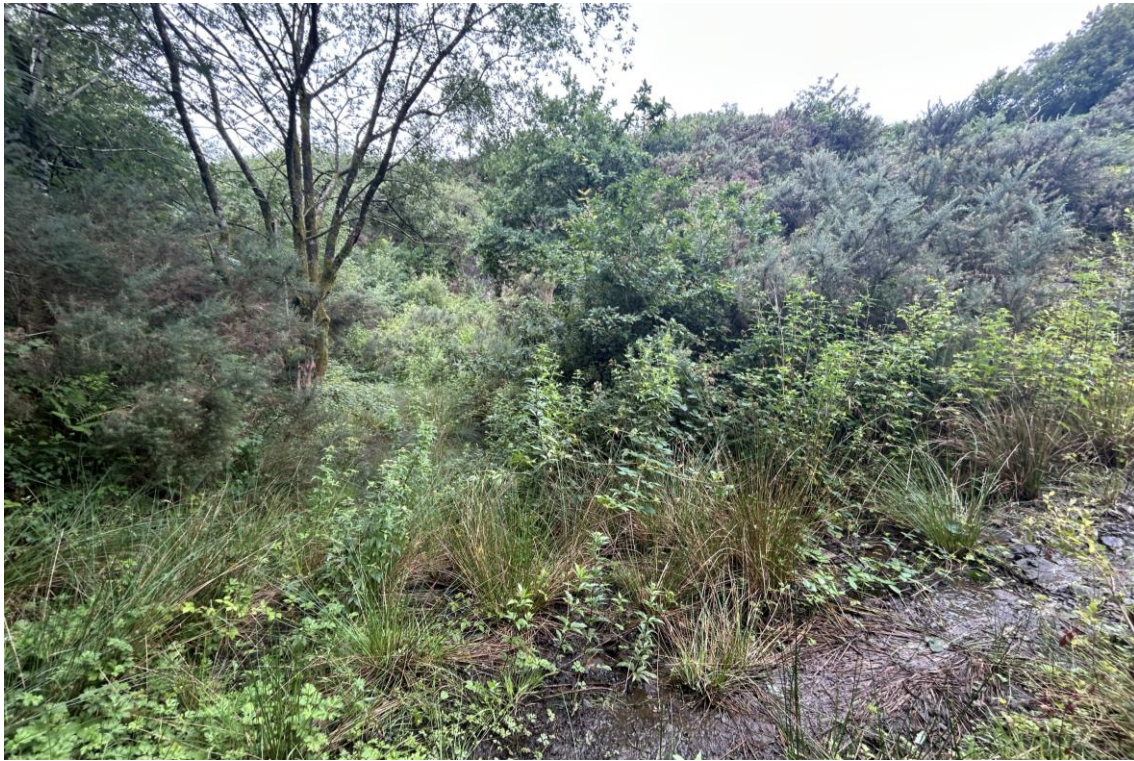
<b>Photo No.</b>	3	<b>Comment</b>	Flows convey towards the flat-lying ground/quarry floor, adjacent to the northern perimeter of the western section of the site.
<b>Feature ID</b>	25/G/01

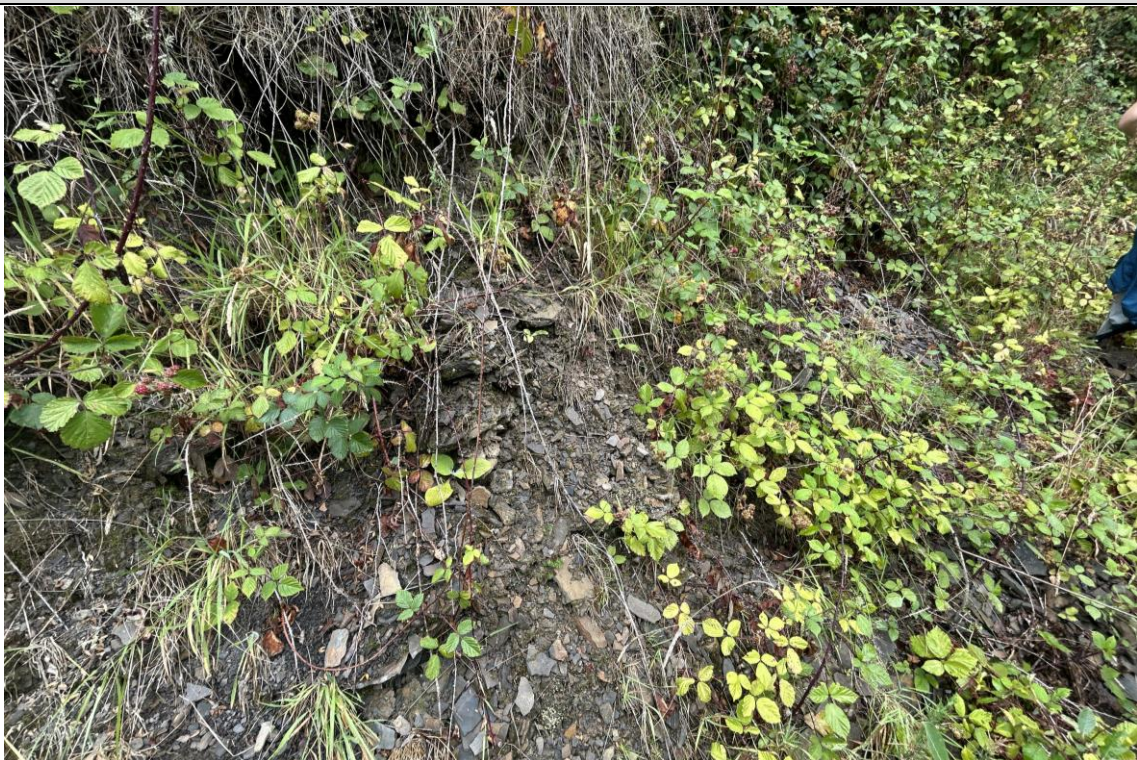
<b>Photo No.</b>	4	<b>Comment</b>	View looking towards a small exposure of sandstones, shales and clays; situated within the densely vegetated northern extent of the site.
<b>Feature ID</b>	N/A
