Coal Tip Name	Cwar Pentwyn Quarry / Cilmaengwyn	Tip Ref Number	L044B
		Ownership Status	Private
Located in	Godre'r Graig, Neath-Port Talbot	Tip Category	D
Led by		Undertaken on behalf of	Welsh Government
Date	08/11/2023	Date of last Detailed Inspection	05/09/2023
Weather	Overcast	Damp	Calm
Comments on access and any limitations	<p>Access to the site was gained via an access track situated just off Graig Road, which leads to Pentwyn Farm.</p> <p>It should be noted that this inspection was conducted without the benefit of a detailed site plan. Dense vegetation significantly limited accessibility and visual inspection. Therefore, instability within these areas could exist, but was not detectable at the time of the inspection. The location of the tip on privately owned land also limited the coverage of this inspection.</p>		
	Description	Status	
RAG Status: Capital & Maintenance Works	Investigate ownership of the site and establish what measures, if any, have been taken with regard to placing recent materials over historic spoil.	2

Coal Tip Name	Cwar Pentwyn Quarry / Cilmaengwyn	Tip Ref Number	L044B
		Tip Category	D
Date of Inspection	08/11/2023	Inspection led by

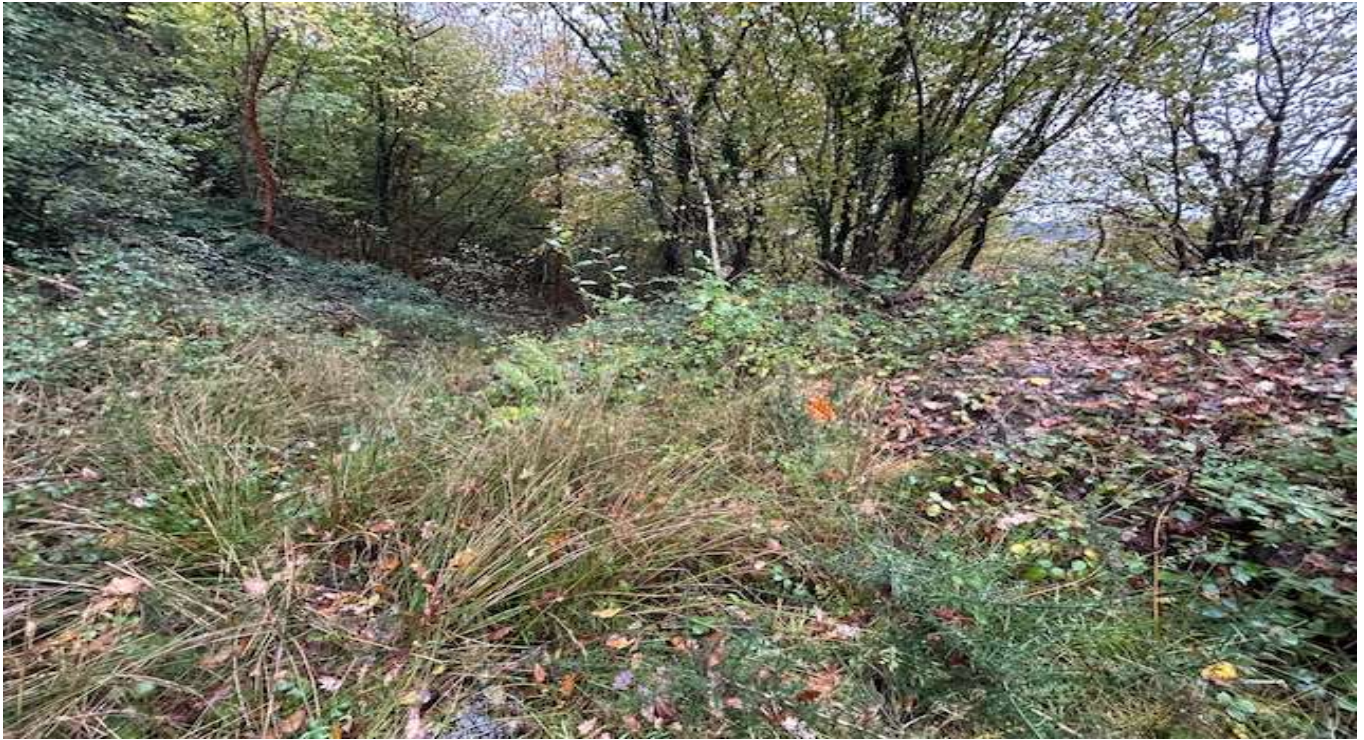
23/L/03	Land Use	E – 274880 N - 206890	Relatively recent quarrying activity appeared to have taken place, with machinery and mounds of excavated material present. Sandstone quarry waste material has been deposited on the north-eastern section of 'Godre'r-Graig Higher / Pentwyn No. 3 Levels' coal tip, located just downslope (approx. 50 m).
23/L/04	Land Use	E – 274868 N - 206891	Evidence of human activity within the Quarry floor, with the presence of machinery, chairs, a boat and electricity extension cables leading downslope (previously recorded as extending downslope towards the properties named 'Glander' and 'Darren View').
Recommendations			Investigate ownership of the site and establish what measures, if any, have been taken with regard to placing recent materials over historic spoil materials. Investigate activity within Cwar Pentwyn to establish if planning or quarry regulations have been breached. Consider undertaking a UAV LIDAR survey. Consider undertaking a geotechnical assessment to fully ascertain the geotechnical characteristics of the tip.

Photo No.	1	Comment	Sandstone quarry waste material deposited on the north-eastern section of 'Godre'r-Graig Higher / Pentwyn No. 3 Levels' coal tip, located just downslope (approx. 50 m).
Feature ID	23/L/03

Investigate activity within Cwar Pentwyn to establish if planning or quarry regulations have been breached.	2	
	Consider undertaking a UAV LIDAR survey. Consider undertaking a geotechnical assessment to fully ascertain the geotechnical characteristics of the tip.	3	
General Remarks	<p>This site comprises of a disused spoil tip located tip located downslope and adjacent to Cwar Pentwyn Quarry. Relatively recent quarrying activity appears to have been operated for the extraction of road building material, as evidenced by the spoil mounds and relatively recently re-furbished access track. The densely overgrown nature of the site significantly limited (and in most cases prevented) accessibility and visual inspection of the composition of the spoil material. The eastern extent of the site was completely overgrown and inaccessible. The limited exposures of the spoil accounting for the western extent of the site appeared to comprise of clays, sandstone and shale material; likely being associated with the adjacent Quarry as opposed to coal workings. However, there are three recorded adits (274206-11; 274206-19; 274206-25) located just to the south-west of the site boundary; as well as the closely associated 'Godre'r-Graig Higher / PentwyncNo. 3 Levels' coal tip just downslope (approx. 50 m). Therefore, despite no evidence of colliery spoil material being identified (during this visit) within the given site boundary; the poor accessibility means that the possibility of the presence of colliery spoil material cannot be completely discounted.</p>

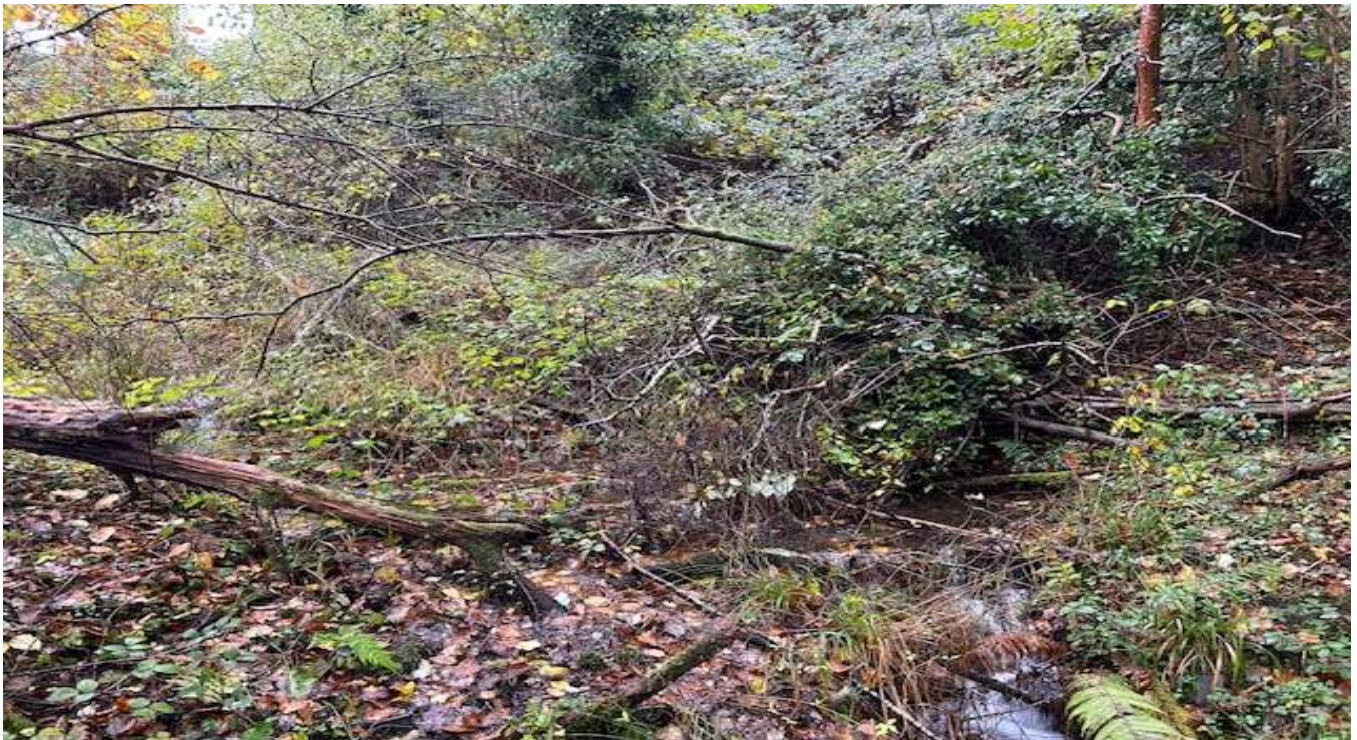
Photo No.	2	Comment	Adit (274206-025) located just to the south-west of the site boundary; associated with the 'Godre'r-Graig Higher / Pentwyn No. 3 Levels' coal tip.
Feature ID	N/A

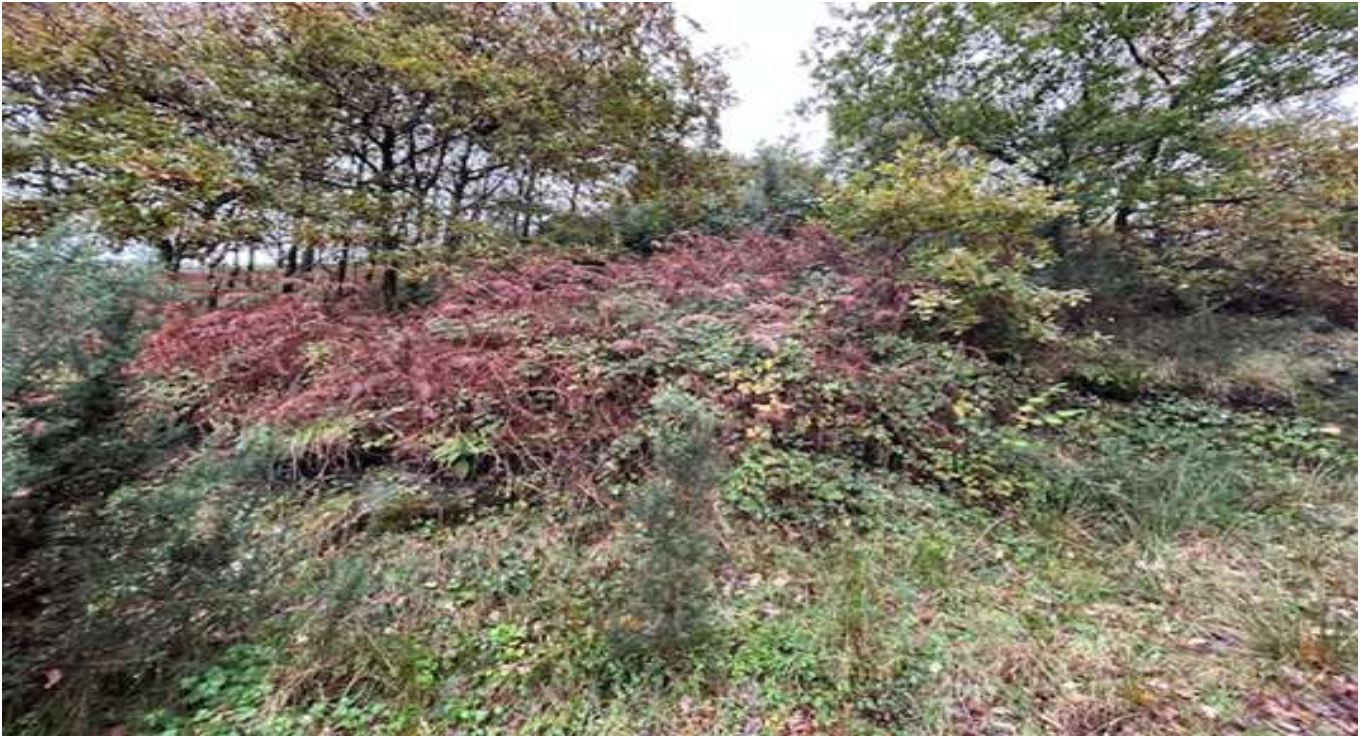
Photo No.	3	Comment	View looking towards the densely vegetated western extent of the site.
Feature ID	23/L/01

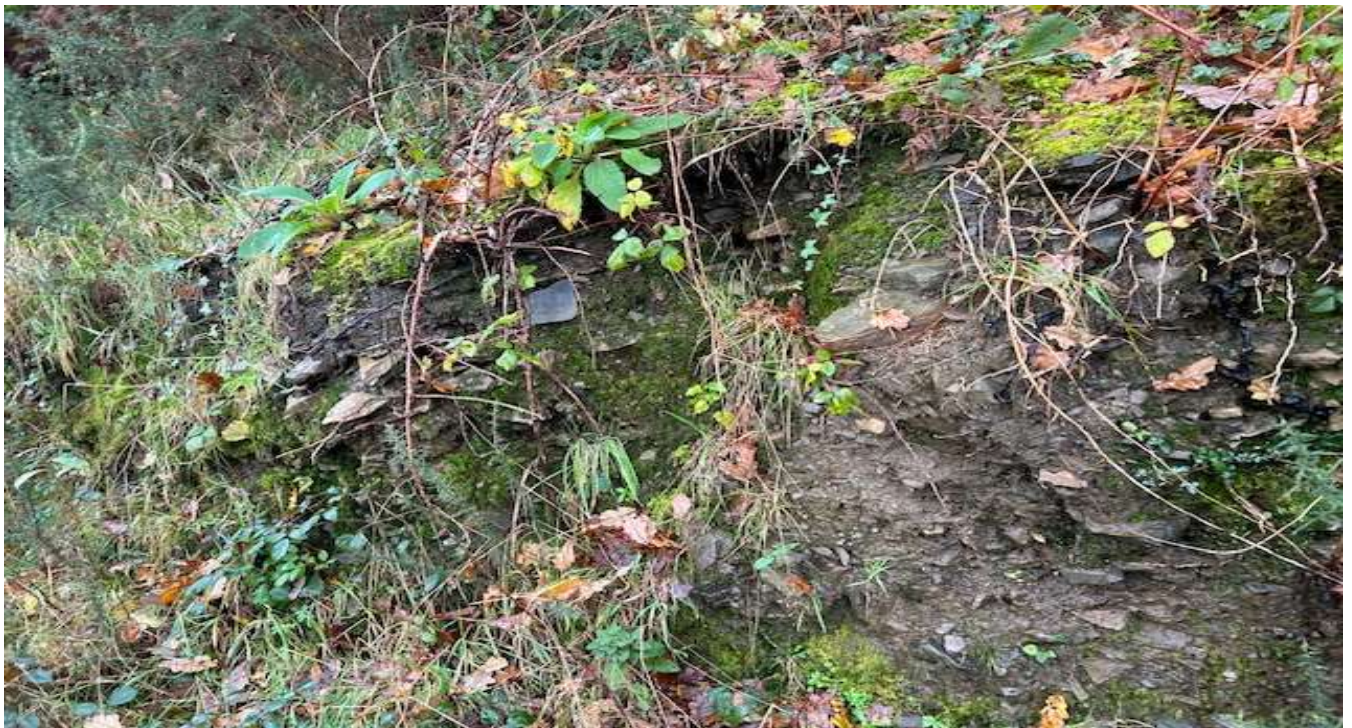
Photo No.	4	Comment	View looking towards a small exposure of sandstones, shales and clays; situated within the densely vegetated western extent of the site.
Feature ID	23/L/01

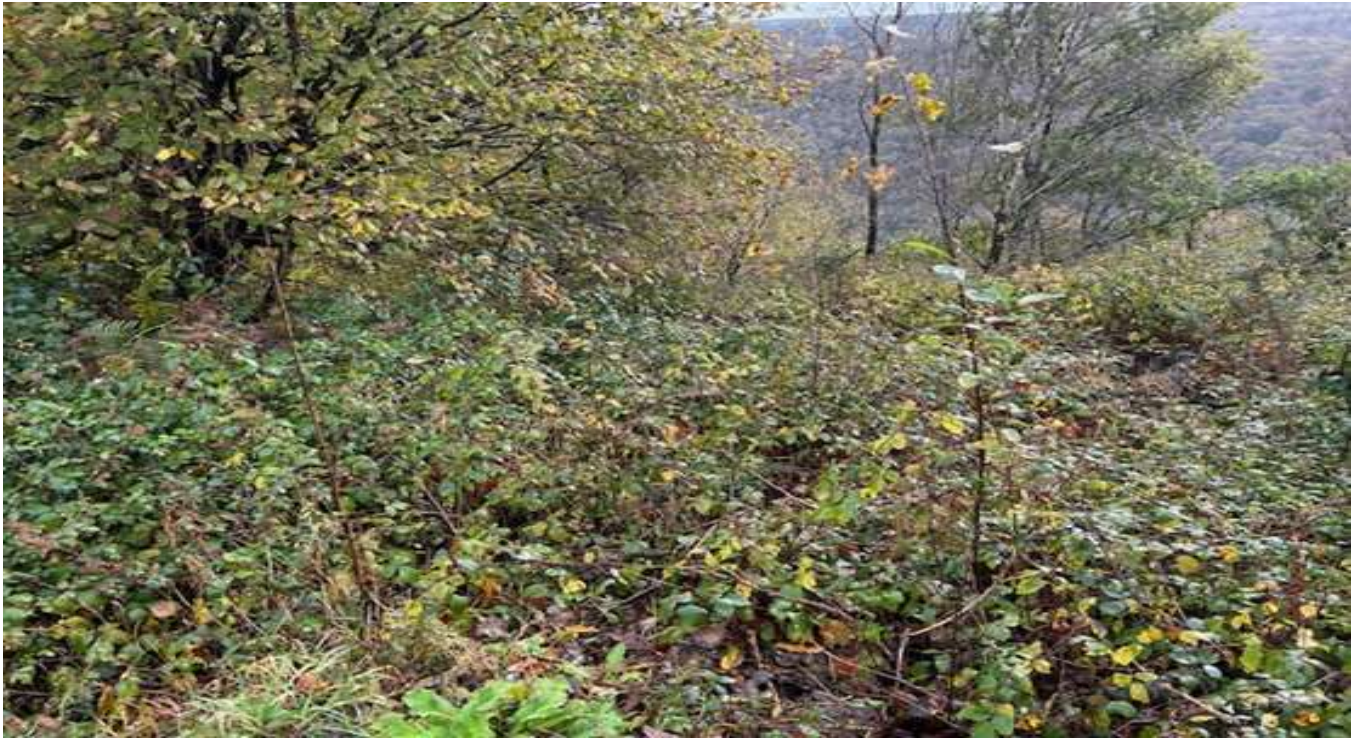
Photo No.	5	Comment	View looking down the flank of the densely vegetated, eastern extent of the site. Image conveys associated accessibility issues.
Feature ID	23/L/01

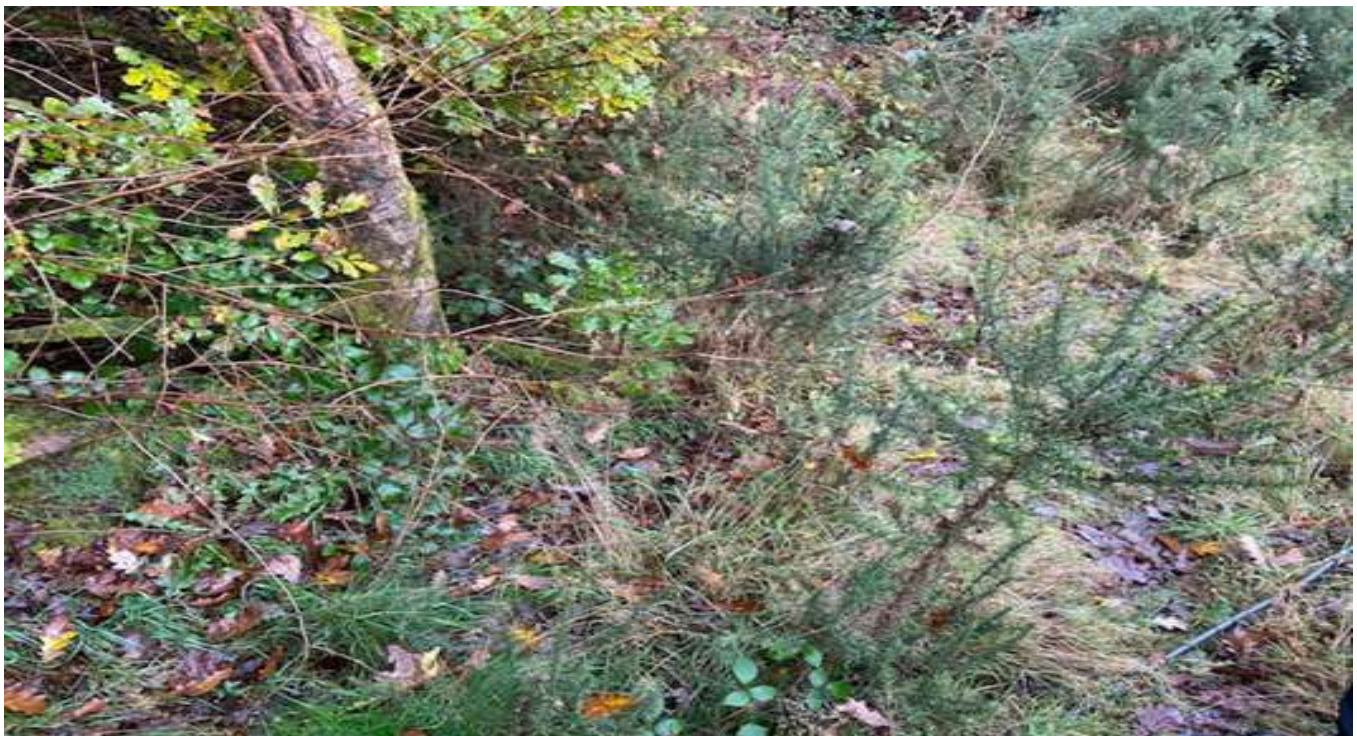
Photo No.	6	Comment	Evidence of human activity within the Quarry floor, with the presence of electricity extension cables leading downslope (previously recorded as extending downslope towards the properties named 'Glander' and 'Darren View').
Feature ID	23/L/04

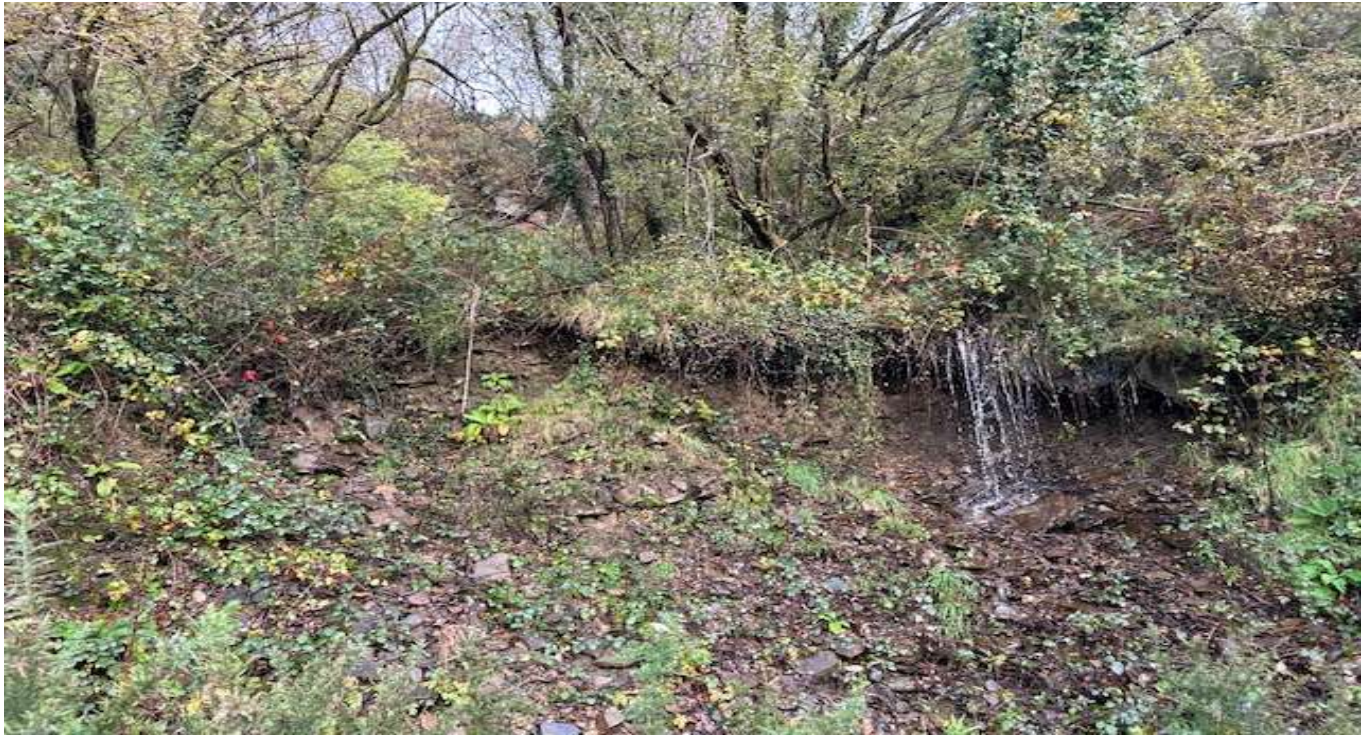
OBSERVATIONS			
GEOTECHNICAL			
ID	Feature	Location	Comment
23/G/01	Ponding	E – 274845 N - 206869	Issues (E - 274889, N – 206911) convey over an excavated face to the North of the site boundary. Flows convey towards the flat-lying ground/quarry floor, adjacent to the northern perimeter of the western section of the site. Resultant minor ponding and associated saturated ground conditions present.
Recommendations			
DRAINAGE			
ID	Feature	Location	Comment
N/A			
Recommendations			
ENGINEERING INFRASTRUCTURE			
ID	Feature	Location	Comment
N/A			
Recommendations			
INSTRUMENTATION & MONITORING			
ID	Feature	Location	Comment
N/A			
Recommendations			
LAND USE			
ID	Feature	Location	Comment
23/L/01	Vegetation Cover	E – 274877 N - 206856	The surfaces of the site are densely vegetated with grass, bracken, brambles, gorse and trees.
23/L/02	Signage	E – 274774 N - 206738	'Private Property Keep Out' signage situated on the access track which leads to Pentwyn Farm.

Photo No.	7	Comment	Issues (E - 274889, N – 206911) convey over an excavated face to the North of the site boundary.
Feature ID	23/G/01

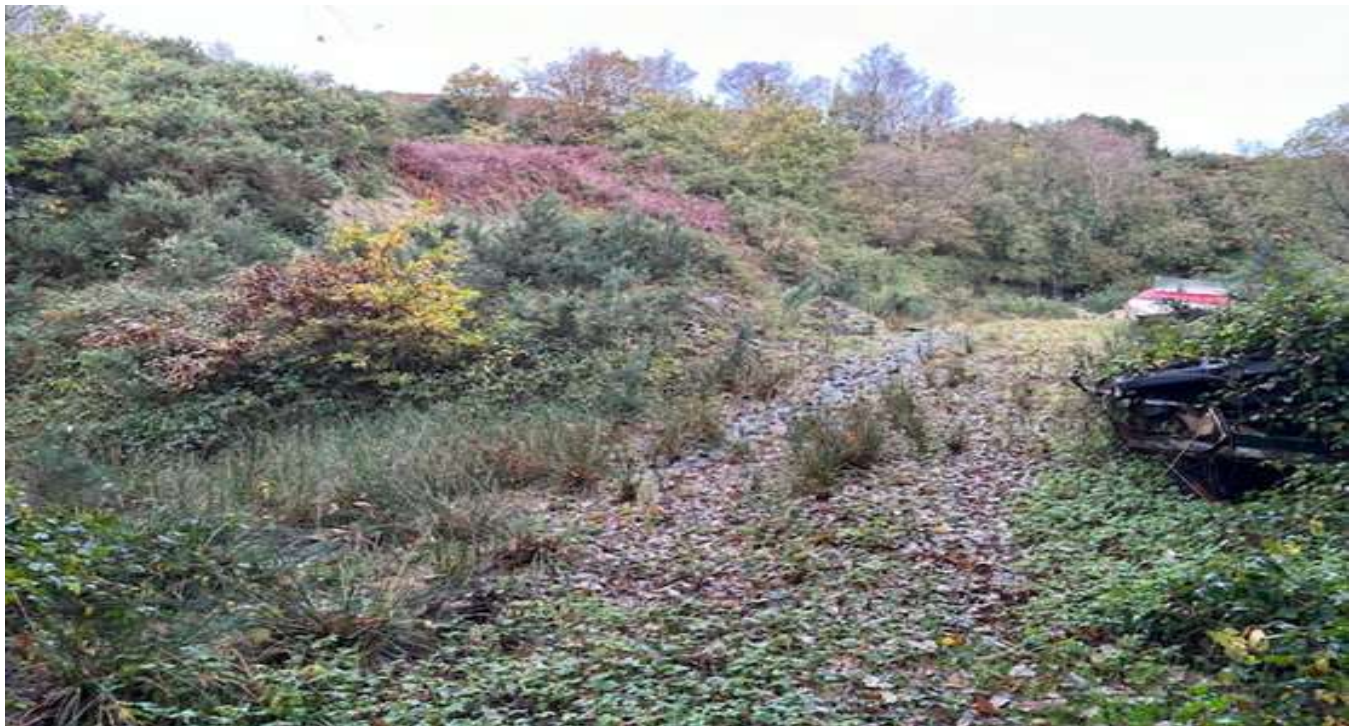
Photo No.	8	Comment	Flows convey towards the flat-lying ground/quarry floor, adjacent to the northern perimeter of the western section of the site. Evidence of human activity within the Quarry floor; abandoned boat.
Feature ID	23/G/01 23/L/04

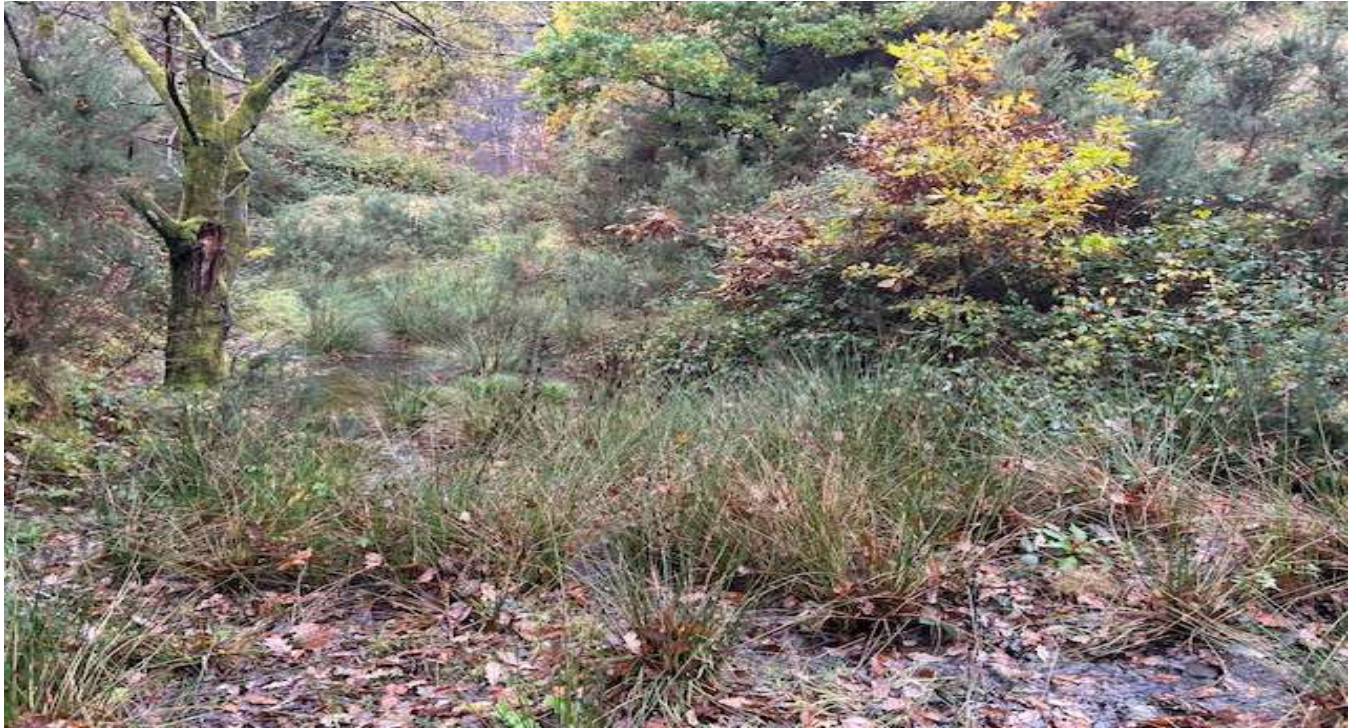
Photo No.	9	Comment	Minor ponding and associated saturated ground conditions present.
Feature ID	23/G/01
