<b>Coal Tip Name</b>	<b>Godre'r-graig Quarry / Cilmaengwyn</b>		<b>Tip Ref Number</b>	<b>T37552</b>		
			<b>Ownership Status</b>	<b>Private</b>		
<b>Located In</b>	<b>Godre'r Graig, Neath-Port Talbot</b>		<b>Tip Category</b>	<b>D</b>		
<b>Inspection Led By</b>		<b>Date of Inspection</b>	<b>09/09/2024</b>	<b>Date of last Inspection</b>	<b>08/11/2023</b>	
<b>Weather</b>	<b>Sun</b>		<b>Dry</b>		<b>Calm</b>	
<b>General Remarks</b> (e.g. access, limitations)	<p>Access to the site was gained via an access path situated just off the Pentwyn Farm access track. The access path extends up the hillside in a north-easterly direction, passing through Cwar Pentwyn Quarry before reaching a narrow, overgrown path which extends up-slope towards the site.</p> <p>It should be noted that this inspection was conducted without the benefit of a detailed site plan; whilst dense vegetation significantly limited accessibility and visual inspection. Therefore, instability within these areas could exist, but was not detectable at the time of the inspection. The densely overgrown nature of the site prevented inspection of the spoil material; it is presumed that the site is comprised of sandstone quarry waste m

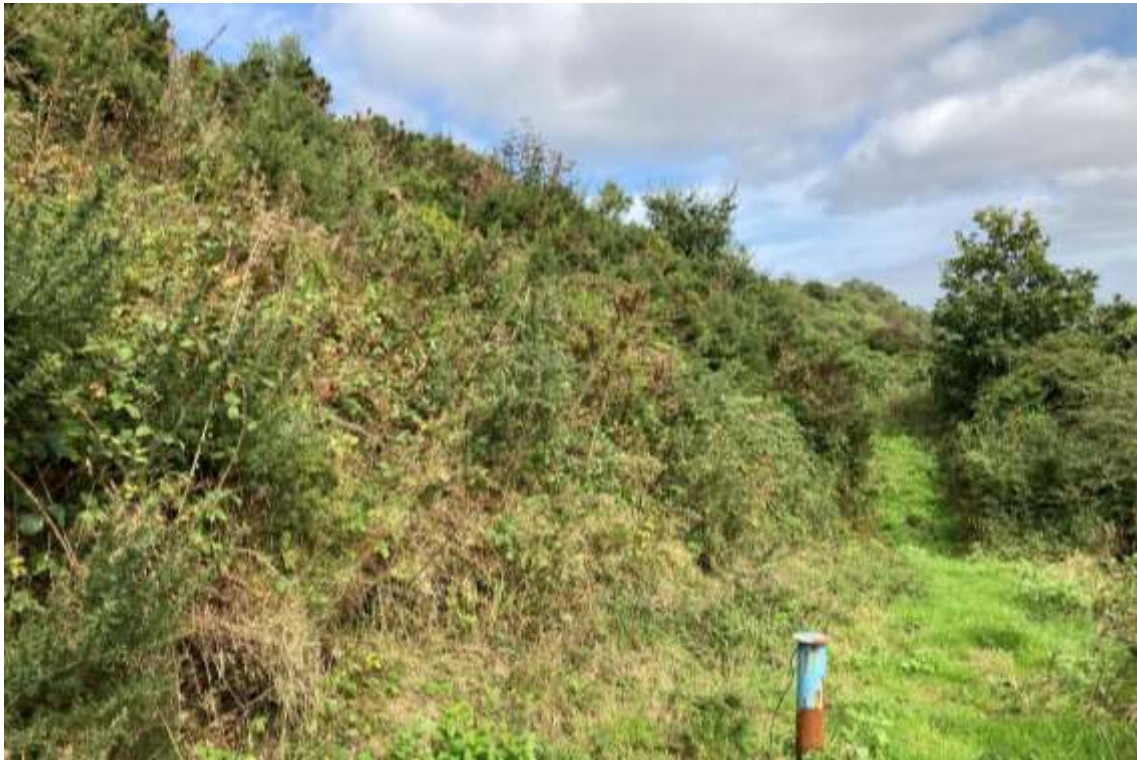
<b>Photo No.</b>	1	<b>Comment</b>	Piezometer borehole located on the site access track, downslope (outside the provided site boundary).
------------------	---	----------------	---

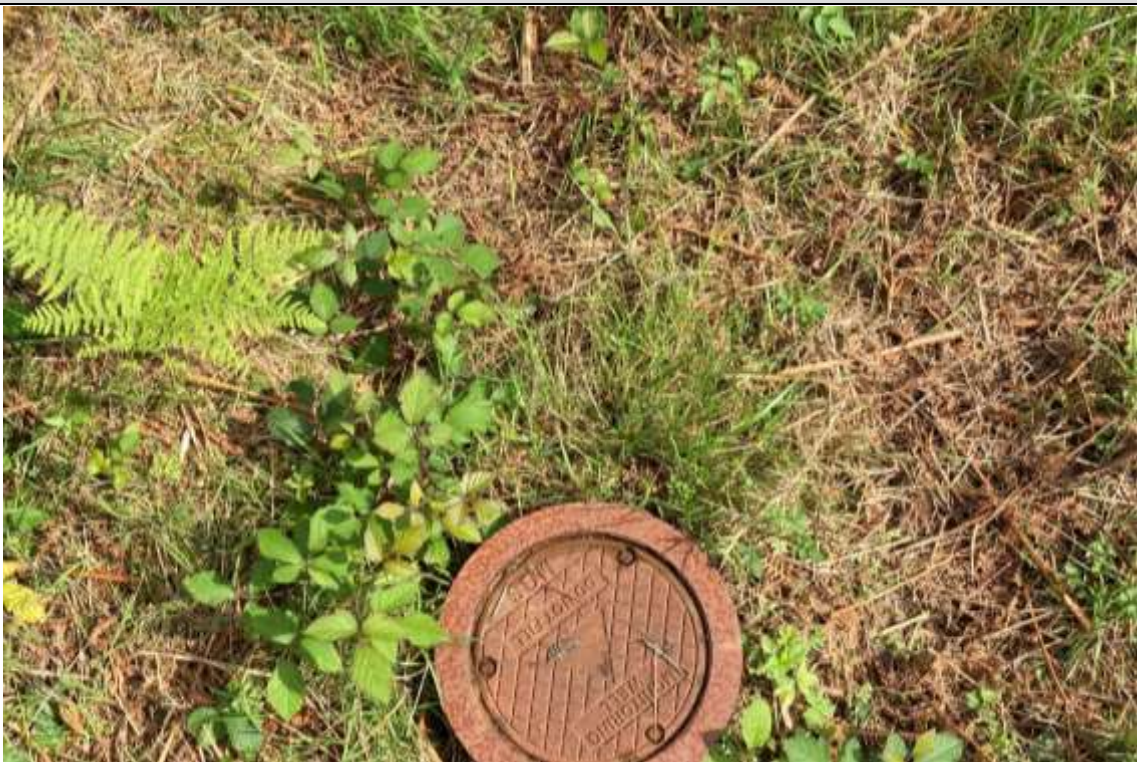
<b>Photo No.</b>	2	<b>Comment</b>	Monitoring well located on the site access track, downslope (outside the provided site boundary).
------------------	---	----------------	---

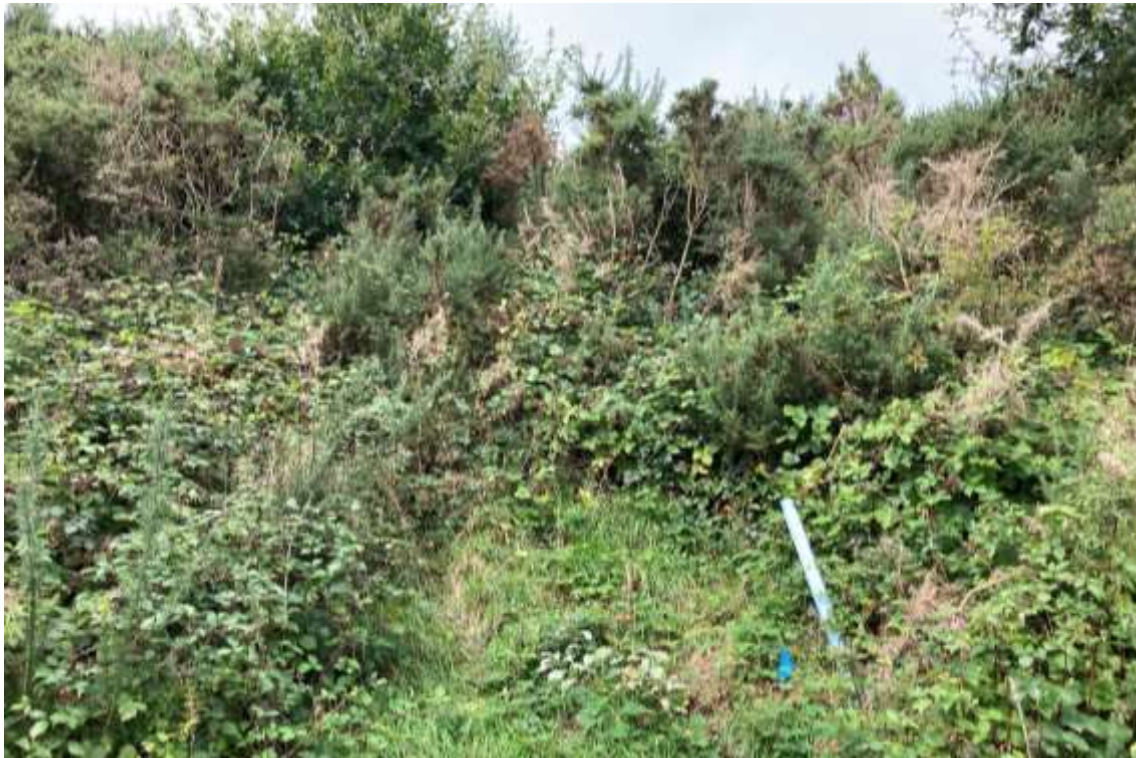
<b>Photo No.</b>	3	<b>Comment</b>	View looking towards the narrow, overgrown access path; of which extends up-slope off the main site access path, towards the site. Plastic casing associated with a piezometer appears to have been discarded next to the path.
