## Godre'r Graig Primary School, Godre'r Graig Preliminary Investigation and Additional Assessment

Report Reference: ESP.7234e.02.3302

## Godre'r Graig Primary School Preliminary Investigation and Additional Assessment

**Prepared for:**  
**Neath Port Talbot County Borough Council**  
 The Quays, Baglan Energy Park,  
 Brunel Way, Briton Ferry,  
 SA11 2GG

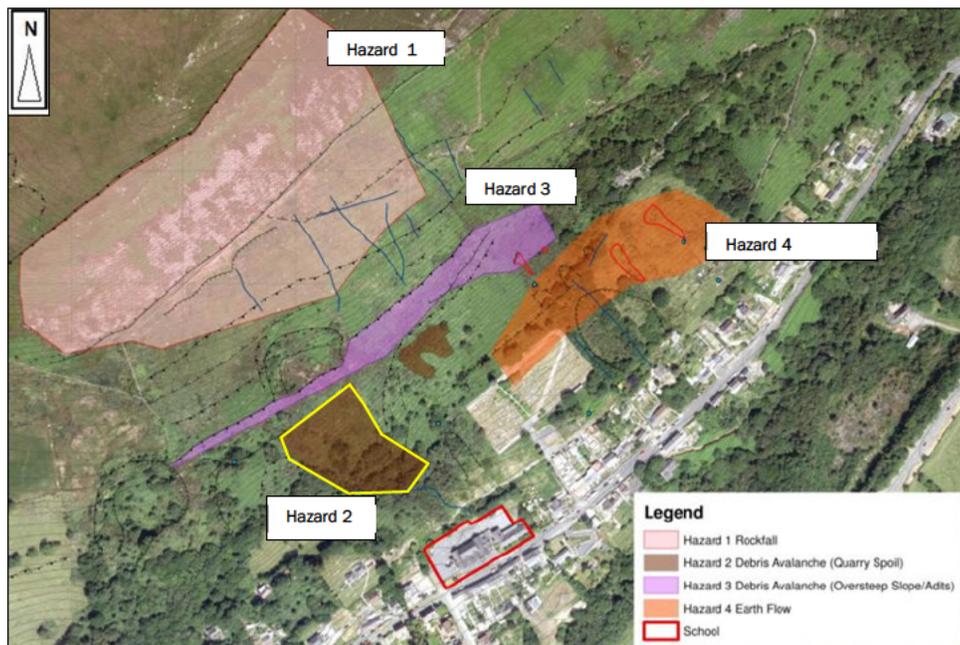
A Landslide Hazard and Risk Assessment for the terrain above the school was undertaken primarily to identify risks from potential landslides. The assessment identified four types of landslide hazards in the study area, two of which are natural and two are man-made. The hazards are outlined below, and their locations shown on Insert 3:

- Hazard Type 1: Rock fall initiating from outcrops of the Rhondda Sandstone
- Hazard Type 2: Impact from debris avalanche initiating from quarry spoil.
- Hazard Type 3: Impacts from debris avalanches originating from the over steep slope associated with the working of the Upper Pinchin seam.
- Hazard Type 4: Shallow earth slides.

Insert 3: Extract from Hazard Location Map taken from previous report ESP, 2019. Site 2 is highlighted in yellow.

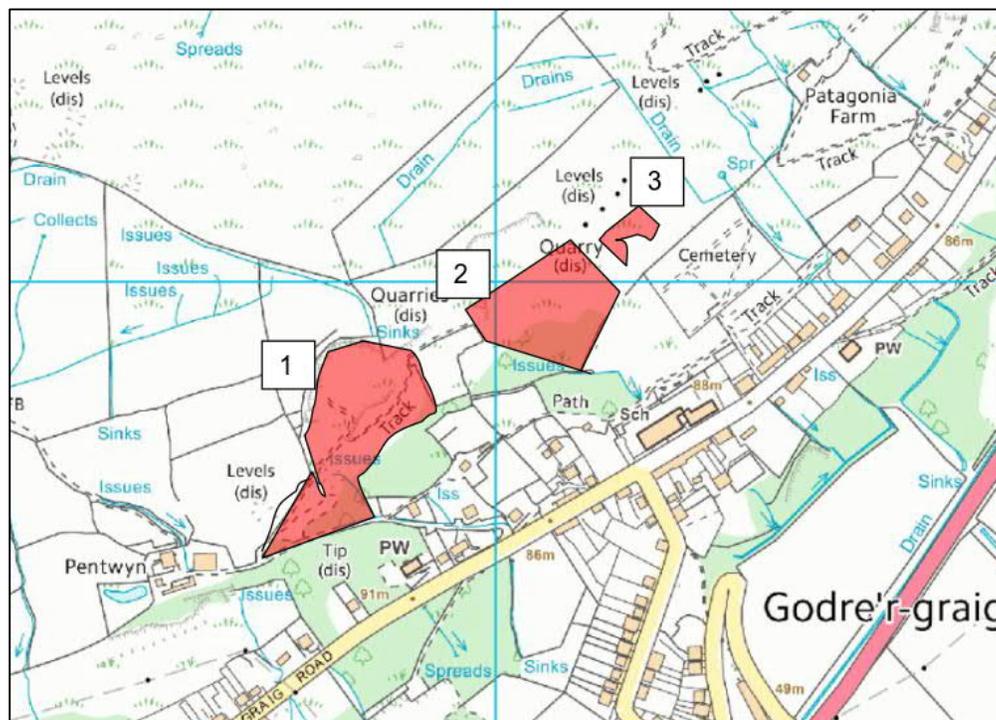
Insert 4: Extract from Coal Authority Report. Site Locations shown by red polygons.

The Coal Authority provided recommendations, considerations and actions for all three sites, however, pertinent recommendations for their site 2, which is the Spoil Tip above the school are replicated below:

- Although they suggest it unlikely, they speculated that a major failure of the spoil tip would be able to reach Godre'r Graig School;
- Consider clearing vegetation to allow inspection of drainage routes at Site 2;
- Consider undertaking a slope stability analysis for Site 2 based on available information supplemented by ground investigation; and
- Undertake an inspection during winter, when vegetation has died back to allow a more detailed viewing of the site with less vegetation constraints. The requirement for further inspection should be determined following the winter inspection.

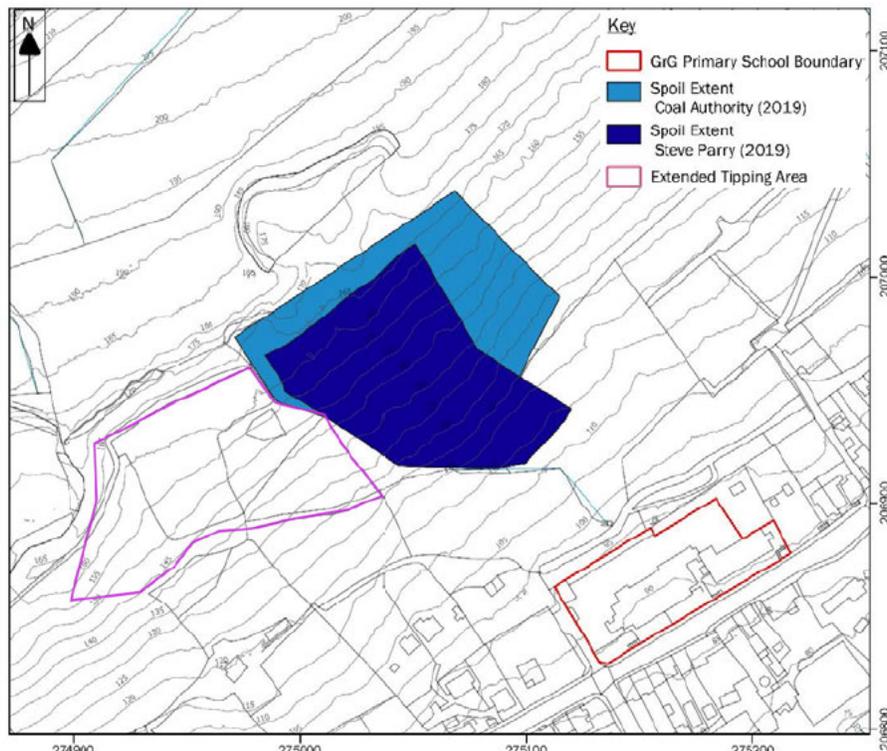
Insert 5: Preliminary Spoil Extent Boundaries identified by the Coal Authority and ESP/PEGS (2019).

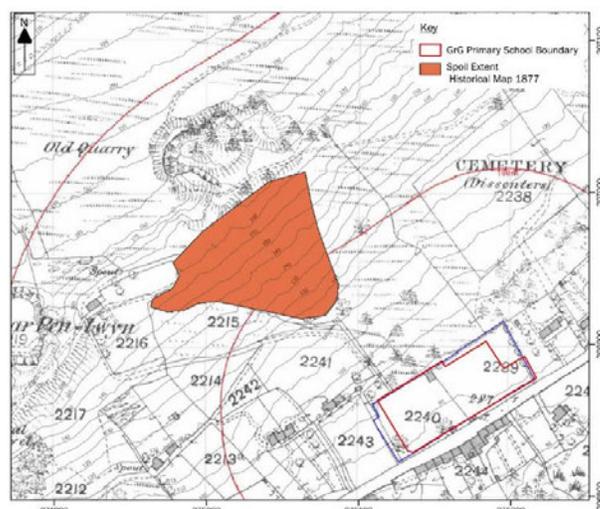
**Insert 6:** Preliminary Spoil Extent Boundaries identified from historical mapping (1:2,500 scale map, published 1877)

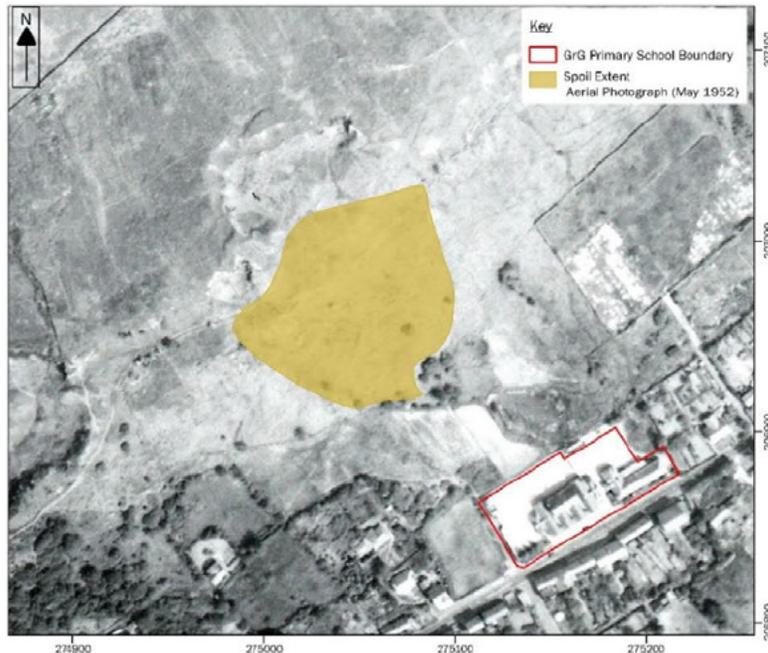
Insert 7: Preliminary Spoil Extent Boundaries identified from aerial photography (27th May 1952, Stereo Pair -5032, 5033).
