**The Coal  
Authority**

## **Site Inspection Report**

### **Pen y Graig Quarry, Ystalyfera**

**Date: August 2017**

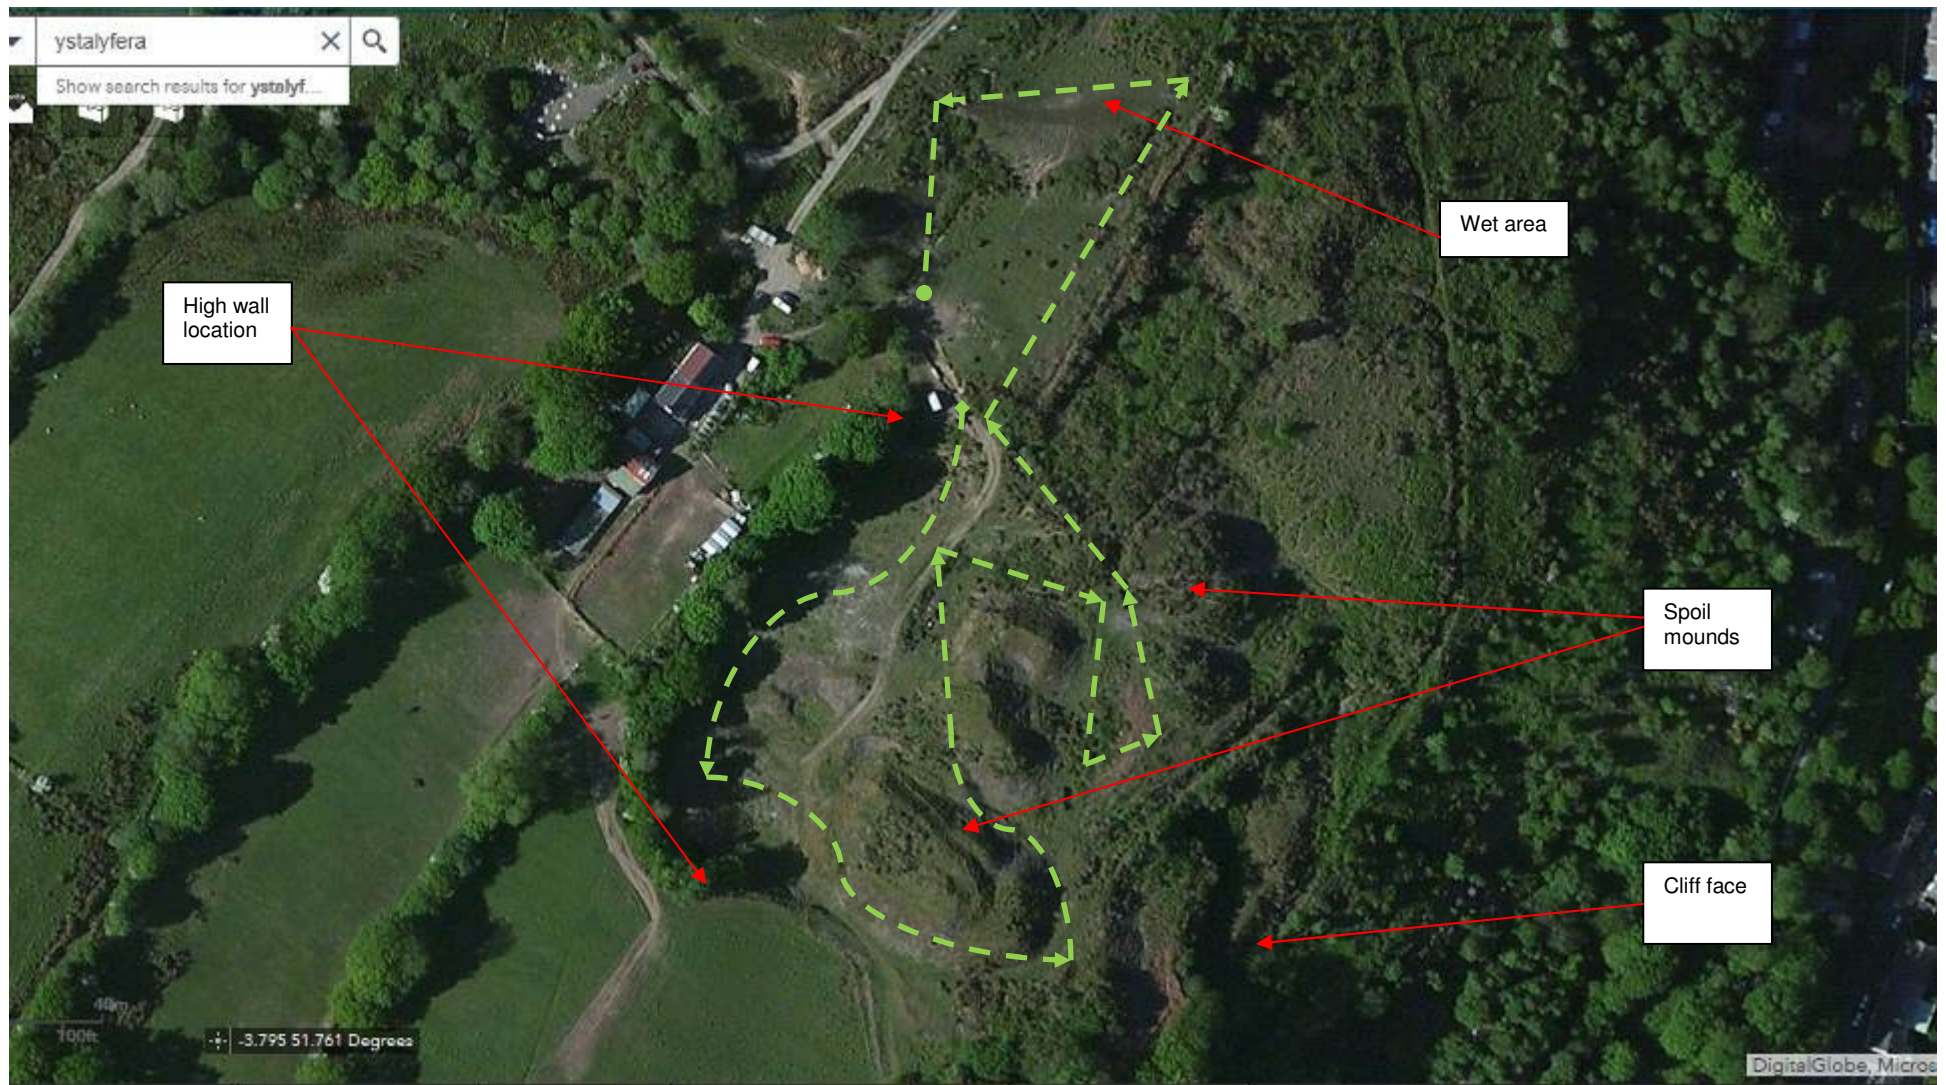
Figure 10 – Inspection Route and Key Locations

Inspection on the 3<sup>rd</sup> August 2017 began at the northern boundary of the site, within the quarry floor, at the foot of the high wall. The inspection then took an anti-clockwise route along the perimeter, followed by an inspection of the various spoil mounds present. The approximate route is shown on Figure 10.
