Neath Canal

Tennant Canal

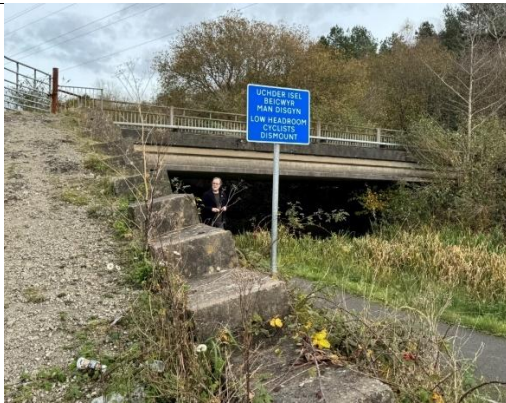
Image 7 – Landfill Site Bridge with low headroom but sufficient for canal

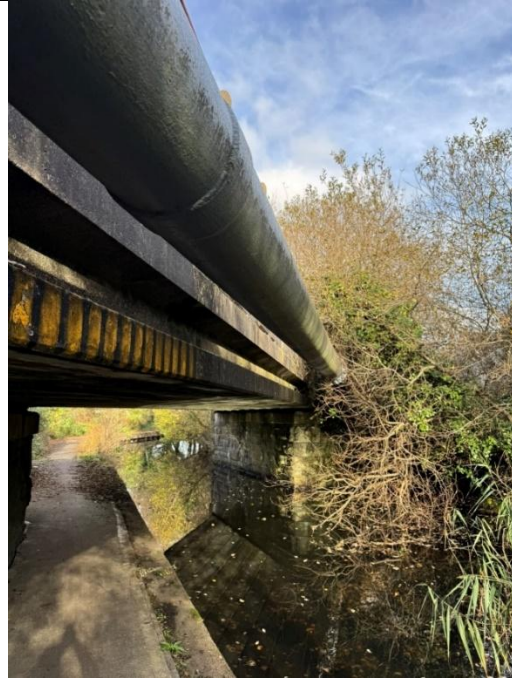
Image 18 – Swansea and Rhondda Bay Railway Bridge with thick vegetation growing on pier

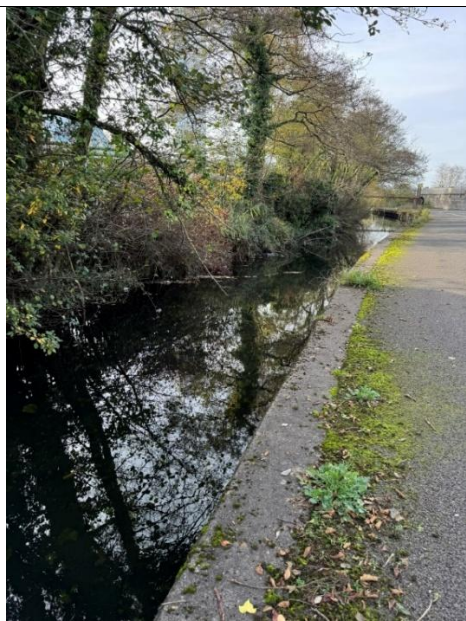
Image 27 – Canal section near Milland Road Bridge with trees overhanging

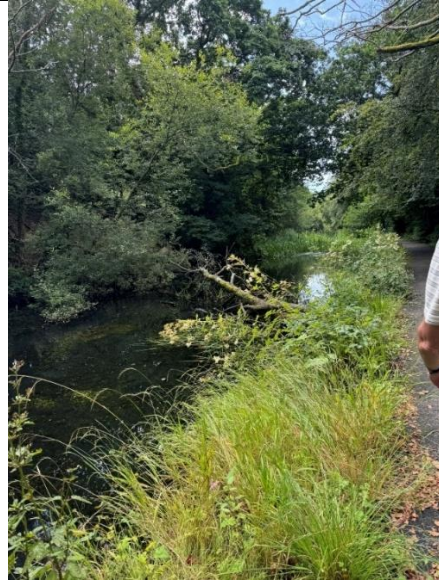
Image 34 – Canalside bridge with low vegetation on embankment

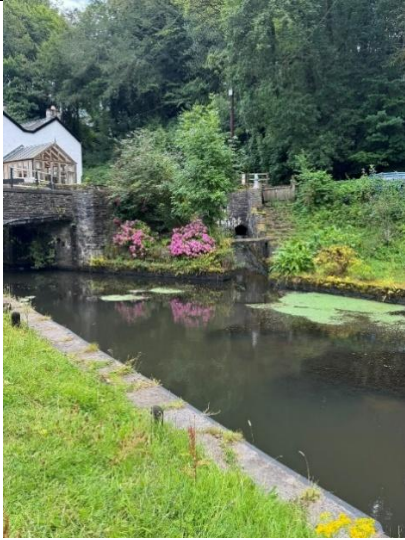
Image 37 – Tonna Lock Structure viewed from opposite embankment

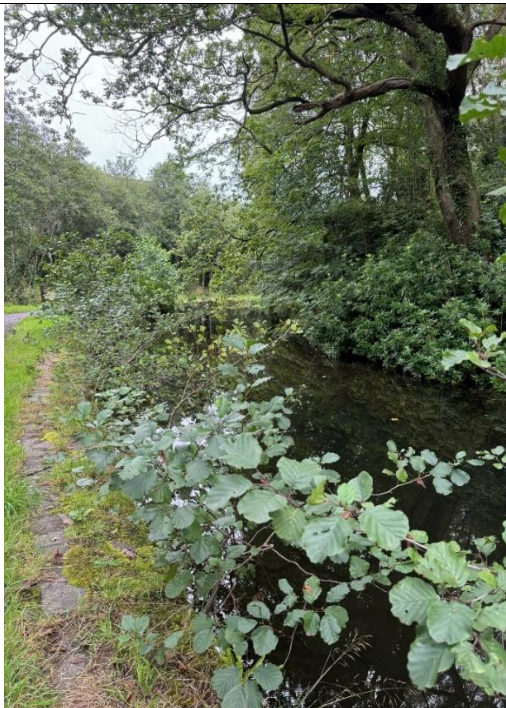
Image 43 – Trees and bushes growing on canal embankments near Howards Footbridge

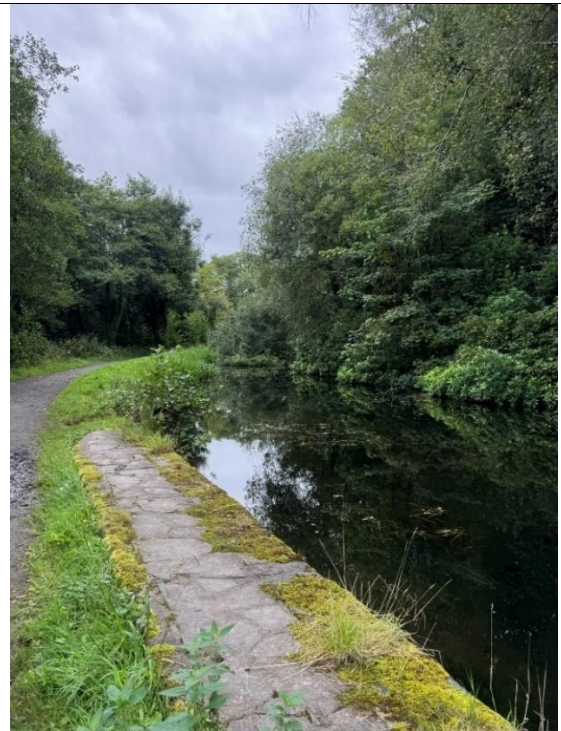
Image 44 – Clearer section of the canal near Howards Footbridge

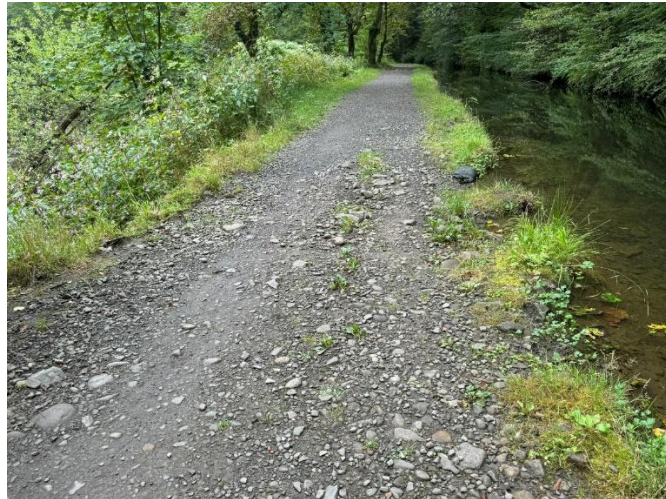
Image 50 - Evidence of overtopping/ flooding (sandbag) across footpath from Canal near Pontygwaith Bridge

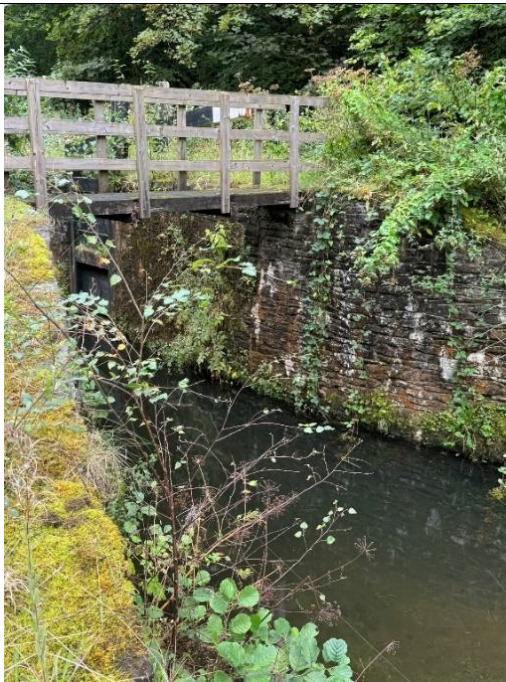
Image 51 – Lock Machin Bridge with buddleia growing on one abutment

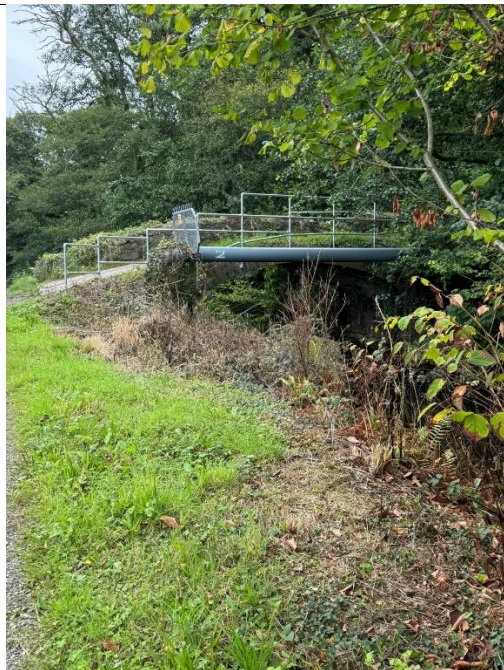
Image 55 – Ynysnedd Bridge with adjacent pipe bridge

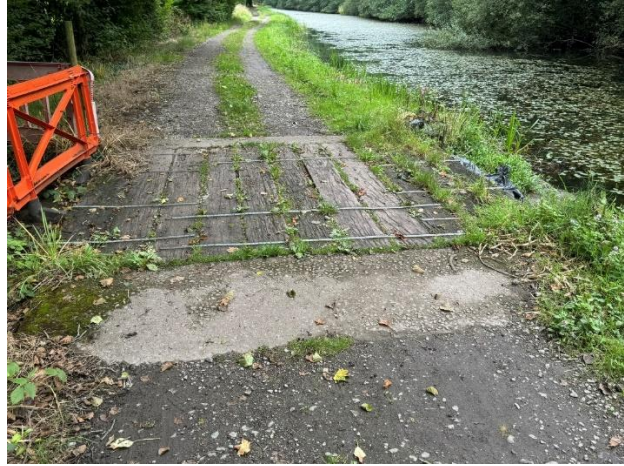
Image 58 – Spillway in footpath to River Neath near Ynysnedd Bridge

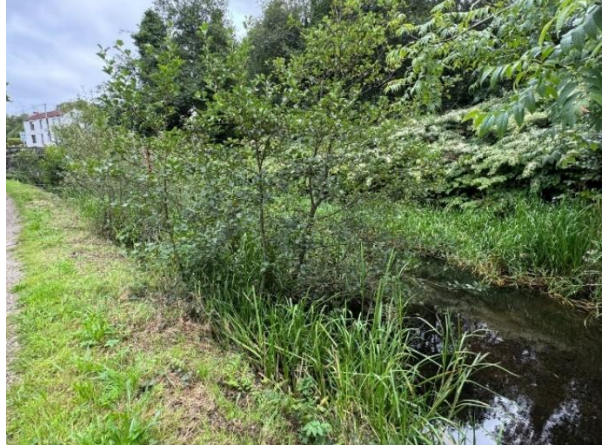
Image 62 – Reeds/shrubs clogging canal near Abertwrch Bridge

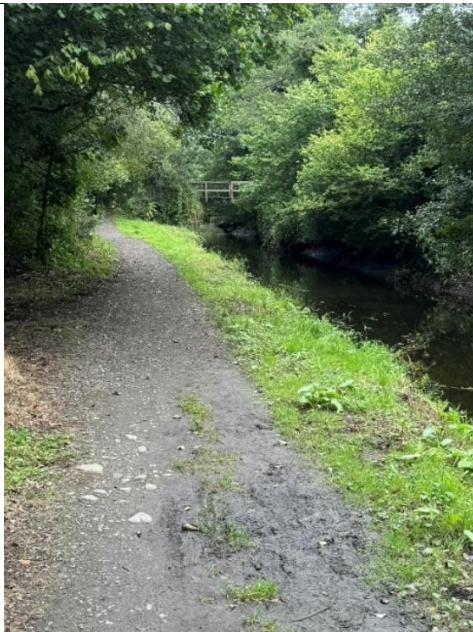
Image 67 – Section of Neath Canal
with trees overhanging

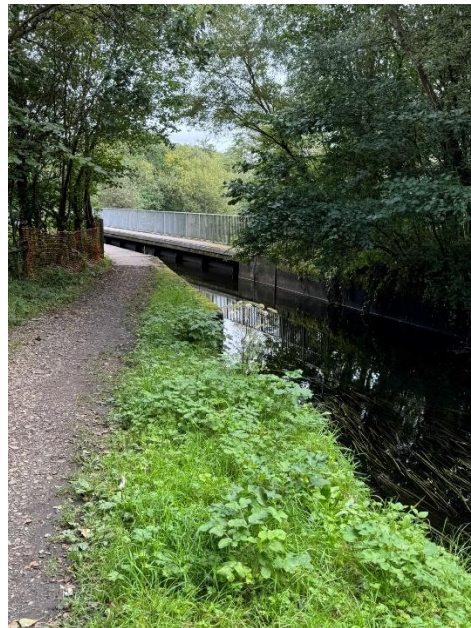
Image 68 – Ynysbwlllog Aqueduct with well-
maintained footpath

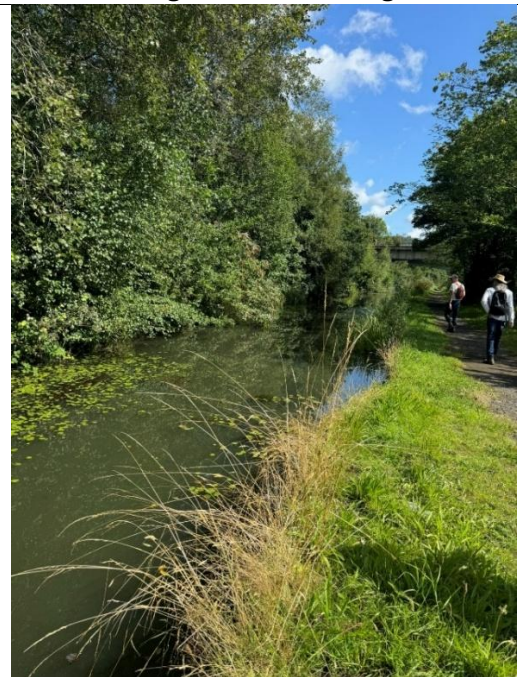
Image 11 – Croft Bridge canal section with small Lilly pads

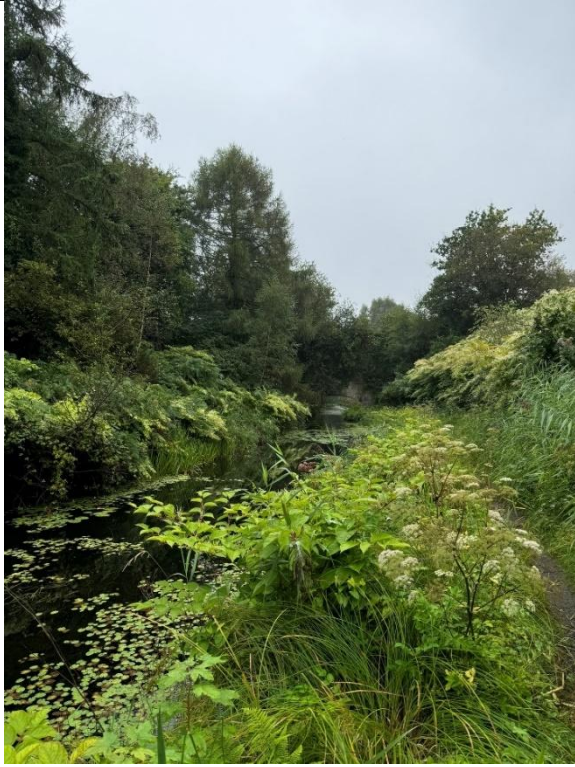
Image 25 – Neath Abbey in Estate New Bridge canal section

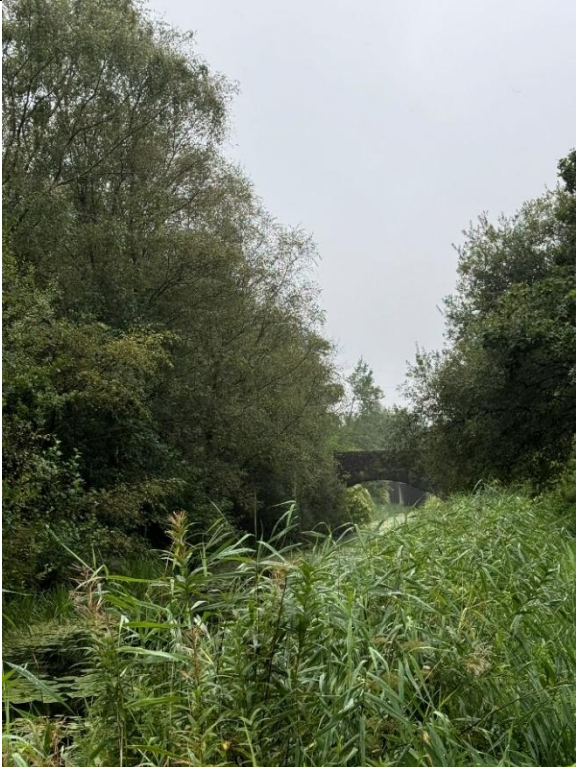
Image 26– Skewen Tramroad bridge

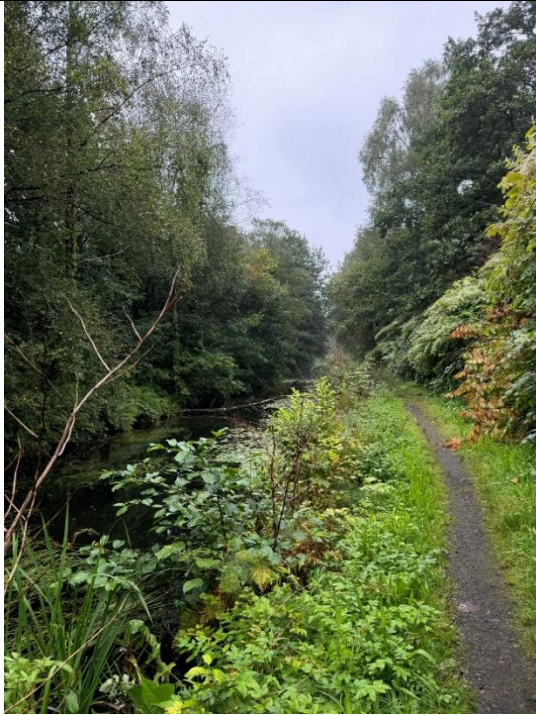
Image 29 – Pipe Bridge canal section

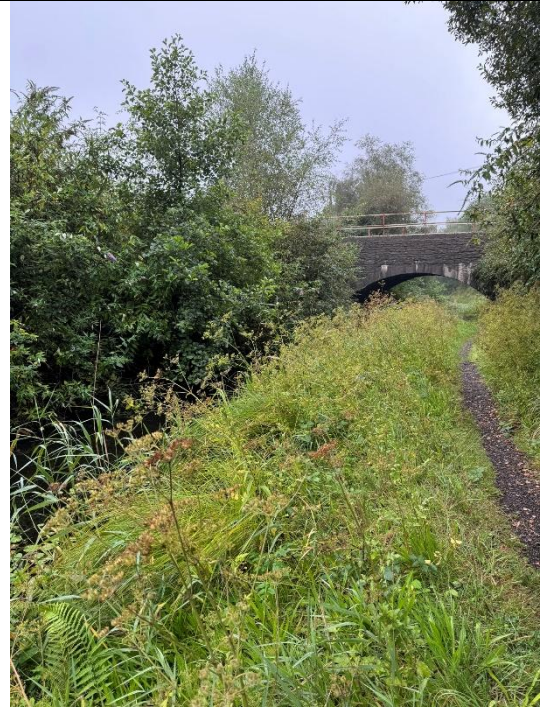
Image 30 – Crown Copperworks Bridge

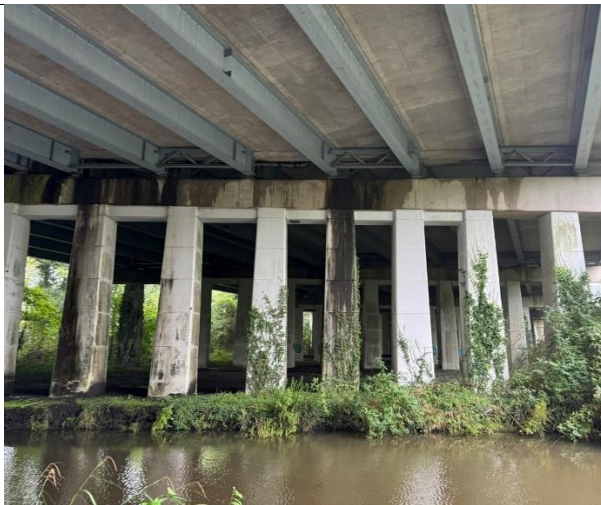
Image 35 – M4 Bridge with canal adjacent to bridge

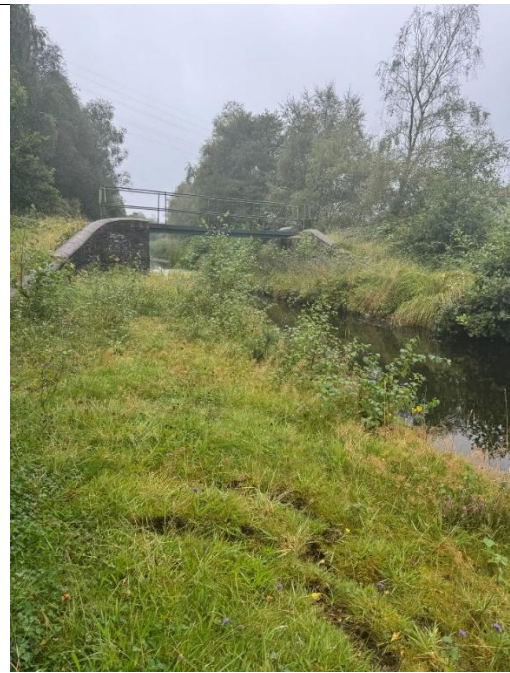
Image 40 – Quarry Bridge with shrubs on embankments

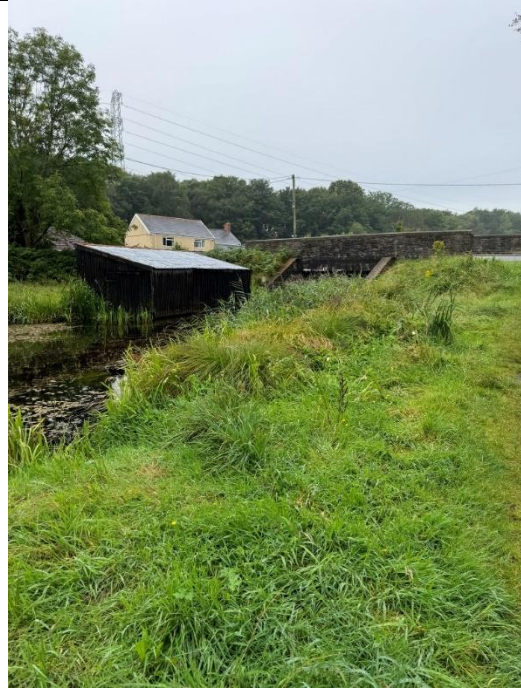
Image 42 – Jersey Marine Bridge with grassy shrubs surrounding
