## Pantteg Landslide, Pantteg

Interpretative Report; Hazard and Risk Assessment Report Reference: ESP.5859e.09.2930 Volume 2

## Pantteg Landslide, Pantteg Interpretative Report; Hazard and Risk Assessment

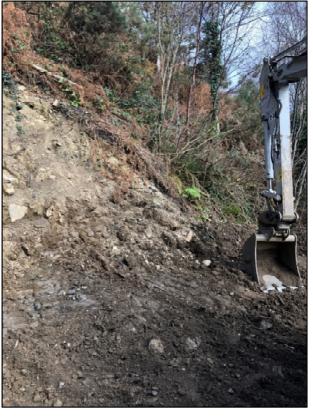
The cliff line at the northern edge of the 'Zone of Distress' or Pen-y-Graig area shows signs of recent rockfall from the cliff, with numerous boulders present at the surface and encountered throughout trial pits excavated in the area. Insert 4 shows a large block of Llynfi Sandstone which could potentially topple.

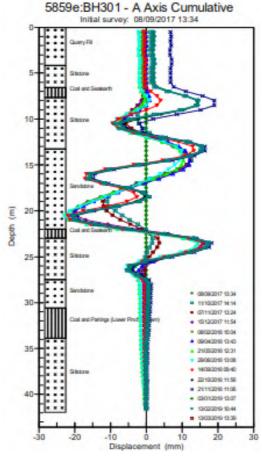
Insert 8 - BH301 Inclinometer (Cumulative)

The inclinometer in BH301 was installed to a depth of 42m and the results have shown the inclinometer to have a suspected 'spiral' shape, which to date has shown movements of around 30mm in all directions. The results show the top

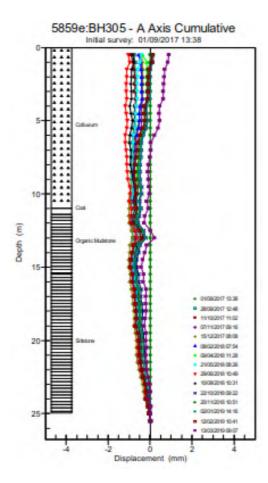
Insert 10 - BH305 Inclinometer (Cumulative)

The inclinometer was installed to a depth of 25m and although some movement, in the region of 3mm has been recorded, it is not considered to be representative of any downslope, or significant movement occurring.

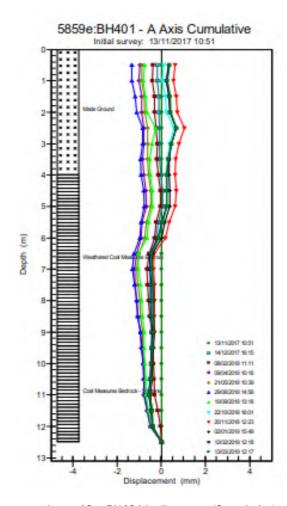
Insert 12 - BH401 Inclinometer (Cumulative)

The results from the inclinometer at BH401 show no significant signs of movement with displacements recorded generally less than 2mm, which is within the realms of the accuracy of the inclinometer.

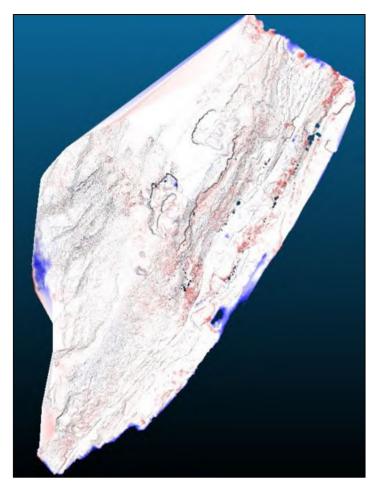
Insert 14 - Extract of LiDAR Isopachyte information. Not to scale.

The isopachytes from the LiDAR data has been generated using Cloud Compare (<a href="https://www.danielgm.net/cc/">https://www.danielgm.net/cc/</a>) to show displacements of ±50cm, with +50cm shown by the red, -50cm shown by the blue and negligible/no displacement uncoloured. We consider that the tree felling work, along with variations in vegetation coverage has had an impact on the LiDAR surveys carried out. Insert 14 provides a graphical representation of the three-dimensional model.

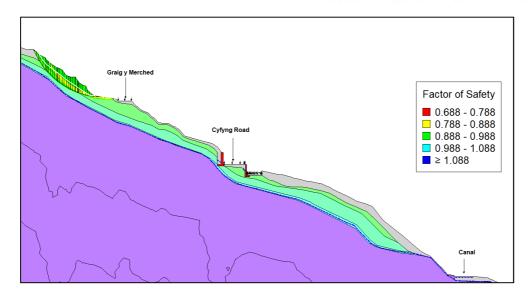
Insert 23 - above Graig y Merched

Analyses of the section has shown that for the strength parameters outlined in Table 21 and on the assumed piezometric surfaces shown, a minimum factor of safety of around 0.7 can be assumed when considering the current slope geometries. This assessment assumes a relatively large slip surface to be created and failure to occur with suspected Made Ground upslope of the site. It should be noted that further assessment shows smaller failures within the steeper section of suspected Made Ground up slope, however, as there is no evidence of these currently occurring, this is likely to be due to the simplifications and relatively conservative parameters adopted.

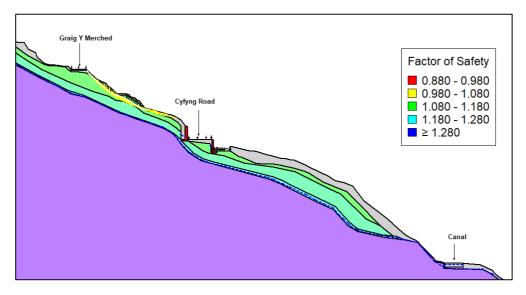
Insert 24 - Between Cyfyng Road and Graig y Merched

Analyses of the section has shown that for the strength parameters outlined in Table 21 and on the assumed piezometric surfaces shown, a minimum factor of safety of around 0.9 can be assumed when considering the current slope geometries. This assessment assumes a slip surface to occur from near the Graig y Merched road and near the top of the retaining wall to Cyfyng road.

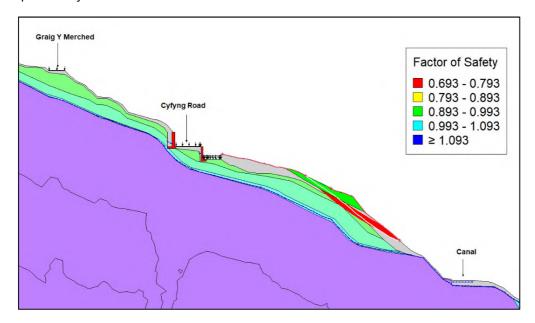
Insert 25 - Below Cyfyng Road

Analyses of the section has shown that for the strength parameters outlined in Table 21 and the assuming piezometric surface shown, a minimum factor of safety of around 0.7 can be assumed when considering the current slope geometries. This assessment assumed a slip surface to

occur within the rear garden area of houses along Cyfyng Road, and forming a similar slip surface to those previously noted in the area.

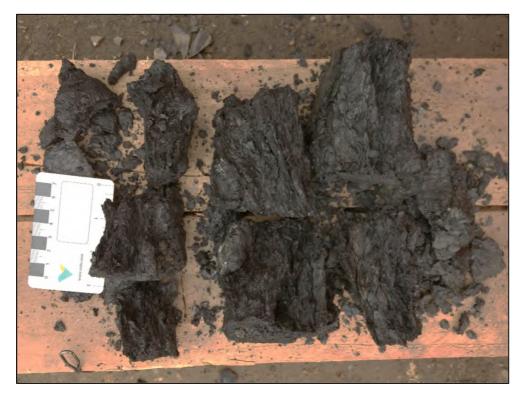
Insert 30 - Sheared mudstone in BH601.

- In BH601 a sheared mudstone was recovered from 8.43m to 8.45m (Insert 30);
- In BH602 an 18mm thick layer of clayey silt with no apparent structure was recovered above a thin coal seam (Insert 31). This was overlain by soft orange brown silty clay. The clayey silt has been interpreted as being a shear surface; and

- The inclinometer installed in BH601 shows movement commencing at between 8.5m and 9.0m in BH601.

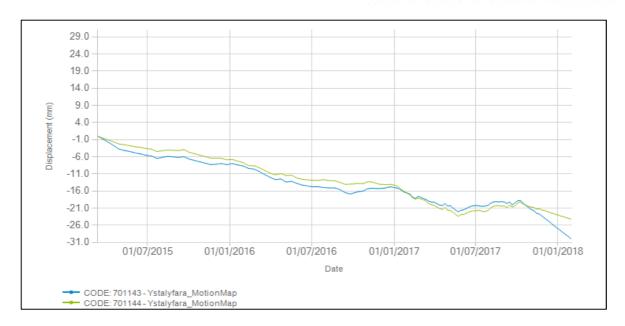
Insert 33 - InSar data against time

Appendix G contains a plot of the InSAR data for Pantteg and the surrounding area. Within this, several higher velocity points are evident within the Pantteg Landslide. The second image in Appendix G is a close up within the Pantteg landslide and there are two locations, close to a marked break in slope that appear to be showing 'real' deformations (marked as area AOI2). Plotting the data from these locations against time shows a consistent downward movement of >20mm over 3 years.

Given the consistent movement with time it seems likely this is the result of on-going, localised, erosion.

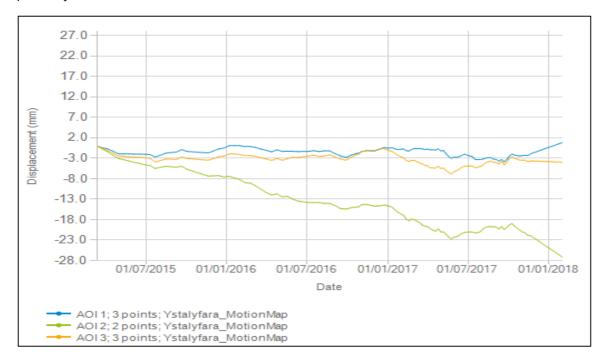
Insert 34 - InSar data comparison.

A comparison between an average of the movements in AOI2 compared with the average movements in the two areas upslope (AOI1 and AOI3) shows that the fluctuations upslope are in the order of 4-5mm which is about the precision of the time-series measurements so they are probably related to 'noise' within the data set itself.

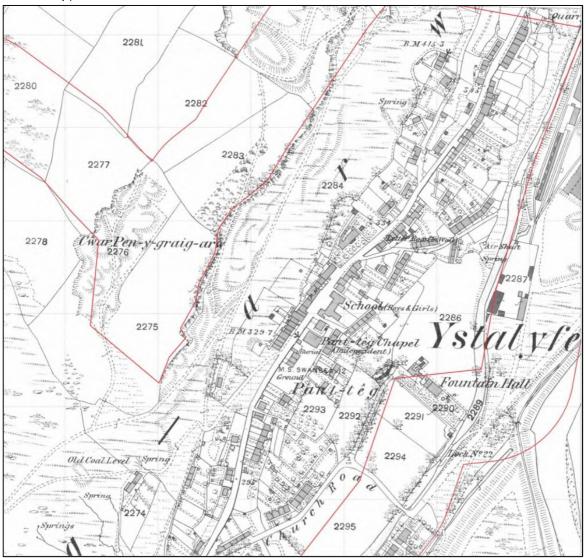
The presence of a bench below the cliff, suggests that the rock cliff may represent the working of the Lynfi Rock as building stone, together with the extraction of any underlying coal. The cliff and apparent mine/quarry waste is evident on the earliest located map dated 1877.

Insert 35 - 1877 Map showing the rock cliff and irregular topography commonly associated with quarry/mine waste.

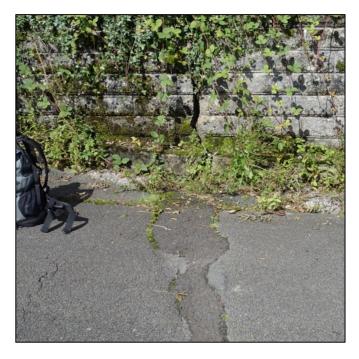
Insert 36 - 20mm tensional opening in retaining wall with distress continuing across Graig Road (15/8/17)

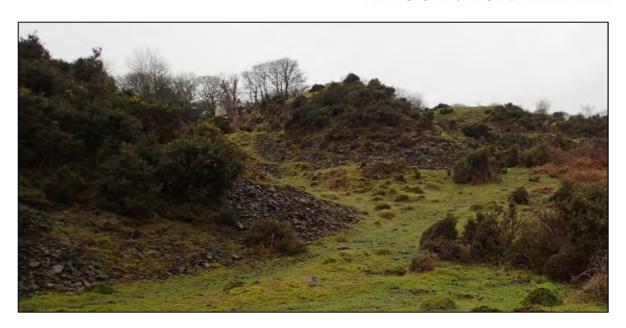
quarry spoil. The quarry spoil appears to be predominantly angular rock bocks (Insert 41) and as such the spoil heaps are likely to be relatively free draining and have a high angle of friction. In addition, the quarry spoil is located a significant distance from the elements at risk and are separated a relatively flat bench at the base of the Llyfin Beds.

Insert 41 - Spoil heaps associated with quarrying (19/2/17)

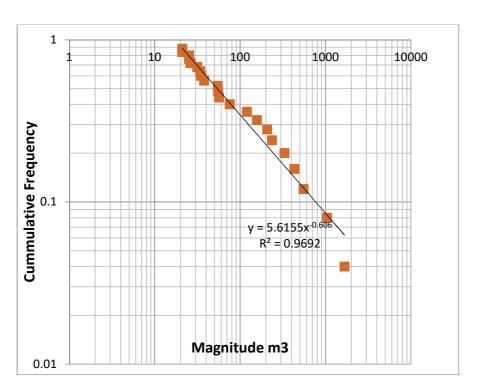
There is a clear power law relationship between cumulative frequency and magnitude (the R2 value is 0.9692). This can be interpreted to indicate that there are not many 'missing' events within the data set.

Based on the magnitude-frequency plot, the 1987 landslide (source volume 1000m³) has an indicated return period of 1:24-years (i.e. there is a 4% probability of a landslide of that volume occurring in one year). In comparison, the 1986 landslide (source volume 550m³) has an indicated return period of 1:8-years or a 12% probability of occurring in one year.

Insert 44 - Cumulative Frequency against Magnitude

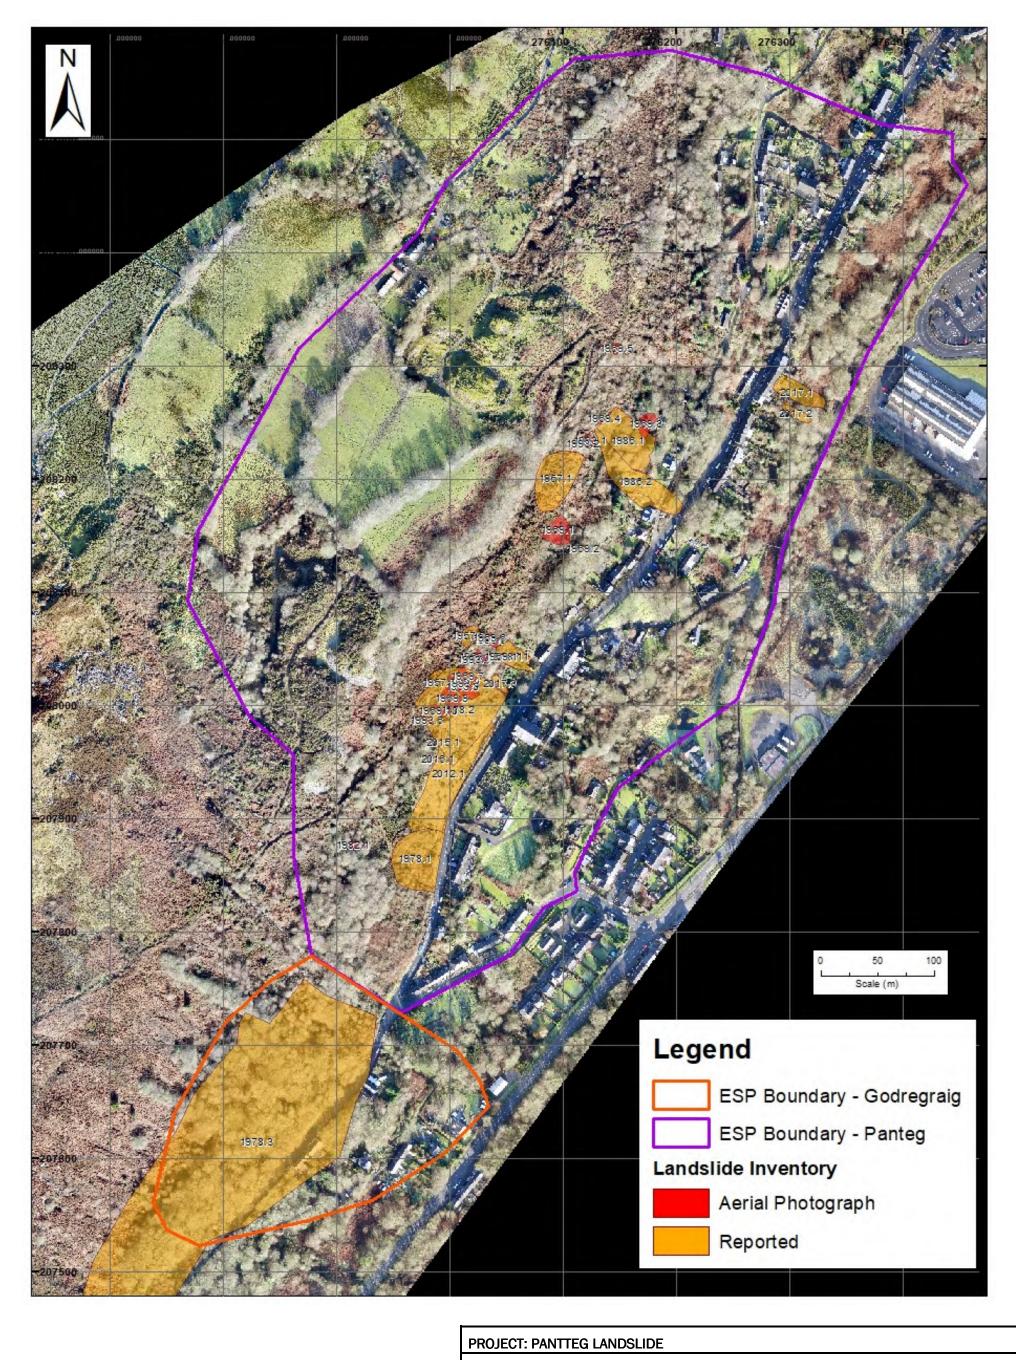
FIGURE 8 - LANDSLIDE INVENTORY

Where Dr maximum depth, Wr maximum width and Lr maximum length, assuming the landslide is ellipsoid in shape. The landslide inventory is shown in Figure 8.

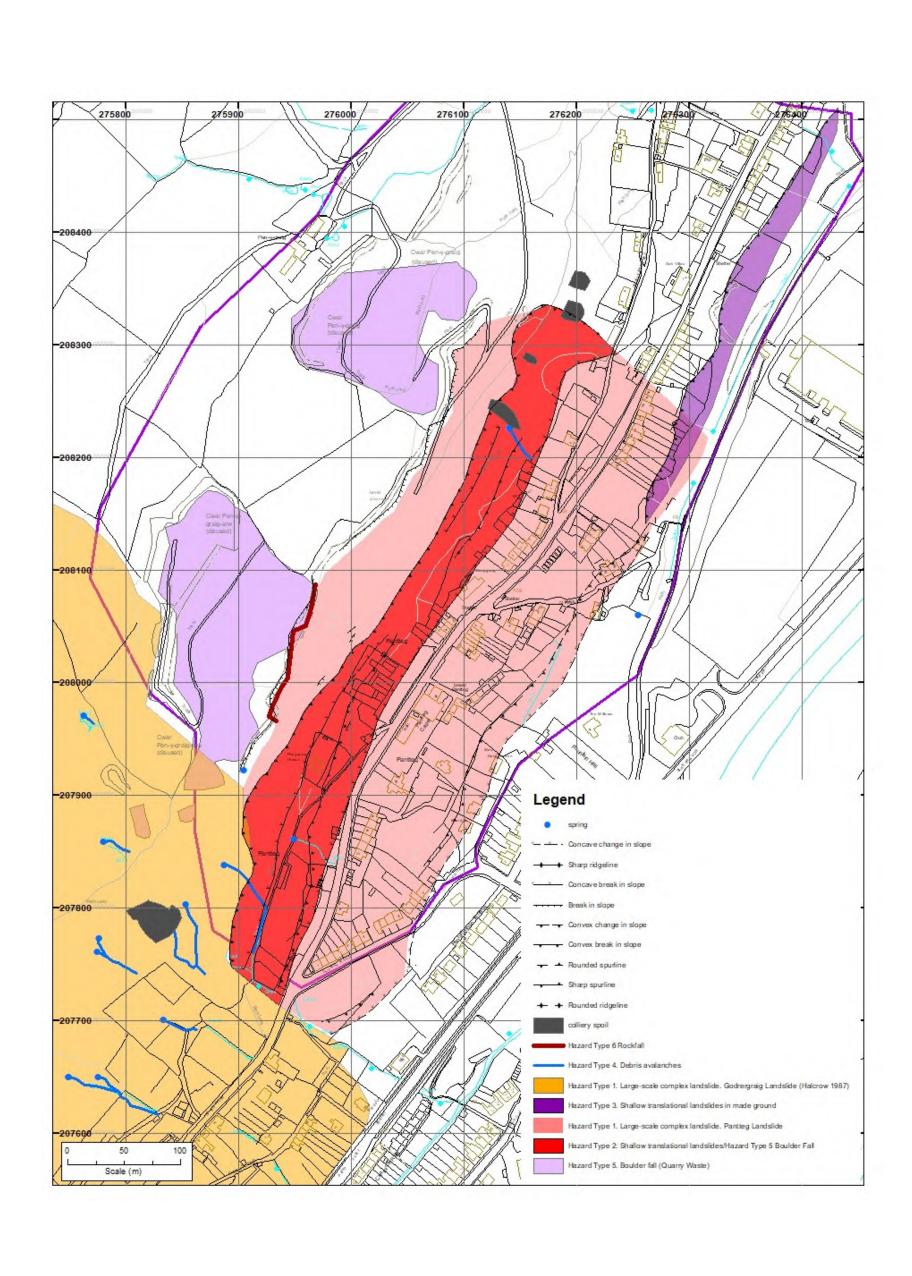
FIGURE 11 - HAZARD TYPES

Based on the landslide inventory the following hazard types are present:

The locations of the source of each hazard type are shown on Figure 5.

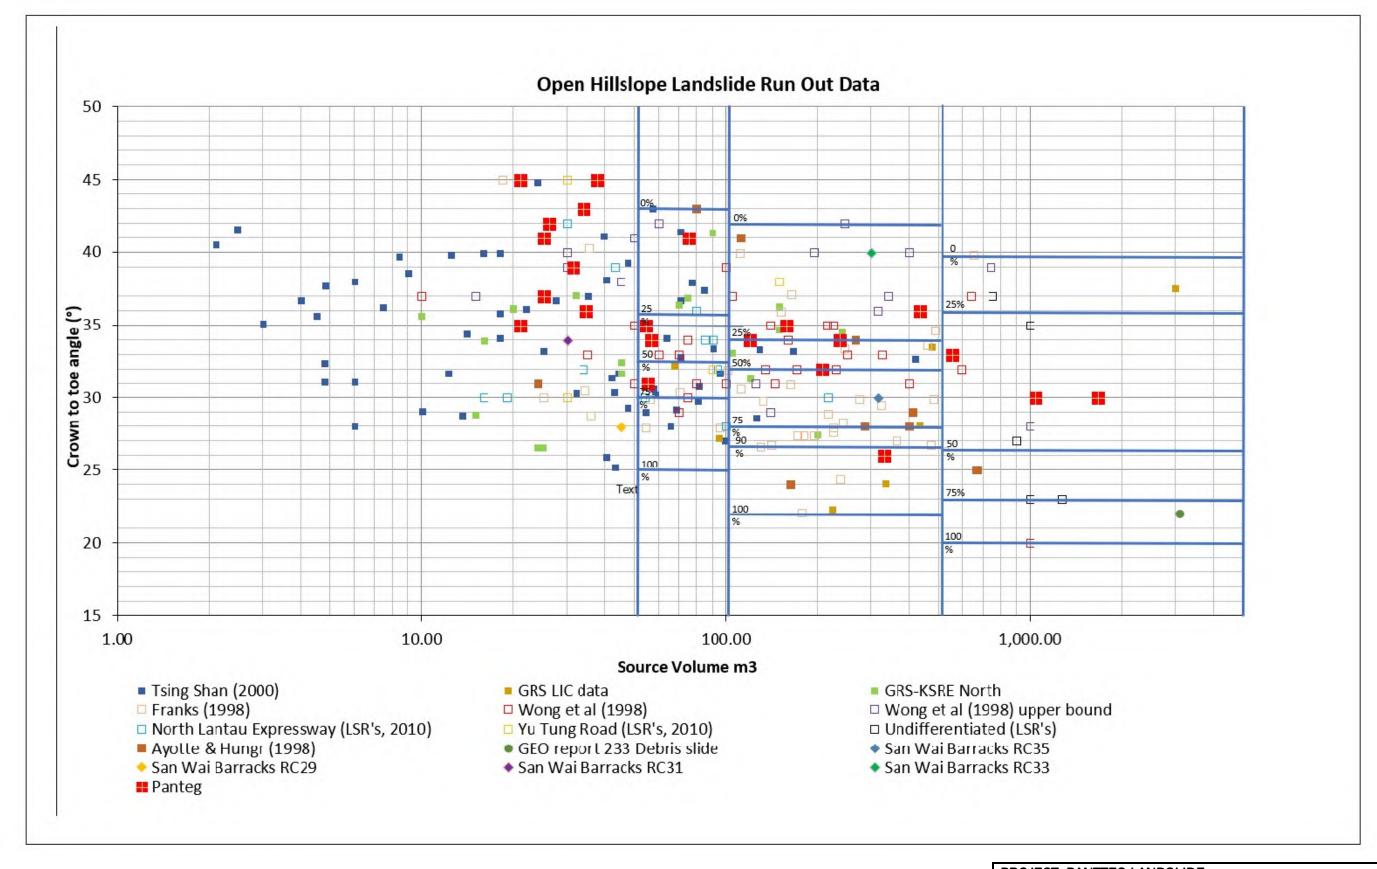
FIGURE 12: LANDSLIDE RUNOUT DATA

As shown in Figure 12, the larger the landslides the lower the travel angle i.e. the further debris travels.

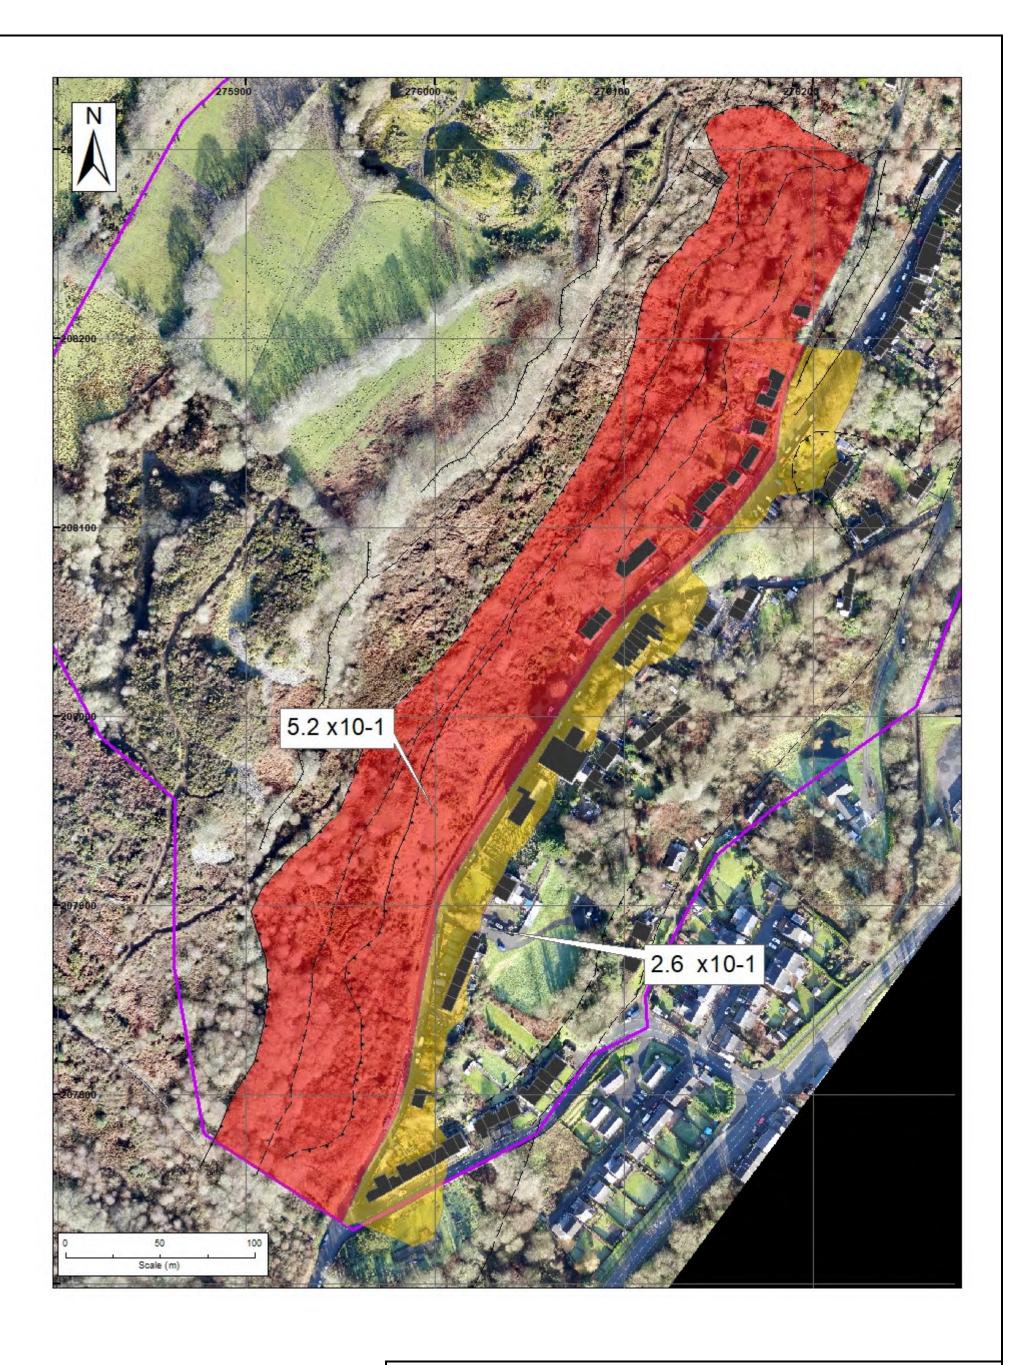
FIGURE 13 - HAZARD PLAN <100m3 VOLUME

The resulting hazard maps for each landslide volume range are shown in Figure 13 to Figure 15.

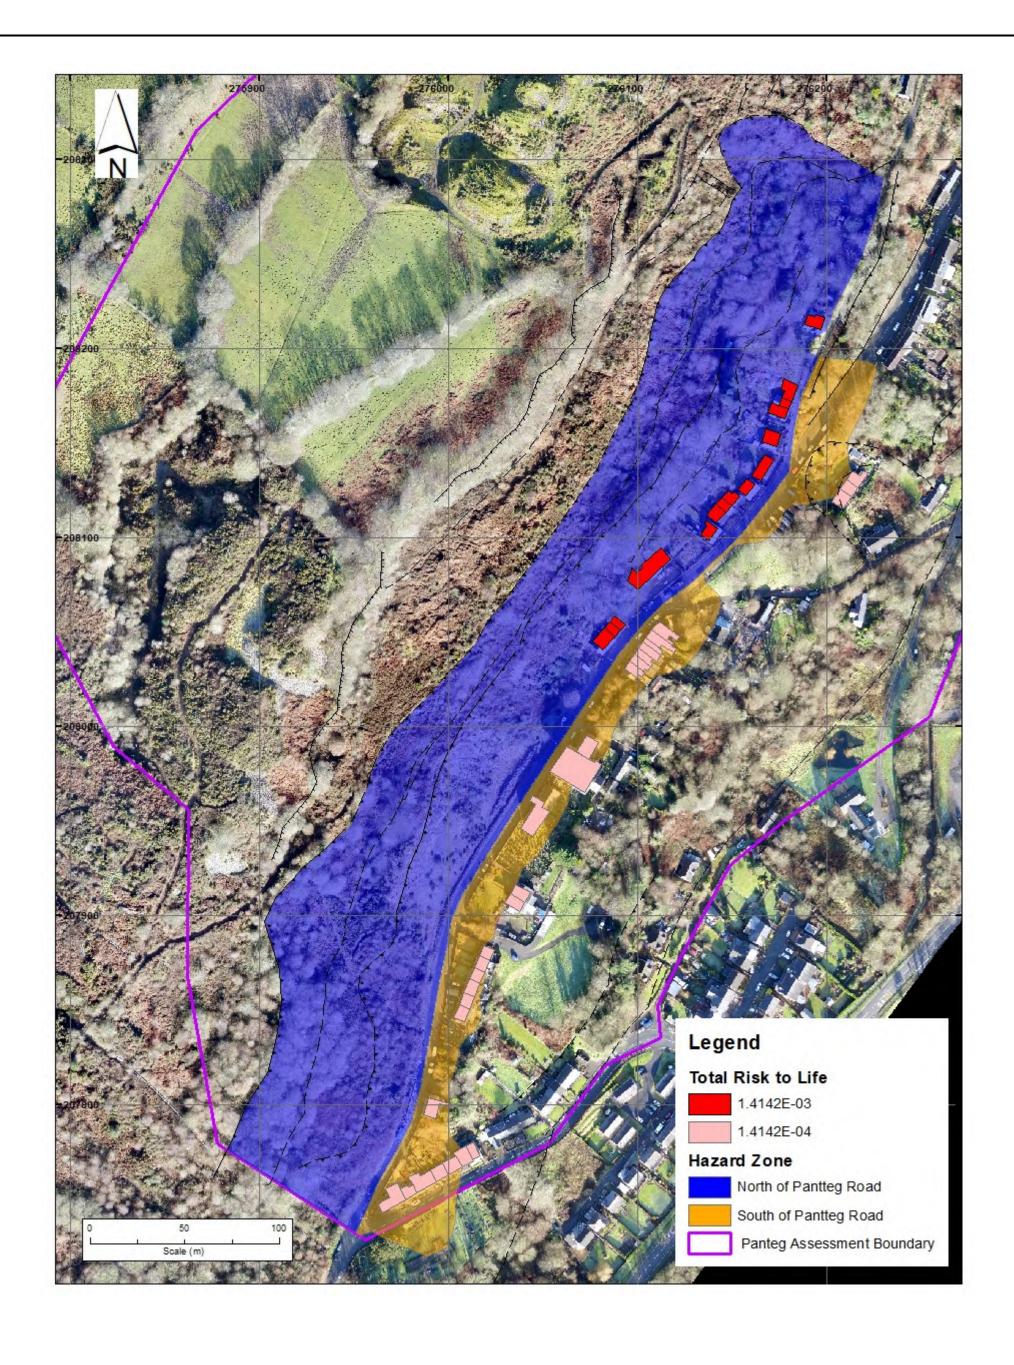
FIGURE 16 - TOTAL RISK (PEOPLE IN BUILDINGS)

The Risk to Life for people within buildings is shown in Figure 16.

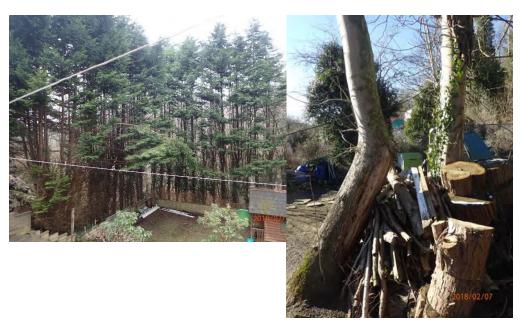
#### Tree ID#G5

#### Survey area SA25

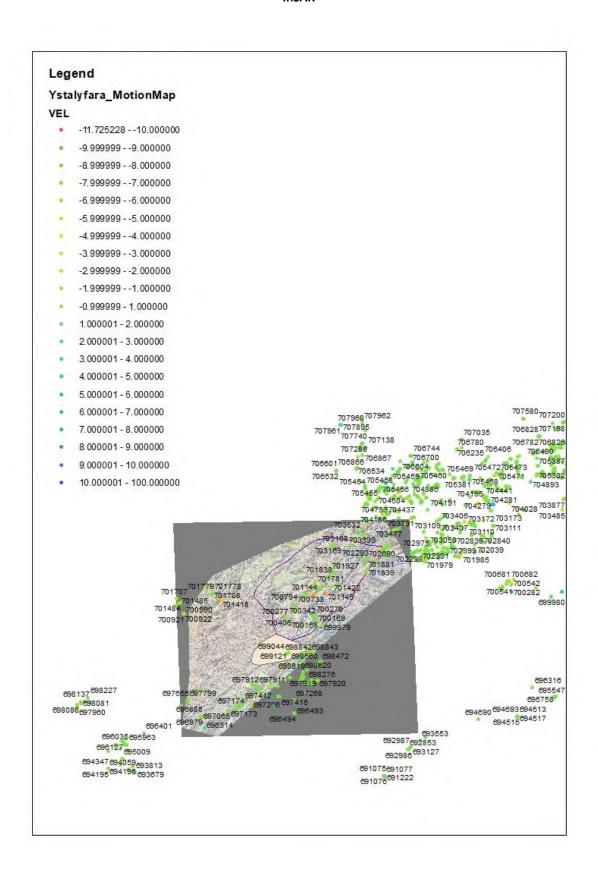
InSAR data for the Pantteg Area

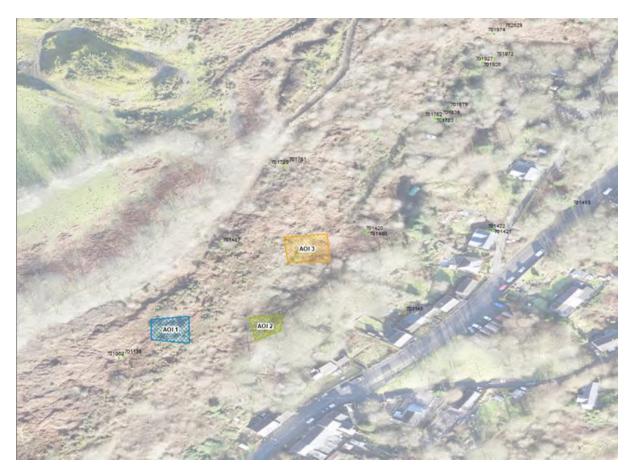
Areas within the Pantteg Landslide where  $\ensuremath{\mathsf{InSAR}}$  detected possible movement.
