Cilmaengwyn Landslide, Tawe Valley
Preliminary Landslide Assessment

Cilmaengwyn Landslide Preliminary Landslide Assessment

Document Reference: ESP.6812e.2973

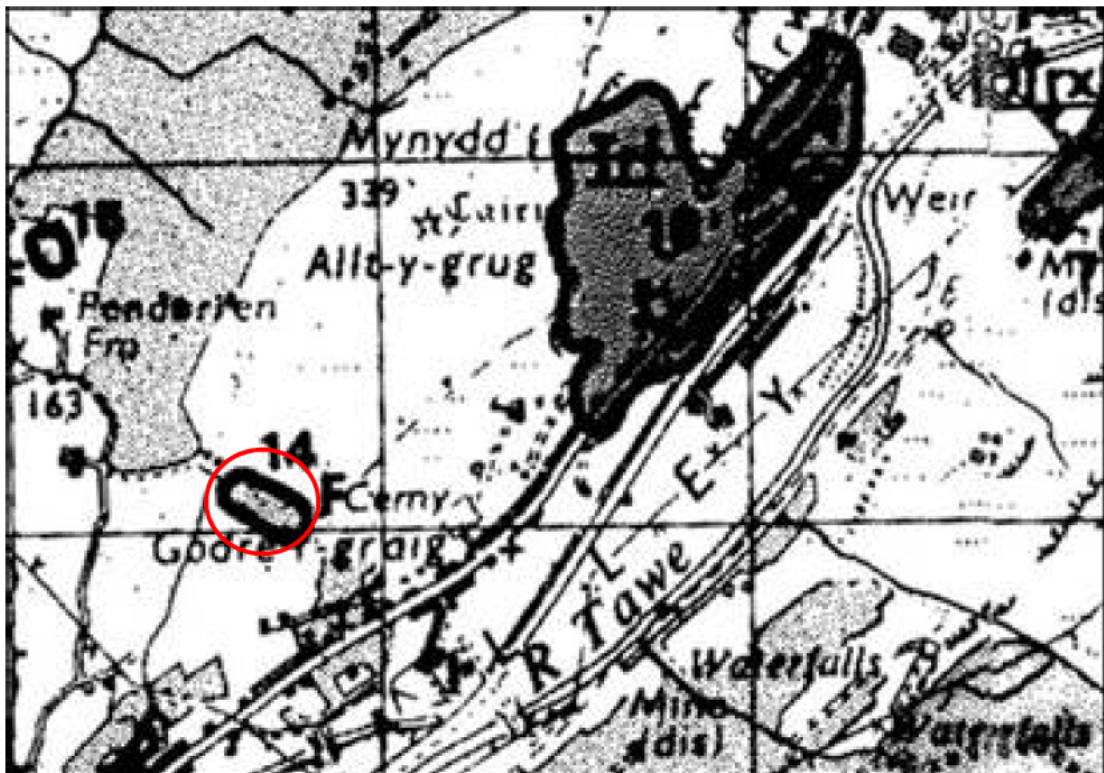
Insert 2: Location and initial search boundary of Landslide TW14.

As discussed in Section 1.2, the boundary for the commencement of this Landslide Assessment was based upon the boundary identified for the landslide TW14 in the South Wales Landslip Survey (Conway et al, 1980). An extract of the survey showing the outline of TW14 is shown in Insert 2 below.

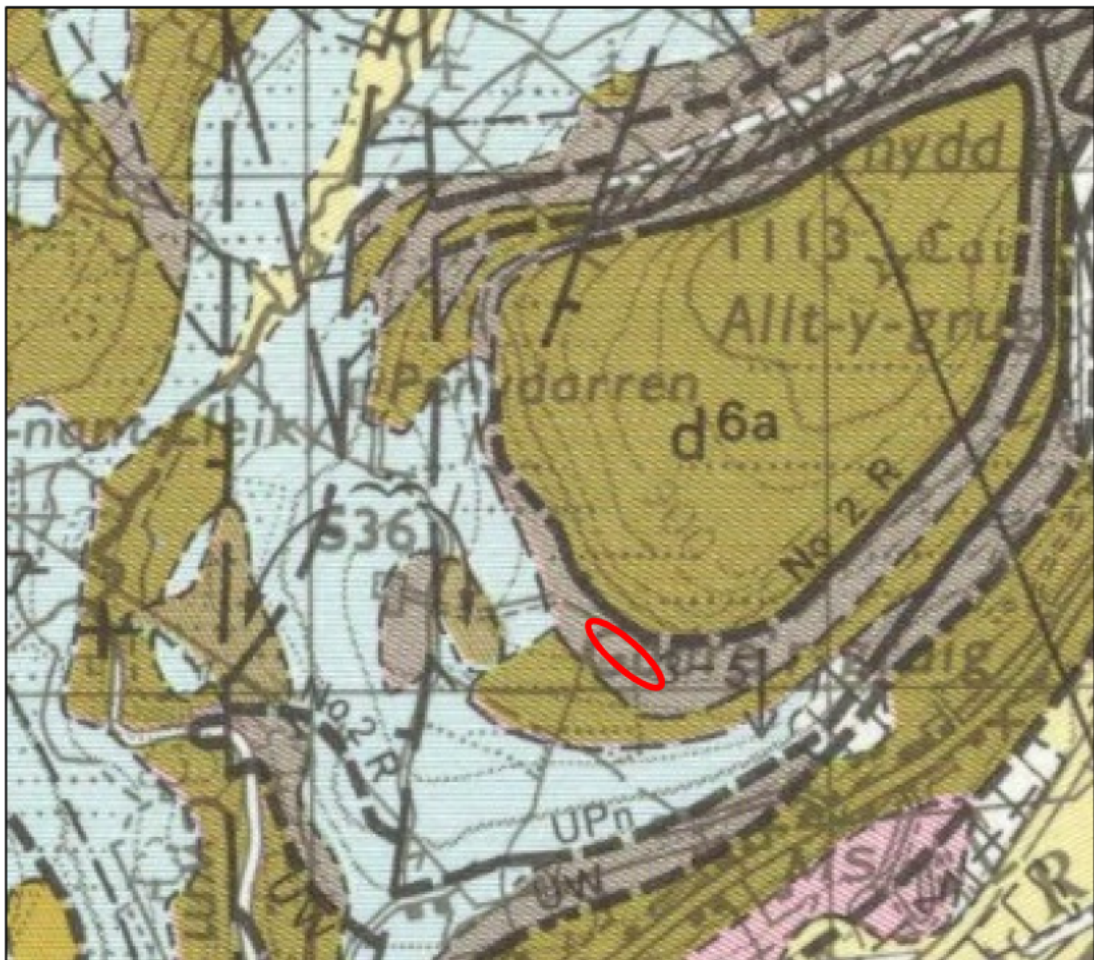
Insert 4: Extract from BGS Solid Geology Sheet 230, 1:50,000 (BGS licence number: C15/05 CSL)

The published 1:50,000 scale geological map for the study area (Sheet 230, available on the website of the British Geological Survey, 2018) generally confirms that above stratigraphy and is shown in Insert 4. The map only shows the presence of the Ynisarwed (or No. 2 Rhondda) and other large seams in the general area of the site, the Pant Rhyd y Dwr or Payne's seams outcrops are not shown.

The map shows the beds in the locality of the site to be dipping toward the south at angles of between 3° and 5°.
