### 7234e:BH01 - A Axis Cumulative

Initial survey: 29/11/2019 09:16

PROJECT:  
SITE: 7234e  
INSTALLATION: BH01  
COMPANY:  
CLIENT:  
NOTE:

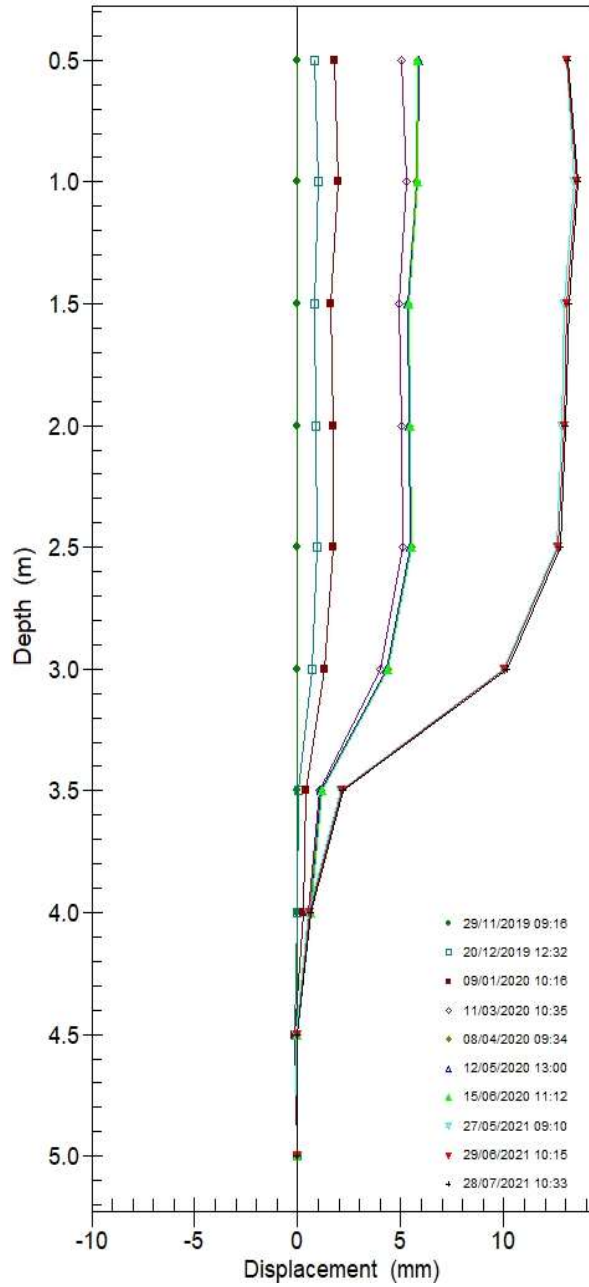
Cumulative Deflection Data in A Axis (mm):

Depth (m)	29/11/2019 09:16:45 (mm)	20/12/2019 12:32:58 (mm)	09/01/2020 10:16:57 (mm)	11/03/2020 10:35:31 (mm)	08/04/2020 09:34:53 (mm)	12/05/2020 13:00:55 (mm)	15/06/2020 11:12:12 (mm)
0.5	0.00	0.83	1.79	5.03	5.85	5.87	5.84
1.0	0.00	1.01	1.95	5.28	5.74	5.79	5.84
1.5	0.00	0.79	1.63	4.92	5.31	5.31	5.38
2.0	0.00	0.90	1.74	5.04	5.42	5.40	5.43
2.5	0.00	0.90	1.74	5.10	5.49	5.46	5.53
3.0	0.00	0.69	1.31	4.03	4.35	4.33	4.38
3.5	0.00	0.04	0.39	1.05	1.13	1.13	1.15
4.0	0.00	-0.03	0.28	0.54	0.60	0.62	0.61
4.5	0.00	-0.13	-0.16	-0.09	-0.06	-0.05	-0.02
5.0	0.00	0.00	0.00	0.00	0.00	0.00	0.00

Depth (m)	27/05/2021 09:10:48 (mm)	29/06/2021 10:15:03 (mm)	28/07/2021 10:33:06 (mm)
0.5	13.06	13.04	13.11
1.0	13.42	13.53	13.60
1.5	12.95	13.06	13.18
2.0	12.78	12.91	13.00
2.5	12.55	12.64	12.75
3.0	9.96	10.04	10.15
3.5	2.05	2.13	2.23
4.0	0.50	0.56	0.62
4.5	-0.10	-0.06	-0.03
5.0	0.00	0.00	0.00

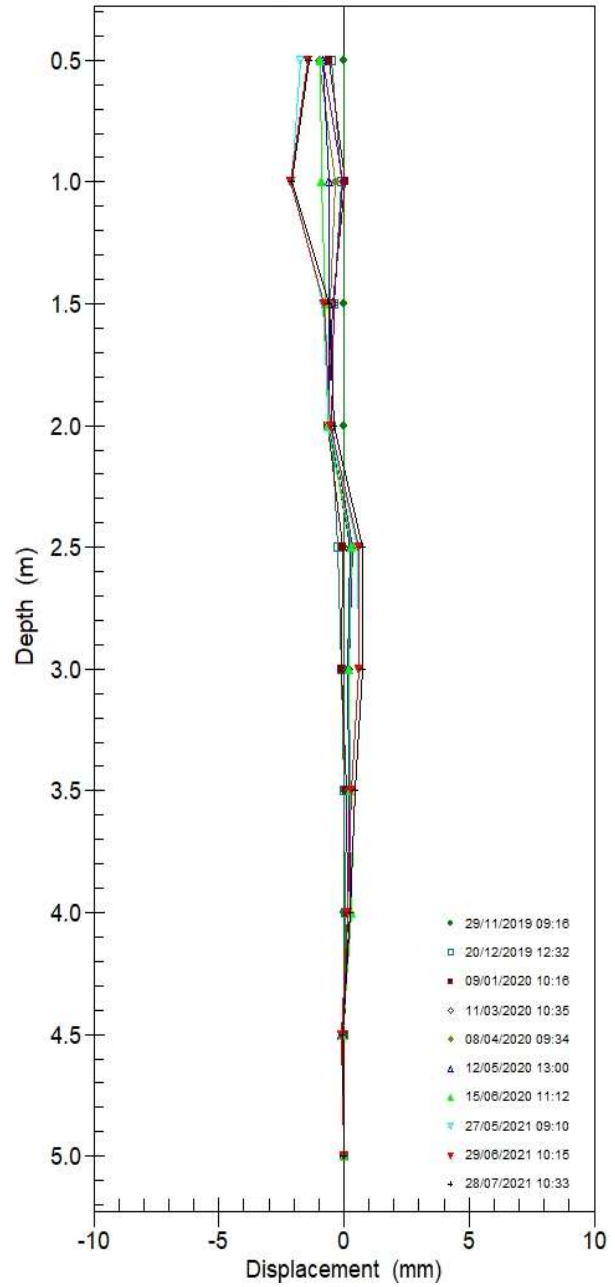
### 7234e:BH01 - B Axis Cumulative

Initial survey: 29/11/2019 09:16

Cumulative Deflection Data in B Axis (mm):

Depth (m)	29/11/2019 09:16:45 (mm)	20/12/2019 12:32:58 (mm)	09/01/2020 10:16:57 (mm)	11/03/2020 10:35:31 (mm)	08/04/2020 09:34:53 (mm)	12/05/2020 13:00:55 (mm)	15/06/2020 11:12:12 (mm)
0.5	0.00	-0.51	-0.60	-0.84	-1.01	-0.86	-0.95
1.0	0.00	-0.09	0.05	-0.03	-0.35	-0.62	-0.92
1.5	0.00	-0.40	-0.44	-0.40	-0.53	-0.61	-0.72
2.0	0.00	-0.51	-0.64	-0.51	-0.58	-0.60	-0.66
2.5	0.00	-0.25	-0.03	0.32	0.29	0.26	0.27
3.0	0.00	-0.12	-0.10	0.18	0.13	0.13	0.17
3.5	0.00	-0.01	0.12	0.23	0.19	0.20	0.26
4.0	0.00	0.02	0.16	0.27	0.25	0.24	0.30
4.5	0.00	0.00	-0.01	-0.04	-0.07	-0.08	-0.03
5.0	0.00	0.00	0.00	0.00	0.00	0.00	0.00

Depth (m)	27/05/2021 09:10:48 (mm)	29/06/2021 10:15:03 (mm)	28/07/2021 10:33:06 (mm)
0.5	-1.72	-1.46	-1.39
1.0	-2.10	-2.15	-2.08
1.5	-0.85	-0.79	-0.62
2.0	-0.60	-0.55	-0.41
2.5	0.56	0.59	0.73
3.0	0.60	0.60	0.75
3.5	0.30	0.30	0.42
4.0	0.14	0.15	0.25
4.5	-0.10	-0.12	-0.07
5.0	0.00	0.00	0.00

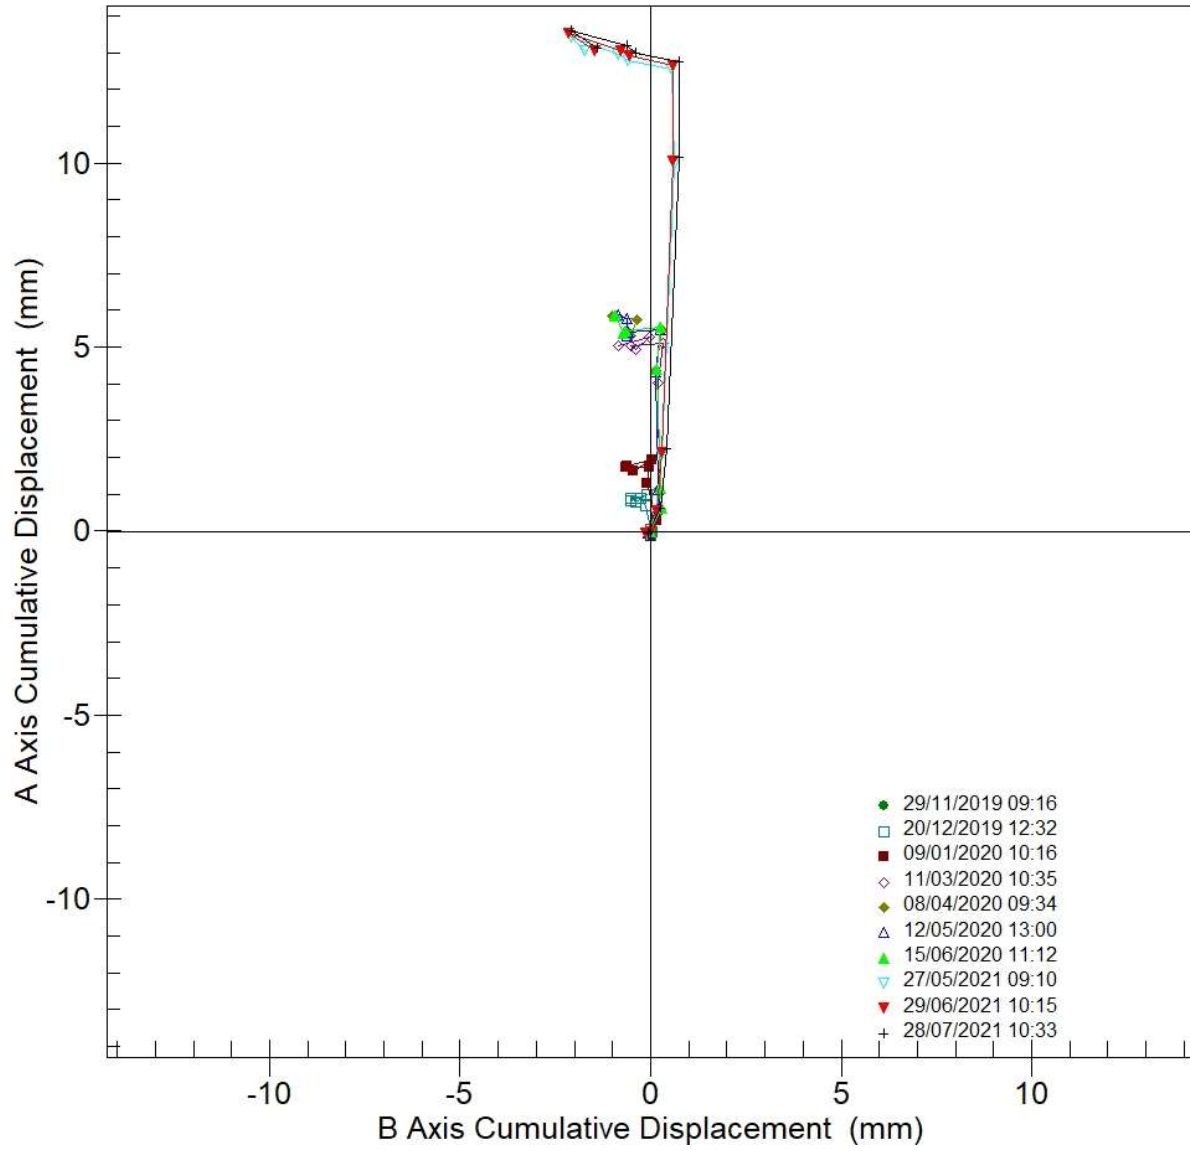
# 7234e:BH01 - A Axis vs B Axis

Initial survey: 29/11/2019 09:16

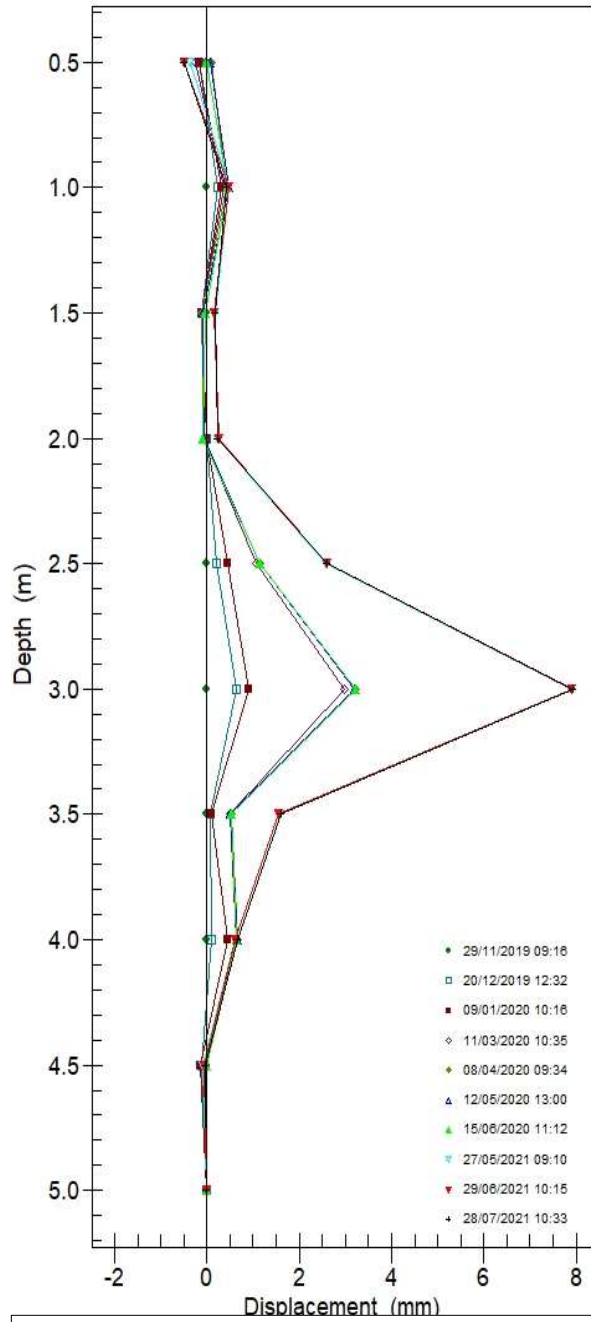
### 7234e:BH01 - A Axis Incremental

Initial survey: 29/11/2019 09:16

Incremental Deflection Data in A Axis (mm):

Depth (m)	29/11/2019 09:16:45 (mm)	20/12/2019 12:32:58 (mm)	09/01/2020 10:16:57 (mm)	11/03/2020 10:35:31 (mm)	08/04/2020 09:34:53 (mm)	12/05/2020 13:00:55 (mm)	15/06/2020 11:12:12 (mm)
0.5	0.00	-0.18	-0.16	-0.26	0.11	0.08	0.00
1.0	0.00	0.22	0.32	0.36	0.43	0.48	0.46
1.5	0.00	-0.11	-0.11	-0.12	-0.11	-0.10	-0.05
2.0	0.00	0.00	0.00	-0.06	-0.06	-0.06	-0.10
2.5	0.00	0.22	0.43	1.07	1.14	1.14	1.15
3.0	0.00	0.65	0.91	2.99	3.22	3.20	3.23
3.5	0.00	0.07	0.11	0.50	0.53	0.51	0.53
4.0	0.00	0.09	0.44	0.63	0.65	0.67	0.63
4.5	0.00	-0.13	-0.16	-0.09	-0.06	-0.05	-0.02
5.0	0.00	0.00	0.00	0.00	0.00	0.00	0.00

Depth (m)	27/05/2021 09:10:48 (mm)	29/06/2021 10:15:03 (mm)	28/07/2021 10:33:06 (mm)
0.5	-0.35	-0.49	-0.49
1.0	0.46	0.47	0.42
1.5	0.18	0.15	0.18
2.0	0.23	0.27	0.25
2.5	2.58	2.60	2.60
3.0	7.91	7.91	7.93
3.5	1.55	1.57	1.61
4.0	0.60	0.62	0.65
4.5	-0.10	-0.06	-0.03
5.0	0.00	0.00	0.00

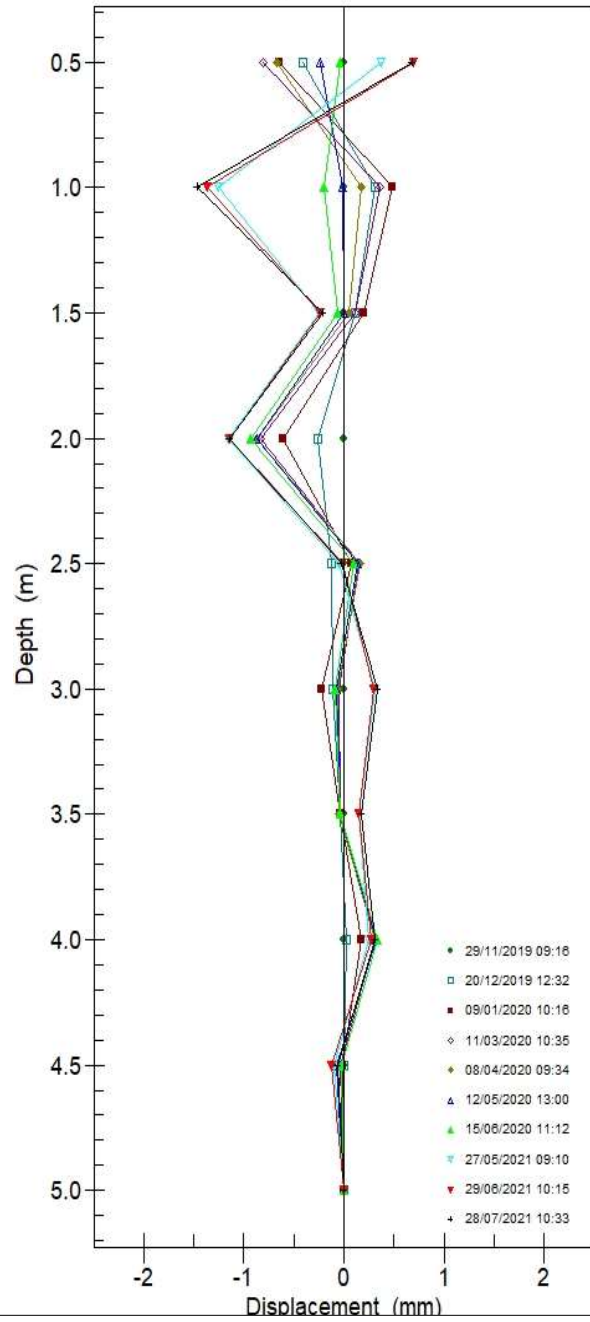
### 7234e:BH01 - B Axis Incremental

Initial survey: 29/11/2019 09:16

Incremental Deflection Data in B Axis (mm):

Depth (m)	29/11/2019 09:16:45 (mm)	20/12/2019 12:32:58 (mm)	09/01/2020 10:16:57 (mm)	11/03/2020 10:35:31 (mm)	08/04/2020 09:34:53 (mm)	12/05/2020 13:00:55 (mm)	15/06/2020 11:12:12 (mm)
0.5	0.00	-0.42	-0.65	-0.81	-0.66	-0.24	-0.03
1.0	0.00	0.31	0.49	0.36	0.18	-0.02	-0.19
1.5	0.00	0.11	0.20	0.12	0.05	-0.01	-0.06
2.0	0.00	-0.27	-0.61	-0.84	-0.86	-0.86	-0.93
2.5	0.00	-0.13	0.07	0.14	0.16	0.13	0.10
3.0	0.00	-0.11	-0.22	-0.06	-0.07	-0.08	-0.09
3.5	0.00	-0.03	-0.04	-0.03	-0.05	-0.03	-0.04
4.0	0.00	0.03	0.17	0.31	0.31	0.32	0.33
4.5	0.00	0.00	-0.01	-0.04	-0.07	-0.08	-0.03
5.0	0.00	0.00	0.00	0.00	0.00	0.00	0.00

Depth (m)	27/05/2021 09:10:48 (mm)	29/06/2021 10:15:03 (mm)	28/07/2021 10:33:06 (mm)
0.5	0.38	0.69	0.68
1.0	-1.25	-1.36	-1.46
1.5	-0.24	-0.23	-0.21
2.0	-1.16	-1.14	-1.14
2.5	-0.05	-0.01	-0.02
3.0	0.31	0.30	0.33
3.5	0.16	0.16	0.18
4.0	0.24	0.27	0.31
4.5	-0.10	-0.12	-0.07
5.0	0.00	0.00	0.00
