Neath Canal

Tennant Canal

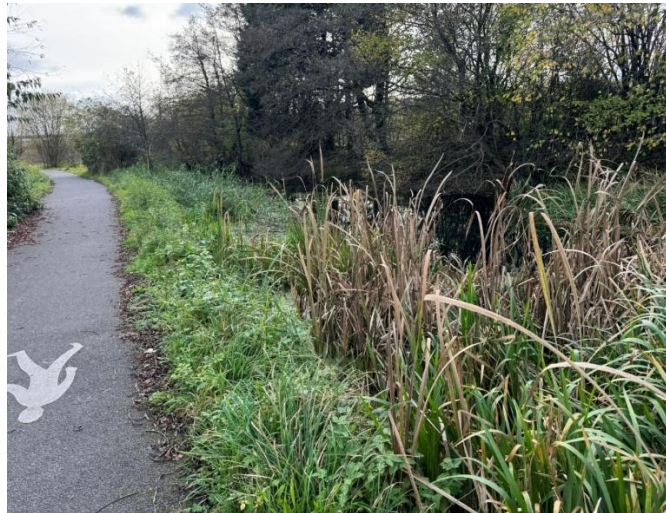
Image 4 – Giants Grave turnover showing reeds and vegetation blocking canal near edges and tarmacked footpath

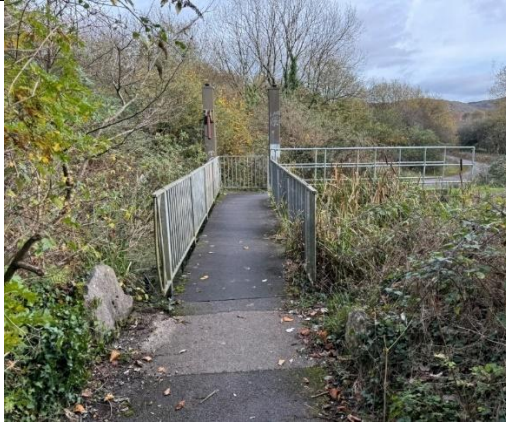
Image 5 – Lift Bridge surrounded by thick vegetation

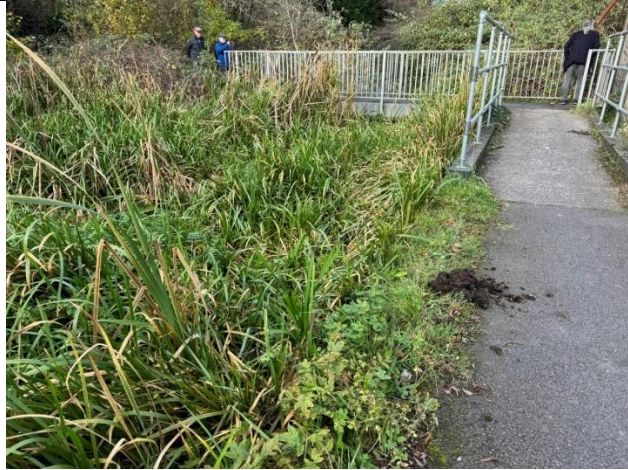
Image 6 – Canal adjacent to Lift Bridge overgrown with thick reeds and vegetation

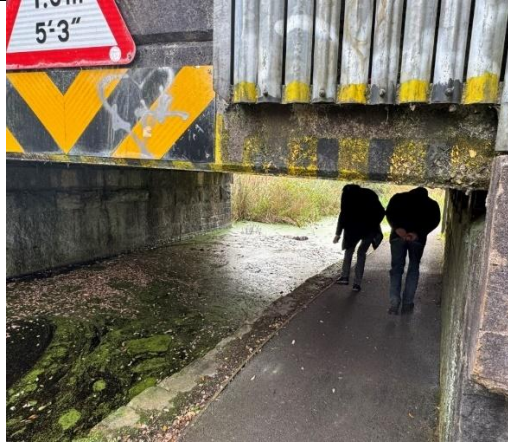
Image 9 - Neath Junction Rail Bridge highlighting low headroom (5'3) for pedestrians but sufficient for canal navigation

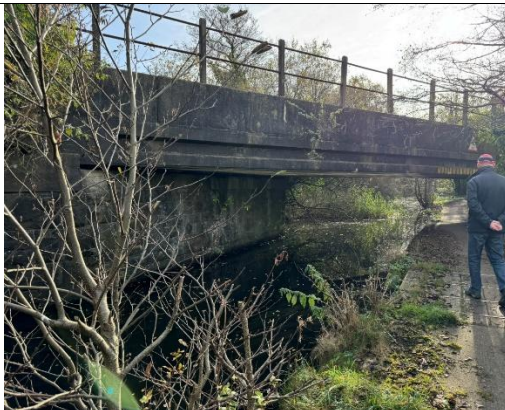
Image 19 - Swansea and Rhondda Bay Railway Bridge with low headroom (5'8) for pedestrians

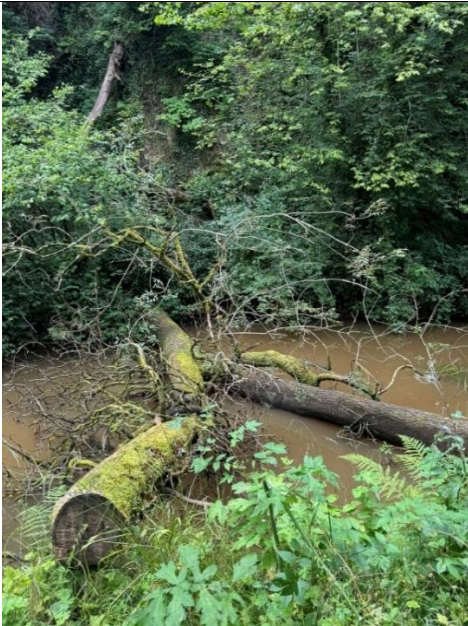
Image 39 – Canal section near Dulais Fach Road Bridge with fallen tree in canal

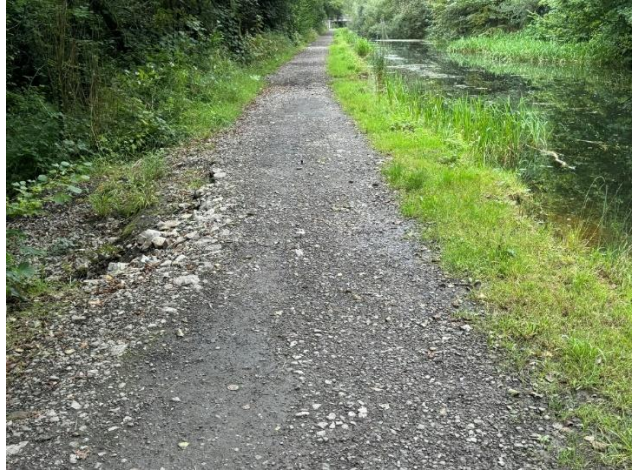
Image 46 – Possible evidence of overtopping (LHS) from Canal near Howards Footbridge

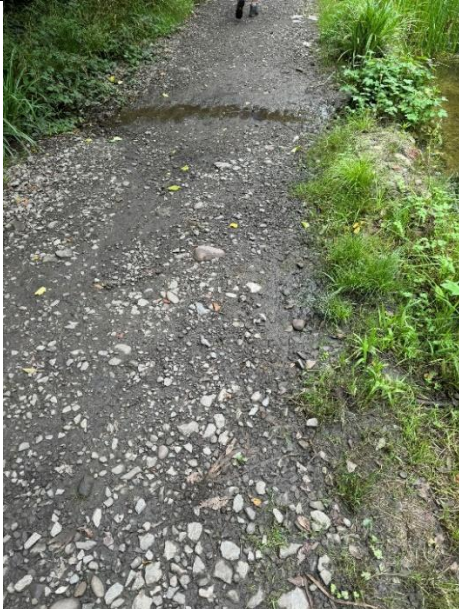
Image 47 – Evidence of overtopping from Canal near Howards Footbridge

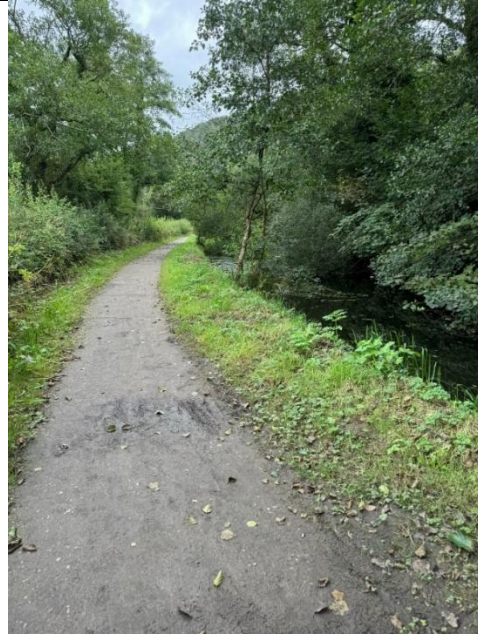
Image 54 – Canal with small trees on embankment near Lock Machin

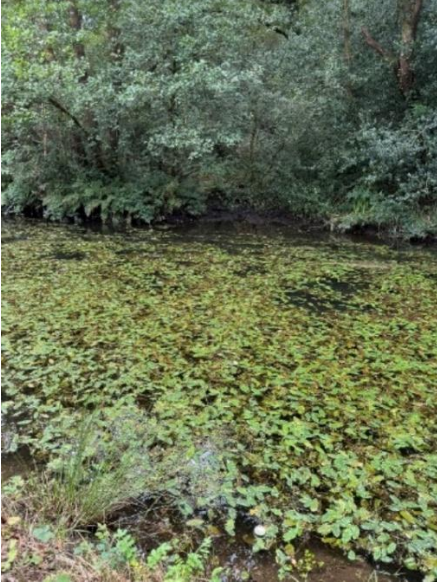
Image 61 – Algae/vegetation blocking canal near Abertwrch Bridge

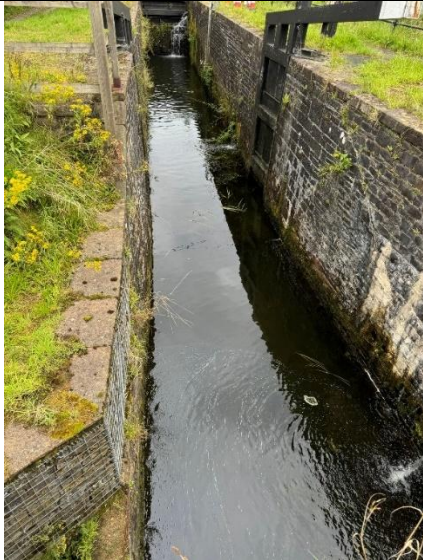
Image 63 – Clun Isaf Lock Structure with efflorescence from masonry

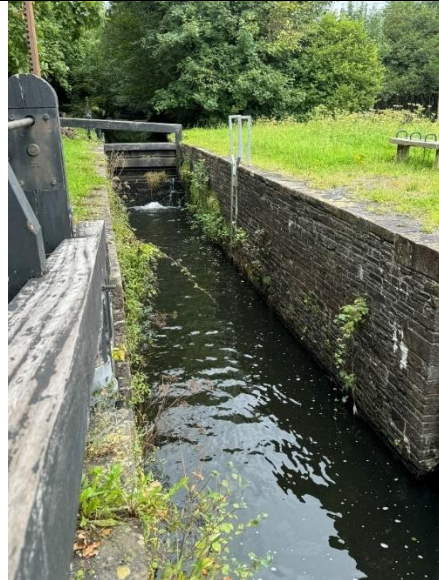
Image 64 – Clun Isaf Lock currently inoperable with view of access ladder

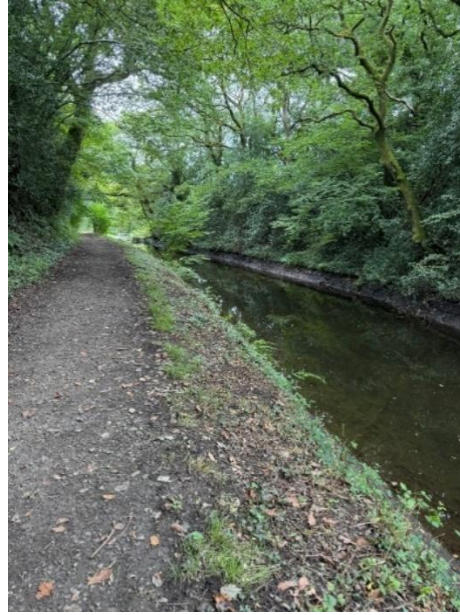
Image 66 – Well maintained section of the canal

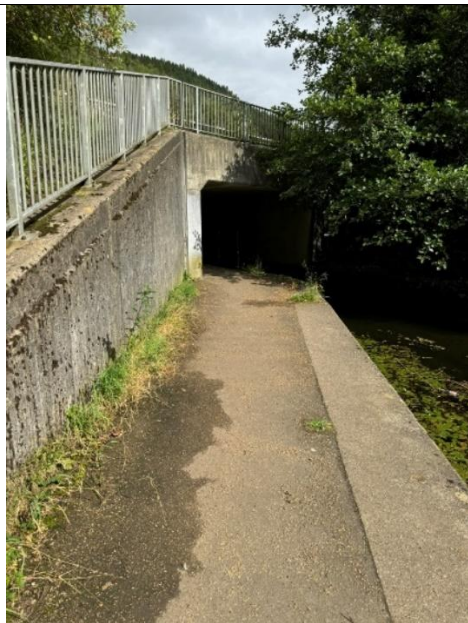
Image 70 – Section of the canal near Ynysbwlllog Aqueduct with reeds and lily pads obstructing navigation

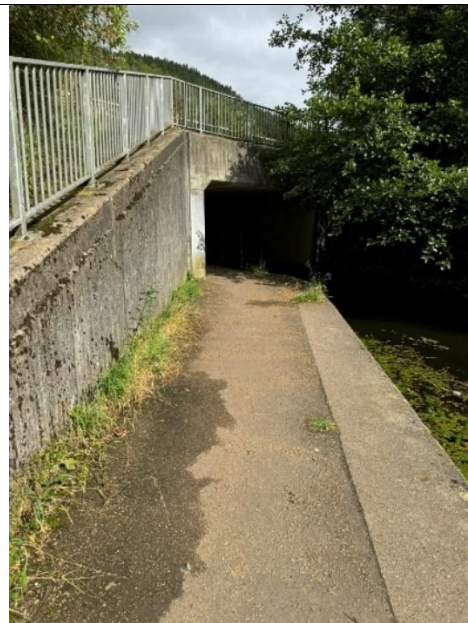
Image 71 – A465 Bridge with pedestrian footpath adjacent to canal

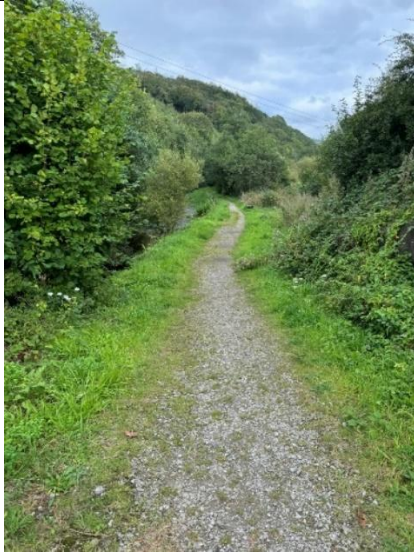
Image 72 – Ynysbwlllog bridge with light vegetation on footpath

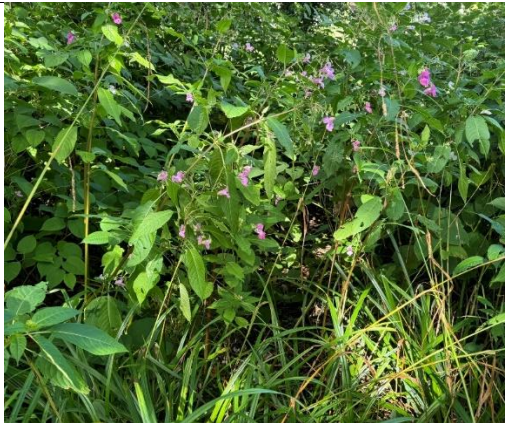
Image 74 - Ynysarwed Isaf Lock currently inoperable

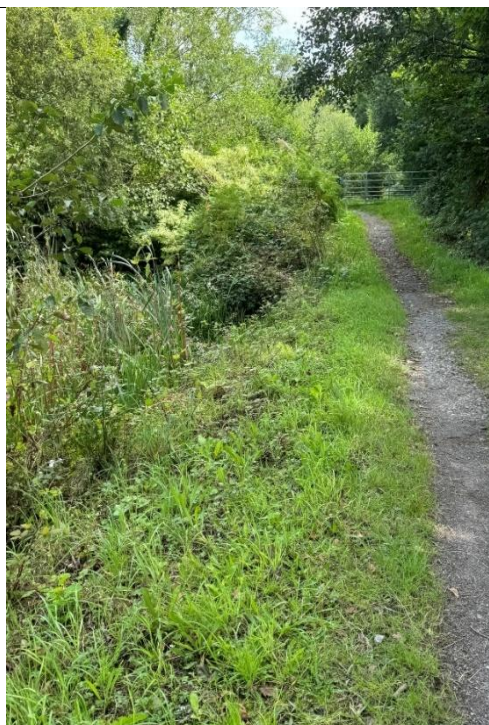
Image 76 – Canal clogged with reeds near Ynysarwed Isaf Lock

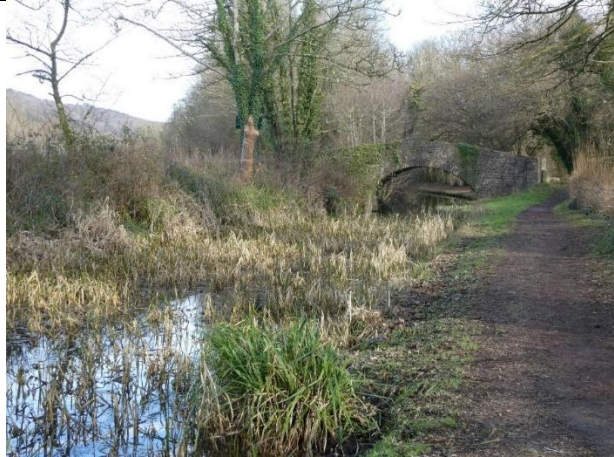
Image 81 – Crugiau Lock now inoperable

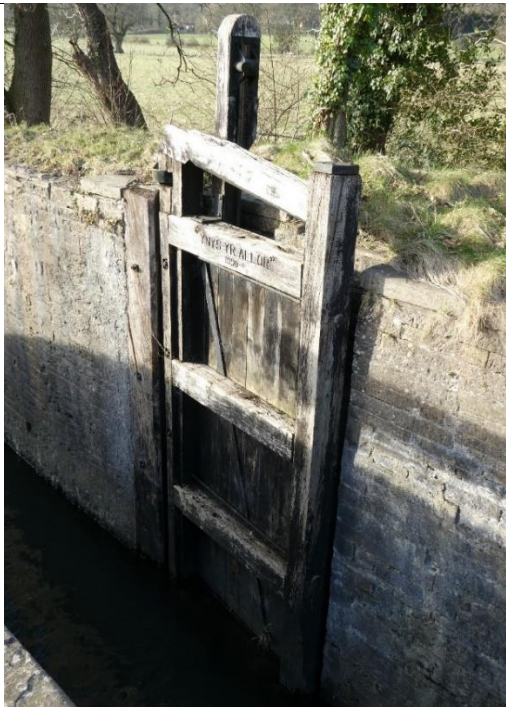
Image 86 - Aberclwyd Lock currently inoperable

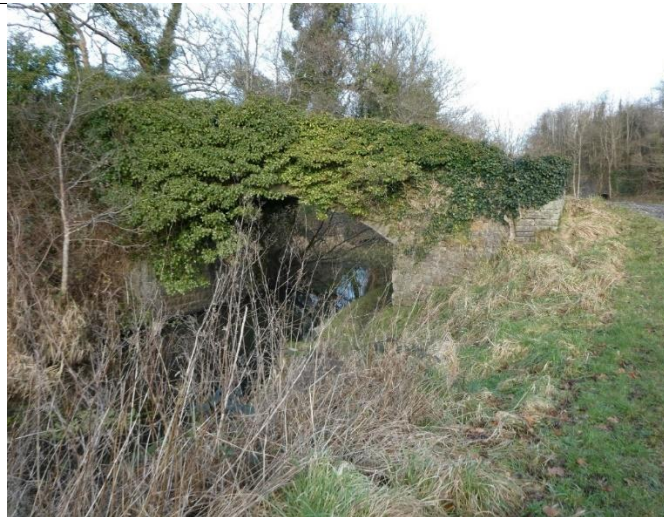
Image 87 – Ynys yr Allor Lock currently inoperable

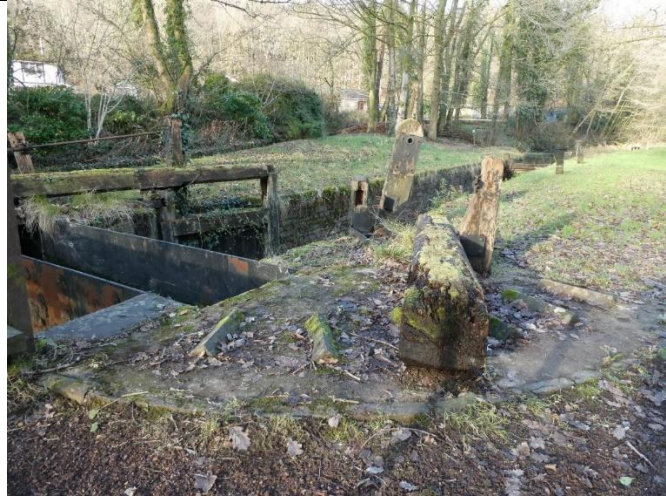
Image 89 - Maesgwyn Lock currently inoperable

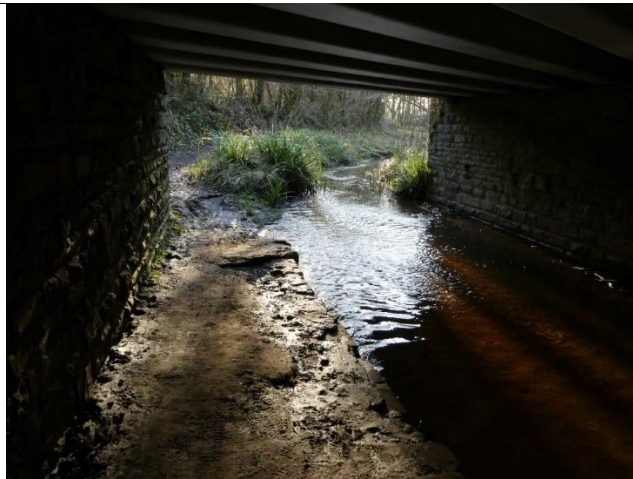
Image 90 – Ysgwrfa Lock currently inoperable

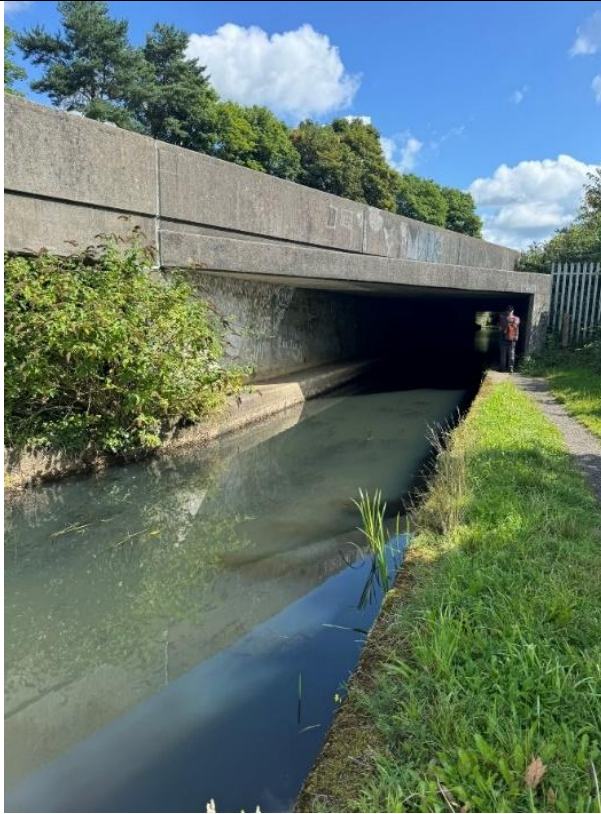
Image 8 – Vale of Neath Railway Canal section in relatively good condition

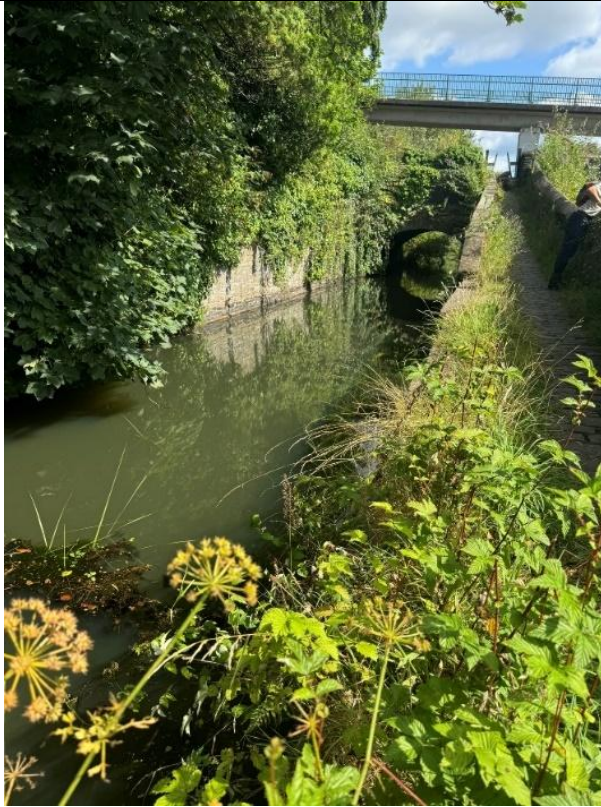
Image 12 – London Main Line Railway canal section relatively clear - tree-lined section of the canal with floating vegetation near the banks, bordered by a grassy towpath where two walkers continue along the route.

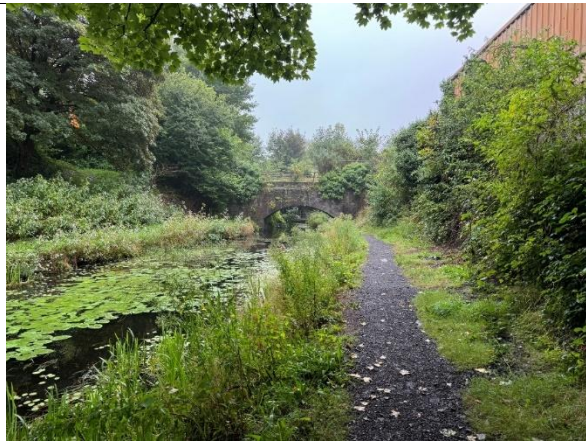
Image 23 – Old Tramroad bridge

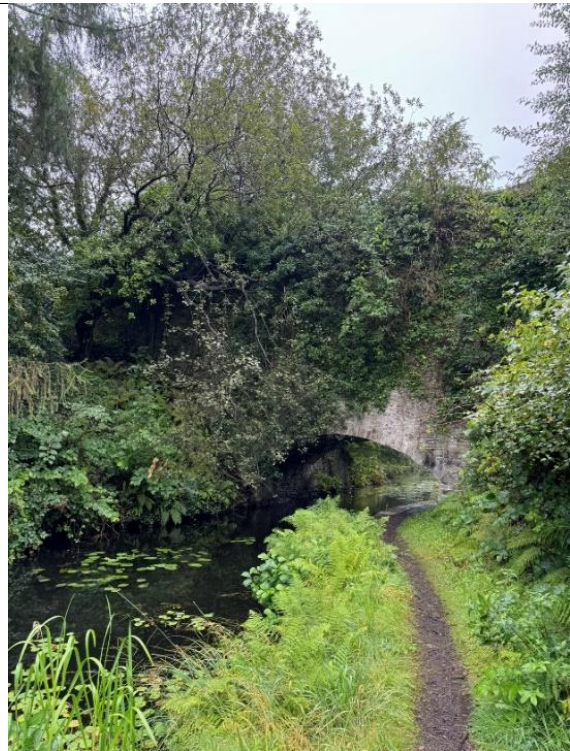
Image 24 – Neath Abbey in Estate New Bridge

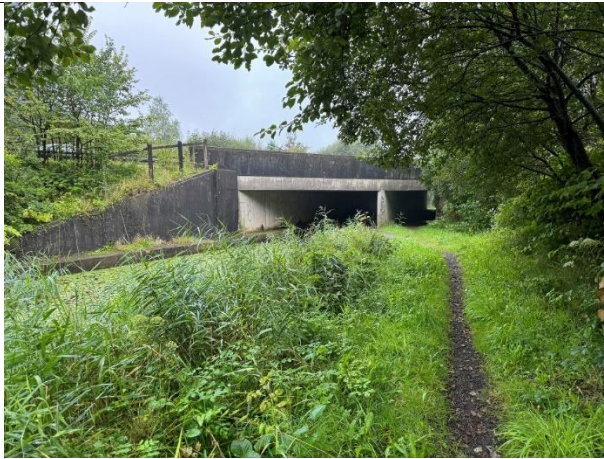
Image 27 – A465 Bridge

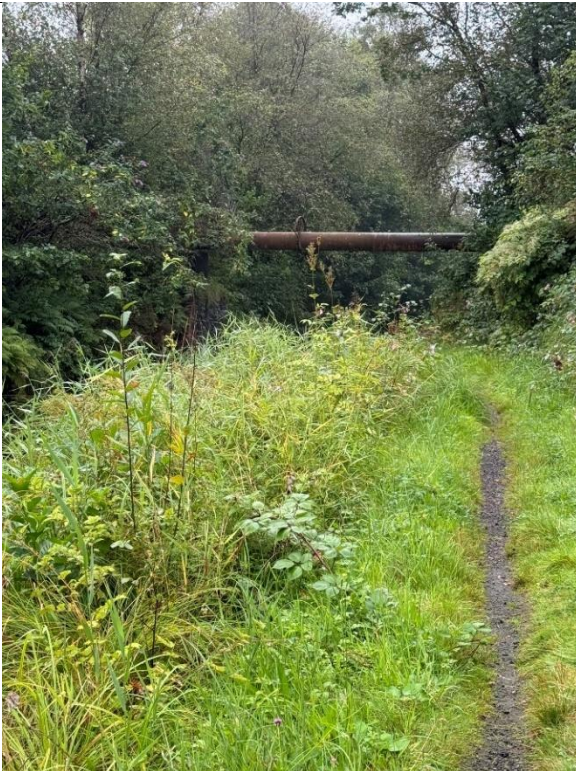
Image 28 – Pipe Bridge

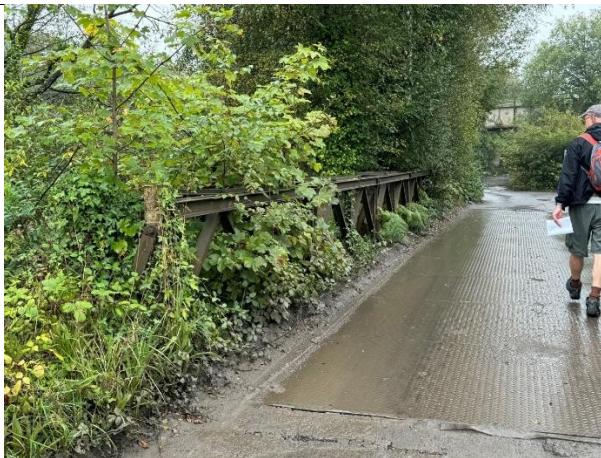
Image 31 – Abbey Wharf Bridge

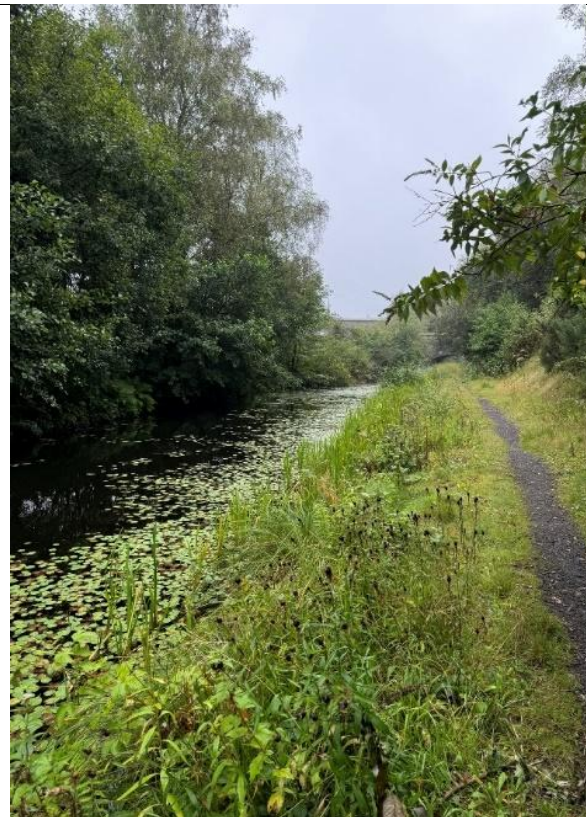
Image 32 – Abbey Wharf Bridge canal condition

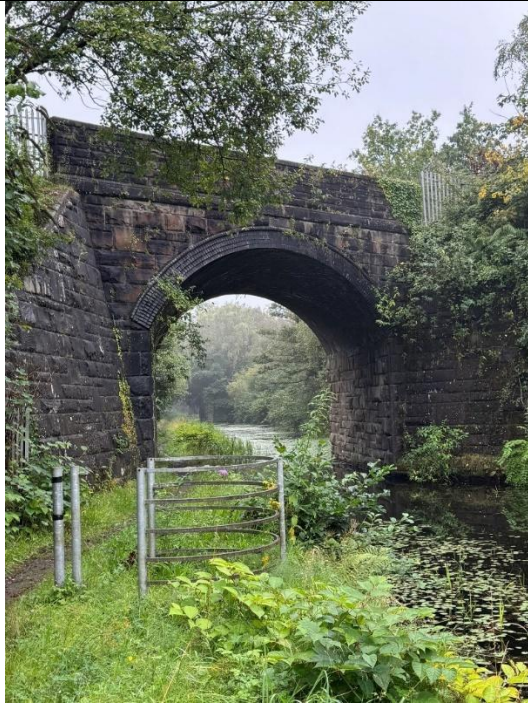
Image 33 – Railway Bridge

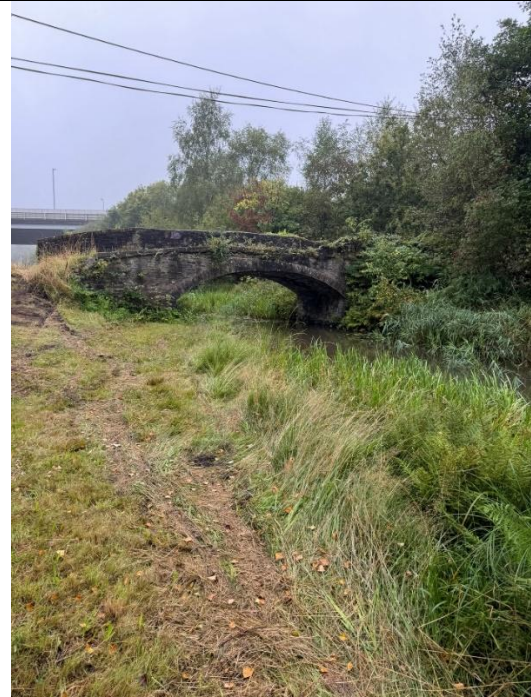
Image 34 – Cwrt yr Betws Bridge

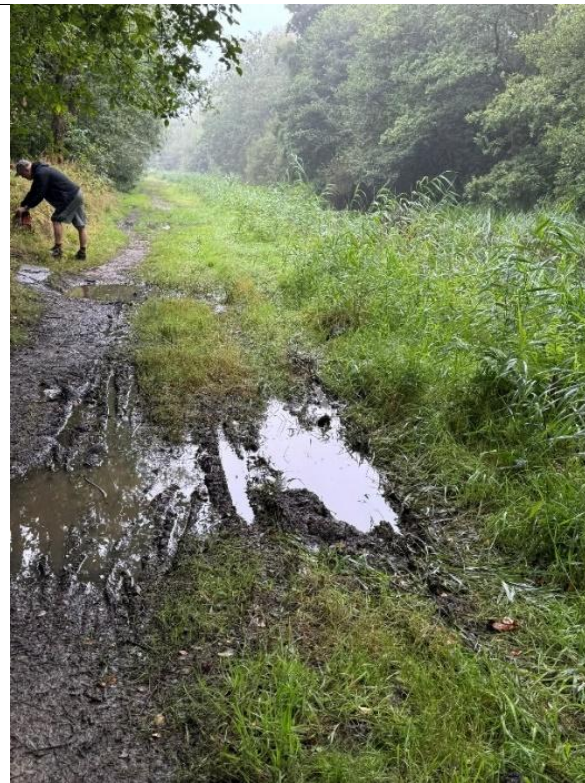
Image 36 – M4 Bridge canal section with minor footpath flooding

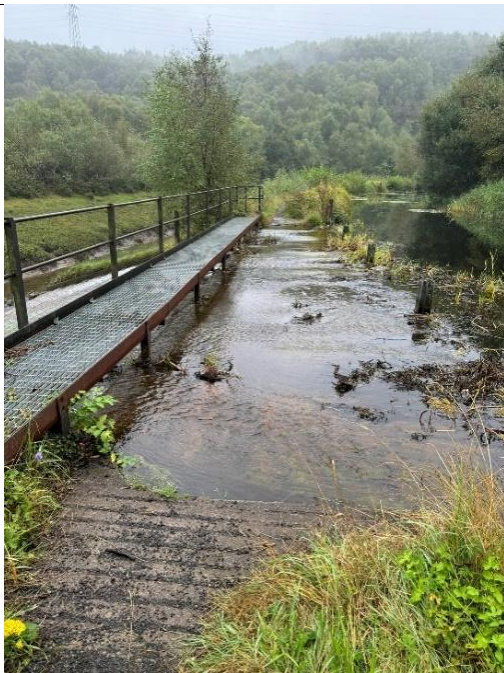
Image 39 – Red Jacket Bridge -

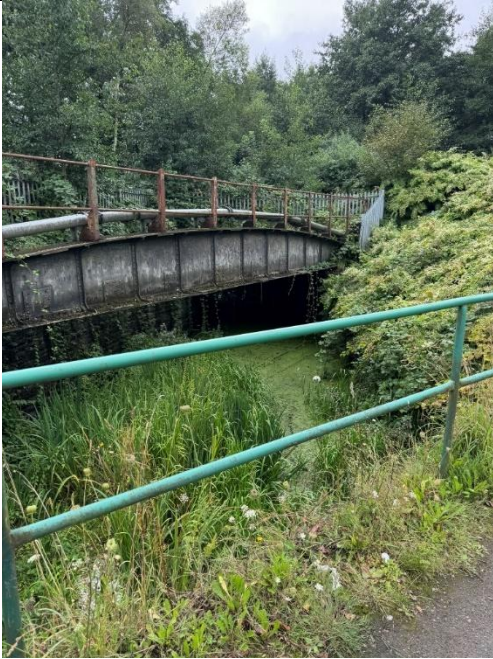
Image 45 – Former Vale of Neath Railway Bridge
